# Lime-Stabilized Test Sections on Route 51, Perry County, Missouri

W.G. JONES, Senior Engineer, Division of Materials Missouri State Highway Department

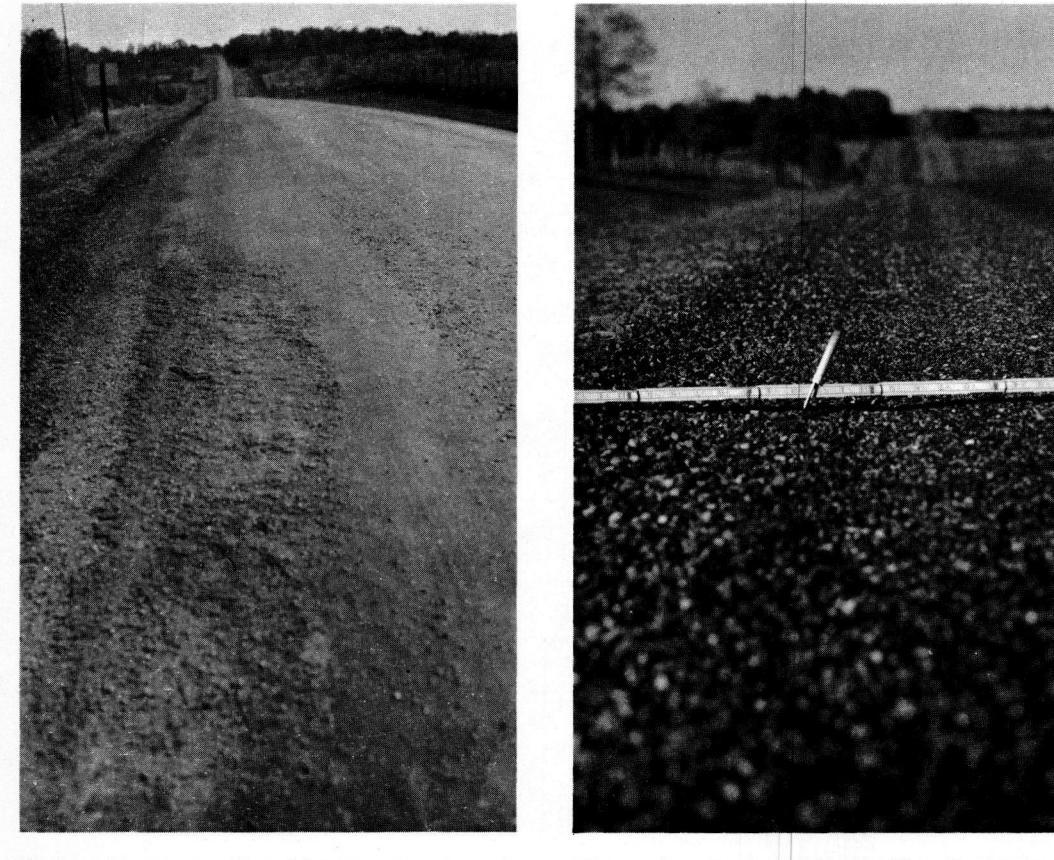
The appearance of this portion is classed as "fair" to "poor." About 12 percent of the total area is showing distress in the form of alligator cracks. This includes about 3 or 4 percent of badly cracked area that is confined to the outer 1 to 2 ft for onefourth of the length. A large part of this edge distress can probably be attributed to thin base. Approximately 600 sq ft (1.2 percent) of complete failure has occurred. Maintenance has consisted of applying light seal in addition to the original seal and placing patches in the failed areas and several other small areas where surface blemish has occurred.

Figure 1. Waste lime, Section I, general view.

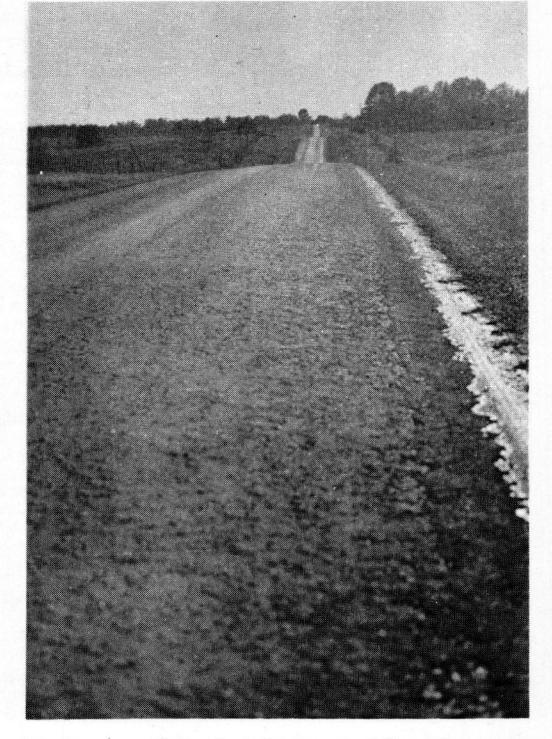
Figure 3. Hydrated-quicklime, Section I, general view.

The appearance of this section is classed as "fair" to "good." About 450 sq ft (0.9 percent) of the area is showing distress in the outer 4 ft while another 5 percent of the surface area shows distress in the outer 1 to 2 ft (thin base at the edges is again probably the main factor). A regular shrinkage crack pattern (blocks of about 4 to 6 ft square) occurs throughout this section, the only section showing such pattern. Maintenance has consisted of resealing the section and patching some small areas to correct surface blemishes.

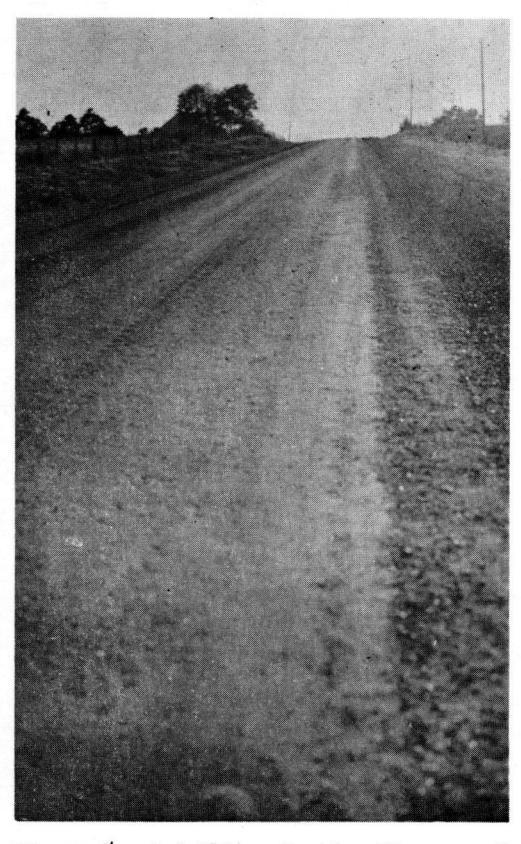
Appearance of this section is rated "good" to "excellent." One area covering 90 sq ft (0.4 percent of total area) has failed and has been patched. Approximately another 1 percent of the area is showing slight distress in the outer 4 ft. There is also a slight amount of edge ravelling and some minor surface blemishes. A been placed by maintenance.

Figure 5. Quicklime, Section II, general view.

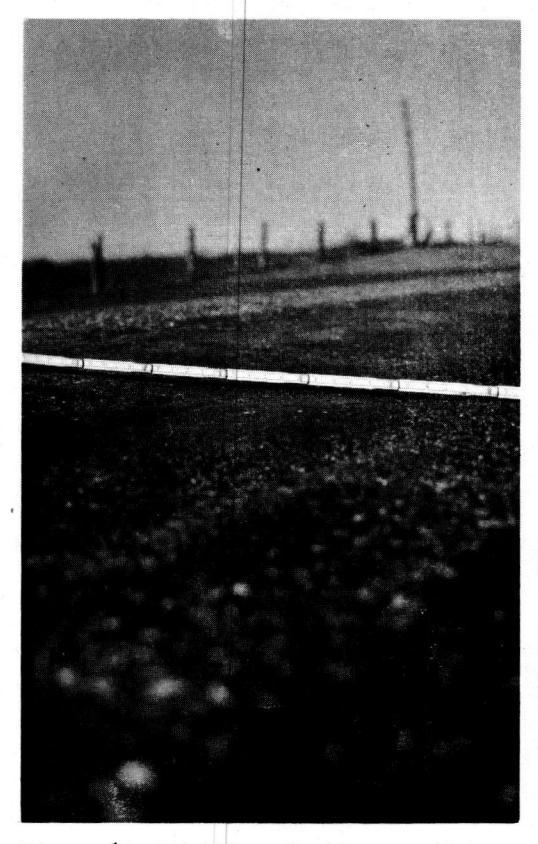
Figure 6. Quicklime, Section II, distortion in outer wheel track.

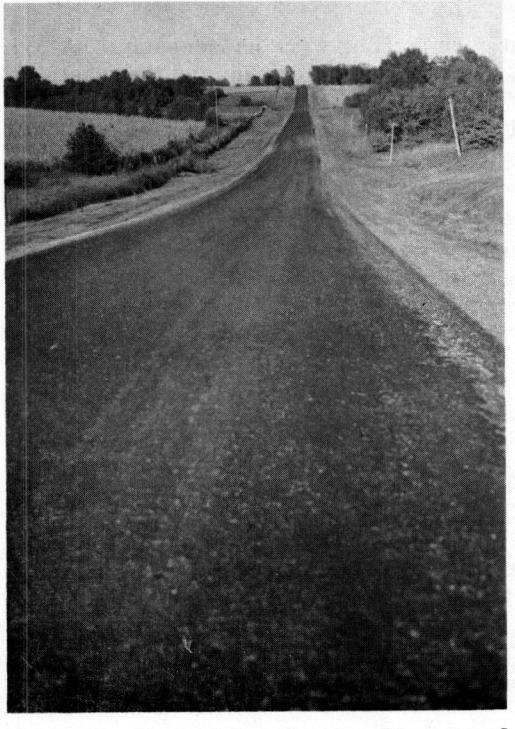
The appearance is rated "good." About 600 sq ft (1.1 percent) is showing distress in outer 4 ft. About another 2 percent of the surface area is showing distress in the outer 1 ft along the edges. Much of this distress can be attributed to thin base at the edges. A light drag seal has been placed on the section since the original.

Figure 7. Waste lime, Section II, general view.

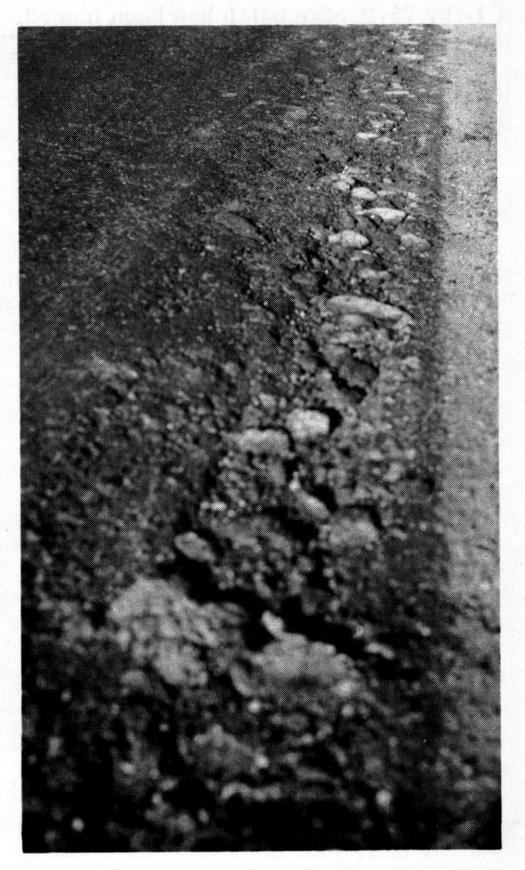
Figure 8. Waste lime, Section II, edge distress.

A large part of the distress occurring in the lime sections is along the edges where thin base is found. This is especially true in the waste lime sections where a combination of thin base and inadequate hardness is found.
