# DYNAMIC TESTS OF AN ENERGY-ABSORBING BARRIER EMPLOYING WATER-FILLED CELLS

Eric F. Nordlin, James H. Woodstrom, and Robert N. Doty,  
California Division of Highways

The results of four full-scale vehicle-impact tests into energy-absorbing barriers using water-filled plastic cells and cartridges are reported. This barrier absorbs the energy of an impacting vehicle through the movement of water horizontally as the barrier is shortened and vertically through orifices as the flexible water cells and cartridges are compressed. The recorded vehicle passenger-compartment decelerations indicated that, although unrestrained occupants would sustain moderate to severe injuries, in most cases, during 60-mph collisions with this barrier design, fully restrained (seat belt and shoulder harness) occupants would sustain little or no injuries during the majority of 60-mph impacts into the nose or side of the barrier. In addition, the barrier did not generate unstable vehicle behavior and, in conjunction with the bridge approach guardrail backstop, effectively redirected a vehicle impacting from the side. The overall barrier performance showed significant improvement over the concrete wedge-shap

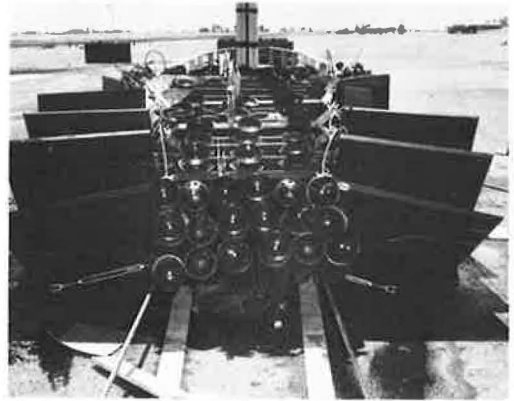
Figure 9.

The barrier itself remained intact (Fig. 9). However, some damage was sustained as many of the fender panels were scarred, and most were damaged on the rear-bottom corners where they were thrust into the ground as the barrier was compressed (Fig. 10). The edges of several diaphragms were broken or showed delamination of the plywood; hinges between fender panels and diaphragms were bent or broken in several locations. Damage was less severe toward the rear of the barrier. There was no damage to the steel backup structure. Static barrier displacement was 9.3 ft.

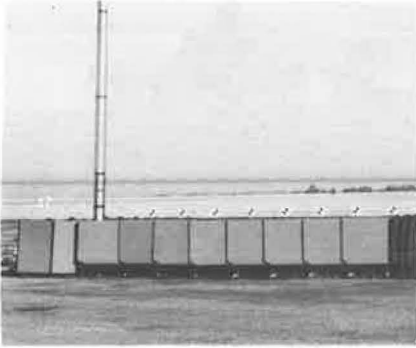
Figure 11.

Barrier Description—In test 216, the barrier used for test 215 was modified by cutting off the lower 6 in. of all the fender panels and cutting the lower rear corner of the panels on a diagonal to eliminate penetration of these trailing corners into the runway, as had occurred during test 215 (Figs. 11 and 12). Also, metallic shoes (or skids) were added to the lower edge of interior panels, heavier hinges were used to attach the fender panels to the diaphragms, and all the evaporation flaps were removed to lessen, at least to some extent, the lateral discharge of the water and danger of loss of telemetry signal.

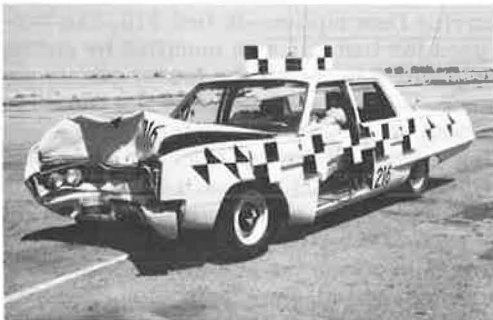
Figure 13.

The maximum crush of the vehicle forestructure was 20 in.; it occurred at the center of the vehicle (Fig. 13; Appendix Fig. 24). Buckling of the car body was indicated by a crimp in the roof over the door post on both sides of the car. The engine deflected the firewall back 1 to 2 in. Steering wheel deformation was  $1\frac{1}{4}$  in. The steering column collapsed 2.9 in.

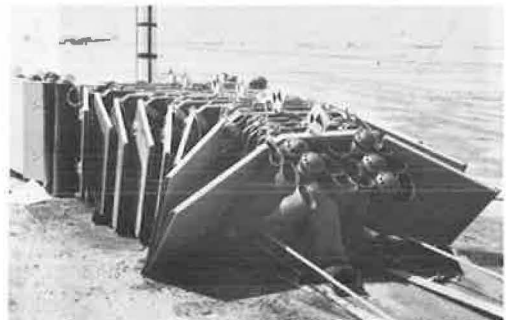
Figure 14.

Fender panels on the left side of the first three modules were scarred. The bottoms or top inserts or both were blown out of 16 cartridges. The barrier moved straight back with negligible lateral movement or buckling. Maximum vehicular displacement of the barrier was 16.3 ft, but the at-rest displacement of the barrier nose was only 10.7 ft (Fig. 14).

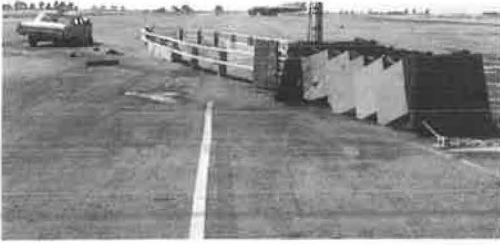
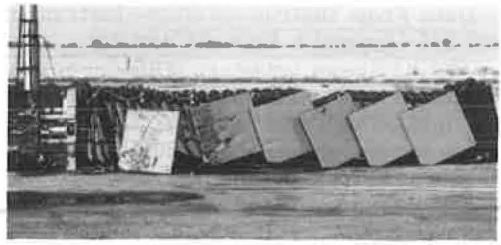
Figure 16.

Several fender panels were torn off the barrier on the left side, mainly because of hinge failures. Two panels were thrown 8 ft beyond the final position of the car and two panels were lodged in the crushed front end of the car. The five cells on the left side of the bridge approach guardrail were all torn off and scattered along the path of the car. Shear pins in the secondary cables sheared off. Permanent displacement of the barrier nose was 1.5 ft (Figs. 16 and 17).

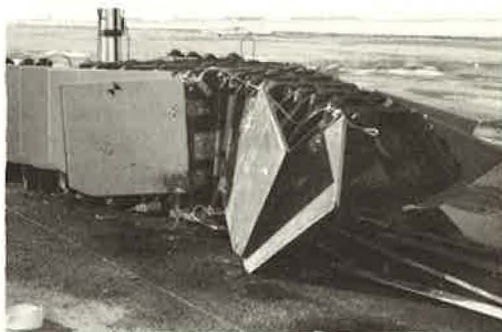
Figure 19.

Maximum vehicular penetration was 15.3 ft, and permanent displacement of the barrier nose was 11.7 ft. There were delamination and splitting of some of the interior panels and diaphragms, bent and broken hinges, and gouging of some of the fender panels. However, no parts became detached from the barrier (Fig. 19).
