AN EVALUATION OF THE IMPACT RESPONSE OF VARIOUS MOTORIST-AID CALL SYSTEMS

J. E. Martinez and D. E. Hairston, Texas Transportation Institute,
Texas A&M University

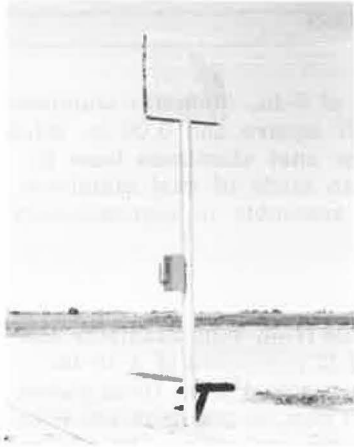
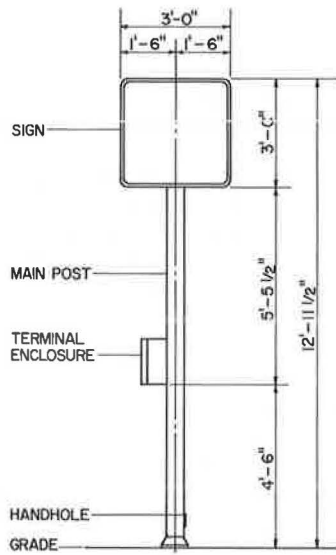
Figure 1. Illinois call-box assembly.

The Illinois installation consists of a support post made of 5-in. diameter aluminum tubing with $\frac{1}{4}$ -in. thick walls. Two aluminum signs, 3 ft square and 0.08 in. thick each, are bolted to the top as shown in Figure 1, and the cast aluminum base is welded to the support post. The terminal enclosure, also made of cast aluminum, is clamped to the support with steel bands. The entire assembly is approximately 13 ft high (Fig. 1).

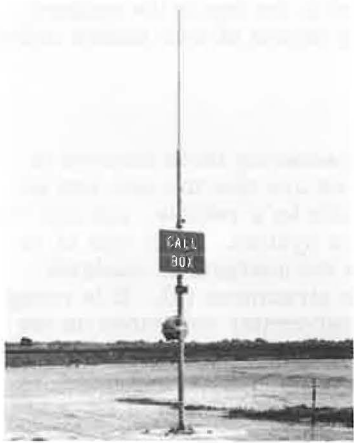
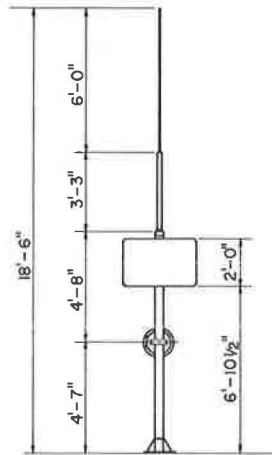
Figure 2. Maryland call-box assembly.

The Maryland installation consists of a support post made from 3-in. diameter aluminum tubing with $\frac{1}{4}$ -in. thick walls. The base of the post is composed of a 10-in. square aluminum plate with a thickness of 1 in. and gusseted with $4\frac{3}{8}$ -in. thick plates. The terminal enclosure (call box) is clamped to the support post by means of two bolts and a steel band, and the antenna is connected to the top of the support post by a friction joint. The structure is more than 18 ft high (Fig. 2).

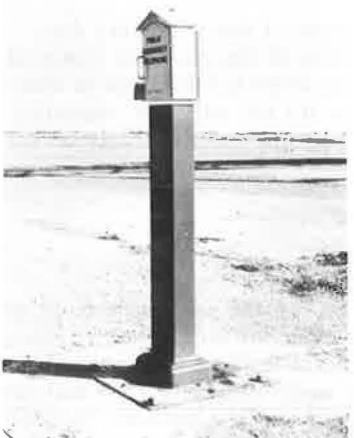
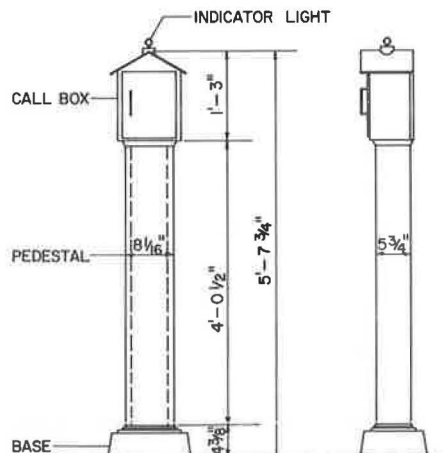
Figure 3. Ohio call-box assembly.

The Ohio installation consists of a hollow rectangular support post made of steel that has a cast metal base. The terminal enclosure is fixed to the top of the support post, and the assembly is bolted to a concrete foundation by means of four anchor bolts. The structure is approximately $5\frac{1}{2}$ ft high (Fig. 3).
