FAULTING OF PORTLAND CEMENT CONCRETE PAVEMENTS

D. L. Spellman, J. H. Woodstrom, and B. F. Neal, California Division of Highways

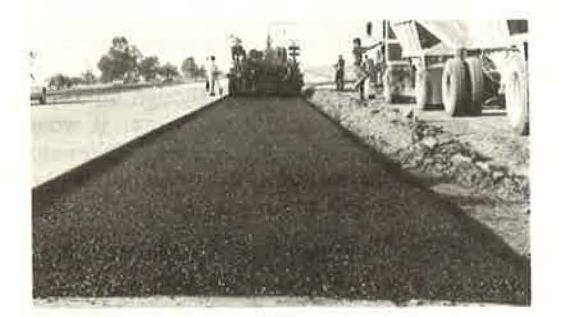
2. One section was placed on I-5 near Willows in northern California. The aggregate base of the shoulder was replaced with permeable AC (very open graded) in a 1,000-ft section (Fig. 1).

Tests were performed using typical CTB aggregates from six sources. The aggregates from these sources had a representative range of characteristics such as durability, particle shape, and geological origin. The CTB specimens were fabricated by following routine procedures and by using the cement content necessary to obtain a Figure 1. Permeable AC shoulder being placed on I-5.

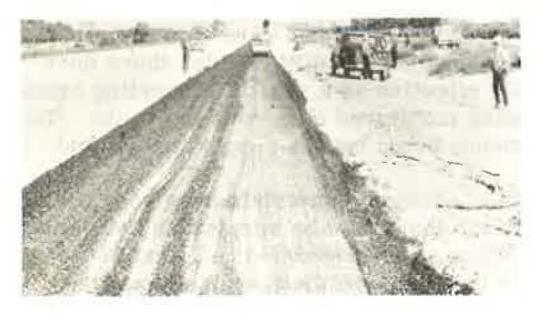
3. Two 2,000-ft sections were placed on US-99 south of Sacramento. In section 1 a seal consisting of a fiberglass-reinforced plastic strip (2 ft wide) was placed along the edge of the slab and over the widened CTB in the shoulder. Aggregate base and AC were then placed as usual (Fig. 2). In section 2, the aggregate base was replaced by permeable AC (Fig. 3).

Figure 3. Rolling of permeable AC, US-99.

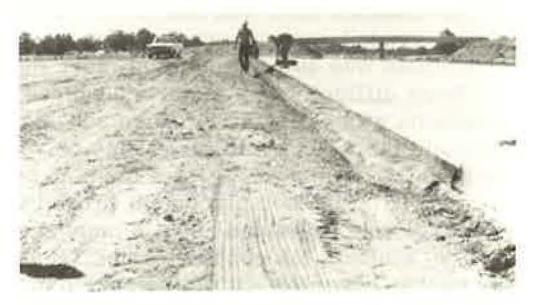
Some difficulty was also encountered in placing the membranes. Although an asphalt emulsion was satisfactory as an adhesive for the membranes on flat surfaces, it would not hold them for a sufficient time on vertical surfaces. As a result, it was necessary to hold the membrane against the slab by hand while the aggregate base was being placed against it. Finished placement proved to be satisfactory, at least for the plastic; the shoulder was examined about 8 months after placement. The material was found to be solidly stuck to the concrete and CTB and had conformed to all irregularities caused by excess concrete left on the edge during pavement construction (Fig. 5). The material cost for fiberglass-reinforced plastic was about \$600 per mile, whereas the cost of the layered coal tar and fiberglass was about three times as much. The underground life of the plastic is unknown; however, if the theory of its use is correct, it would probably be sufficient to at least delay faulting for many years.

Figure 5. Shoulder opening showing plastic conforming to irregularities.

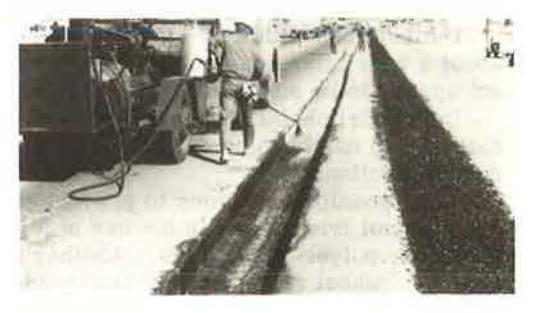
5. Two 2,000-ft sections were placed on I-80 west of Sacramento. This was a partial shoulder replacement of a pavement that had been in service about 8 years and had moderate faulting. A 2-ft wide section of the outer shoulder adjacent to the slab was removed down to the bottom of the slab. Loose material was broomed away, a tack coat of asphalt emulsion was applied, and then 0.5-ft permeable AC and 0.25-ft dense-graded AC were used to complete the shoulder. A 2,000-ft section was replaced in both the eastbound and westbound lanes. The basic objective of this work was to eliminate erodible shoulder material from the areas adjacent to the slab to see if faulting could be arrested. In addition to providing erosion resistance, the permeable AC is expected to provide better drainage that may also help reduce faulting tendencies. Performance of the test sections will be compared to that of adjacent untreated areas (Fig. 4).

Figure 4. Partial shoulder replacement, I-80.

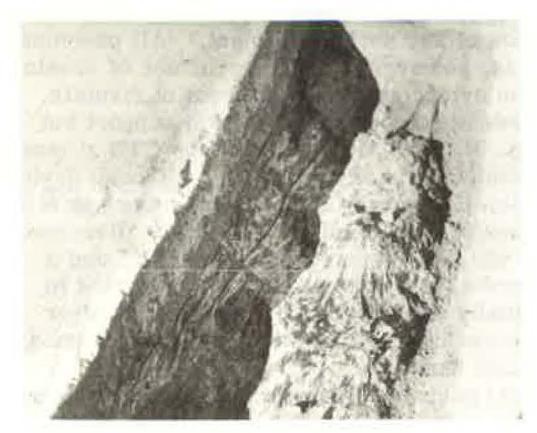
At several locations, tracer sands were placed under slabs near the joints and under the shoulder pavement prior to removal of the 3- by 6-ft sections. Upon exposure, definite evidence of strong water action was found under the leave slab but less action under the approach slab. Small channels caused by rapid water movement were evident under the leave slab at some sites. At one location, there were indications that the water may have moved in a circular path or at least involved strong movement in a direction transverse to the centerline of the pavement in addition to longitudinal movement.

Although base settlement has long been suspected as a cause of faulting, there was no evidence found during the field investigation of any such settlement. (All pavements opened had cement-treated bases.) There was, however, positive evidence of erosion of the base surface under the leave slab. The evidence was in the form of rivulets caused by water movement, which might result in some lack of uniform support but would not allow the slab to be depressed (Fig. 6). The top portion of the CTB at many locations has been found to be loosely cemented and readily erodible. Although drying of the surface before curing may be responsible for part of the problem, much is felt to be due to the trimming operation used to conform to grading tolerances. Because a high base will result in thin pavement, for which a contractor is penalized, and a low base results in the use of excessive concrete, considerable effort is exerted in obtaining the proper grade. Trimming is usually done about an hour or more after original placement. The surface material, once loosened, is never fully rebonded and so does not form a monolithic erosion-resistant base.

Figure 6. Channels indicating water movement on CTB surface.

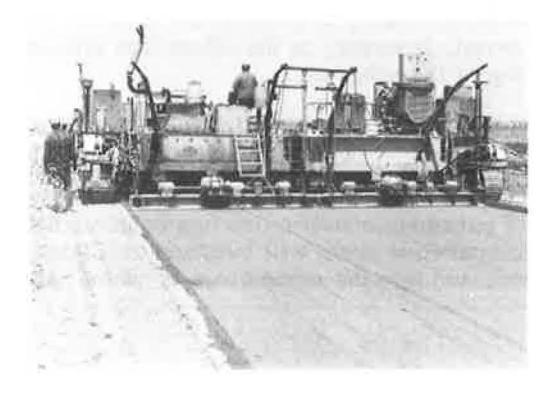
Recently it has been noted that a few contractors are changing their CTB placing methods. They have changed to central mixing, whether required or not, and to placing with a slip-form paver. Instead of a wet mix and internal vibration, they use the regular dry mix and a vibrating screed behind the paver, followed by rollers. This results in a much harder appearing surface and trimming is seldom if ever, necessary. Unfortunately, there is no test method available for measuring the abrasion resistance of CTB in place. If the trend to the type of construction continues, our objection to CTB due to trimming may be overcome (Fig. 7).

Figure 7. Placing CTB with slip-form paver.
