# Dynamic Testing of Malleable Aluminum Transformer Bases for Highway Luminaires

John E. Haviland, New York State Department of Transportation  
David J. Segal, Calspan Corporation, Buffalo, New York

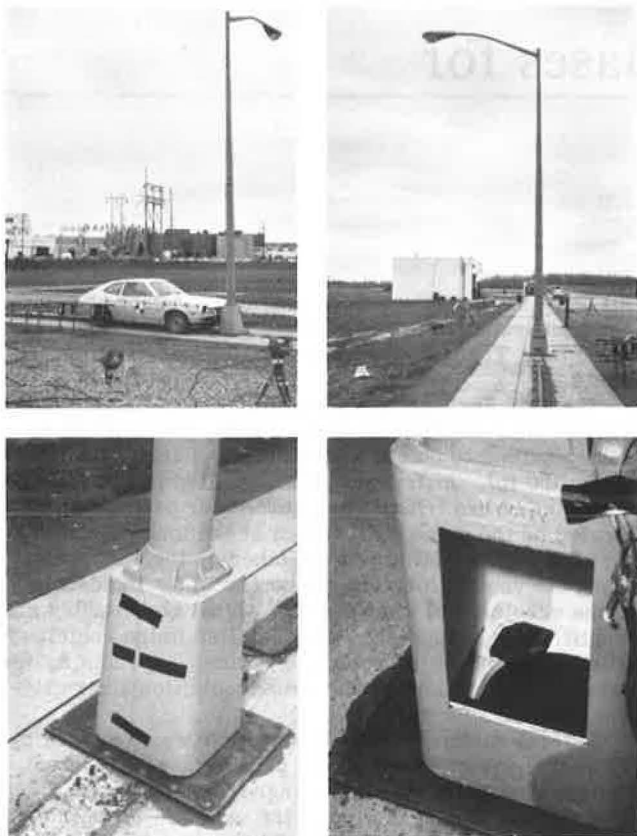
Figure 1. Typical installation of pole and base for impact testing.

Photographs of a typical installation are shown in Figure 1.
