# Nondestructive Inspection of Overlaid Bridge Decks with Ground-Penetrating Radar

#### GERARDO G. CLEMEÑA

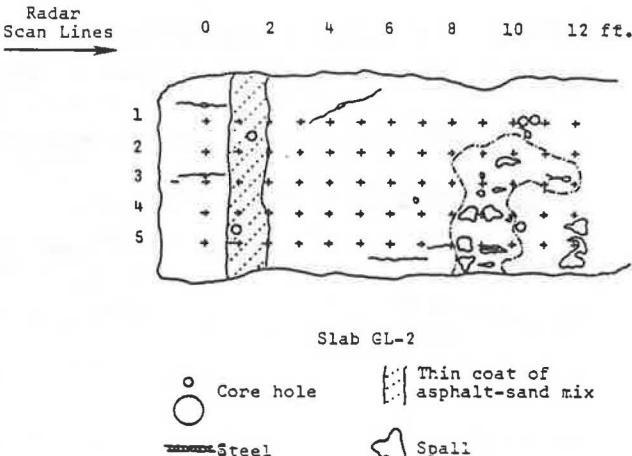
#### Figure 6. Condition of concrete deck slab.

Spall Delamination slabs, labeled GL-2, as determined by visual inspection and sounding with chains and a hammer. The radar survey on this slab consisted of five linear scans made at 1-ft intervals along the length of the slab with the use of an 8-in sand spacer. The resulting set of five radar reflection profiles is shown in Figure 7. These profiles are guite similar to those recorded for the other deck slab studied.

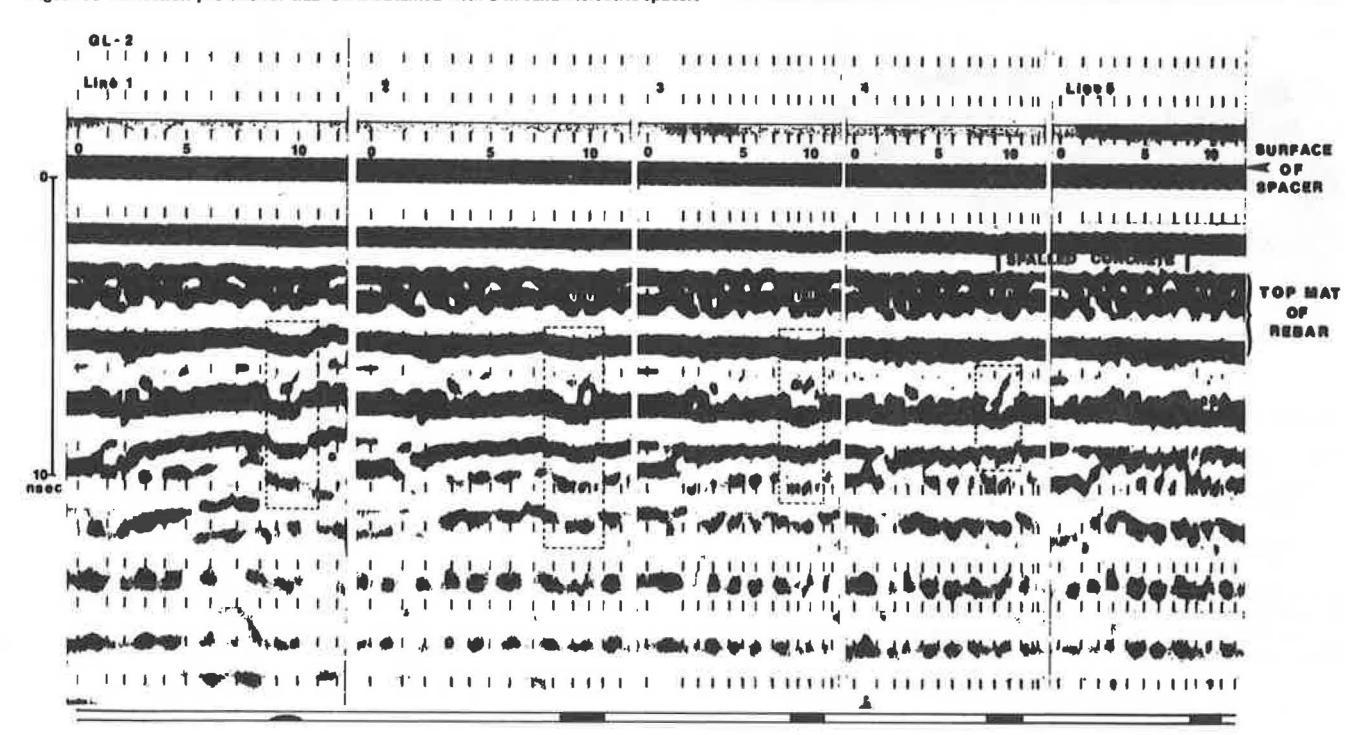
Figure 7. Reflection profiles for slab GL-2 obtained with 8-in sand dielectric spacer.

Examining Figure 7, one can observe that, at approximately 4 ns (i.e., around the third and fourth bands), the reflection pattern assumed the shape of blips. These blips and other sharper ones, shown in profiles presented later, characterize reflections from the relatively small cross section of rebars and therefore would serve as a prompt indicator of such reflections.

After identifying the reflection bands from the rebars, the next step is to search for any irregularities along them. Looking first at scan line 1, one can see a distinctive depression from the 8- to ll-ft marks along these bands. This depression corresponds to the nearby large delaminated area, which was located by conventional sounding on the right side of the slab (Figure 6). In scan line 2, the same feature appeared from about the 8- to ll-ft marks, where the transducer went directly over the delamination. This feature was similarly observed in the remaining scans, except in scan line 5, where it was practically not discernible. The slight rugged feature to the left of the depression and in about the 0.5- to 3.5-ft area cannot be fully accounted for by the asphalt-sand band. It is probable that there was incipient deterioration along both sides of the asphalt-sand band, since those areas were wheel paths and most of the delaminated areas in these slabs were found to be located in the wheel paths.

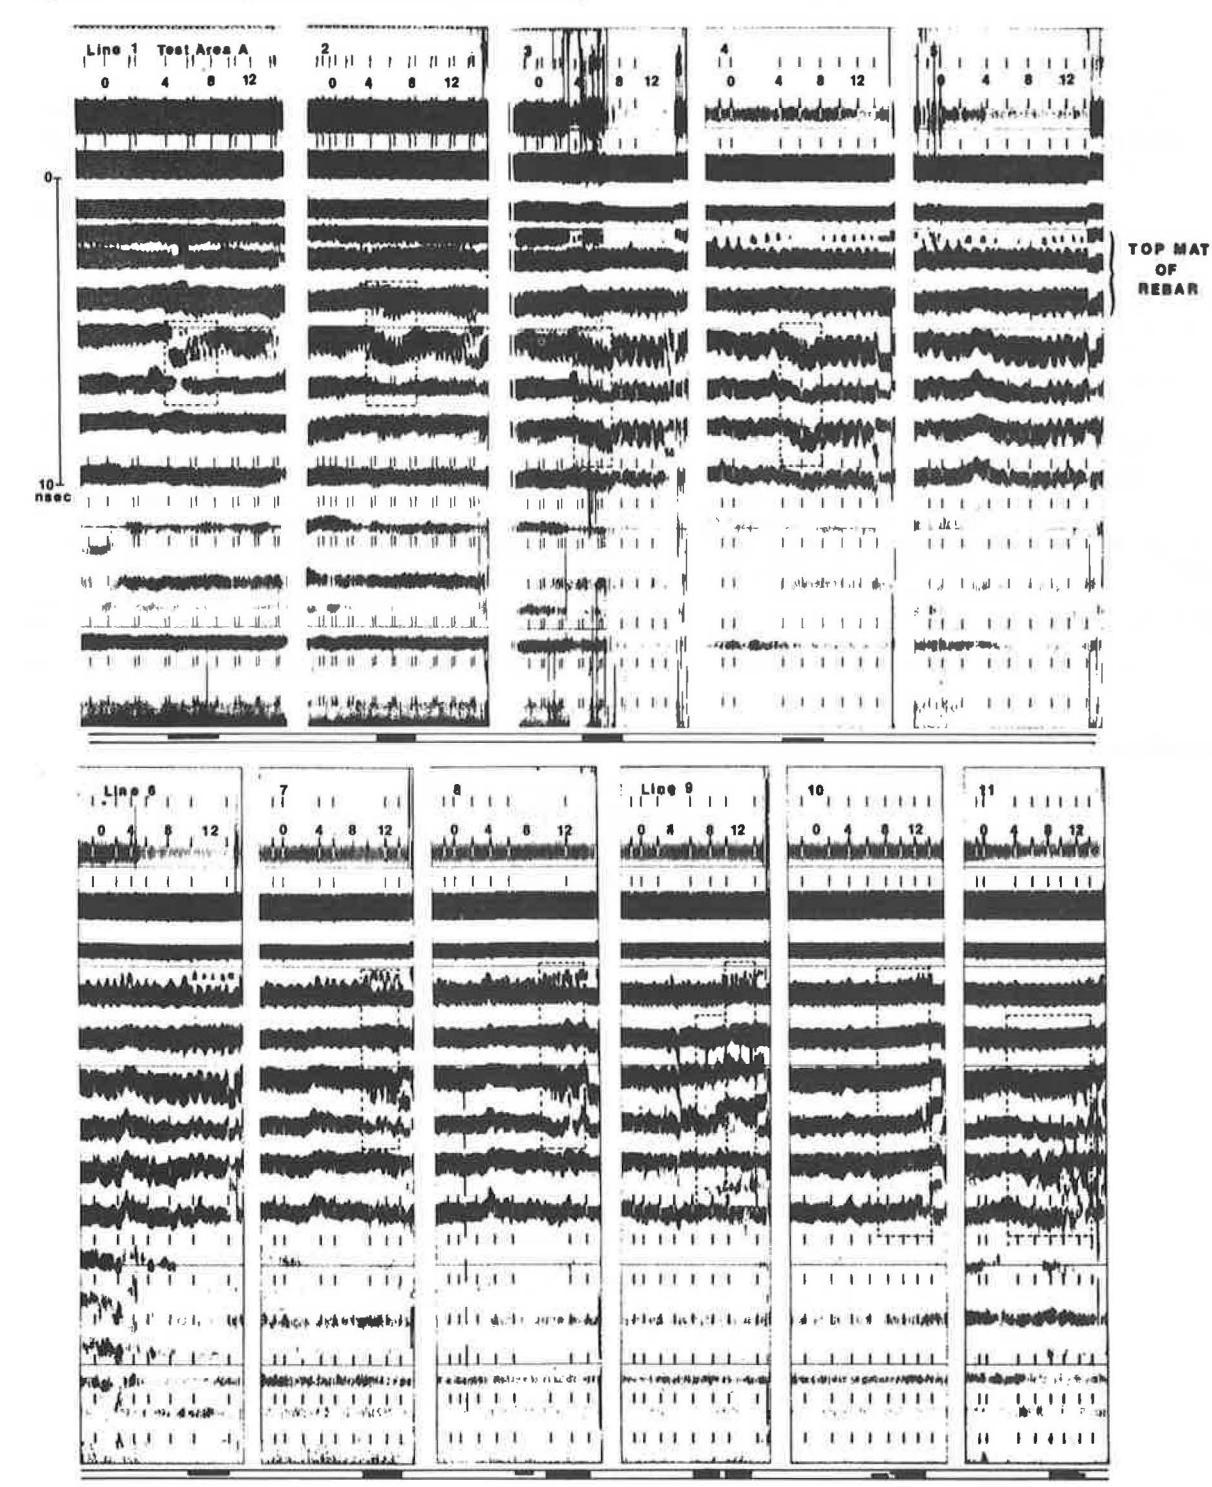
Figure 9. Some reflection profiles for test area A in concrete deck 1.

Figure 8 shows that test area A contained two large delaminated areas and a relatively smaller one. The large delaminated area located between the 4- and 8-ft marks was detected by the transducer as it went over the area with the 4-in dielectric spacer on scan lines 1 through 4, as shown in Figure 9. The transducer began to "see" the other large

delamination, which is in the upper-right quadrant of the test area, in scan line 7. The neighboring smaller delamination was not noticed until scan line 9, and even then it was not distinguished from the larger one. However, it is probable that the entire quadrant was delaminated, as indicated in scan line 11. Furthermore, for practical purposes, delineating the two neighboring delaminations may not be important.
