Repair of Timber Bridge Piling by Posting and Epoxy Grouting

R. RICHARD AVENT

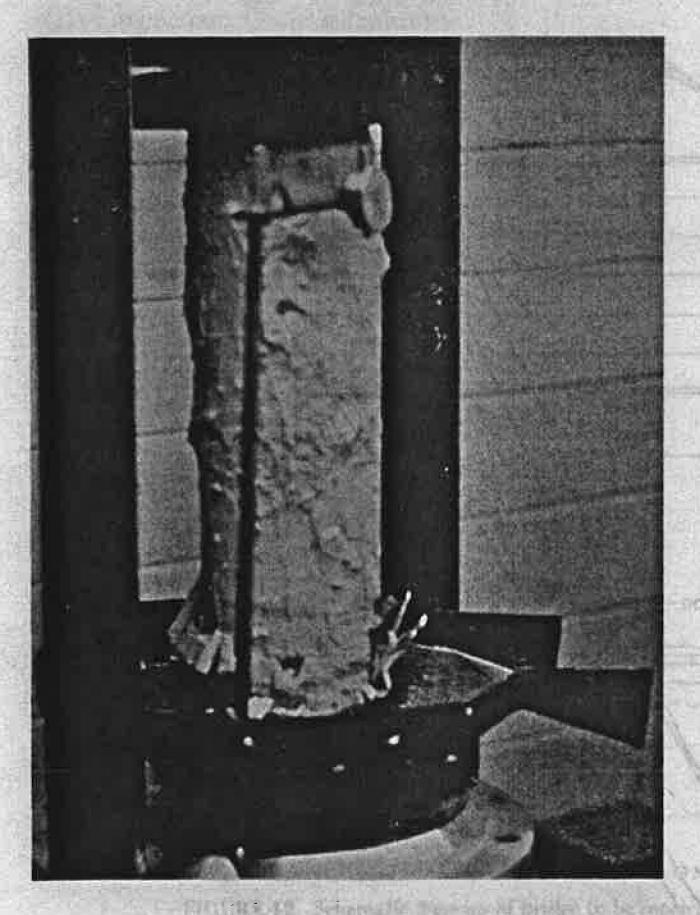
FIGURE 9 Failed compression test specimen.

Because the column sections were only 24 in. long, the member stiffness had little influence on the strength. However, these tests indicate that the epoxy-repaired section is as strong as the timber itself in pure compression.

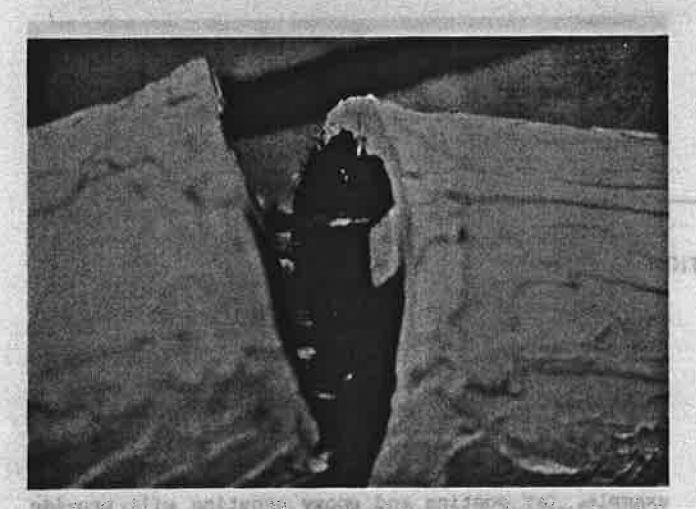
FIGURE 10 Failed joint of a typical flexural test specimen.

A failed section is shown in Figure 10. An examination of each of these sections indicated that the extreme fiber tension section failed initially. The

failure did not occur at the epoxy-to-wood bond, but rather in the epoxy itself. This failure type indicates the effectiveness of the pressure-injected epoxy at the bond line because the epoxy failed before the bond. A load-deformation curve was plotted for each specimen. These plots are shown in Figure 11. It can be seen that the stiffnesses of the epoxy-repaired sections are similar to that of the control specimen, which was a solid section of the same stock. Although not measured, it should be noted that the failures represented ductile behavior. After ultimate load was obtained, the spiral bars provided a significant level of reserve ductile strength.

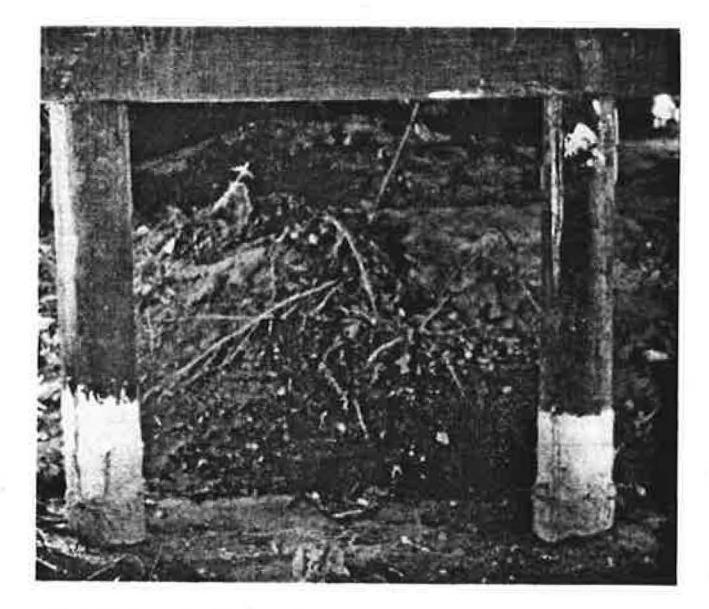
FIGURE 15 Piles Number 1 (left) and Number 2 (right) 1 year after repair.

Number 3 showed no migration problems. For each case, a nozzle back-pressure of approximately 20 psi was obtained. A set of permanent deflection measuring devices was placed on each repaired joint as shown schematically in Figure 17. These devices are being monitored over a multi-year period to evaluate longrange behavior of the epoxy-repaired piles. The results from the gauge readings over the first 2 years are given in Table 4 and indicate that practically no relative movement has occurred at any of the epoxy bond lines.
