Construction of a Geogrid- and Geocomposite-Faced Soil-Nailed Slope Reinforcement Project in Eastern Canada

COLIN ALSTON

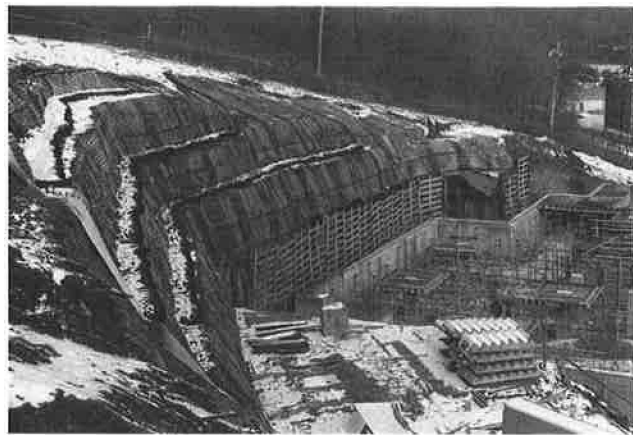
FIGURE 6 Geotextile-geogrid-faced permanent slope and geotextile-timber-grillage-faced temporary slope.

consequence of this delay was that the temporary slope, including the relatively weak woven geotextile surface membrane, was required to remain in service throughout the entire winter season and spring thaw. During this time, some relatively large slabs of soil dislodged from the soil face, primarily as a consequence of freezing and thawing, and these slabs were too heavy for the woven geotextile surface retention membrane; this resulted in tearing of the geotextile and detachment of the membrane from the restraining blocks that had secured it to the soil nails. Additional support to the temporary slope covering membrane was supplied with a timber grillage in areas where the service life of this slope support system had to be prolonged (Figure 6), and this application was successful.

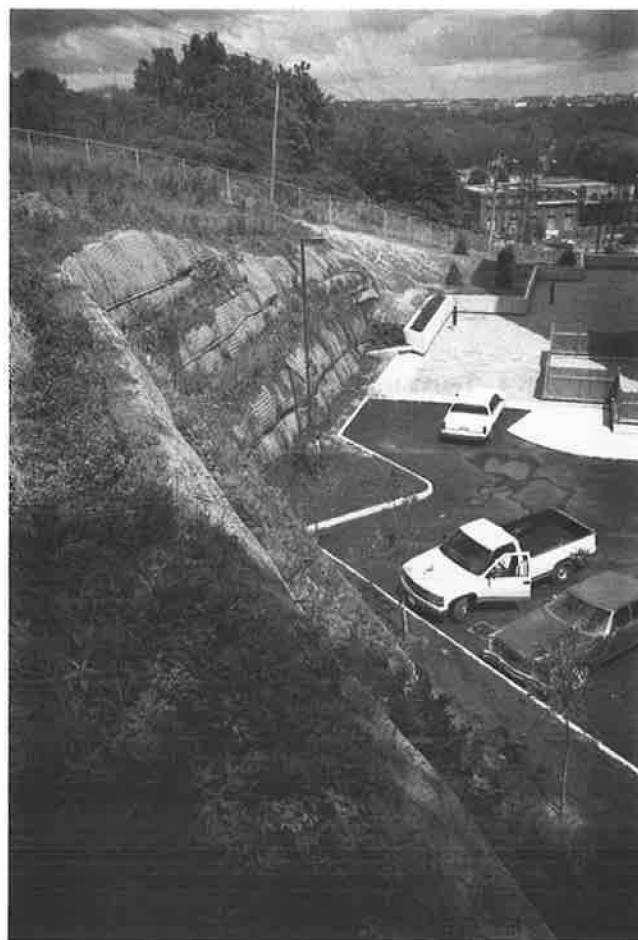
FIGURE 7 Completed slope in area of Figure 6.

The permanent slope at the Cambridge site is now structurally complete; it is being vegetated with creeping vines as visual screening. Photographs of the geogrid-surfaced and geocomposite-faced areas of the slope are presented in Figures 7 and 8. Since the void filler was injected under the geotextile-geogrid surface area of the slope, there has been no further deterioration, and the slope support is satisfactory.

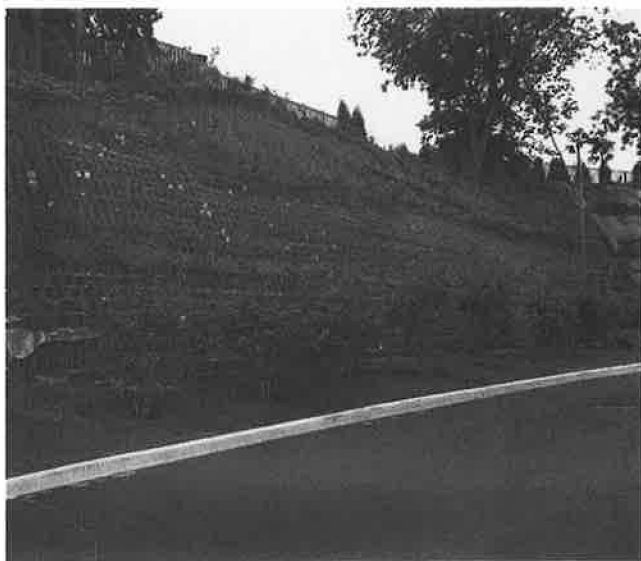
FIGURE 8 Geocomposite-faced slope.

The geocomposite facing has not experienced any problems. Both facing systems permit free drainage of wet areas of the face.

The unfaced portion of the permanent slope suffered surface deterioration and slumping, and the surface profiling was lost through a succession of minor slumps in the face. This necessitated the rebuilding of the face using the geocomposite wall described previously. There was some loss of the design shape in the portion of the terraced slope that had been covered with geogrid and geotextile, but which had not had the void-filling slurry injected beneath the surfacing membrane before the onset of winter.
