THE STABILITY ANALYSIS OF A FOUNDATION FAILURE

BY DONALD W. TAYLOR

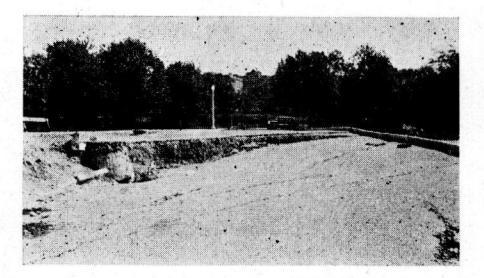
a settlement which in places amounted to 6 ft. In the pond, a little over 100 ft. to the west of the roadway, a small island was raised and greatly increased in size. Figure 2 is a photograph of the slide on the roadway looking toward the south, while Figure 3, also looking toward the south, shows the island. The immediate area of the slide is shown to larger scale in Figure 4.

Figure 2. The Slide Looking South

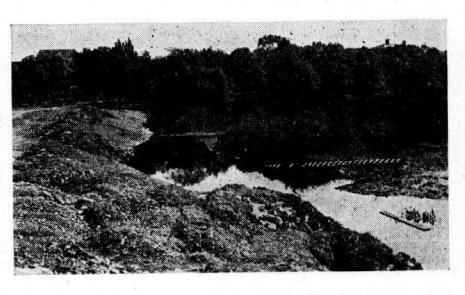
Figure 3. Island in Pond Affected by Slide

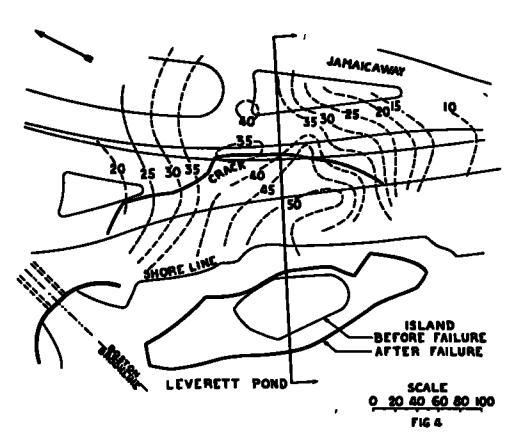
20 ft. below the area which settled, but extending only slightly outside the limits of this area, there was a pocket of peaty silt with a thickness of as much as 50 ft. Figure 4 gives the thicknesses of this stratum, the various dotted lines being lines of equal thickness. The numerous wash borings which had previously been made at the site of the overpass proper had given no indications of this dangerous stratum. Along station 20 + 50 which is normal to the main roadway and approximately through the center of the slide, three undisturbed sample borings were taken, using 6-in. casing. The location of this section is shown in Figure 4 and the section itself in Figure 5. From each of these large borings four samples were

Figure 4. Plan of Slide

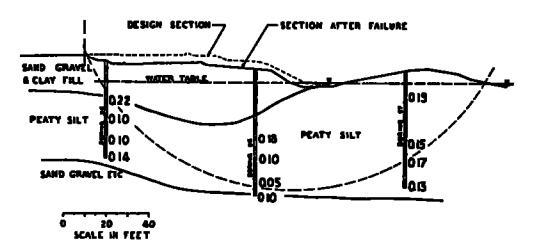
Figure 5. Section Showing Locations of Undisturbed Samples. Shearing Strengths in Tons per sq. ft. given by Large Figures

Before the start of construction the overburden load on the stratum of peaty silt varied from 0.3 to 0.5 ton per sq. ft. The additional load caused by filling for the approach ramp amounted on the average to 0.6 ton per sq. ft. giving an ultimate overburden load of 0.9 to 1.1 ton per sq. ft. Shearing tests were run on all samples at a normal load equal to or slightly less than the overburden load before construction. It was found in this series of tests that there were only minor changes in shearing strength due to small changes in normal load and due to differences in speed of conducting tests. The shearing strengths at these light normal loads varied from 0.05 to 0.22 ton per sq. ft. and are indicated on the section in Figure 5.

The rupture arc is indicated by a light dashed line in Figure 5. The Swedish method of analysis for this case is relatively simple because the location of the rupture arc is known. In contrast, when the stability of a proposed cross-section is being investigated, numerous trial arcs must often be used to determine which is the most dangerous and the procedure may become very tedious.

An average value for the magnitude of the shearing strength along the rupture arc was obtained by study of the data of Figure 5. This value was chosen before any stability analyses were made and was taken as 0.10 ton per sq. ft. Because of the small number of samples and the variations in their shearing strengths the probable accuracy of this average value was low and it was admitted that it might possibly be in error by 50 per cent or more.

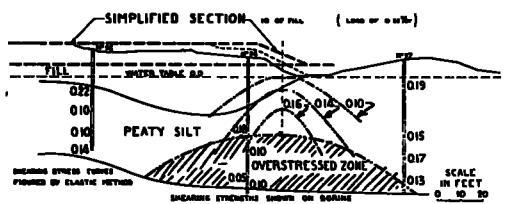
The first stability analysis was very simple. The fill at Sta. 20 + 50amounted to about ten feet of material weighing about 110 lb. per sq. ft., or a load of about 0.55 ton per sq. ft. The cross section of this fill may be represented in simplified form by the heavy dotted cross section shown in Figure 6. Dr. Leo Jürgenson¹ has designated such a section as a "terrace" loading and has given a solution of shearing stresses induced by such a loading on an elastic mass. The curves of Figure 6 represent maximum shearing stresses determined by this method, curves being shown for stresses of 0.10, 0.14 and 0.16 ton per sq. The foundation under discussion was ft. not truly elastic and these computed stresses must be recognized as a rough approximation. However, they are of considerable value as an indication of the conditions which existed. A comparison of these shearing stresses with the shearing strengths obtained by laboratory tests showed that the shaded area of Figure 6 was overstressed in shear and therefore was in a plastic state. Inspection of the figure makes it evident that when the amount of overstress in the shaded zone was thrown to the material outside, the size of the plastic zone must have been greatly increased and a failure was probable.

Figure 6. Section Showing Overstressed Zone as Indicated by Jürgenson's Terrace Loading Analysis

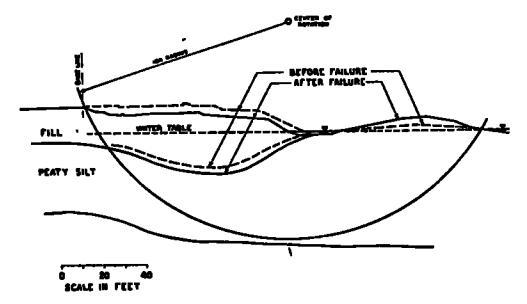
Figure 7 shows the cross-section at Sta. 20 + 50 as used for the first circular arc analysis. From all available level and boring records the cross-sections shown were determined for the situations before and after the failure. The water level in the pond was at Elev. 3 and the water table in the fill was assumed to be

Figure 7. Section for Circular Arc Analyses

Factor of Safety = 0.67After failure,

Factor of Safety = 0.93

Inasmuch as the actual factor of safety must have been unity or slightly greater just after failure, it appears that the value used for average shearing strength must have been on the conservative side by about 10 per cent. This of course does not mean that all data used were accurate within 10 per cent as there may have been numerous compensating errors. However, it was very encouraging to find that the value obtained by laboratory tests was in such good agreement with the full scale failure test in nature.

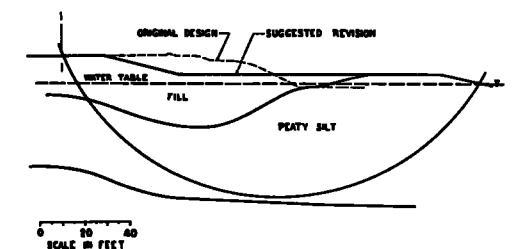
Figure 8. Section Showing a Suggested Design Revision

In the redesign, three revisions were introduced which greatly improved the stability conditions. First, a realignment of the southbound roadway was made which moved it 34 ft. further from the pond. Secondly, a large portion of the area between the southbound roadway and the pond was lowered to Elev. 7 where originally it had been at Elev. 15. This change introduced a large relief in Thirdly, fill to Elev. 7 was added load. connecting the island to the shore, thus moving the shoreline to the outer edge of the island. Fill in the vicinity of the island constituted a load which assisted in balancing the load on the roadway side of the failure mass. This balancing load, however, could be used only to a limited degree as a heavy fill in the vicinity of the island would be very likely to cause a failure further out in the pond, on an arc displaced to the right from the one analyzed.

A design incorporating these three changes is shown in Figure 8. When analyzed on the original surface of rupture this section shows a factor of safety of 1.10. This design, however, was not given serious consideration. Large settlements would be obtained in the roadway due to compression of the peaty stratum. Also a failure along a rupture arc further toward the pond was possible. Most important of all, the publicity which the slide had caused made it imperative that even the most remote possibility of another failure must not be allowed. Thus even though it is probable that the odds were in favor of this section being stable, it was not adopted.

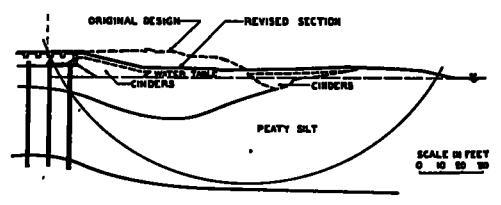
Figure 9. Section Similar to That Used in Reconstruction

A design introducing a viaduct on steel bearing piles driven through the compressible stratum to the underlying firm stratum was proposed by the consulting engineers and met with favor because of its eliminating any possiblity of further subsidence on the highway. Such a structure, however, did not materially decrease the danger of failure in the area toward the pond from the roadway. In the section of Figure 9, an analysis along the arc shown gives a factor of safety of 1.10. This factor was increased to 1.23 by decreasing the load by the use of cinder fill on the slope adjacent to the roadway. These analyses made use of the previous average

shearing strength of 0.10 ton per sq. ft. in the peaty silt, which was conservative in this instance as enough time elapsed before the start of reconstruction to allow some consolidation. The use of cinder fill just under the center of rotation had no effect on the factor of safety along the arc analyzed in Figure 9 but was adopted as it greatly reduced the tendency of failure along arcs with centers of rotation further to the right.

The reconstruction was carried out using a section essentially similar to that of Figure 9. The completed structure was opened to traffic in the Spring of 1938 and there have been no indications of further subsidence.
