# **APPENDIX G**

# I-BEAM SUMMARIES-0.6-IN. STRAND

# BEAM NAME: *IA-6-6-1* END: *NORTH* DATE: 10/10/2005

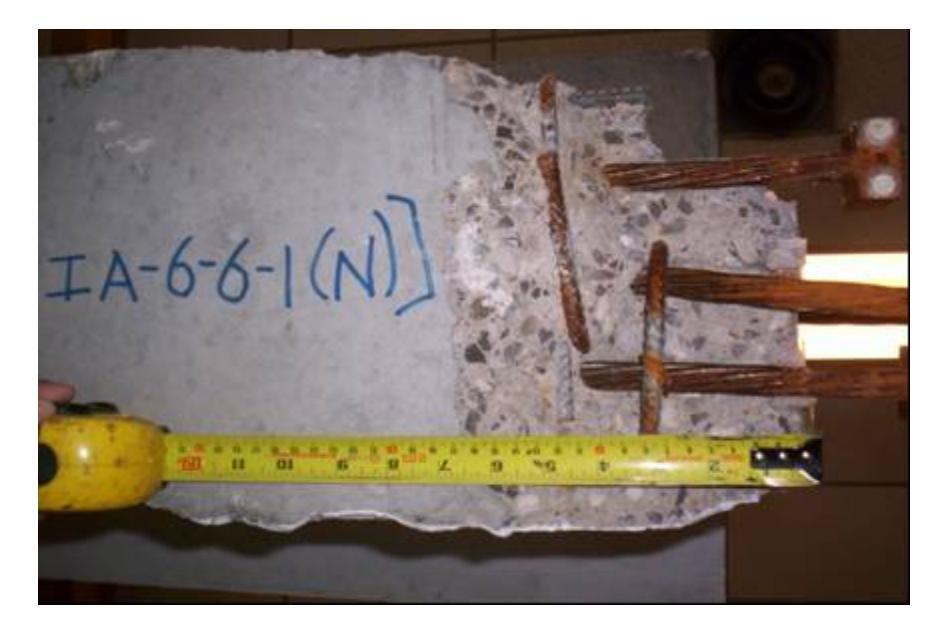
The bottom surface of concrete at the North end was damaged during transportation and the strands were exposed. As a result, the support point was moved to 9 in. from the end instead of 6 in.

### Photo showing the damage at the Bottom surface of North end of beam IA-6-6-1

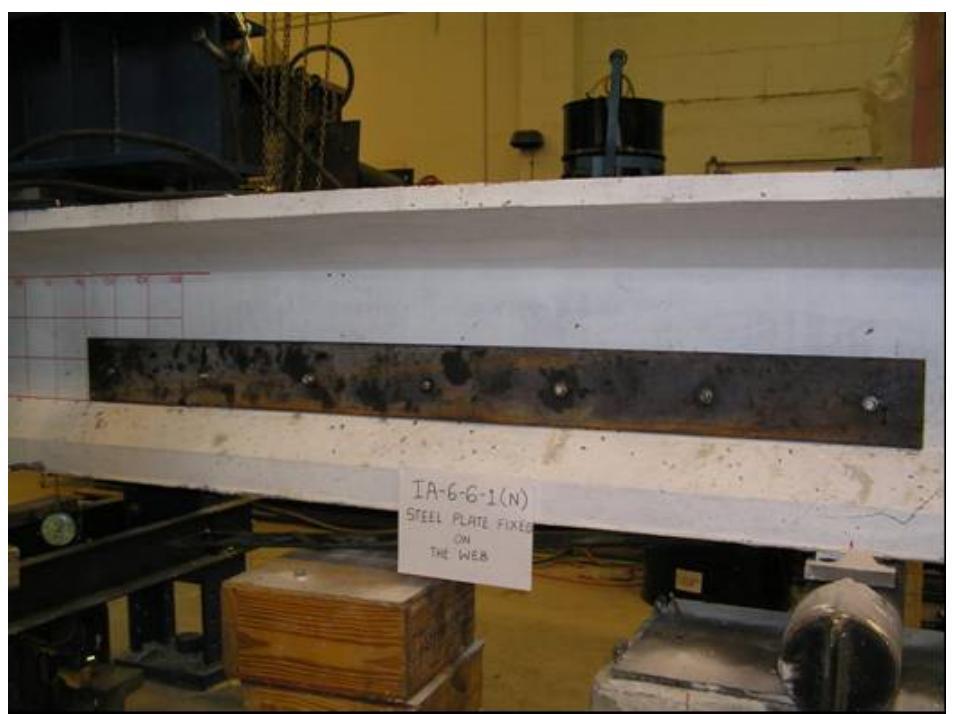
Photo showing the external steel plate attached on the web for compensating the horizontal reinforcement at the North end.

Before starting the test, the web was reinforced with externally connected steel plates on both sides of the beam in the South shear span. Dimensions of the steel plates were 6in. x x1/4 in. and they extended from the South support up to the first loading point from the South end. Holes were drilled through the web to allow the plates to be bolted to the web. The plates were also glued to the surface of the concrete web.

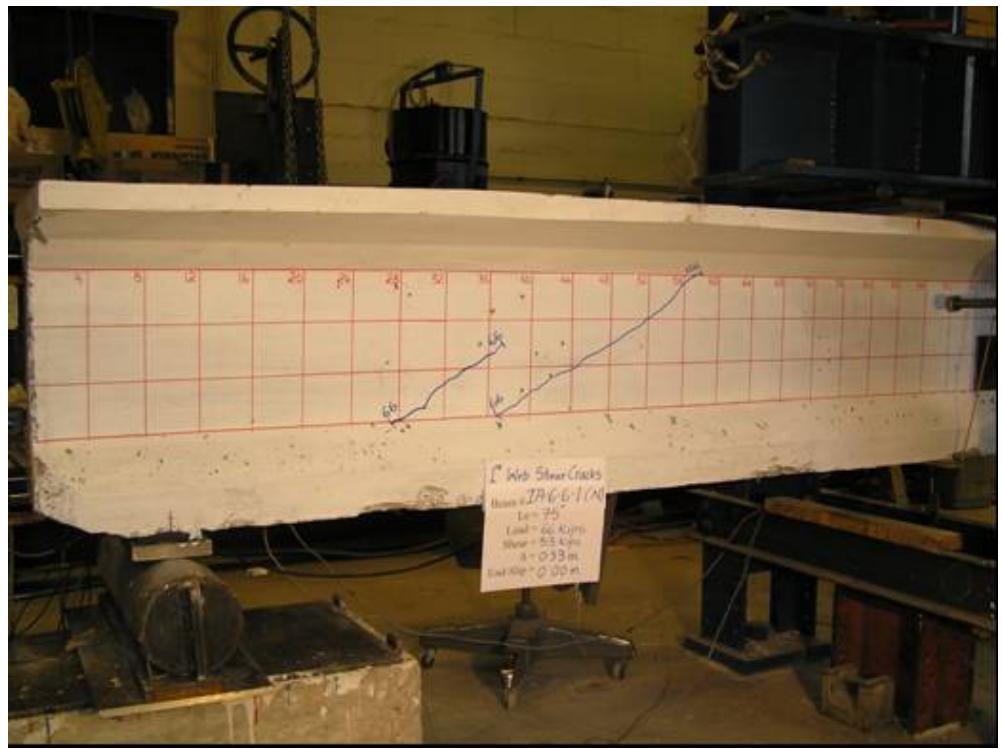
First web shear cracking was observed at the load of 66.3 kips (Shear = 33.15 k;  $\Delta$  = 0.33 in.). These cracks occurred in the form of two diagonal cracks in the shear zone. No flexural cracks were observed at this point. The first flexural crack was observed at the load of 73.3 kips (Shear = 36.7 kips;  $\Delta$  = 0.38 in.). The flexural crack appeared as a single crack at Station 80.

Photo of the North end of the beam IA-6-6-1 showing the first web shear cracking

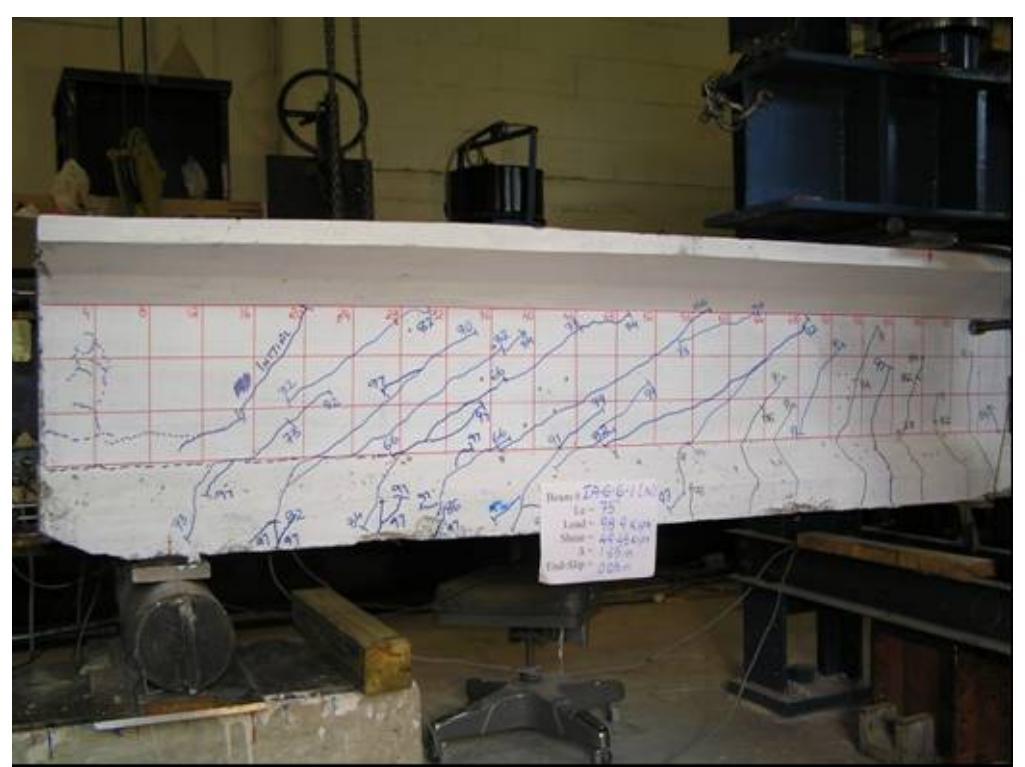
As the load reached 98.9 kips (Shear = 49.5 kips;  $\Delta = 1.0$  in.), an audible crack was heard with the value of load suddenly dropping to 87 kips. A large crack was observed in the South shear span. The load value did not attain its maximum at any increment beyond this point. Finally as the deflection increased to 1.65 in. shear failure was observed at the southern shear span in spite of attaching external steel reinforcement. End slip reading at the South end remained 0.00 throughout the loading and unloading cycles.

Photo of South end of beam IA-6-6-1 showing the cracking pattern at the maximum load

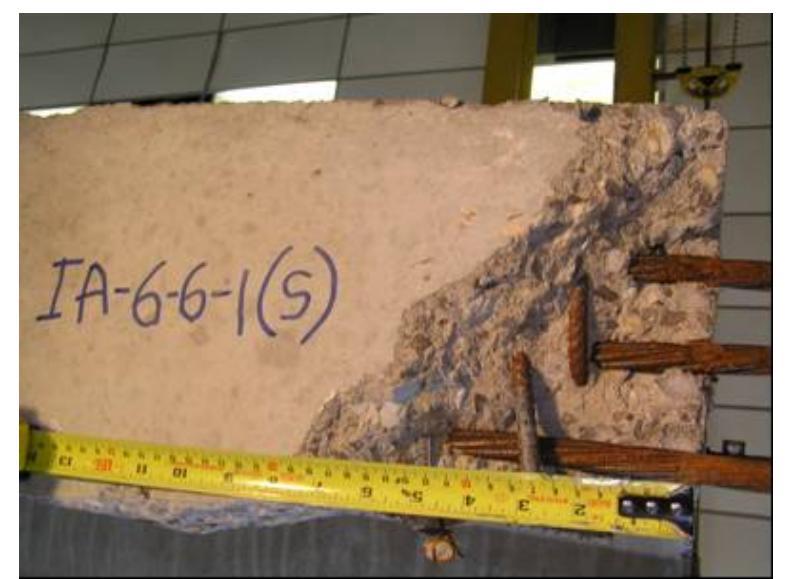
The bottom corner of concrete beam at the South end was damaged during handling at the prestressing plant. The strands were exposed as seen in the photo below. Because of the damage, the support point was located 9 in. from the South end of the beam instead of 6 in. The test on the South end of Beam IA-6-6-1 was tested before the North end. Cracking and other damage that occurred to the beam when testing on the South end affected the test that was performed on the North end.

Photo showing the damage at South end caused during handling

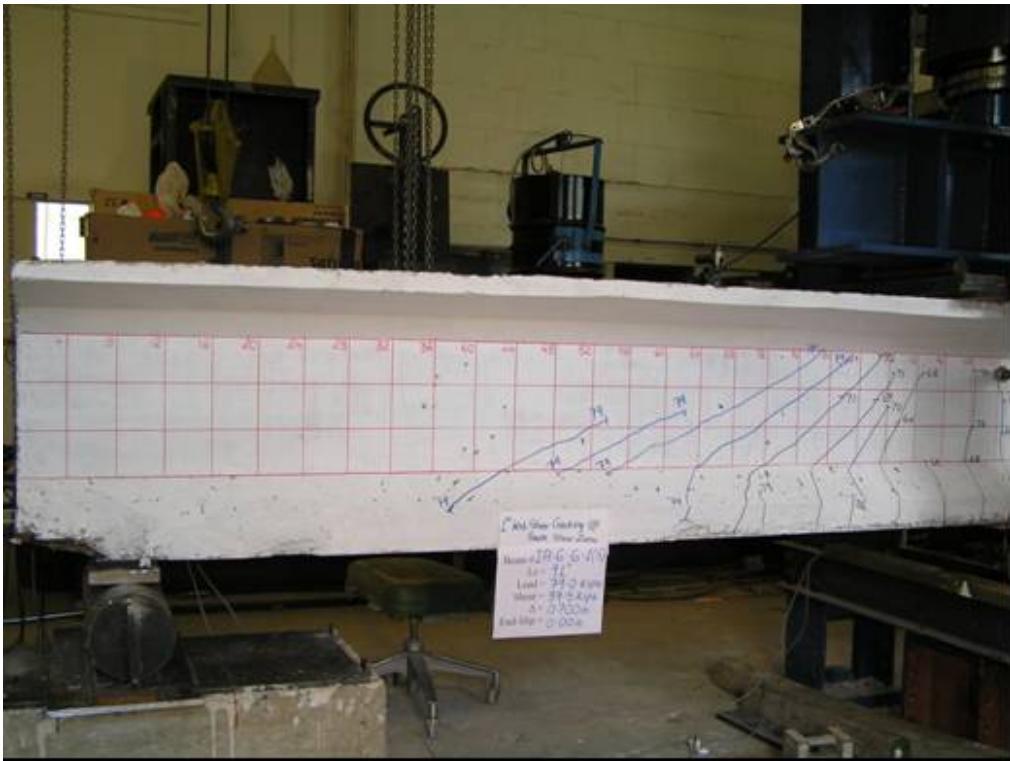
First flexural cracks were observed at a load of 64.6 kips (Shear = 32.2 kips;  $\Delta$ = 0.4 in.). The flexural cracks occurred within the maximum moment region at Stations 88, 104 and 112. Initial web shear cracks were observed at the load of 79 kips (Shear = 39.5 kips;  $\Delta$  = 0.7 in.). Load dropped to 76.8 kips immediately after the web shear cracks formed. DEMEC readings were taken at the reduced value of load.

Photo of the South end of the beam IA-6-6-1 showing the first web shear cracking

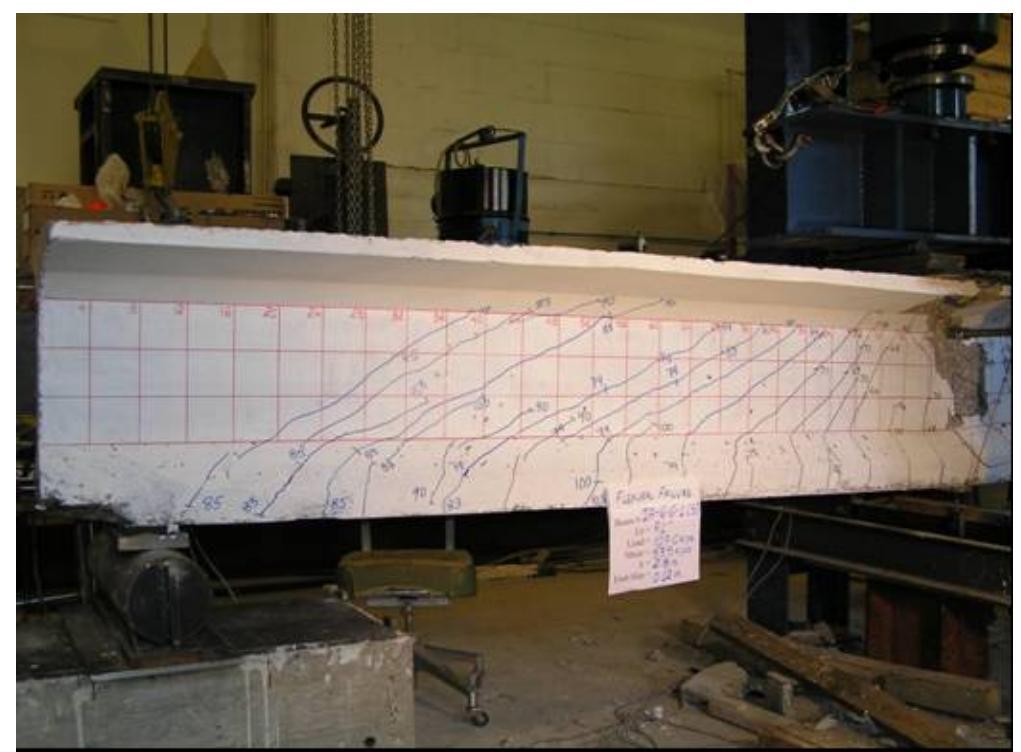
First end slip of 0.01 in. was observed at the load of 83.5 kips (Shear = 41.6 kips;  $\Delta$  = 0.8 in.) The value of end slip continued to increases with load till the point of flexural failure at the load of 107 kips (Shear = 53.5 kips;  $\Delta$  = 2.8 in.). Maximum end slip value recorded was 0.12 in. End slip readings at the North end remained 0.00 throughout the loading and unloading cycles. The beam failed in flexure at a maximum moment of 4387 k-in., which exceeds the nominal flexural capacity of 4040 k-in.

The beam exhibited a flexural failure in that it was able to achieve its nominal flexural capacity and sustain that load through large deformations (ductility). The fact that strand slip occurred demonstrates that the strand is able to develop tension sufficient to support the flexural loads even while slipping.

Photo of South end of beam IA-6-6-1 showing the cracking pattern at Flexural failure

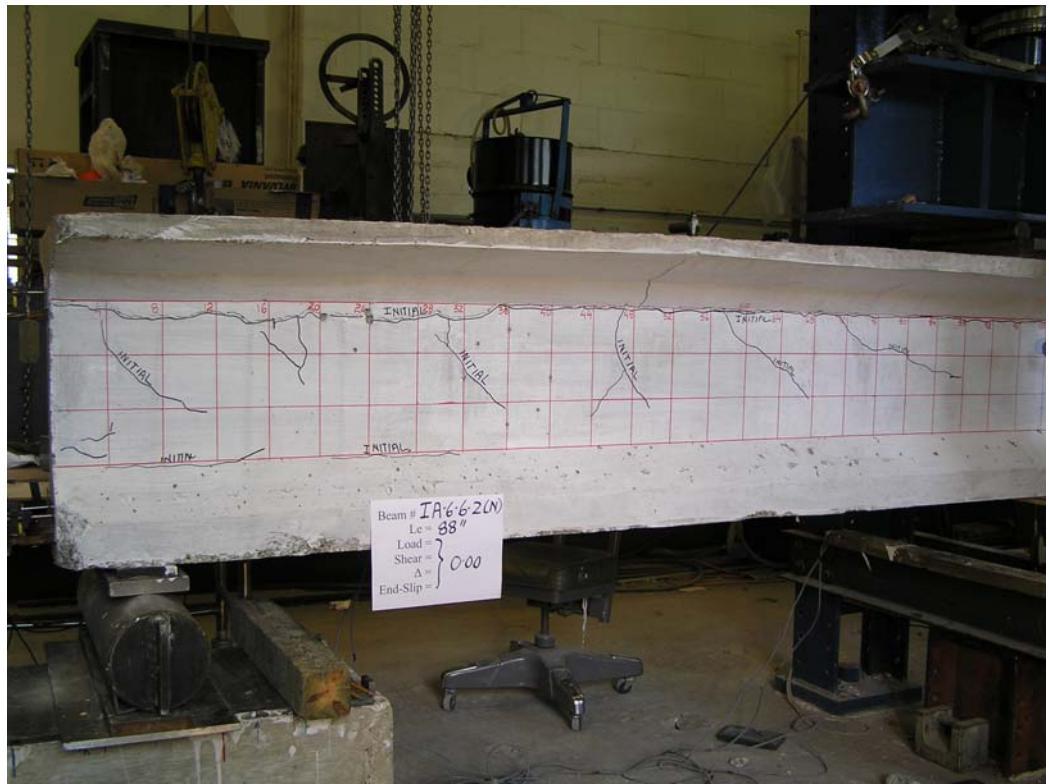
<u>**TEST SUMMARY</u>** The initial condition of the beam was recorded on photographs. There were several initial cracks</u> present on the beam with a significantly long crack at the junction of flange and web. These cracks were caused during handling of the beam in the prestressing plant.

Photo showing the cracks present on the beam IA-6-6-2 before starting the test.

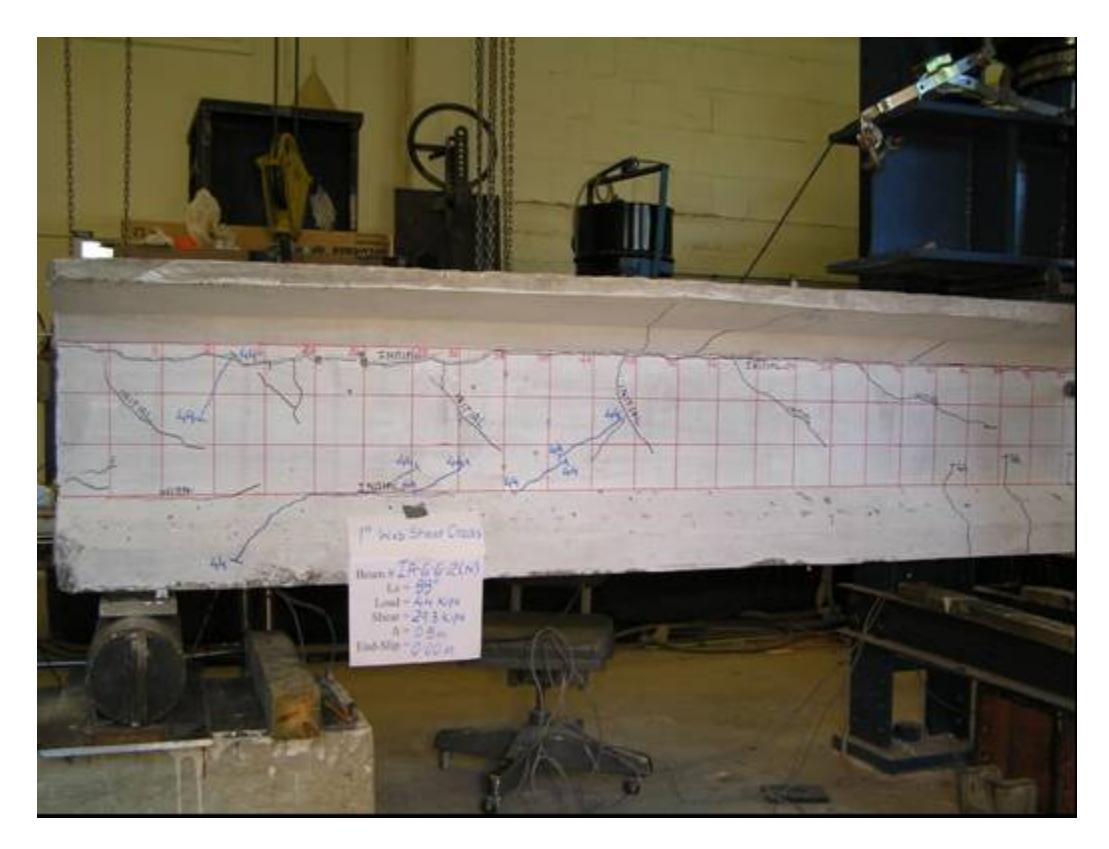
First flexural cracks occurred nearly simultaneously with the first web shear cracks at the load of 44 kips (Shear = 29.3 kips) and deflection of 0.5 in. First flexural cracks occurred as a pair of cracks located at Stations 96 and 100. First web shear cracks occurred in the form of three cracks almost parallel to each other in the shear zone.

Photo of the North end of the beam IA-6-6-2 showing the first web shear cracking (incidentally the point of first flexural cracking as well)

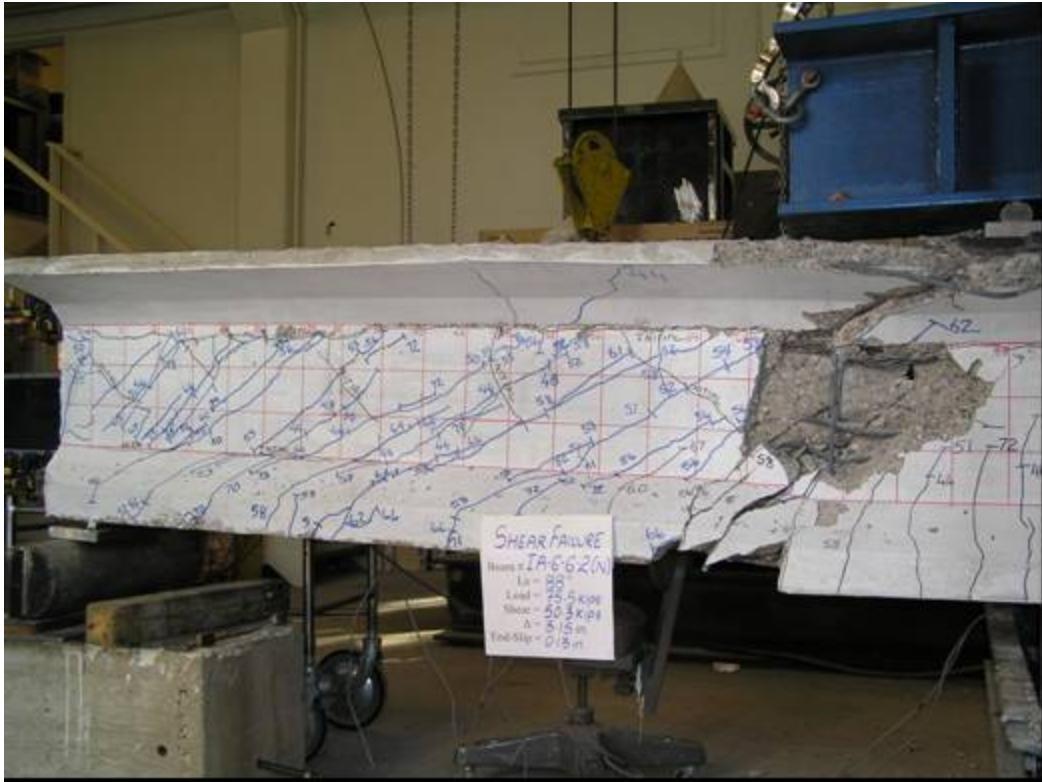
The first end slip of 0.01 in. was observed along with an audible shear crack at 58.5 kips (Shear = 39 kips;  $\Delta$ = 1.1 in.). The value of end slip continued to increase very gradually till at Shear failure the maximum value of end slip was 0.13 in. No significant changes were noticed during further load increments. The maximum value of load attained was 75.3 kips (Shear = 50.2 kips;  $\Delta$  = 2.9 in.) when the shear cracks were seen to grow wide with concrete spalling from the sides of the web. As the deflection increased to 3.1 in., the load dropped to 73.8 kips and a sudden shear failure occurred with diagonal crushing of the concrete in the web. The end slip reading at the South end remained at 0.00 in throughout the loading and unloading cycles.

Photo of North end of beam IA-6-6-2 showing the cracking pattern at failure

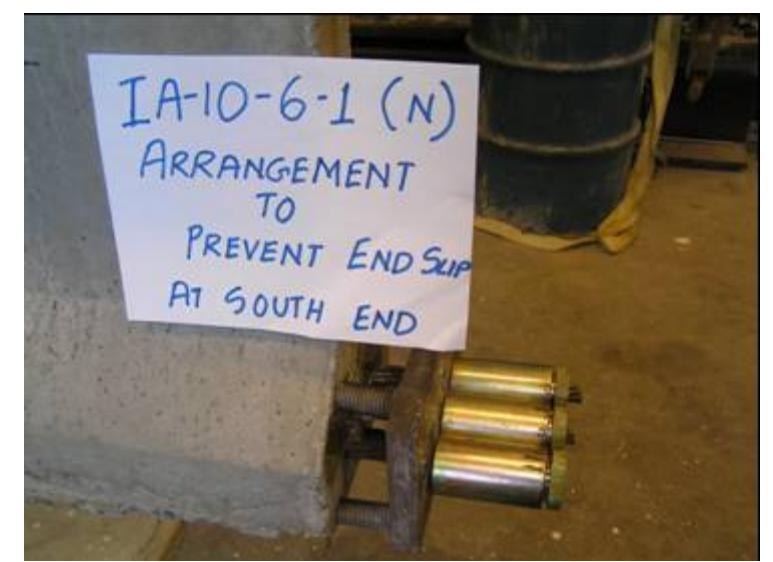
Before starting the test the strands on the South end were fixed with chucks for preventing any end slip from that end as the South end was already tested.

Photo showing chuck assembly at South end to prevent strands

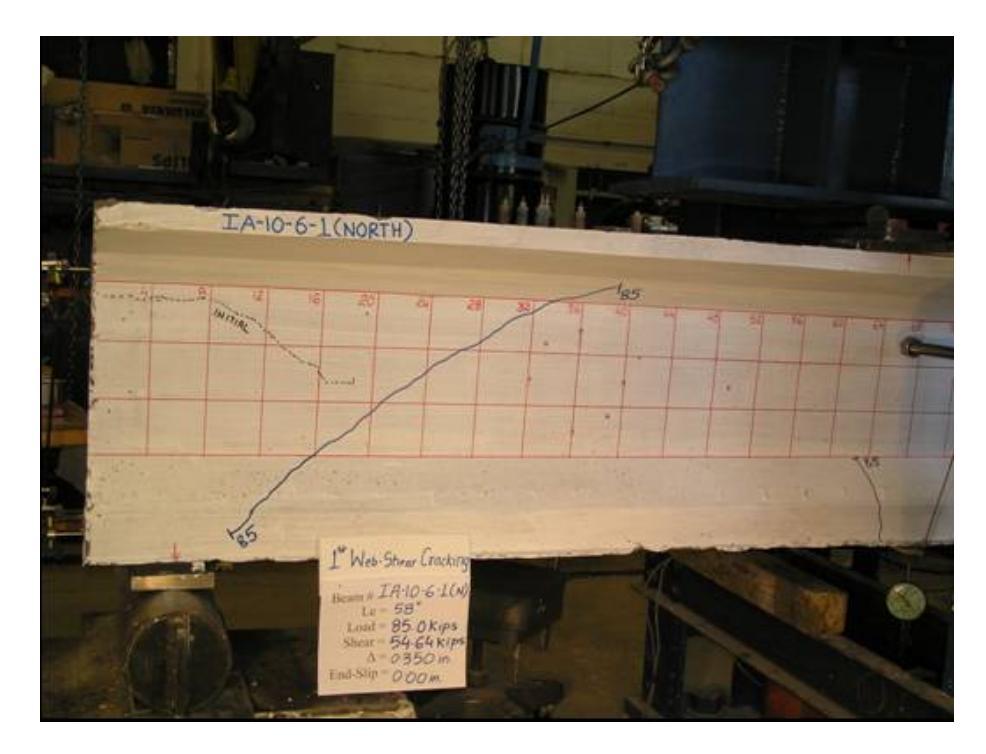
First flexural crack was observed simultaneously with the first web shear cracking at the load of 85.2 kips (Shear = 54.8 kips; deflection = 0.35 in.) No significant drop in load was noticed.

Photo showing first web shear cracking for IA-10-6-1-N

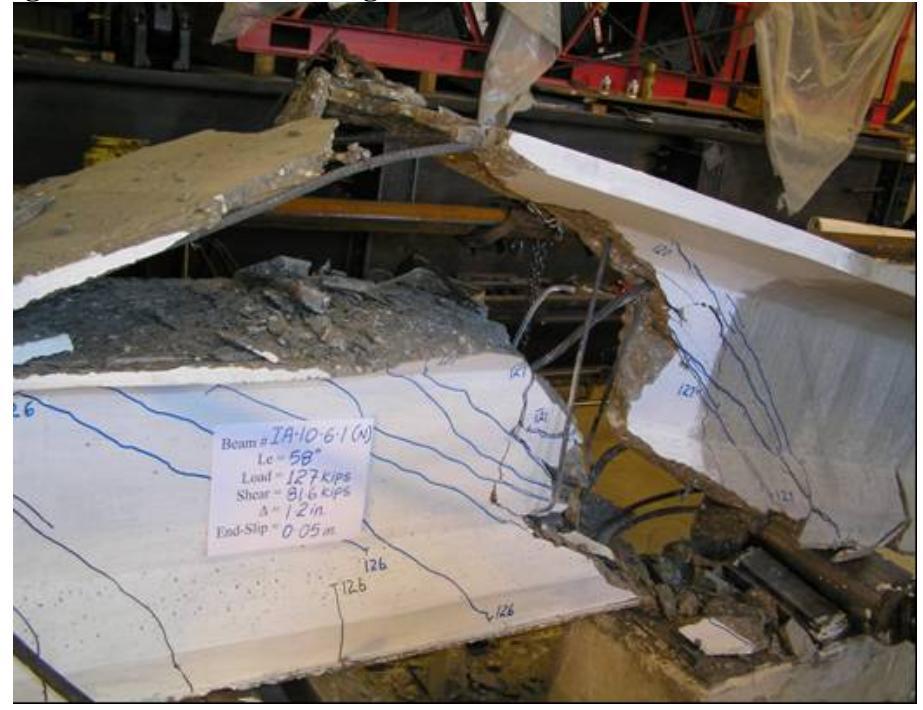
It was noticed that the shear cracks were growing wider in the South side shear zone. Finally the beam gave off violently at the maximum load of 127 kips (Shear = 81.6 kips; deflection = 1.2 in.) The shear failure of beam at the opposite side was extremely violent with the beam literally breaking into two halves. Unloading data for the beam could not be noted due to the nature of beam failure.

Photo showing shear failure at the opposite end for IA-10-6-1-N

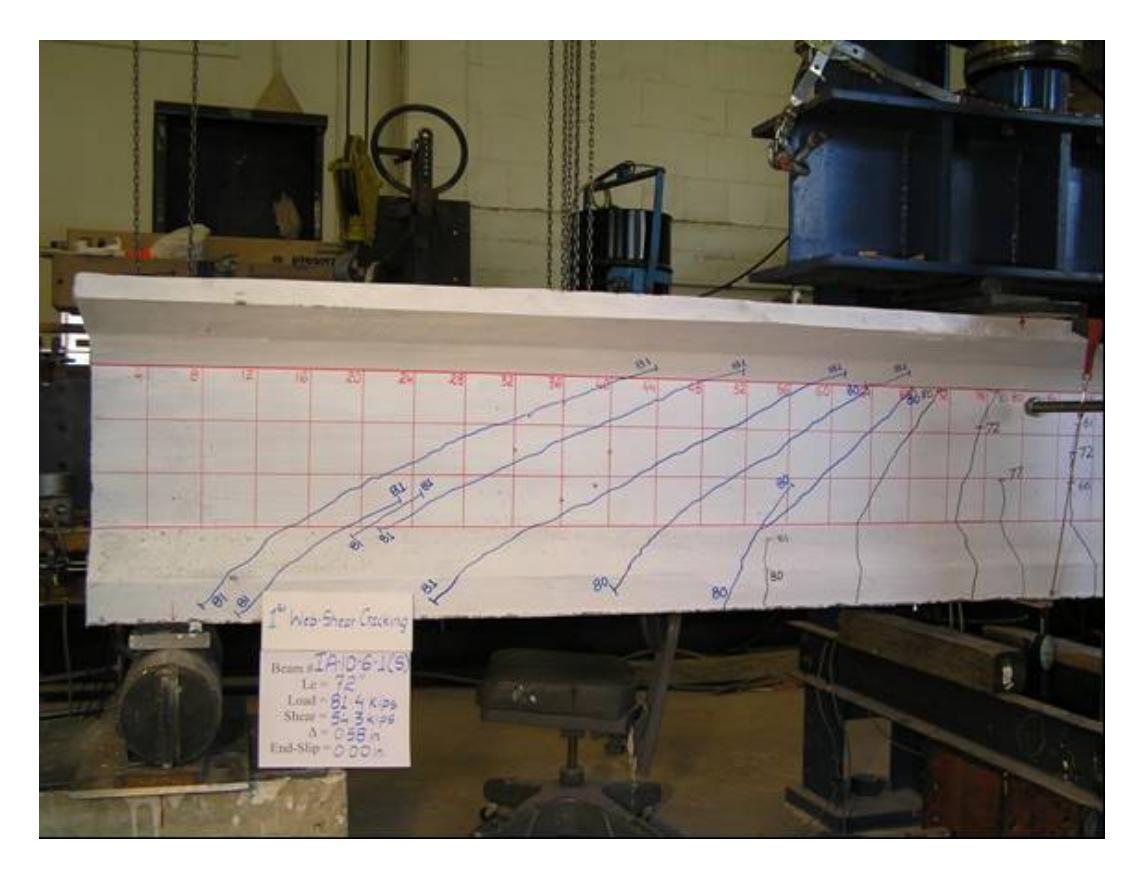
The first flexural crack was observed at a load of 65.7 kips (Shear = 43.8 k;  $\Delta$ = 0.33 in.). The first secondary crack was observed at a load of 77.6 kips (Shear = 51.7 k;  $\Delta$ = 0.45 in.). At the load of 80.6 kips (Shear = 53.7 k;  $\Delta$ = 0.5 in.) an inclined flexure-shear crack was observed near the first loading point from the South end. Initial web shear cracks were observed at the load of 81.6 kips (Shear = 54.4 kips;  $\Delta$ = 0.58 in.). The value of load dropped to 77.2 kips after the web shear cracks formed. Web shear cracks formed one succession, one after another starting from the loading point nearest to South support and moving towards South support.

Photo of the South end of the beam IA-10-6-1 showing the first web shear cracking

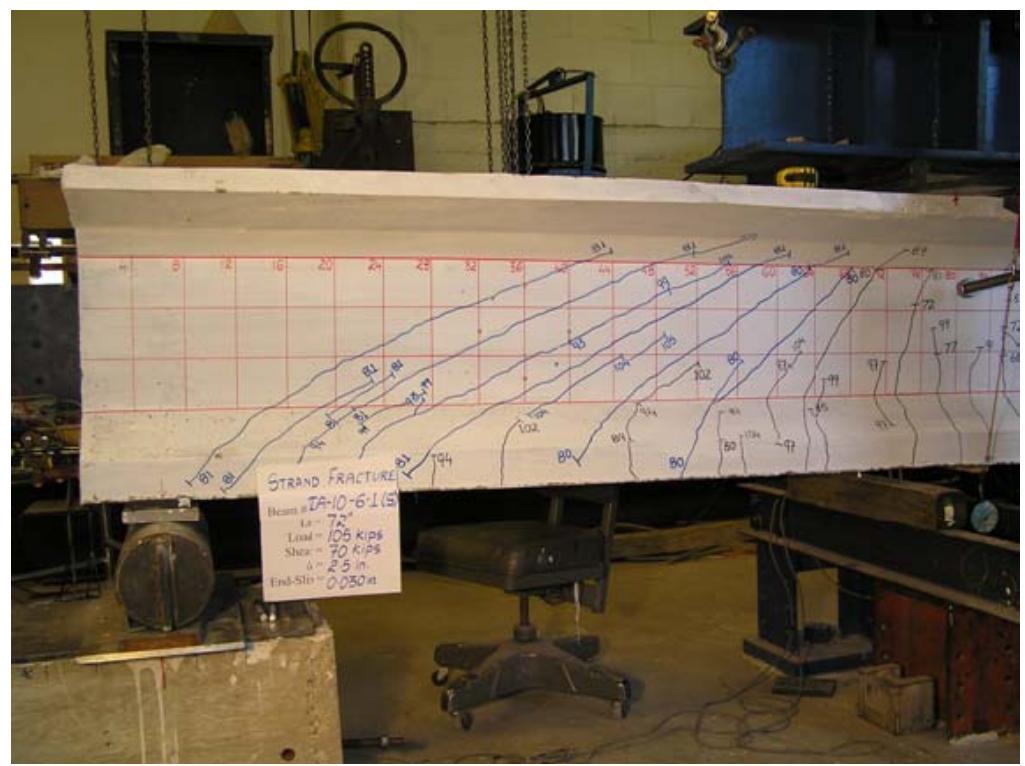
End slip of 0.01 in. was observed at the load of 92.7 kips (Shear = 61.8 kips;  $\Delta$ = 0.9in.). End slips increased gradually with each load increment until beam failure. Beam failure was caused by a strand fracture. At that time the maximum value of end slip was 0.03in. A sudden violent noise was heard at the load of 105 kips (Shear = 70 kips;  $\Delta$ = 2.5 in.). Load value dropped to 94 kips. After careful observation of the widest crack where concrete spalling took place, it was noticed that one of the strands (Bottom East) had fractured.

Photo of South end of beam IA-10-6-1 showing the cracking pattern at strand fracture

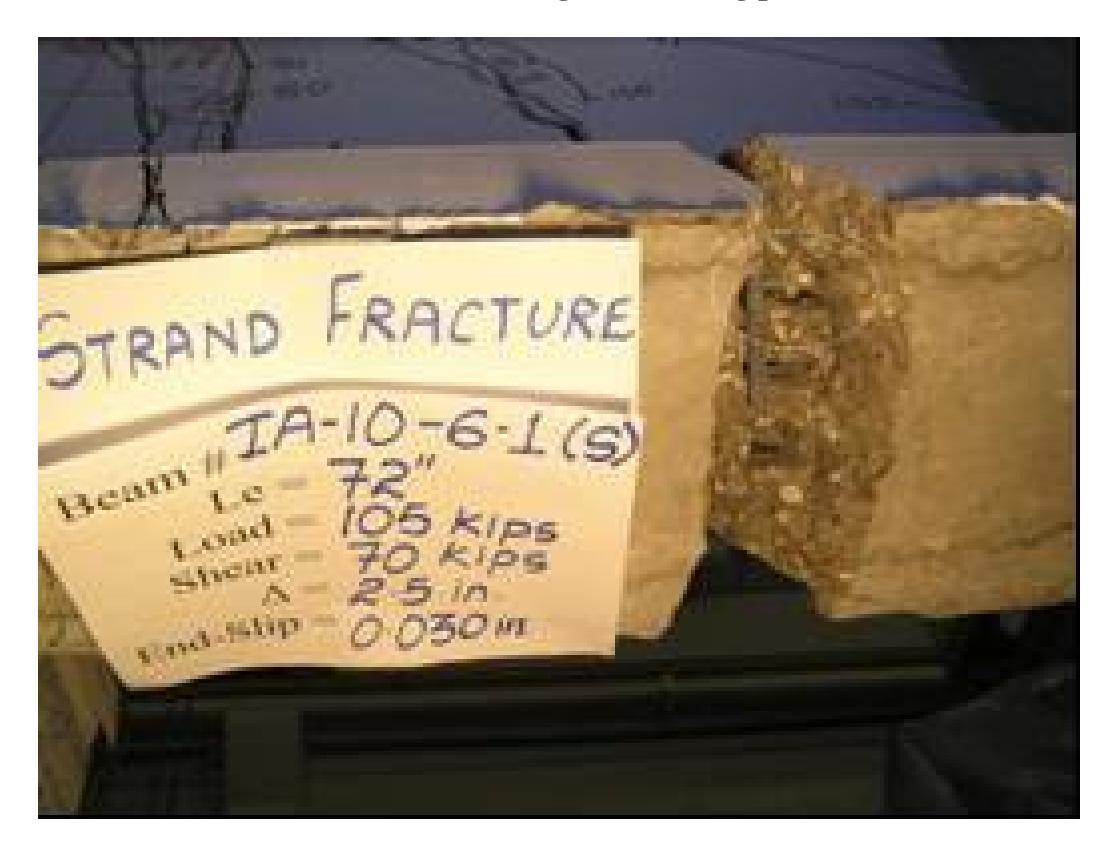
This beam failed in flexure, and the bond of the strand was adequate to develop strand tension necessary to support the flexural capacity.

Photo showing the fractured strand (Test IA-10-6-1-S)

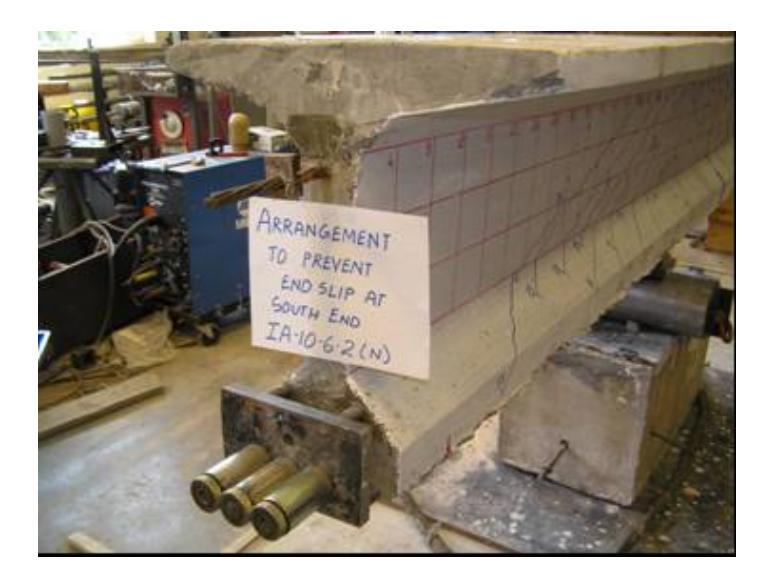
Before starting the test, strands at the South end were prevented from slipping with an arrangement of chucks as shown in the photo below.

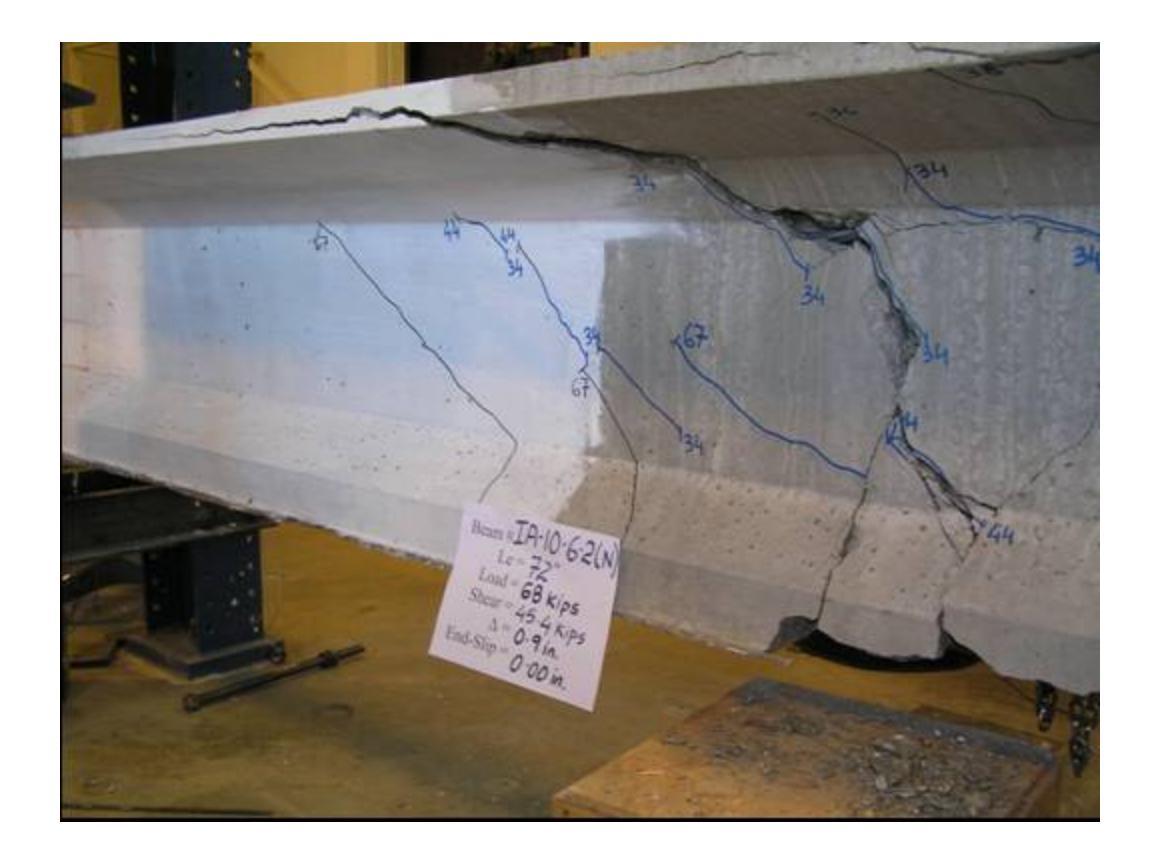
For this particular test, there was no web shear crack noticed in the North side shear zone. The loading was stopped when the beam was observed to have failed in shear near the South support. The maximum load reached was 67.8 kips (Shear = 45.2 kips; deflection = 0.9 in.)

Photo of the North end of the beam IA-10-6-2 showing shear failure in the South side shear zone.

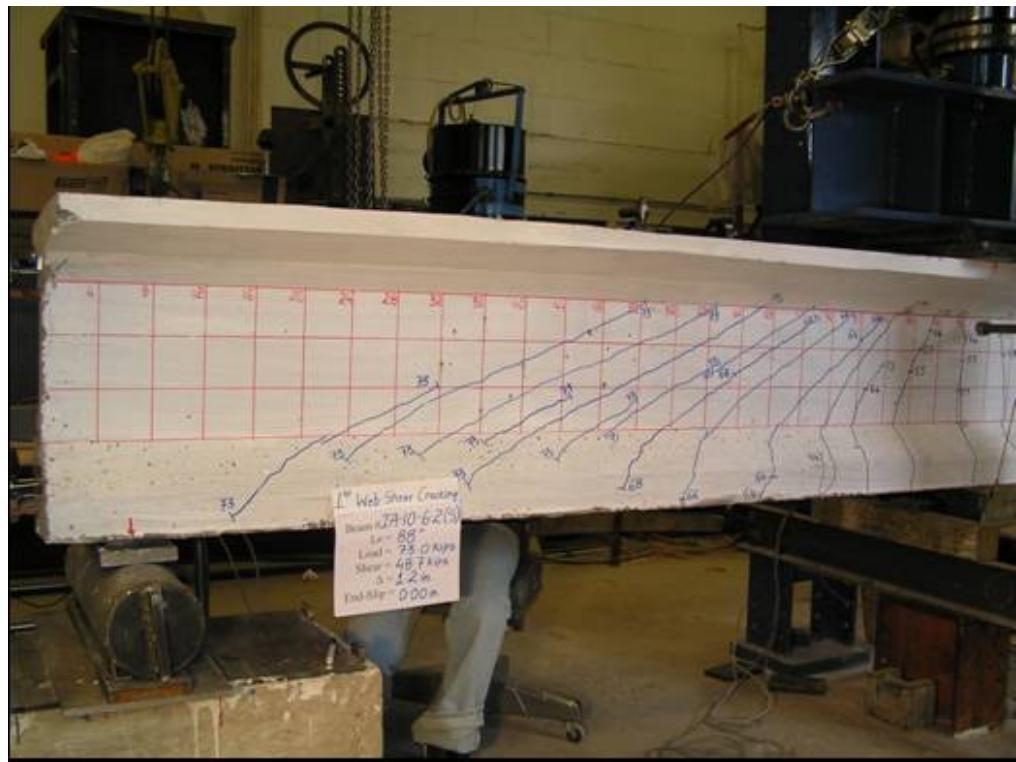
First flexural crack was observed at the load of 51.4 kips (Shear = 34.3 kips;  $\Delta$ = 0.35 in.) A single crack was noticed at Stn. 96 at this stage. No significant drop in load was recorded. At a load of 63.5 k (Shear = 42.3 kips;  $\Delta$ = 0.68 in.) an inclined flexural shear crack was observed between Stations 68 and 80. The load value dropped to 63.4 kips after this crack occurred. Initial web shear cracking was observed at the load of 73 kips (Shear = 48.7 kips;  $\Delta$ = 1.2 in.). At this load, a number of web shear cracks formed nearly parallel to each other in the shear zone.

Photo of the South end of the beam IA-10-6-1 showing the first web shear cracking

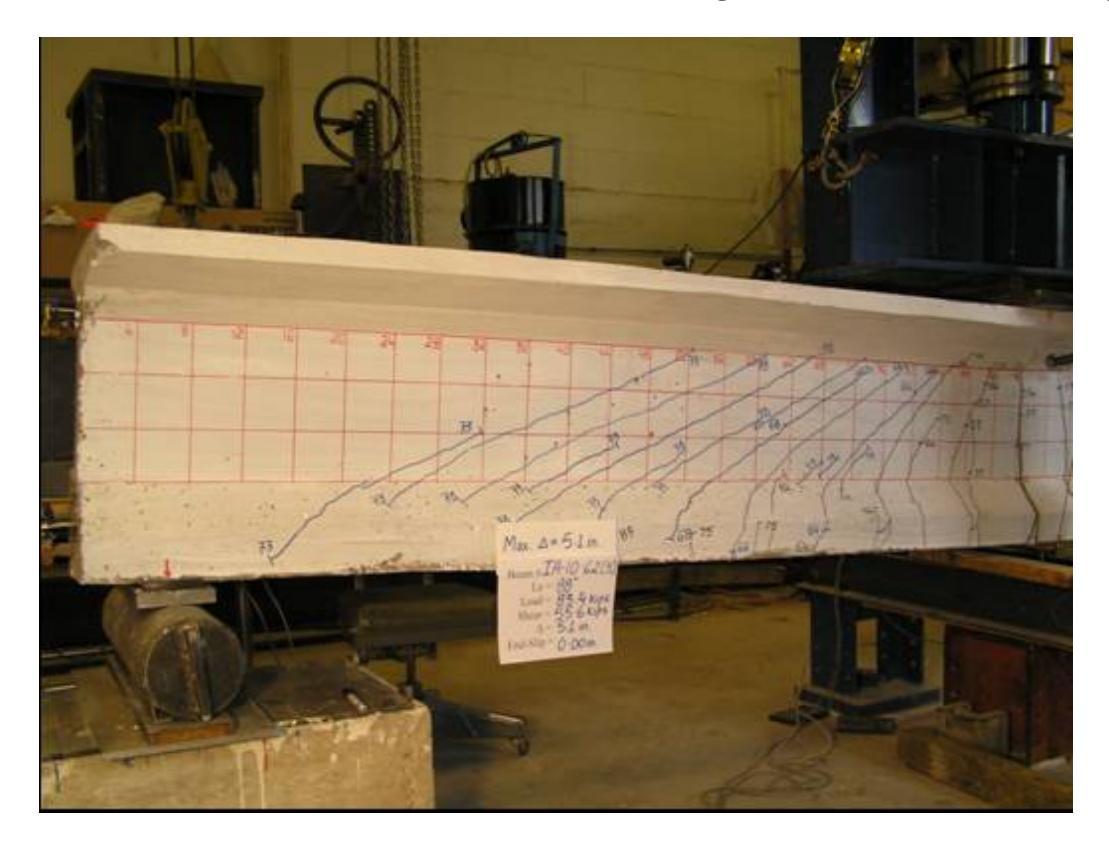
No significant changes were noticed as the deflection was incremented further. Maximum deflection attained was 5.7 in. and load at this point was 83.4 kips (Shear = 55.6 kips). Crack width of the central crack was noted as 0.5 in. End slip value still remained 0.00in at both ends. Further increments in deflection were not possible as the hydraulic ram had reached its stroke limit. The beam was completely unloaded and the deflection, end slip and DEMEC readings were noted. The beam failed in flexure without significant strand slips.

Photo of South end of beam IA-10-6-1 showing the cracking pattern at the maximum load (Deflection value in the photo is mistakenly written as 5.1 in. instead of 5.7 in.)
