Effects of Vehicle Type and Tire Pressure on Dry-Weather Road Maintenance

Paul H. Greenfield, *USDA Forest Service, San Dimas, California*
S. Colin Ashmore, *Nevada Automotive Test Center*

In 1993 a structured test was conducted to measure the effects of different vehicle types on road maintenance for operation in a dry climate. Three different vehicle types were compared: high-tire-pressure logging truck, low-tire-pressure logging truck (both were 18-wheel, western U.S.-style logging trucks), and a mix of light, two-axle vehicles. The test track consisted of four different sections and three individual lanes. Comparisons were made for roadway roughness (washboarding, potholing), material loss, and rutting. Results are presented indicating that grade and alignment have substantial impacts on road maintenance ratios between light and heavy vehicles operating under dry conditions. Maintenance ratios between light and heavy vehicles are on the order of five to one for the dry operating conditions experienced.

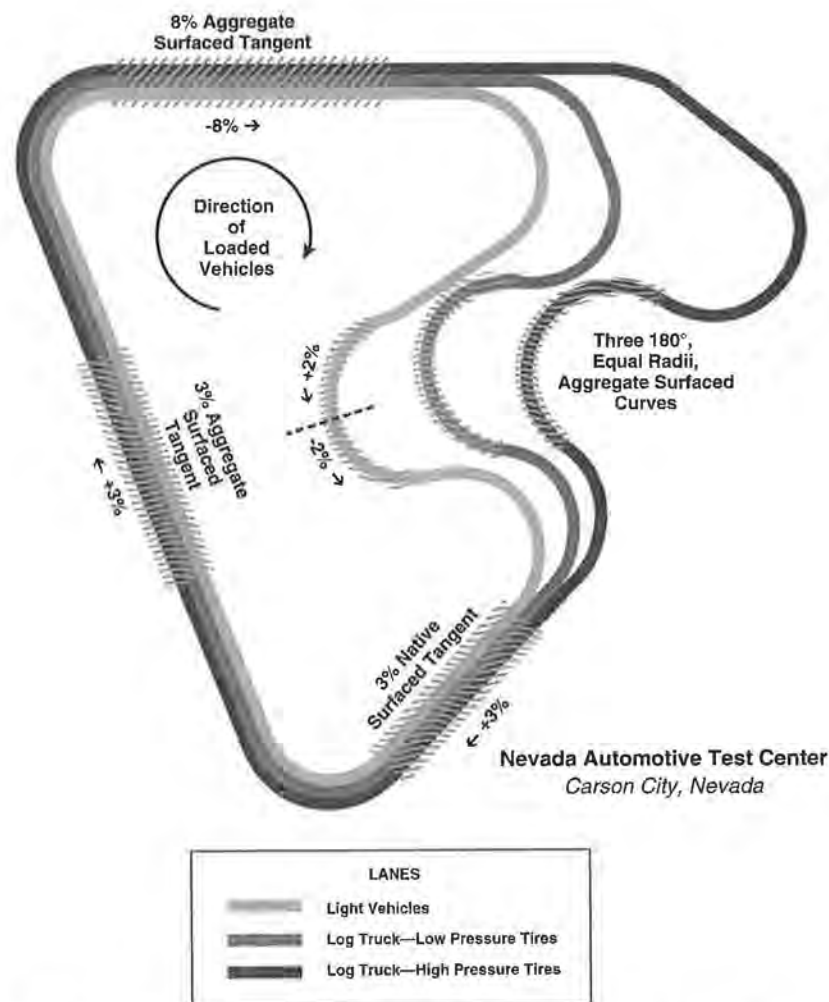
Four test sections were constructed that were representative of typical Forest Service road design and aggregate material selection. The course shown in Figure 1 was constructed with 76 mm (3 in.) of 38-mm (1.5-in.) minus base material and 15.2 cm (6 in.) of 25-mm (1-in.) minus surfacing material. The native test section consisted of 15.2 cm (6 in.) of compacted native soil. In reference to Figure 1, the loaded vehicles traveled clockwise, and the unloaded vehicles traveled counterclockwise, resulting in a combination of adverse and favorable grades. The track geometry consisted of the following:

FIGURE 1 Diagram of NATC Test Track for dry-weather maintenance comparisons.

As shown in Figure 1, each test section was three lanes wide, each lane dedicated to a specific vehicle class, and no mixed-vehicle running was conducted. The following were the vehicle classes to which each lane was dedicated:

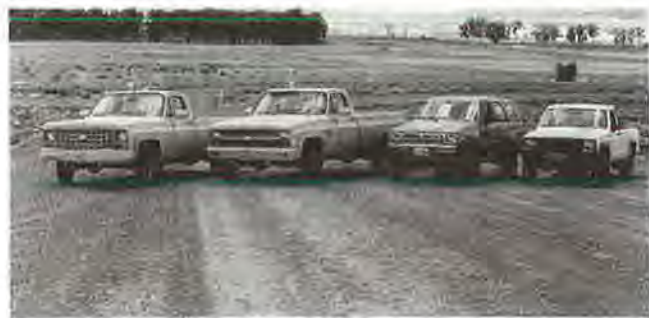
Four light vehicles (Figure 2) were selected to represent typical traffic using Forest Service roads. Before the start

FIGURE 2 Light vehicles used for comparison testing.

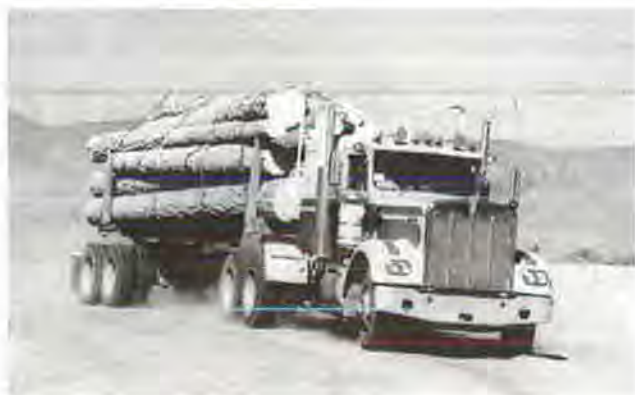
Two nearly identical Class 8 western U.S.-style logging trucks were selected to meet the contract requirements for two heavy logging trucks (Figure 3). These vehicles had five axles—one steering axle, two drive axles, and two trailer axles—in the loaded configuration, and one steering and two drive axles in the unloaded configuration (trailer carried on top of vehicle for return trip). Before the start of the test, the vehicles were inspected, serviced, and aligned to factory specifications. Previous road testing confirmed the performance equivalency of

FIGURE 3 Heavy vehicle operating on test course.

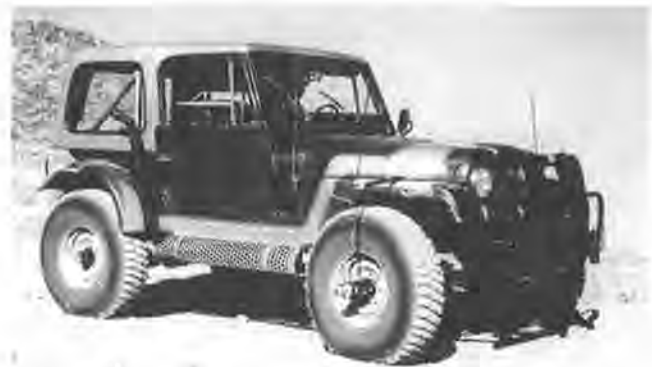
NATC's dynamic force measurement vehicle (Figure 4) was used to perform longitudinal profiles of the road roughness (5). An initial "trigger" level was set by having maintenance personnel view and drive the test track. A spectral analysis of the washboard energy was then used to determine when subsequent washboarding had reached the "trigger" level for road maintenance, thus ensuring that all test sections were maintained at an equal level of washboard amplitude.

FIGURE 4 Dynamic force measurement vehicle used to determine when maintenance should occur.

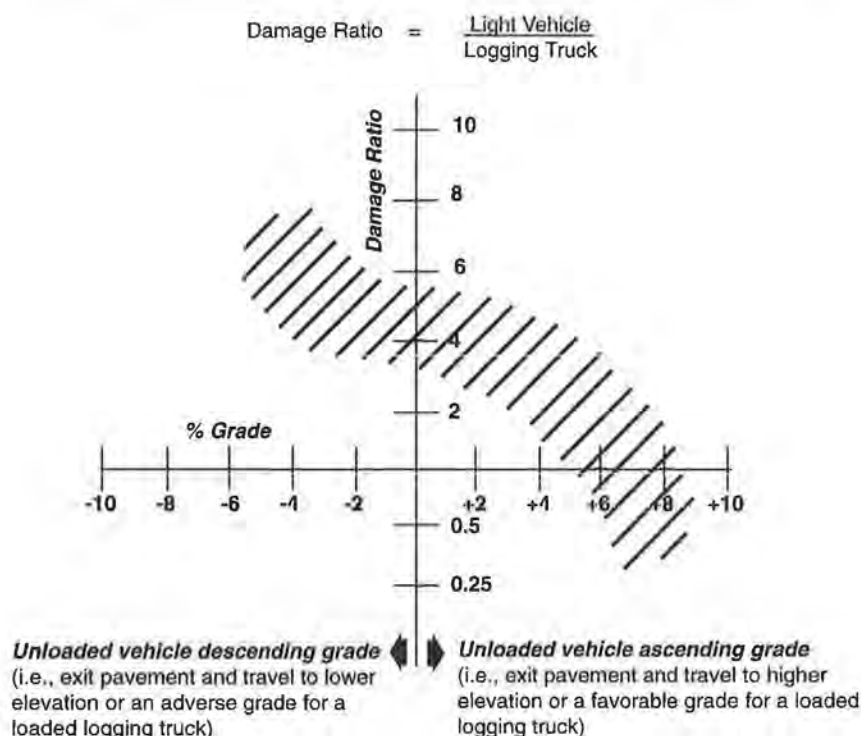
FIGURE 5 Graphical display of maintenance trends for dry-weather vehicle comparisons.

On the 8 percent grade, the unloaded vehicles ascended the grade. On the two 3 percent grades, the unloaded vehicles descended the grade. Given that unloaded vehicle traffic ascending a grade caused the majority of the washboarding, the 8 percent grade was at a disadvantage and the 3 percent grades had the advantage from the standpoint of washboard generation. However, for grade operation, the data indicate that there would be a crossover grade where the light vehicle did less damage than the heavy vehicle for an adverse grade, as shown in Figure 5.
