# External Prestressing for Bridge Rehabilitation in Italy

Mario P. Petrangeli, *University of Rome "La Sapienza," Italy*

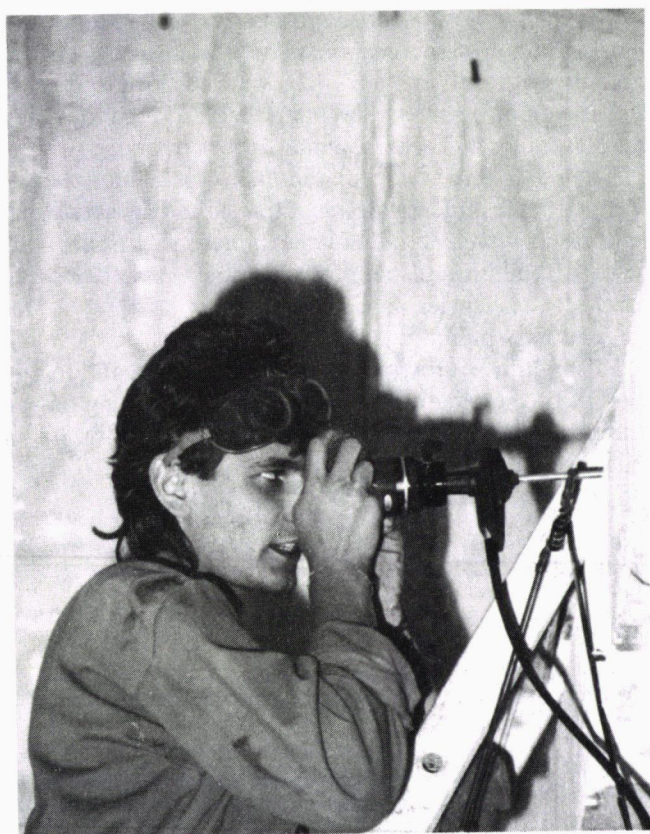
FIGURE 1 Control with an endoscope of a prestressing cable embedded into a beam. Photographic images of cables can also be obtained by this technique.

Boring of 100-mm-diameter cores with stress release, ultrasonic pulse velocity measures in conjunction with the surface hardness, and Windsor penetration tests were commonly used to assess the concrete. The efficiency of the grouting as well as the possible corrosion of the prestressing cables were systematically inspected with an endoscope (fiber optics), which proved to be a powerful tool (Figure 1). The 3-mm-diameter holes, which were needed to thread the instrument head to the cable, were easily drilled at single points.

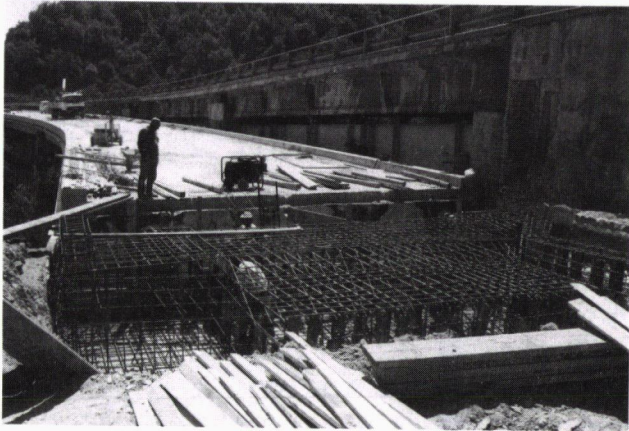
FIGURE 2 New abutment built to withstand longitudinal horizontal forces; in front, deck with continuous slab.

A change in the static scheme was the solution often adopted for decks originally joined on each pier. The deck slab has been made continuous over 8 to 10 piers, that is, over a length of 300 to 400 m, so that all of the horizontal forces are transmitted to a new abutment to be built behind the original one (Figure 2).

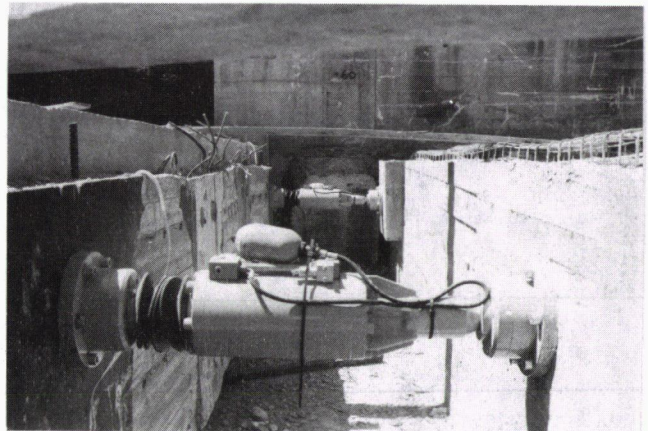
FIGURE 3 Energy-dissipating devices for strong earthquakes: (left) modified old deck; (right) new abutment.

Special energy-dissipating devices have been placed at the new abutment to reduce the seismic forces (Figure 3).

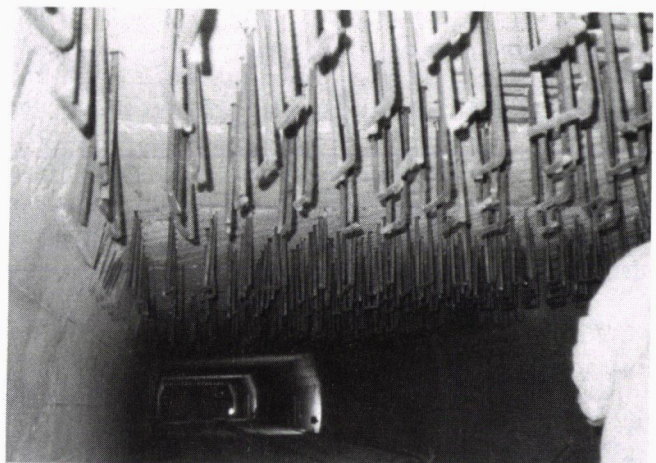
FIGURE 4 Dowels ready to connect new anchor blocks to existing p.c. box deck.

The deviation blocks have usually been cast in situ with ready-mixed concrete with a minimum compressive strength of 45 MPa. The blocks are joined to the original section by steel dowels (20 to 24 mm in diameter) embedded with resin in 30- to 40-mm-diameter holes drilled in the old concrete (Figure 4).

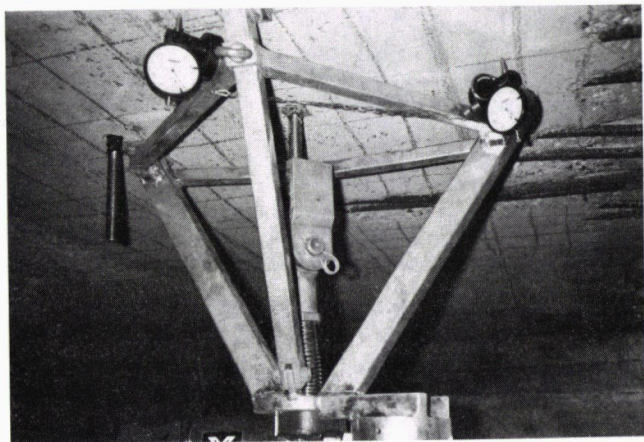
FIGURE 5 Device for a pullout test on a 20-mm-diameter, 170-mm anchored connector. The test was stopped at a force of 100 kN.

Some tests carried out in box girder bridges (Figure 5) showed that a pullout force of 100 kN can be easily reached with a 20-mm-diameter dowel and an anchorage length of 16 to 18 cm, provided that the old concrete can offer a strength of about 35 MPa. Maximum working loads of 20 kN (axial) and 40 kN (shear) per dowel were generally accepted at the stressing of the cables.

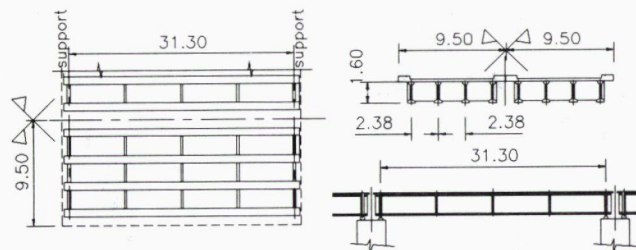
FIGURE 6 Typical simply supported p.c. deck built 20 to 30 years ago.

Seven 25-year-old viaducts of a mountain section of the A3 Motorway had serious problems because of deficiencies in the construction and the effects of deicing salts. All of the viaducts have simply supported decks (32 in total) spanning over 32 m (Figure 6). Every carriageway had four double T-beams, that is, 256 in total, most of which were seriously damaged because of the lack of grouting in the prestressing cables.

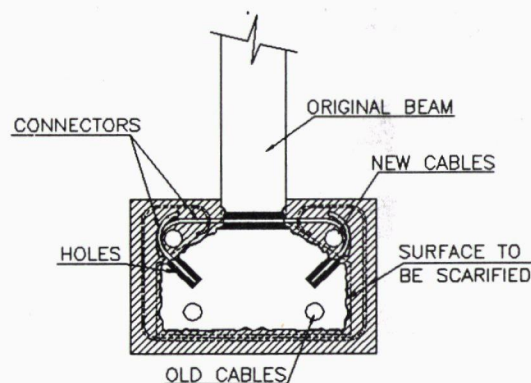
FIGURE 7 In early applications new cables were incorporated into concrete pour added to original section.

When the prestress losses were supposed to be between 60 and 10 percent, appropriate new cables were added to the beams. In this case the new cables were embedded in concrete cast around the lower flange of the beam. Rebars sealed in holes drilled in the existing beams guaranteed the connection between the old and the new concrete. The anchorages of these cables were

made with concrete blocks or steel frames according to each situation (Figure 7).

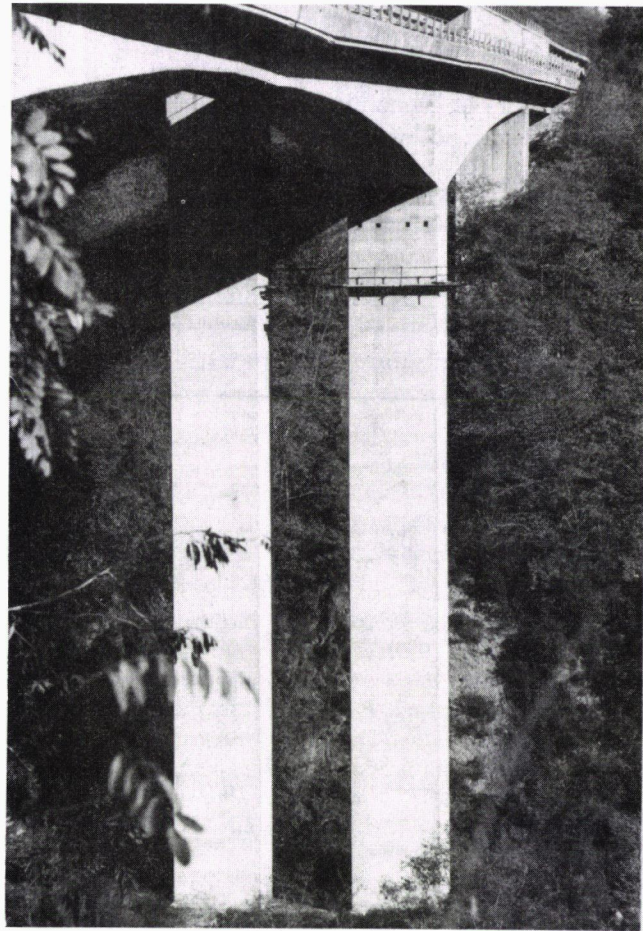
FIGURE 8 Ruiz Viaduct before repair. A large deflection at midspan is visible to the naked eye.

According to the solutions adopted at the time, no rigid connection was made at the end of the opposite cantilevers: a short dropped span (9 m) was built at the midspan of the Ruiz Viaduct, whereas a simple hinge connected the two facing cantilevers of the Stupino Viaduct at midspan (Figure 8). The large creep, developed over the 20 years of the bridge's life, caused unacceptable deflections at midspan (5).

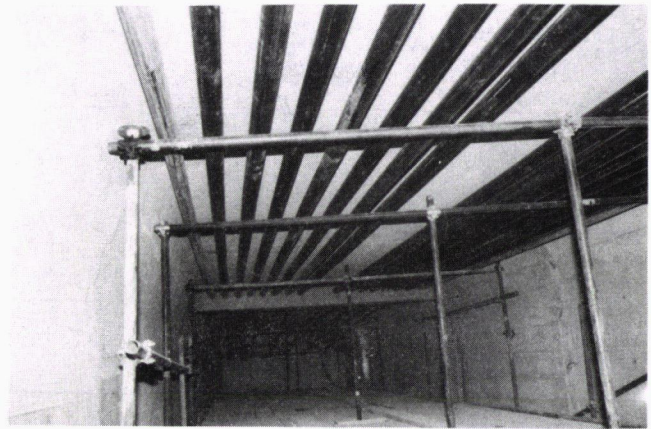
FIGURE 10 External cables added inside Stupino Viaduct. HDPE sheets were grouted with cement-mortar.

The prestressing cables added inside the box girder, at the bottom of the upper slab, allowed a reduction in the deflections and the addition of a lightweight aggregate wearing course to make the road profile acceptable. This is a classic example of external prestressing with grouted cables. The prestressing forces were trans-

ferred to the existing section with concrete anchor blocks and shear connectors (Figures 9 and 10).

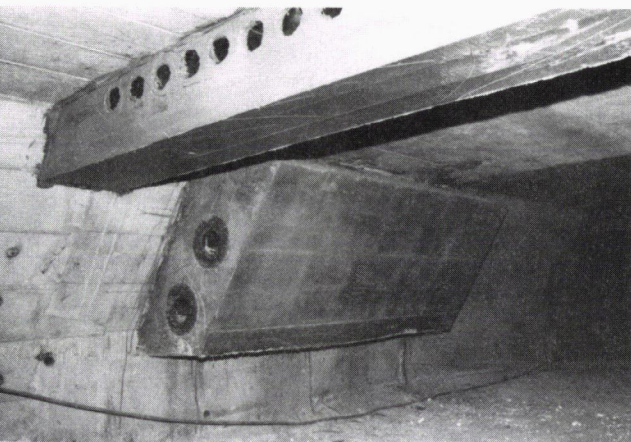
FIGURE 9 Deviation block (upper slab) and anchor block (web) ready to receive cables.

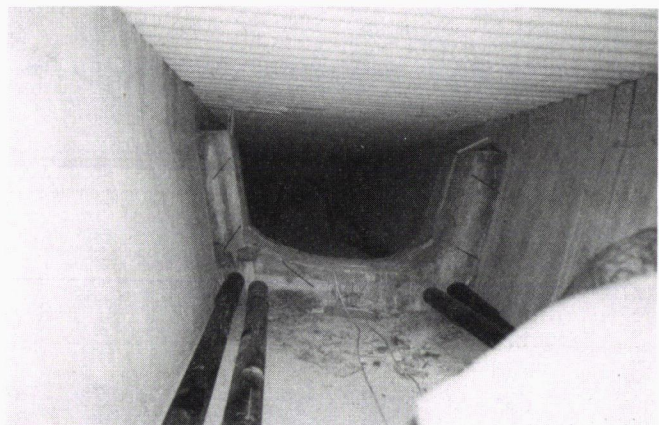
FIGURE 11 Deviation block added inside box girder. The external prestressing cables are composed of single sheeted strands. They will not be grouted.

Rehabilitation work was done on five viaducts with a total of 142 simply supported decks composed of two V-shaped beams for each carriageway (Figure 11). The decks had just been finished when some shear cracks appeared in a number of beams. The beams were initially prestressed with pretensioned strands, and the cracks were probably due to the insufficient strength of

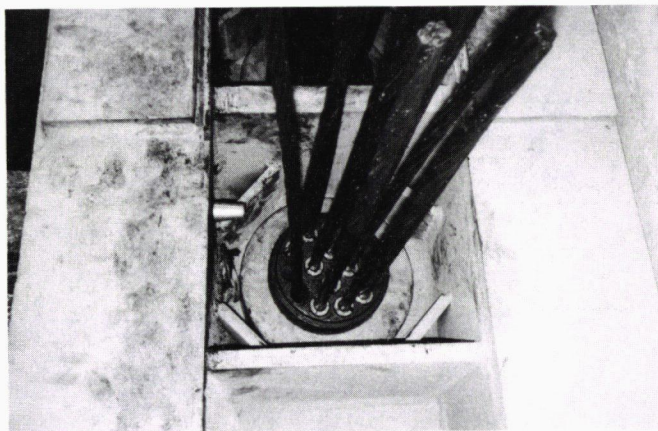
FIGURE 12 Steel frame placed at end of each beam to anchor new cables.

In this case external cables formed with single sheathed and greased strands were used. The strands were encased in an HDPE tube without any injection, and the anchorages have been designed in such a way that a single unit can also be replaced. A steel frame that transfers the force to the p.c. beam at its ends was chosen because of the narrow distance between two adjacent beams (Figure 12).
