# Modification of Sand-Drain Principle for Pressure Relief in Stabilizing Embankment Foundation

RAY WEBBER, Assistant Construction Engineer, and  
W. C. HILL, Soils Engineer, Oregon State Highway Department

A 20-foot double embankment on the Portland-Salem Expressway crosses a peaty, poorly drained area. The application of the sand-drain principle to the perimeter of the embankment area provides outlets for the free water under pressure of the embankment loads and permits accelerated consolidation of the foundation soils under these loads without lateral flow beyond the toes of the embankment.

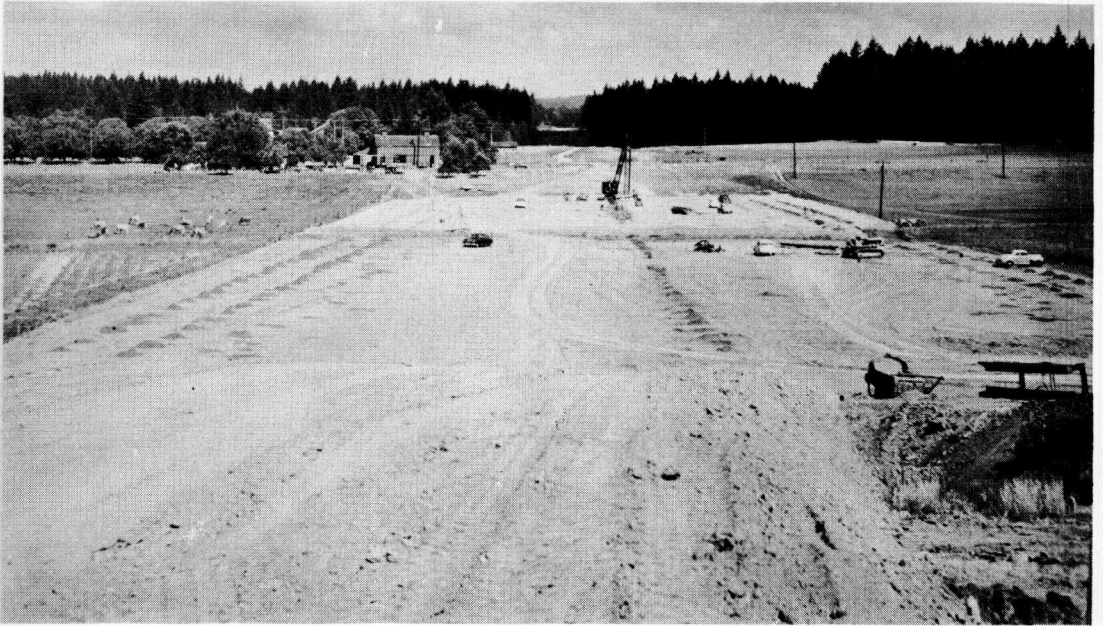
Figure 3. Working platform looking north, summer, 1952. Companion figure to Nos. 15 and 16. Pressure relief drain layout shown by excess  $\frac{1}{4}$  in. -0 drain material.

bankments and 15 ft. apart along the inner toes. The transverse distance between rows of drains was about 110 ft., as shown in Figure 3 and Figure 15. The working platform upon which the pile driving equipment was to operate was a departure from the usual permeable sand blanket, being a dense soil blanket about 3 ft. thick laid over the natural ground surface. This would allow for an initial flow of foundation pore water under

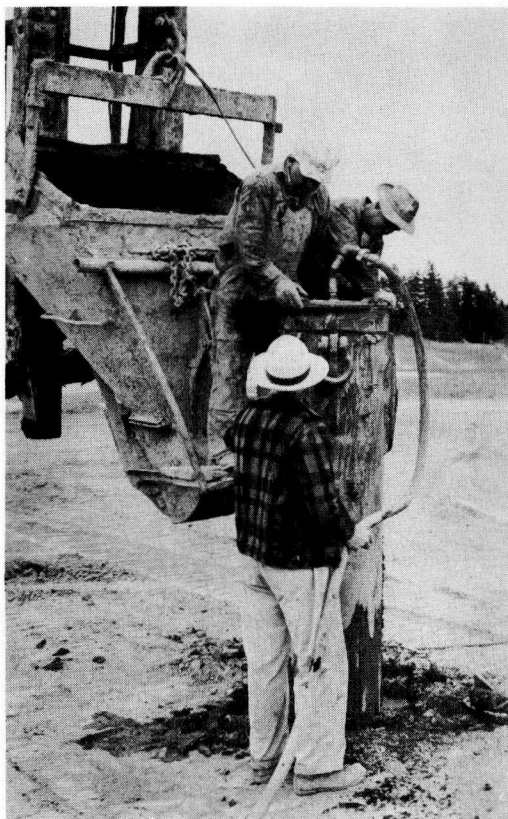
Figure 6. Clamping the air pressure cap on steel mandrel filled with  $\frac{1}{4}$  in. -0 drain material. Note the driving cap on the ground lower right.

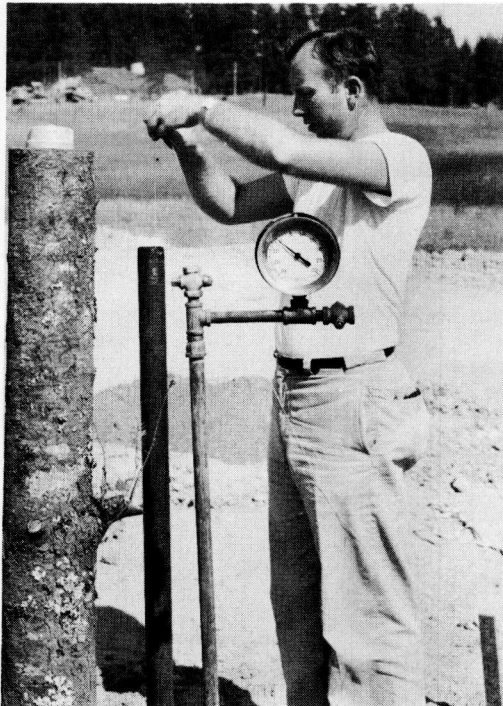
Figure 12. Checking water rise against pressure piezometric gauge. Vacuum of  $\pm 1\frac{1}{2}$  inches initially applied. Gauge reads in pounds per square inch plus and inches of mercury minus.

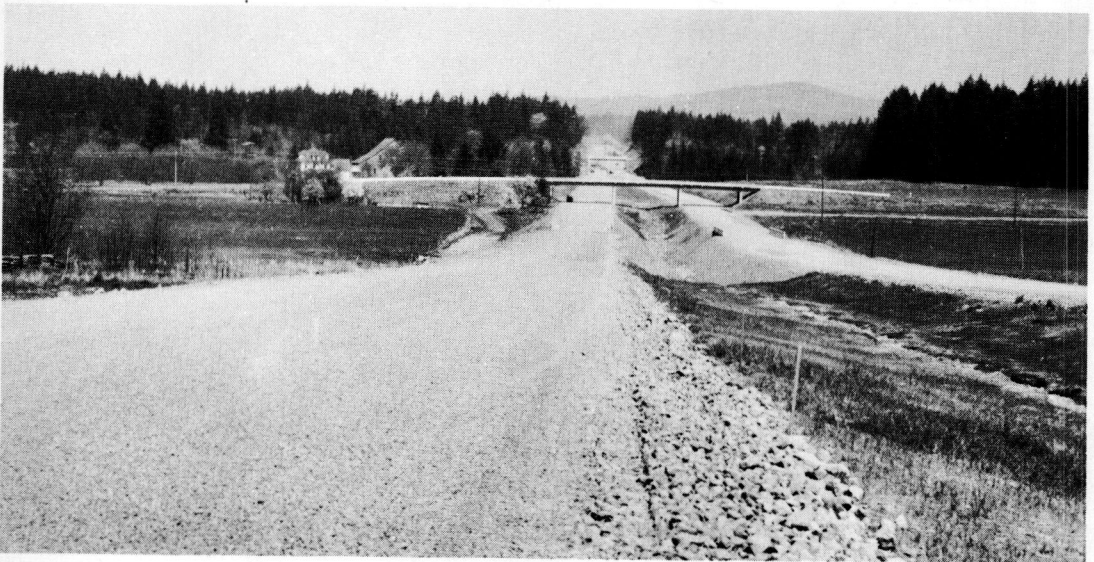
Figure 16. Looking north along west embankment just prior to placing asphaltic concrete paving. See Figures 3 and 15.
