HIGHWAY RESEARCH BOARD
Bulletin 123

Bituminous Resurfacing

CONDITIONING AN EXISTING CONCRETE PAVEMENT FOR BITUMINOUS RESURFACING

CONDITION SURVEYS OF BITUMINOUS RESURFACINGS OVER CONCRETE PAVEMENTS

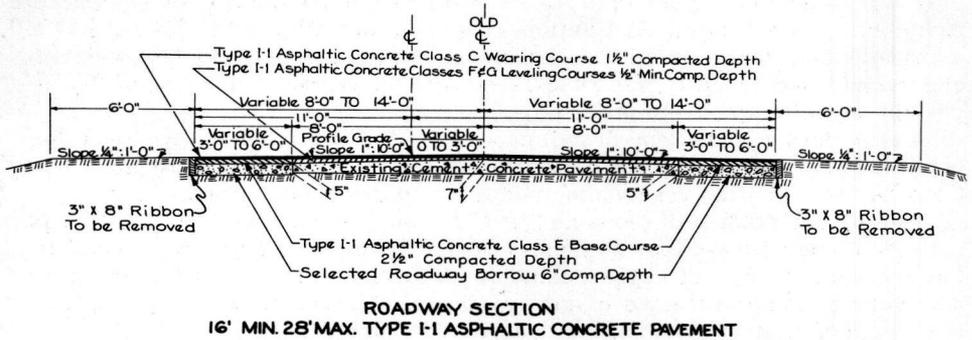
Figure 1.

A typical cross-section of this project, as shown in Figure 1, consisted of 3 feet of widening on each side of the old pavement with a $2\frac{1}{2}$ -inch asphalt-concrete base, after which a leveling course with a minimum thickness of $\frac{1}{2}$ inch over high points, or an average thickness of 1 inch was placed over the old 16-foot roadway. The depth of leveling mix on the new base course varied from $\frac{1}{2}$ to $\frac{3}{4}$ inch. A wearing surfacing of $1\frac{1}{2}$ -

inch uniform thickness was constructed to complete the resurfaced roadway. In areas where depths of more than 2 inches of leveling course were required to produce a uniform grade line, leveling mix was spread by motor-patrol blade to prelevel the depressions in the old cement concrete pavement. The shoulders on each side of the pavement were excavated to a width of 5 feet and depth of 6 inches below grade line of the finished subgrade. This area was then filled and compacted with selected gravel roadway borrow upon which to lay the asphalt concrete base mixture. One exception to the above cross-

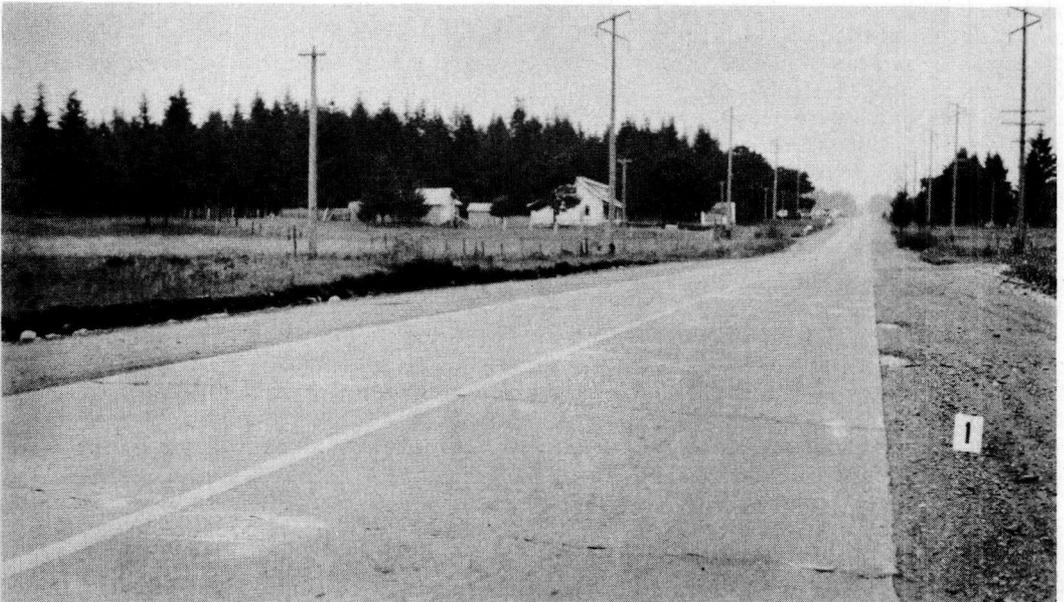
Figure 2.

Figure 2 shows the old pavement as it appeared in March 1940, or nearly 26 years after it was constructed. Note the transverse cracks and the indications of pumping movement of the slabs at the expansion joints by the light patches near the center line. Figure 3, taken in September 1940, illustrates the resurfaced pavement at the same location as Figure 2, while Figure 4 was taken in October 1954, showing the conditions of this pavement 14 years later. These three views were taken at the north end of the project at the same location.

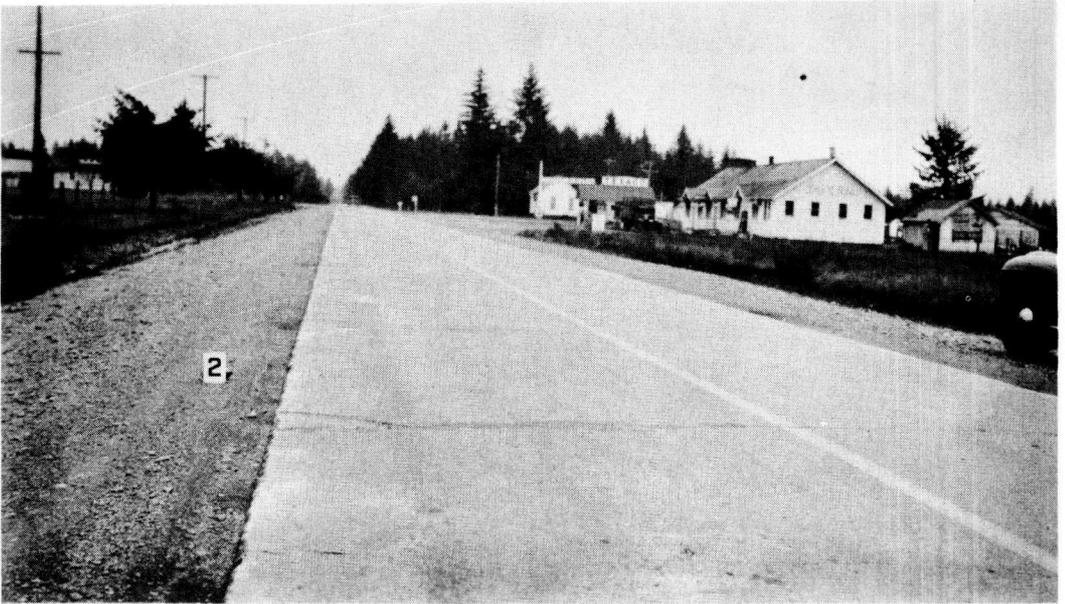
Figure 5.

Figure 5 reveals the condition of the old pavement at approximately the center of the project and although some of the corners of the slabs are broken and the expansion joints

are chipped, the 26-year old pavement is in fair condition at this point.

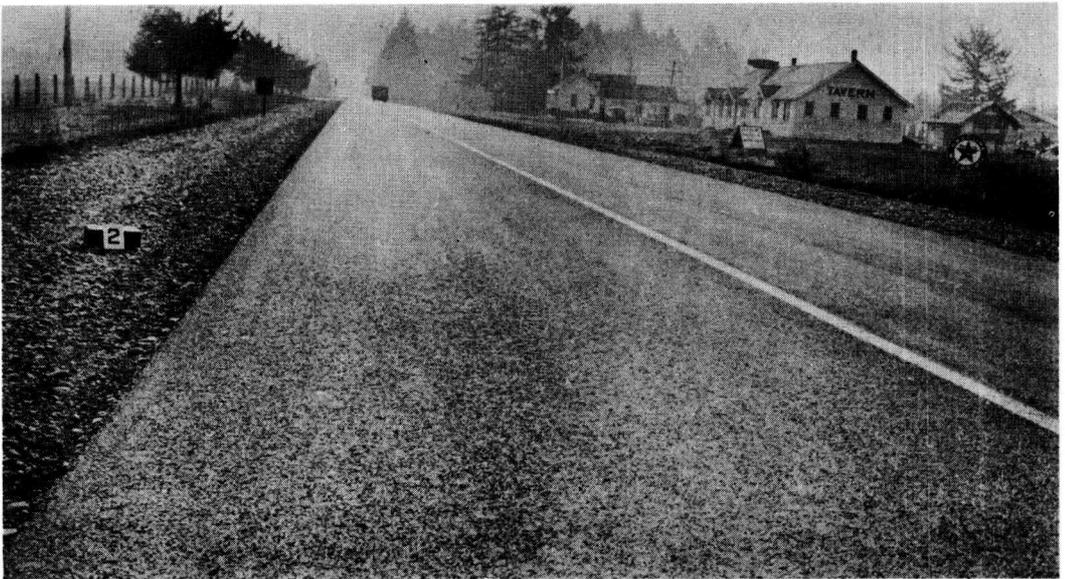
Figure 6.

Figure 6 exhibits the completed resurfacing work in September 1940, showing the rather granular texture of the wearing surface. Figure 7 discloses this same area in October 1954, or 14 years later.

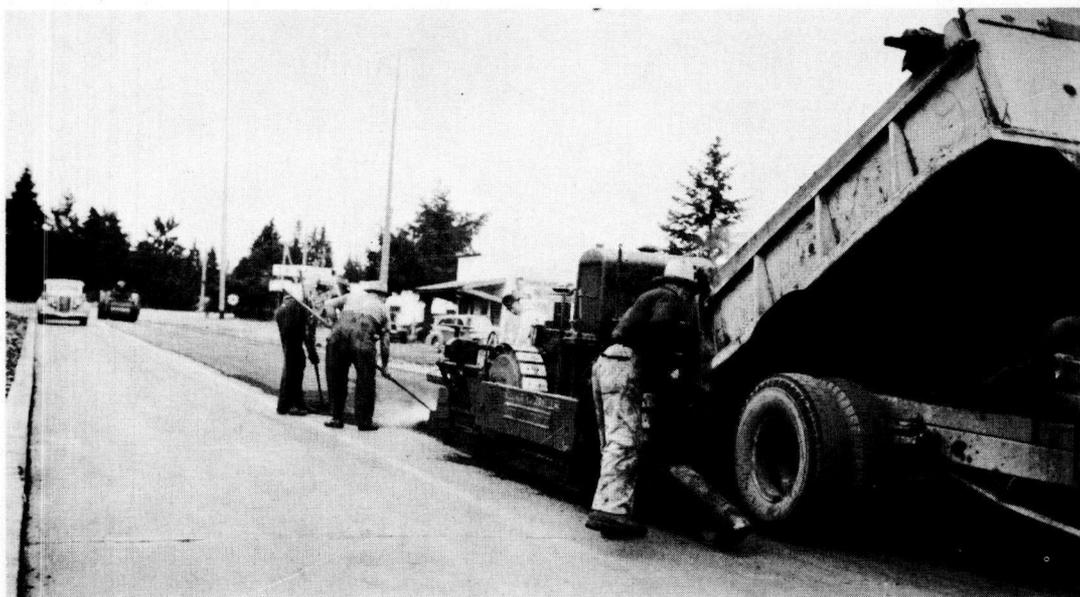
Figure 8.

leveling materials. These were placed with a heavy motor-patrol blade. The pavement was rolled with one 10-ton, three-wheel and one 8-ton tandem roller. Figure 8 shows the spreading machine working on leveling mix and the three-wheel roller can be seen in the background.

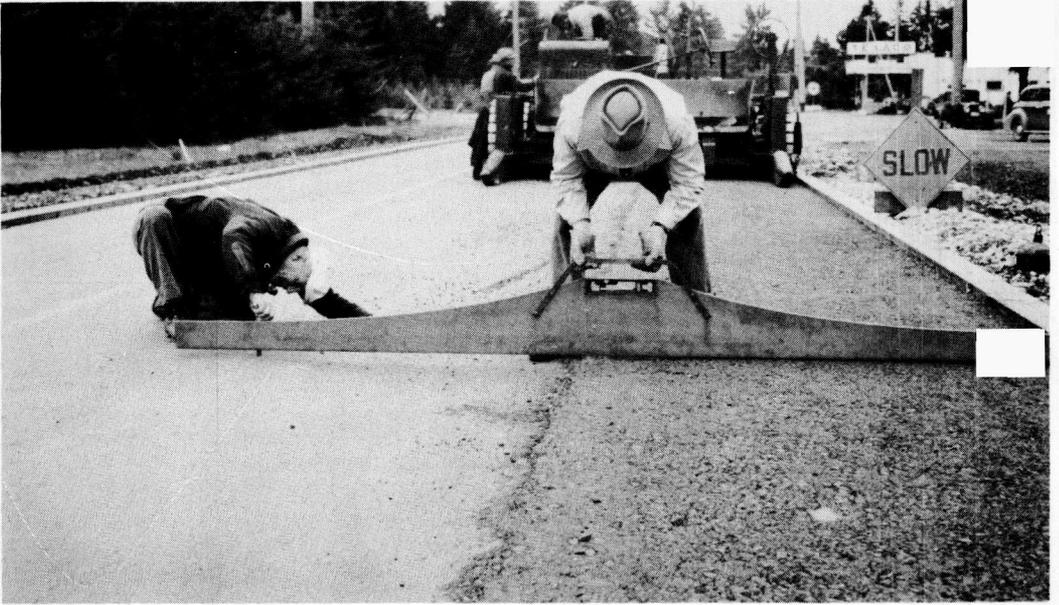
Figure 9.

Figure 9 demonstrates a straightedge equipped with an adjustable carpenter's level for obtaining the thickness of mat on the old pavement for correct crown. Marks indicating the thickness of the mat were placed on the pavement each 25 feet of length for the information of the machine operator and inspector.

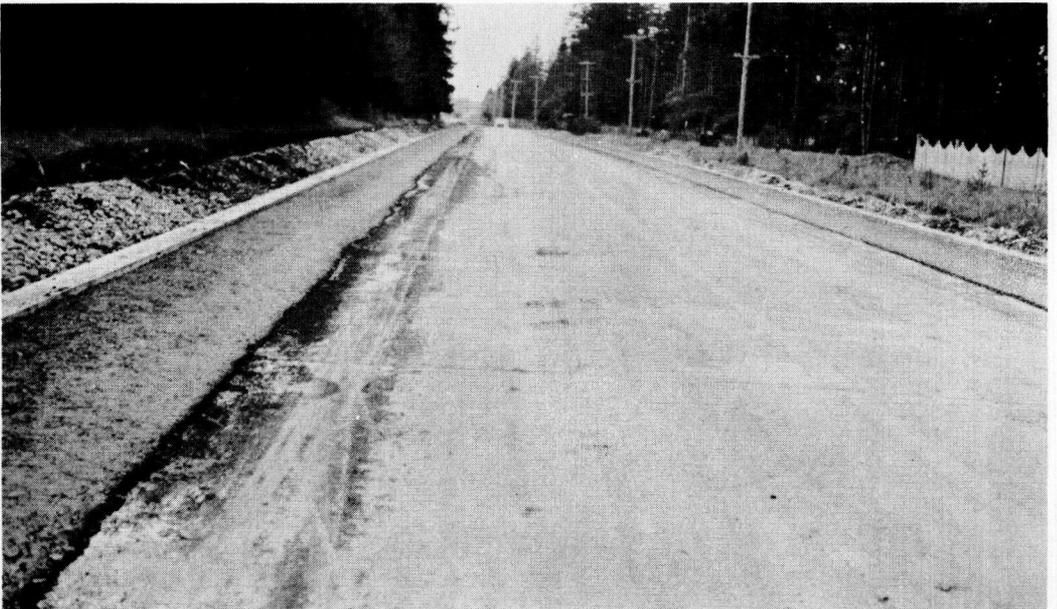
Figure 10.

Figure 10 discloses the base mix compacted in place on each edge of the old pave-

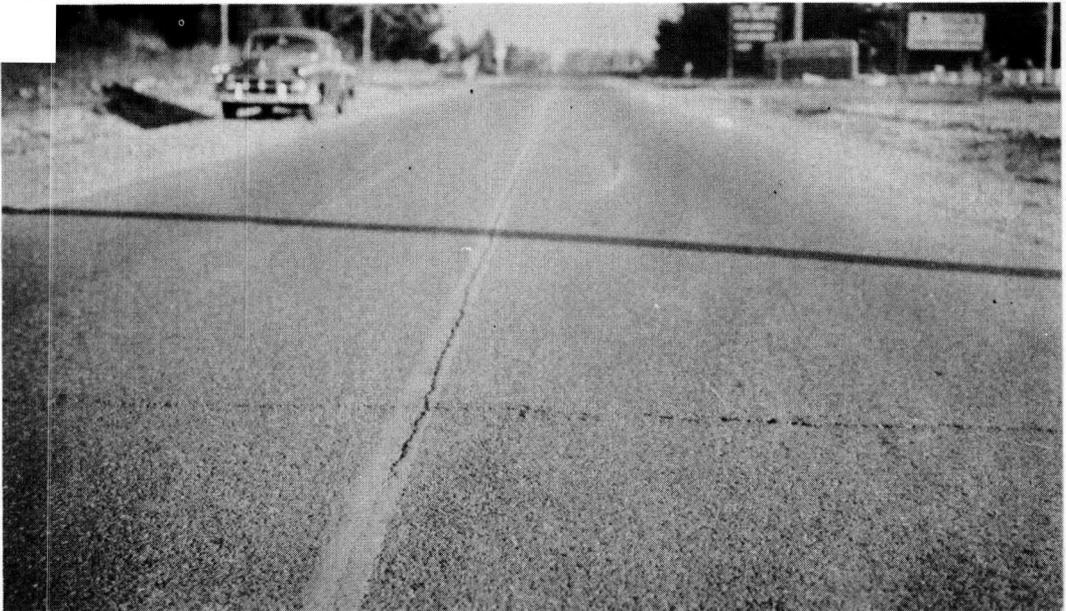
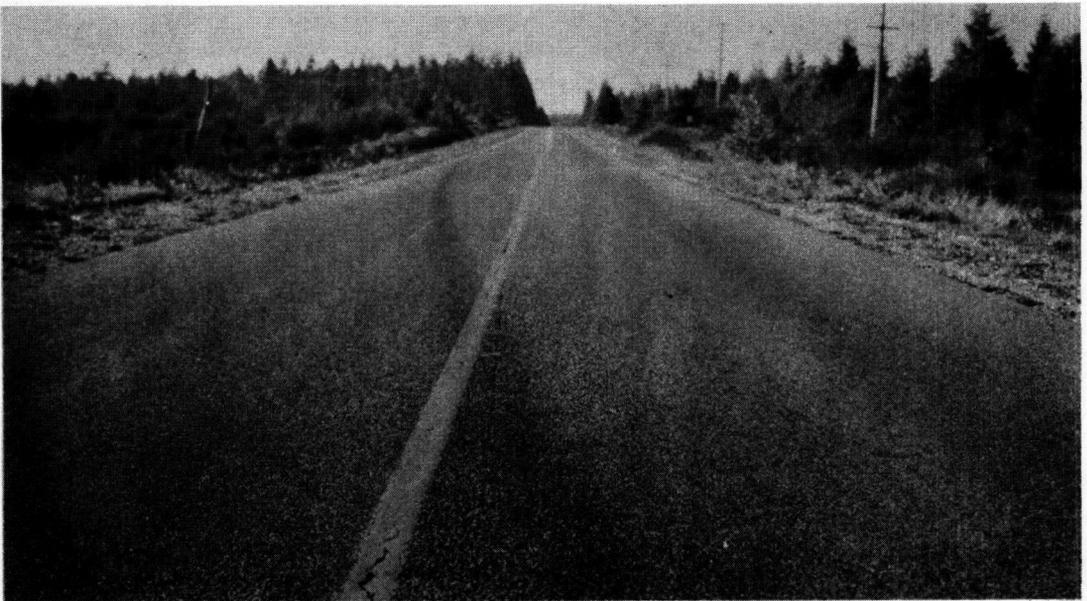
general classes that are common in this type of construction. The first class is where a relatively thin flexible pavement is placed over a rigid pavement or base and the expansion joint pattern in the rigid base reflects through to the new surface after a few years. The second class of crack pattern is where the nonrigid base under the widened area is lacking in thickness or contains plastic material which causes the pavement to yield under traffic during wet weather or during the early spring thawing period.

Figures 11 and 12 illustrate the first type of crack pattern that developed in this pavement to a minor extent the second year after it was laid. The second type of

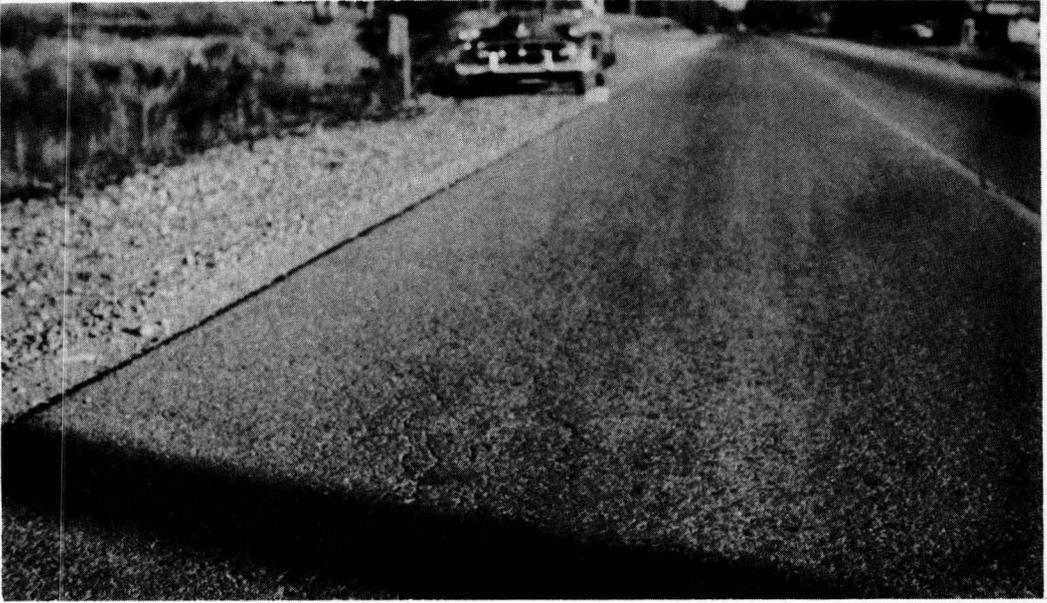
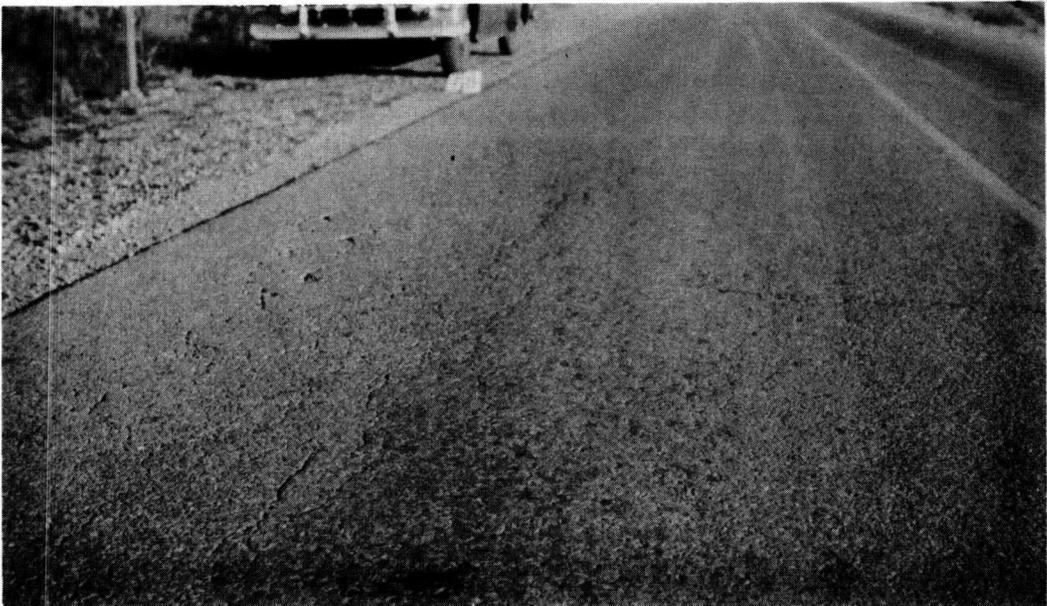
crack pattern in Figures 13 and 14 indicates the foundation under the asphalt concrete pavement has yielded and caused the surface to form an irregular crack pattern, sometimes called alligator cracks. There are cases where this type crack will form due to lack of compaction of the widened area, and the area, under traffic, will compact and subside causing the cracks to form. However, cracks caused from lack of compaction will usually heal up in following years and will not recur when the base material is unyielding. The cracks over the old concrete pavement are less noticeable during the summer and early fall months before cool weather causes the old pavement to contract. To date little patching has been done on this asphalt-concrete resurfacing, and the cracks have never been poured with a crack-filling material. However, such areas as shown in Figures 13 and 14 will need attention in the next year, since they are becoming progressively wider and allowing more water to reach the base or foundation.

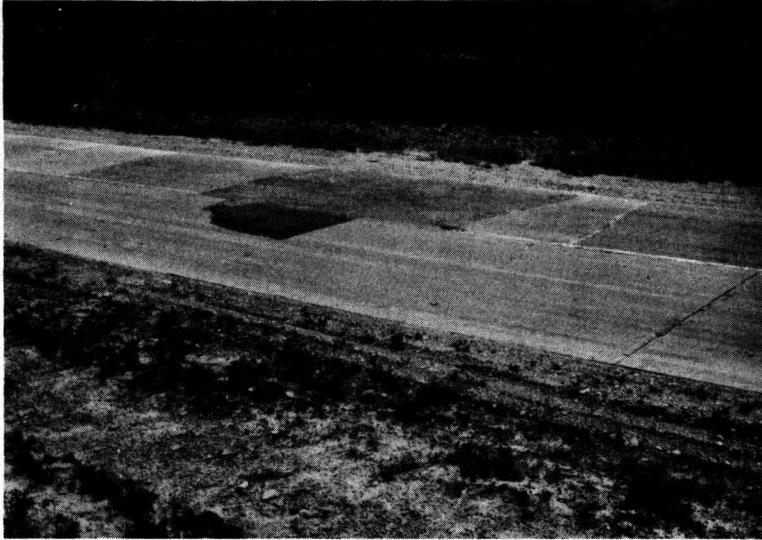
Figure 1. Condition of old pavement prior to resurfacing. Fore-ground is passing lane.

material, installing drains, and then placing pavement patches of either plain portland-cement concrete or of the flexible type. Before any work started, an accurate condition survey of the pavement was made and recorded on a condition survey form (see Figure 9 for an example). The survey noted all faulted joints and extent of the faulting, patches, cracks and breaks in the slabs, pumping joints, and other conditions considered to have an influence on the resurfacing. Figures 1 through 4 illustrate the condition of removal

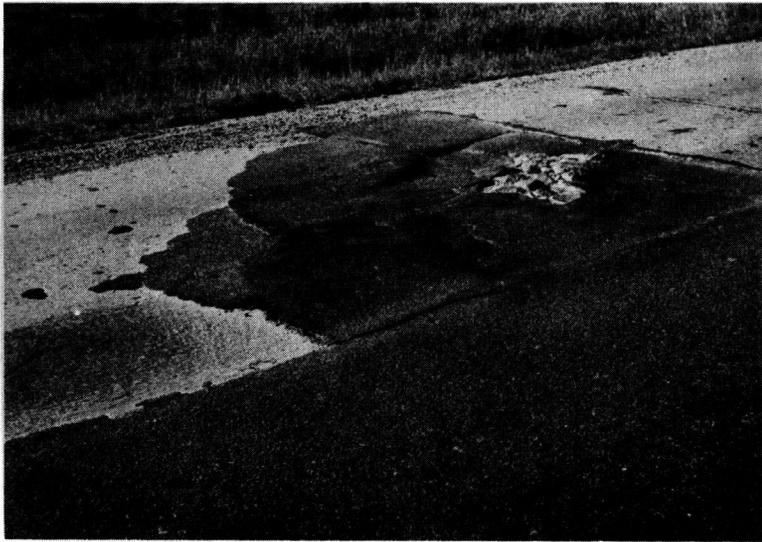
Figure 2. Condition of old pavement prior to resurfacing. Fore-ground example of extensive bituminous patching. Background example of numerous corner breaks.

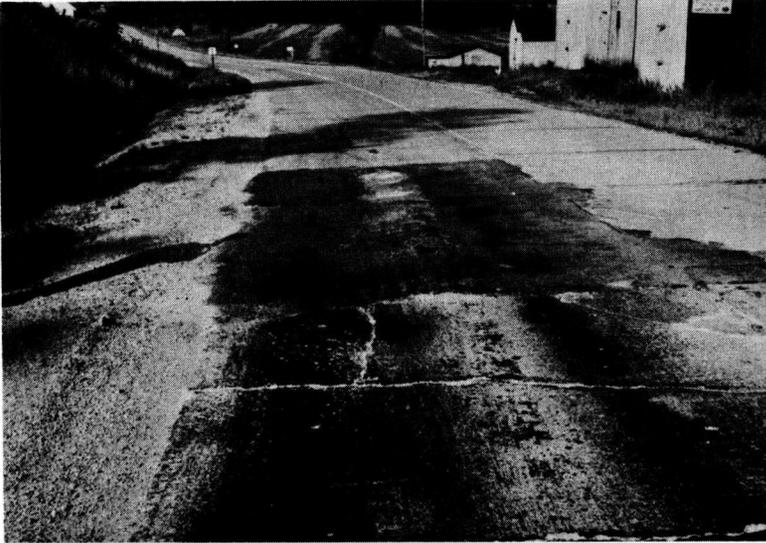
Figure 3. Condition of old pavement prior to resurfacing. View shows faulted and pumping slabs and extensive bituminous patching.

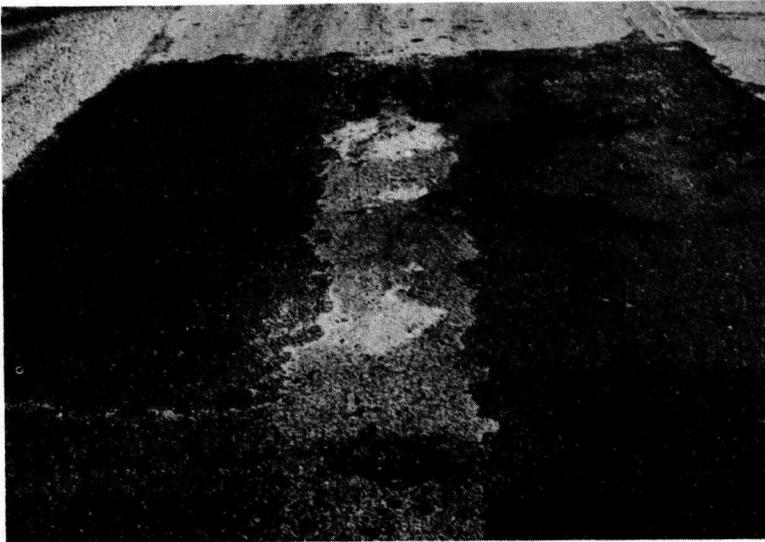
Figure 4. Condition of old pavement prior to resurfacing. View shows a pumping joint that has broken through an extensive bituminous patch.

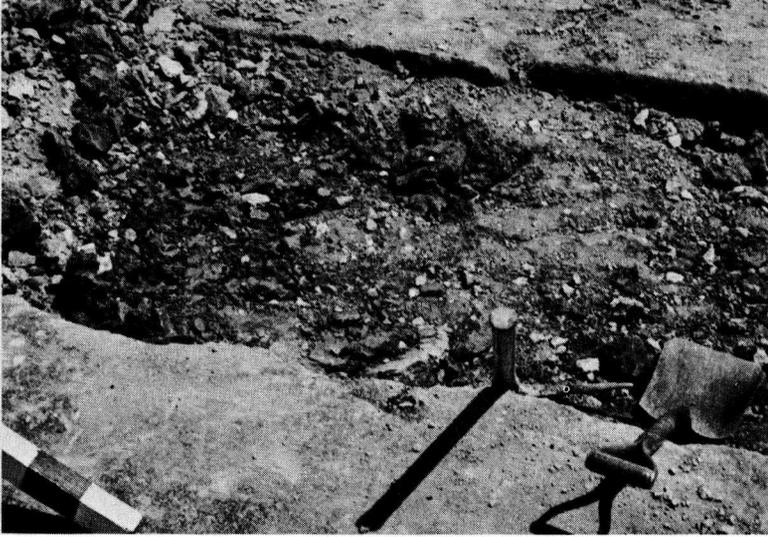
Figure 5. View showing old concrete removed preparatory to patching. This is a minimum width removal of 4 feet.

tice necessitated the removal of some sound pavement in areas of triangular corner breaks. It was felt that if small triangular patches were placed, however, they would soon be rocking under the traffic load. Figure 5 illustrates a minimum width of removal.

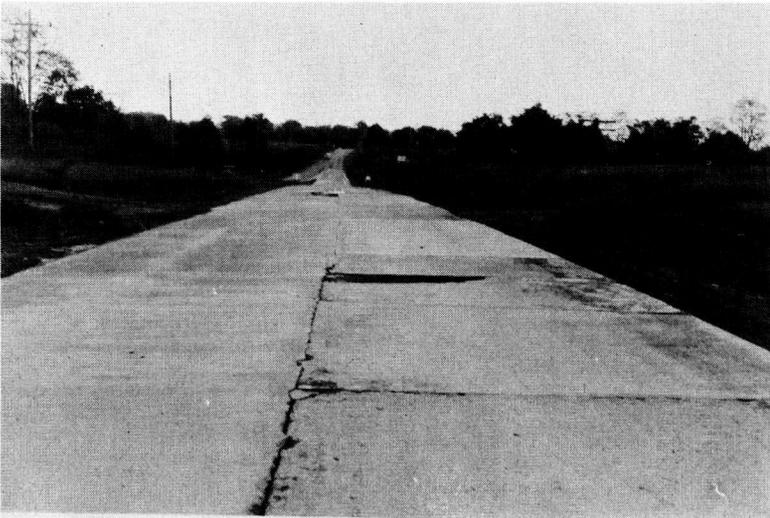
Figure 6. View showing a large size plain concrete patch on left. Right side partially patched. Surface of patches were float finished and were not edged.

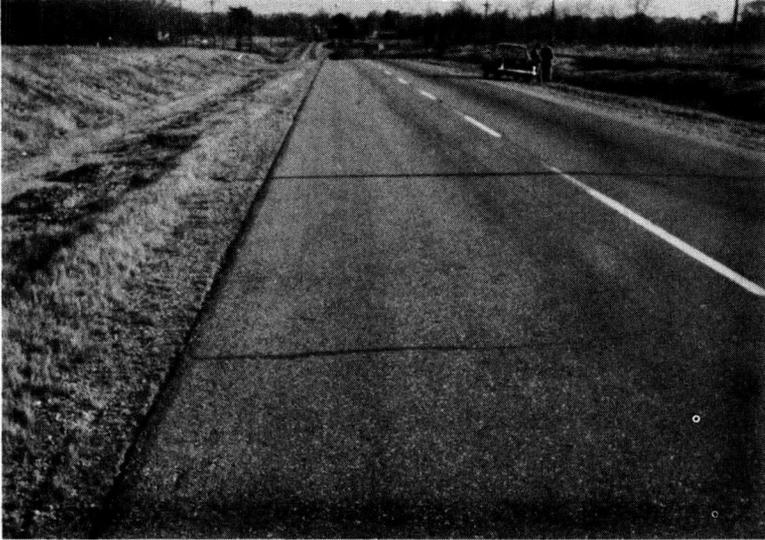
Figure 7. Typical condition of the resurfaced pavement December 1, 1954.

Annual condition surveys have been made each May since the project was completed. The pavement and drains were carefully checked and a record made (see Table 1). The pavement was last examined on December 1, 1954. Figures 7 and 8 illustrate the present general condition of the pavement.

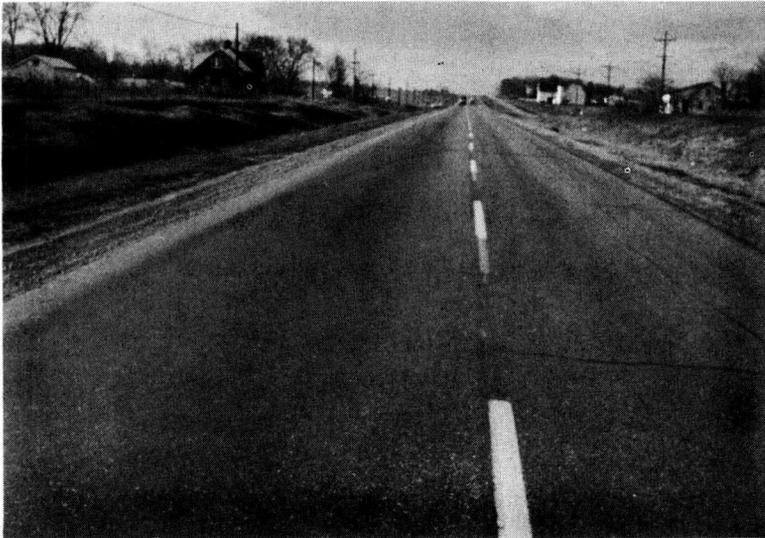
Figure 8. Typical condition of the resurfaced pavement December 1, 1954.

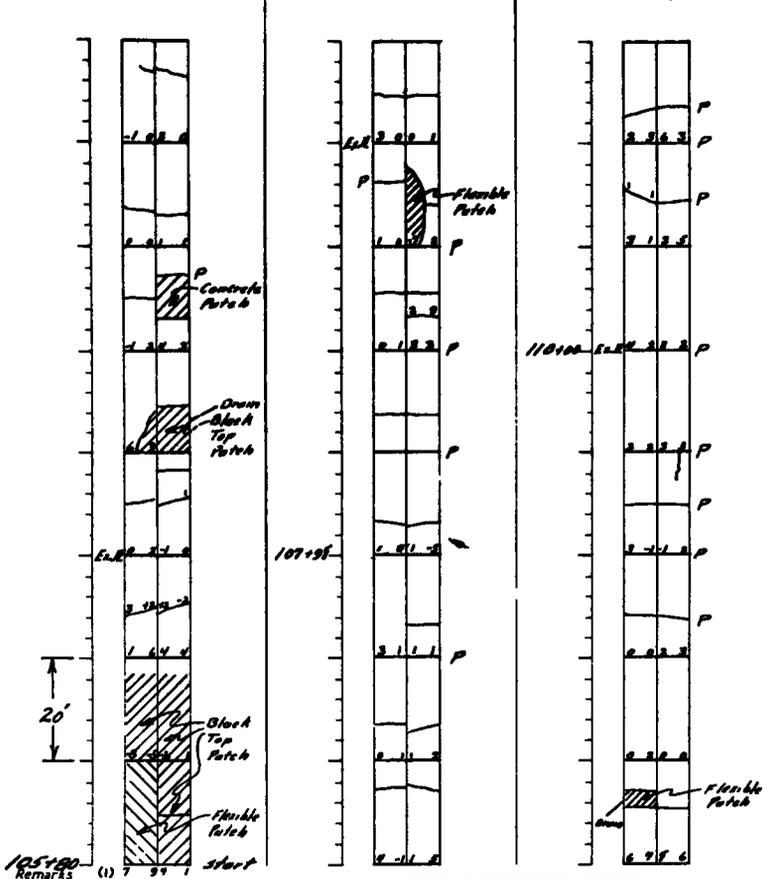
Figure 9.

OHIO DEPARTMENT OF HIGHWAYS CONCRETE ROAD SURVEY
FIELD SKETCH SHEET

Remarks (1) 7 9 1 short
light surface treatment on right lane.
Undersealed
(1) Faulting recorded in sixteenths of an inch
(2) P = Tamping cracks or joints

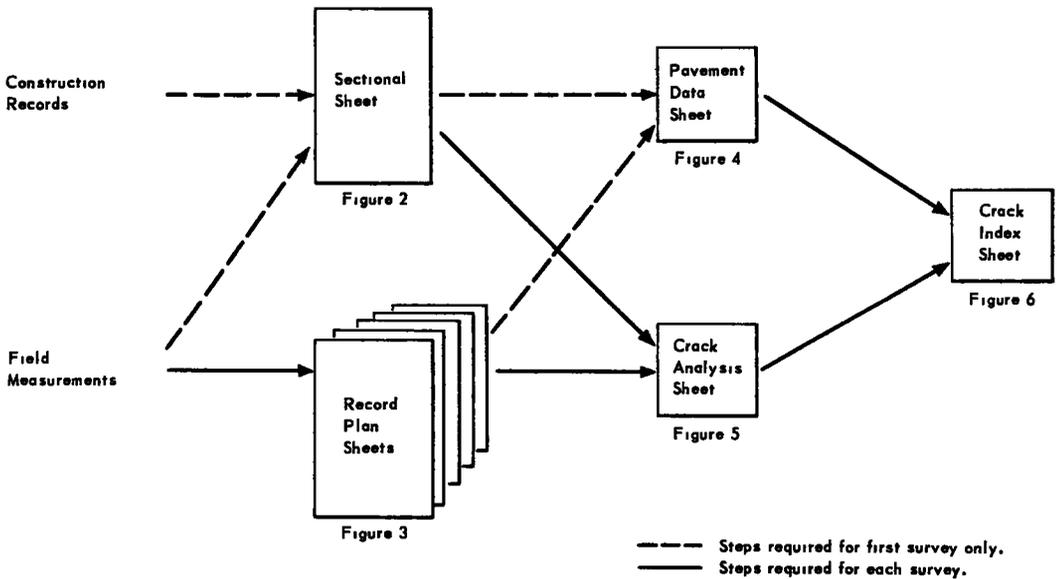
Figure 1. Data flow diagram for survey data of one section.
