AN AIRPHOTO STUDY OF THE TRIASSIC AREA IN ALBEMARLE COUNTY, VIRGINIA

P. L. MELVILLE

*Associate Research Engineer
Virginia Department of Highways*

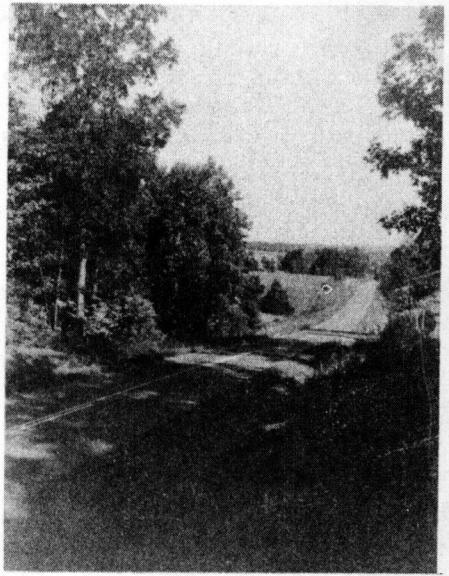
Figure 2 Albemarle County-Scottsville Area Change in physiography at the fault line: the picture was taken on soil derived from Precambrian parent material looking toward the Triassic Basin (Rt. 6).

It is west of the Fall line within the physiographic province commonly known as the Piedmont Plateau, close to the Blue Ridge. The elevation ranges from about 400 to 500 ft. above sea level. The drainage is fairly simple in pattern and the streams flow into the James River which bounds the area to the southeast. The topography is gentle with flat land and rolling hills as illustrated by Figures 2 and 3. (11)

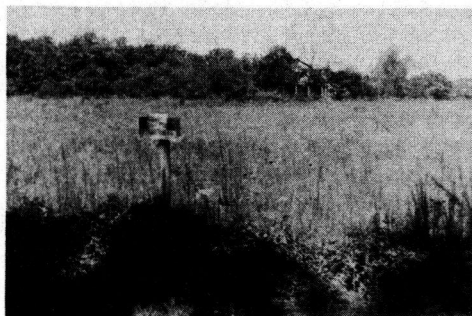
Figure 4 Albemarle County-Scottsville Area Typical Pre-Cambrian Landscape with farm (Rt. 712) glaciation has apparently been found in Triassic formations (12).

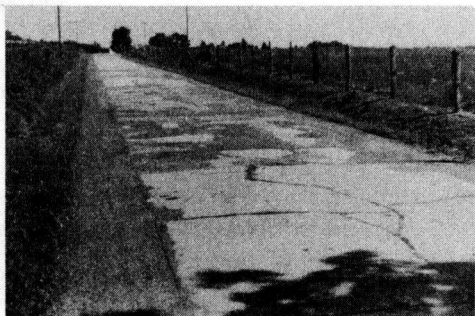
Figure 15 Albemarle County-Scottsville Area Poor performance of concrete pavement on soil derived from Triassic parent material.

(Rt. 20)

the state and was built by the County Road Department in 1919. Since accurate records on this pavement are not available, one should remember that any findings of the performance survey might be infirmed by the fact that different sections were built by different contractors with different materials. This fact will obviously affect the quality of the resulting concrete, but since the section boundaries are not available, it had to be overlooked in the survey. Nevertheless, it is indeed striking to note the difference in performance of the pavement in the two soil areas as shown in Figures 15 and 16. A crack count was made over two five mile stretches of road: in the Triassic basin the average number of cracks for 0.1 mile was 32 against 12 on adjoining Pre-Cambrian soil for approximately the same traffic. This means a crack interval of 44.0 against 16.5 feet. The pavement built without joints (either longitudinal or transversal) is still in excellent condition for its age in the Pre-Cambrian area but shows generalized failure in the Triassic basin. Map cracking, spalling, and scaling were observed, but from the large amount of patching it was not possible to determine the occurrence of blowups. Thus, it appears that the poor drainage and bearing power

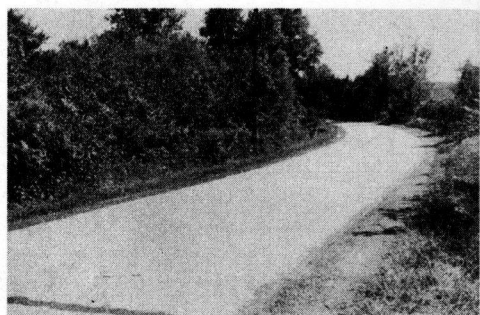
Figure 16 Albemarle County-Scottsville Area Excellent performance of concrete pavement on soil derived from Pre-Cambrian parent material.

(Rt. 20)

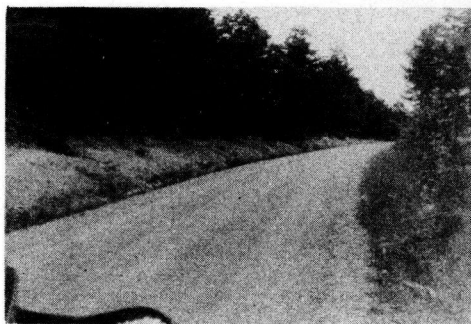
Figure 18 Albemarle County-Scottsville Area A secondary road on fairly well drained soil from Pre-Cambrian parent material (note typical vegetation of pine trees)

An inspection of Figures 17 and 18 will show clearly the difference in appearance of the roads in the two areas. Especially obvious is the difference in drainage characteristics which are emphasized at the time of the "spring break-up." As shown in Figure 19, at any season the surface water will remain for days after any rain while it disappears much faster on surrounding soils derived from Pre-Cambrian parent materials. The deep red-brown sticky mud is unfortunately

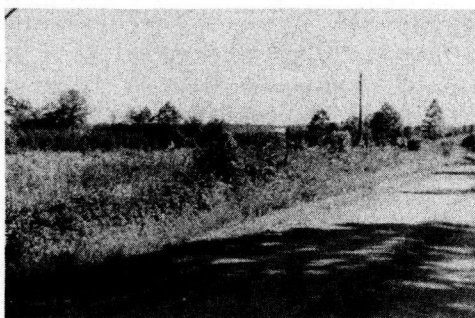
Figure 17 Albemarle County-Scottsville Area A secondary road on poorly drained soil from Triassic parent material (note typical flat landscape and vegetation of cedar trees)

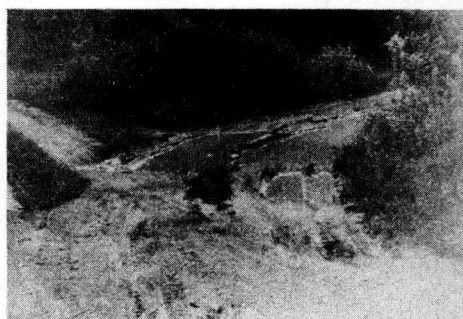
Figure 19 Albemarle County-Scottsville Area A secondary road on soil derived from Triassic parent material. Note poor drainage of plastic soil.

(Rt. 735)
