Wire Mesh Reinforcement in Bituminous Resurfacing

ERNEST ZUBE, Supervising Materials and Research Engineer
California Division of Highways

This paper describes an experimental project in which the California Division of Highways in 1954 placed several test sections for the purpose of comparing the relative merits of various types of wire mesh.

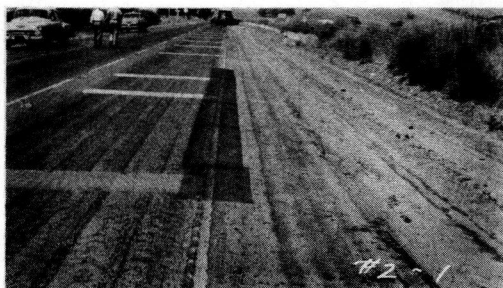
Figure 10. Typical expanded metal test section just prior to paving. Short section of longitudinal joint covered.

the job site in 2 and 4 foot wide strips by 8 feet long. As the expanded metal is rather expensive the two and four foot wide sheets were being tried in order to determine the most economical size which would prevent crack formation. The 8 foot long sheets were satisfactory for the passing lane as 8 feet of old concrete pavement remained due to a shift of the centerline. For the 12 foot wide travel-lane some sheets were cut in half and an 8 foot and 4 foot long sheet used, allowing an overlap of about 3 inches. All joints such as expansion and contraction joints and random cracks of the slabs were covered with the metal. Short sections of the longitudinal joints between the old concrete and new cement treated base were also covered with 2 foot and 4 foot wide sections of the metal, (see Figure 10).

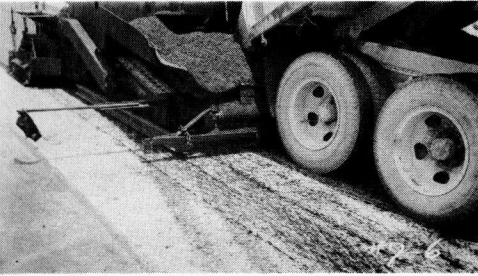
Figure 15. Close-up of paving operations. Figure 16. Position of mesh after placing leveling course.

Note sled attachment on left. distance, or would bend or shatter the concrete, or the charge would drive the stud completely through the disc necessitating the driving of additional studs.

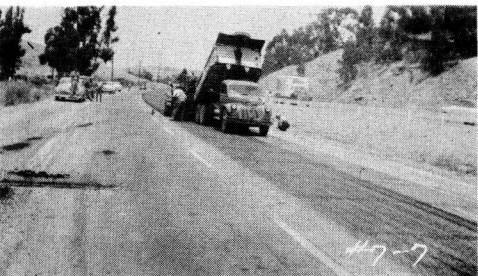
Figure 17. Paving over 3- by 8-inch mesh.

Figure 18. Fastening leading edge of first sheet.

securely fastened to the pavement by means of the stud driver, at about 1 foot intervals. All succeeding sheets were lapped one diamond, taking care that the sheets in place always overlapped the sheet being laid. The next operation was the fastening of the individual sheets to each other. This was done by two men, using medium sized hog rings and a hog ring clipper, (see Figure 6). About four to five rings were used at each lap, the wires being tied along the length of the diamond. The first diamond on each edge of the sheet was always fastened as well as two or three diamonds in between. The hog rings, when crimped into lock position, do not rigidly clamp the wires together and the rings could be freely moved in a longitudinal direction. Vertical movement, however, is restricted to a large extent. The 3-12-30 mesh laid very flat against the pavement and very little curl or raised areas were noted along the entire 600 foot section.
