Pavement Widening and Resurfacing in Idaho

L. F. ERICKSON, Materials Engineer, and
PHILLIP A. MARSH, Assistant Materials Engineer
Idaho Department of Highways

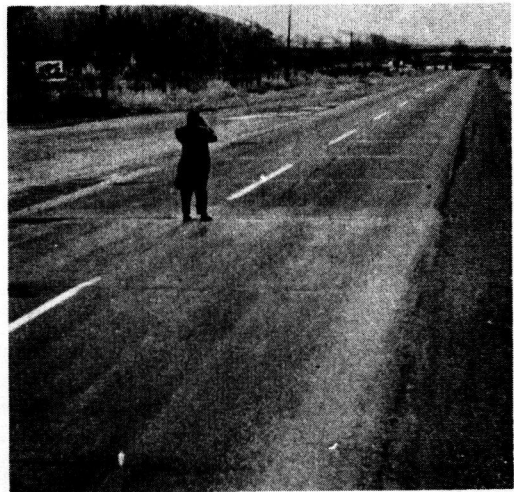
Figure 8. Reflected joints in resurfacing of portland-cement concrete pavement, no base added.

The resurfacing of portland-cement concrete pavements without the addition of base overlying the old pavement results in reflection of nearly all dummy and expansion joints and other cracks. (see Figure 8). The edge of the concrete pavement also reflects through the new pavement by the appearance of longitudinal cracks. Where compaction apparently was lacking in the base beneath the widened section, traffic compacted the pavement with the result that a groove was formed. (see Figure 9). The riding qualities of these pavements are generally fair but one pavement is definitely poor. All transverse and edge cracks have had to be sealed.

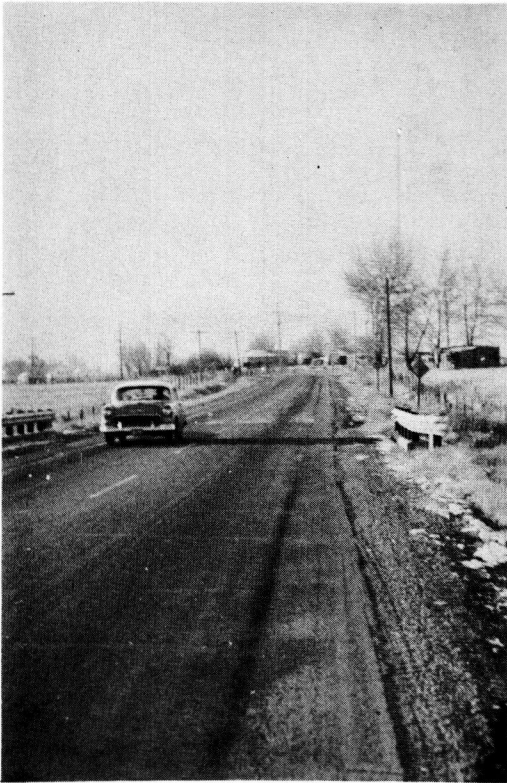
Figure 9. Traffic compaction of widened section, portland-cement concrete pavement, no base added over old pavement.

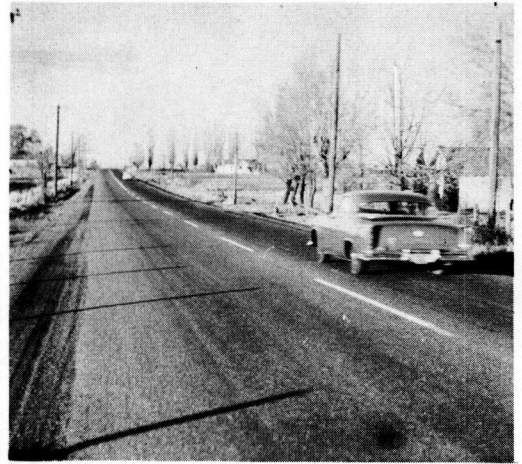
Figure 10. Resurfaced portland-cement concrete pavement with six inches of base added, in perfect condition seven years later.

A pavement constructed in 1951, with a 6-inch base overlaying a portland-cement concrete pavement is still in excellent condition and does not reflect cracks, joints or the edge of the old pavement. Adjacent sections without the crushed gravel base exhibit reflection cracking of the usual type. (see Figures 10 and 11).
