NRC. HIGHWAY RESEARCH BOARD,

Bulletin 131

***Widening and Resurfacing
with
Bituminous Concrete***

WIRE MESH REINFORCEMENT IN BITUMINOUS RESURFACING	
Ernest Zube -----	1
PAVEMENT WIDENING AND RESURFACING IN IDAHO	
L. F. Erickson and Phillip A. Marsh -----	19
HIGHWAY REHABILITATION BY RESURFACING	
K. B. Hirashima -----	26
PROGRESS OF REFLECTION CRACKING IN BITUMINOUS CONCRETE RESURFACINGS	
Vincent J. Roggeveen, and Egons Tons -----	31

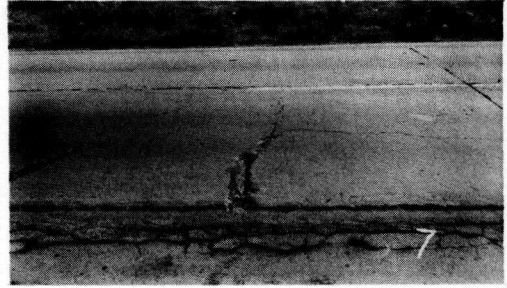
Figure 3. Random cracks.

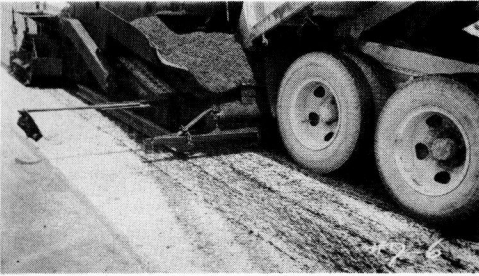
Figure 15. Close-up of paving operations. Figure 16. Position of mesh after placing leveling course.

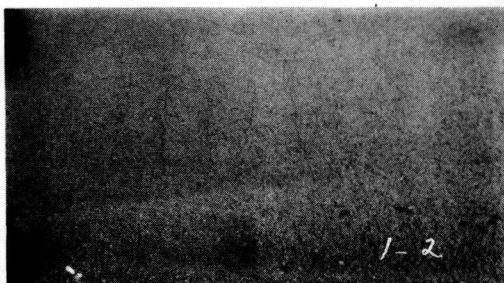
Figure 22. Typical transverse cracking of leveling course following first roller pass. Cracks were closed by traffic within 24 hours.

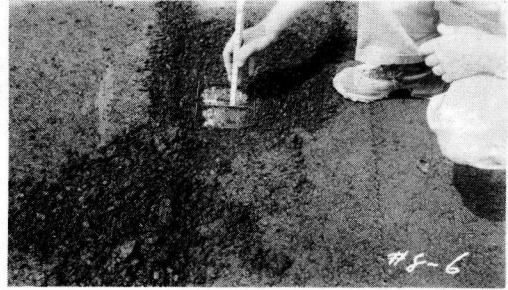
Figure 23. Position of fabric after completion of leveling course.

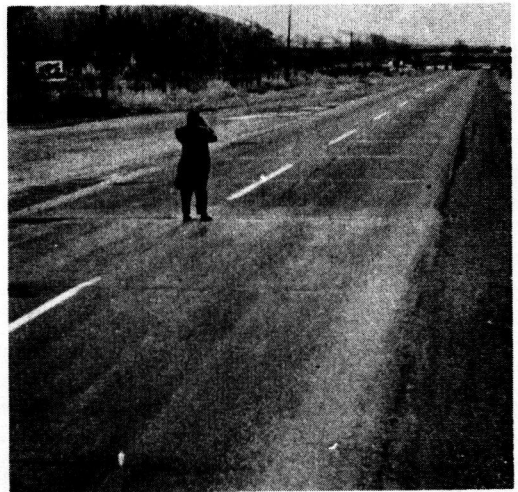
Figure 8. Reflected joints in resurfacing of portland-cement concrete pavement, no base added.

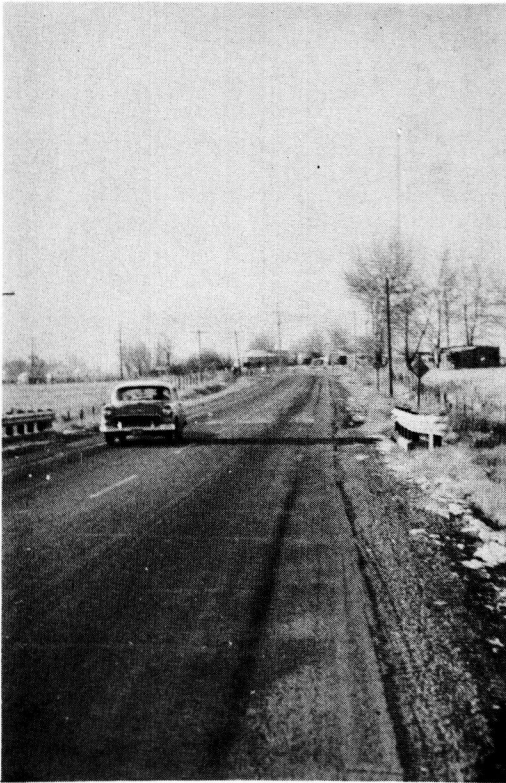
Figure 9. Traffic compaction of widened section, portland-cement concrete pavement, no base added over old pavement.

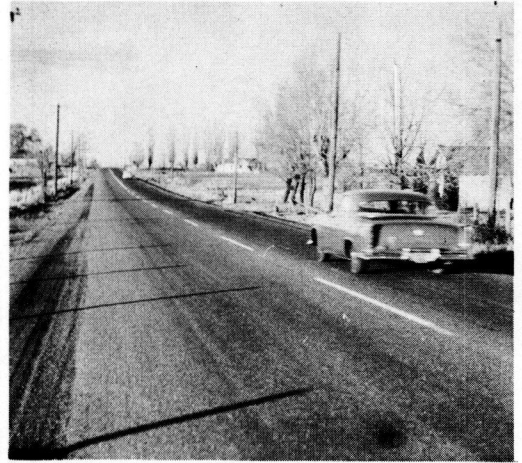
Figure 10. Resurfaced portland-cement concrete pavement with six inches of base added, in perfect condition seven years later.

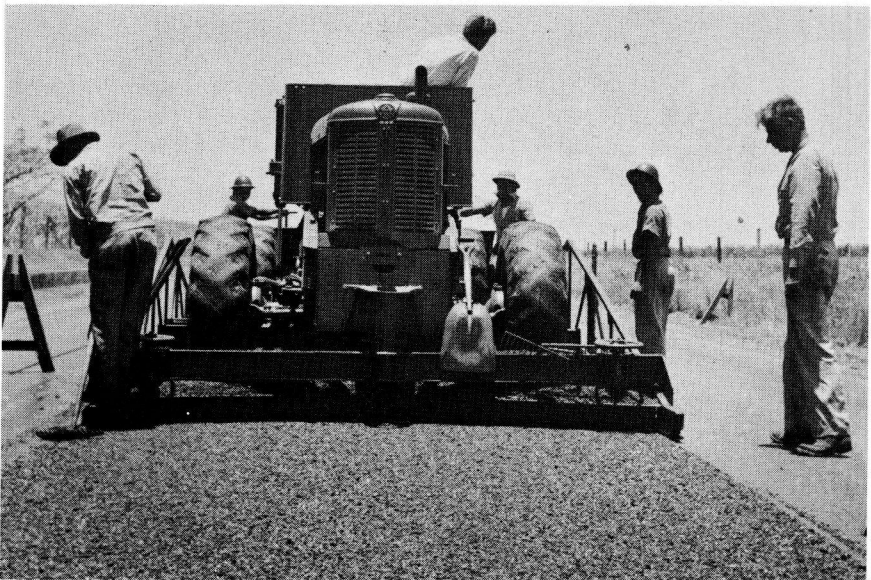
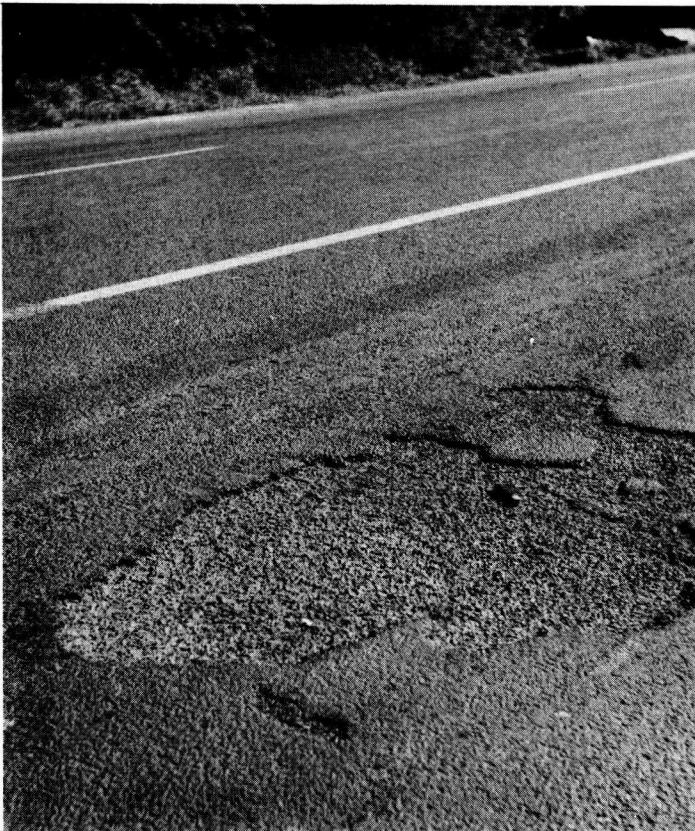
In ordinary two-layer resurfacing, a motor grader was sometimes used to spread the first layer or leveling course. The use of a motor grader is advantageous if a relatively thick first layer is to be laid. In multiple-layer resurfacing on the other hand, the individual layers are laid down as thin as possible. The theory is that each successive layer corrects the undulations and unevenness of the previous layer until the best possible riding qualities are attained. In order to do an effective job of leveling out the small undulations, the wheel base of the leveling machine must be long compared to the wave length of the undulations. A motor grader with a long wheel base is generally available on highway construction projects. But the single blade of a motor grader is inadequate for multiple-layer leveling. The type of leveler used in our work was devised by Jess Kopp, at the time a contractor's construction superintendent. It consists of a series of screeds suspended from the frame of an Austin-Western Road Grader. Figures 1, 2, and 3 show front, side and rear views of the Kopp leveler.

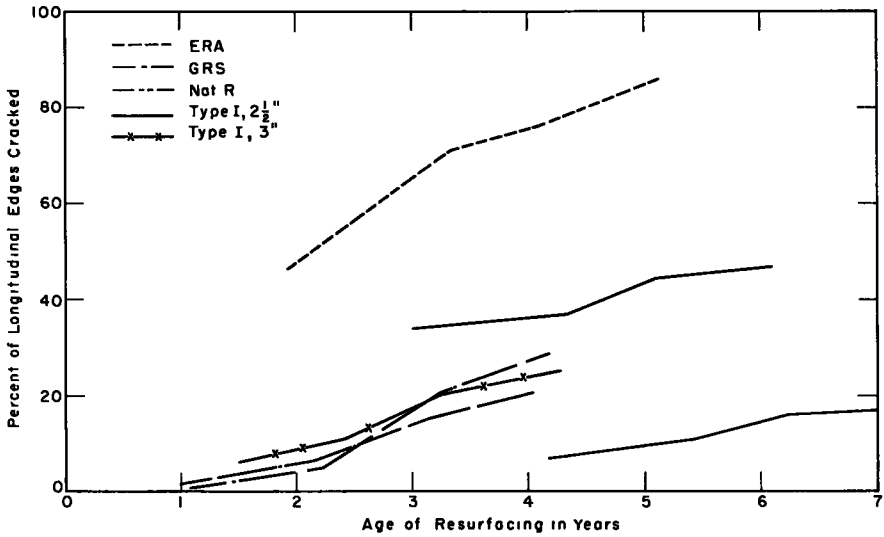
Figure 26. Longitudinal edge cracking. Average curves.
