# **Performance of an Experimental Project to Determine the Efficiency of Several Plain And Reinforced Concrete Pavements**

**CARL E. VOGELGESANG**, Chief Engineer, and  
**WILMER E. TESKE**, Research Engineer  
State Highway Department of Indiana

This report describes the design and performance of an experimental concrete pavement constructed in 1931 a few miles north of Indianapolis on State Road 29. The purpose of this experiment was to determine the relative efficiency of several designs of reinforced concrete pavement, expansion joints, and contraction or dummy joints. Nine special design sections, each approximately 2,700 feet in length, and seven standard sections were incorporated in 8.35 miles of test pavement. Special design features in the nine sections included variations in the type and amount of reinforcement, type and spacing of transverse joints, and type of joint filler.

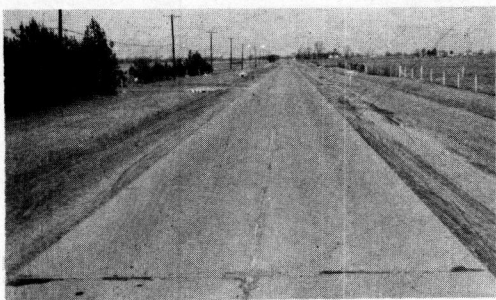
Figure 3. The general appearance of the heaviest bar mat (Design 1) and wire mesh (Design 2) reinforced sections with 60-ft joint spacing reflects the ability of the reinforcement to hold many of the cracks tightly closed and free from maintenance even after 23 years.

Figures 3, 4, 5, 6 and 7 show the typical surface condition of the various test sections as they appeared during the 23 year survey. These show distinctly how the pavement surface of the various designs have withstood the deteriorating effects of time, weather and traffic.

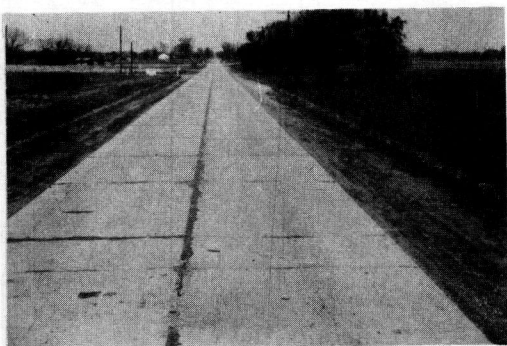
DESIGN NO. 9

Figure 4. The double-bar mat reinforced section with 50-ft joint spacing developed a crack pattern similar to the heavily reinforced sections of Designs 1 and 2; however, in Design 9 the reinforcement was not as successful in preventing the development of significant cracks as it was in the other two sections.

Design 9, with the double bar mat reinforcement and 50-ft joint spacing, developed a crack pattern similar to Designs 1 and 2. However, it proved to be less successful in preventing the development of significant cracks than did Designs 1, 2, 7 and 8, as seen in Table 6 and Figure 10. In view of this, it appears that the distribution of the reinforcement also has an effect on the ability of the reinforcement to prevent the development of significant cracks, and that the double bar mat, under conditions existing on this experiment, was less effective than the single layer of reinforcement used in Designs 1, 2, 4, 7 and 8.

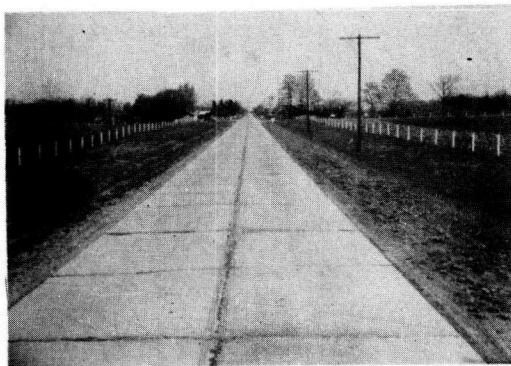
Figure 5. General performance of these two special design sections with an intermediate amount of bar mat (Design 7) and wire mesh (Design 8) and with 30-ft joint intervals was somewhat less satisfactory than that of the other reinforced sections.

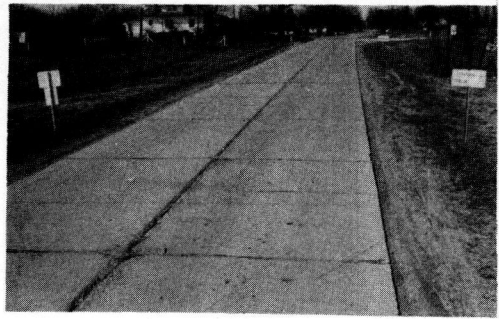
Figure 6. Designs 3 and 4 containing the least amount of bar mat and wire mesh reinforcement respectively, and with 20-ft joint spacing, have retained more slabs free of cracks than any other section on this project. There were still approximately 75 percent of the original slabs of the Design 4 section free of any cracks even after 23 years of service.

The number of original panels for each of the jointed sections still free of any cracks is shown in Table 7. In Design 4, with wire mesh and 20-ft joints, there still were approximately two-thirds of the original panels free of any cracks after 23 years. In sections designed with longer joint spacings practically all original panels had cracked. In comparing the length of slabs after 23 years to their original lengths, the design sections arrange themselves in the same order as their joint spacings, with the shortest spacing retaining the highest percentage of original slab lengths as shown in Table 8. Here, too, it is indicated that for comparable designs wire mesh was more successful than bar mat in preserving the continuity of the original designs.

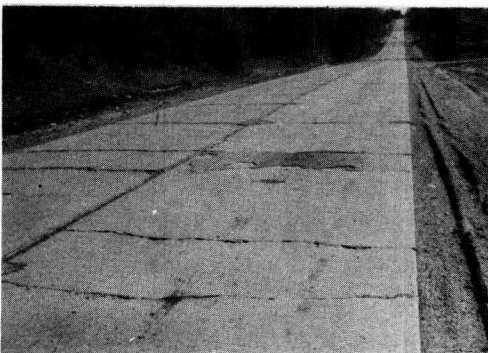
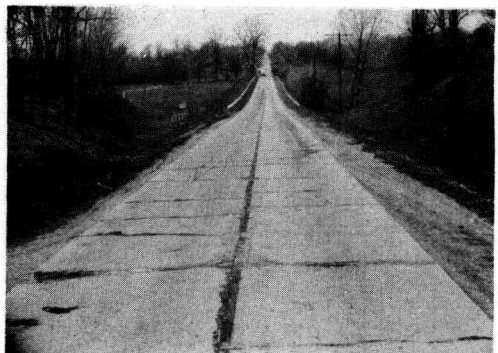
Figure 7. The effectiveness of including joints in the standard pavement design of 1931 (Design 10) is reflected in the somewhat better appearance of Design 5 with 20-ft joint intervals than any of the other similarly plain sections. The performance of the standard pavement (Design 10) was not greatly affected by either joint spacings of 30 ft (Design 6) or the substitution of a tar paper layer beneath the slab in lieu of sprinkling the subgrade.

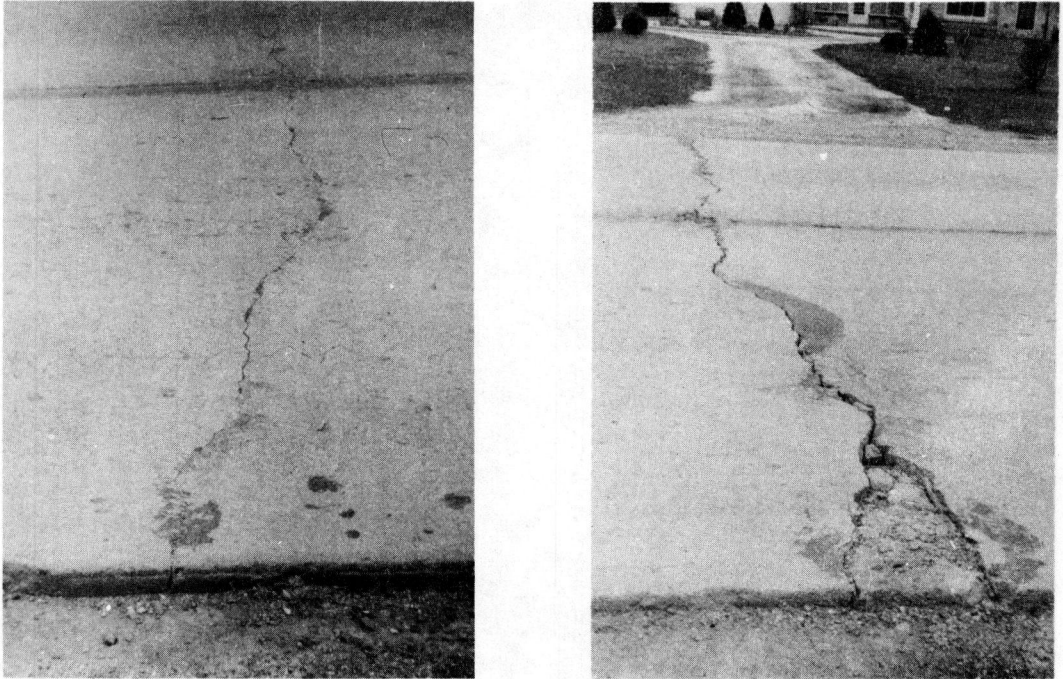
Figure 8. These represent the types of significant cracks which developed in the heavy reinforced sections (Designs 1, 2 and 9). The left shows the more normal condition of an old crack which is still held tight by the reinforcement while the other is an extreme example of one of the few cracks where the steel has also failed and deterioration of the concrete has advanced.

Most cracks logged in the heavily reinforced sections, Designs 1, 2 and 9, were not classified as being significant. This reflects the ability of the reinforcement to hold many of the cracks that developed in these sections so tightly closed that adjacent slabs did not open or move sufficiently to allow edge spalls to form. The interlocking faces of the cracked surfaces combining with the shearing resistance of the steel have kept the adjacent slabs at most of these cracks from faulting. However, this was not always true and a number of the cracks in each section had developed edge spalls. These may, or may not also be associated with ravelling, scaling or faulting. Some early cracks that developed in the heavily reinforced sections are shown in Figure 8 as they appeared after 23 years. There were only a few cracks in the Design 1 and 2 sections which indicated steel failure to the extent shown in the photograph on the right. More typical of the significant cracks which developed in these sections is that shown by the crack on the left which had only minor edge spalls and some slight scaling. Notable was the lack of faulting at almost all of these cracks.

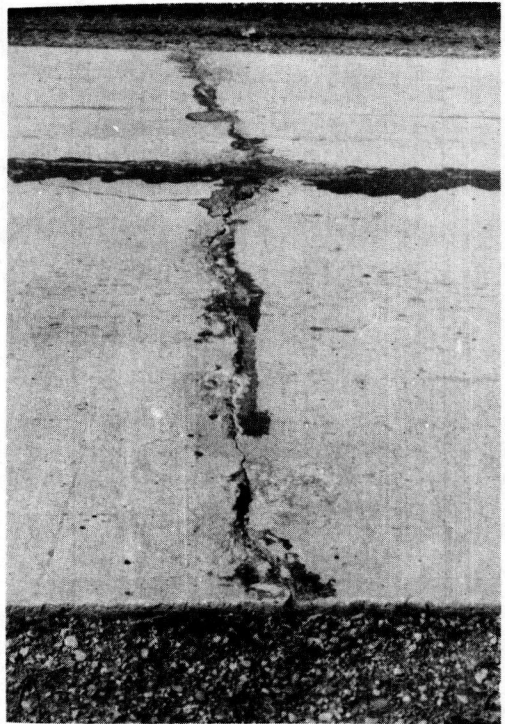
In contrast to the cracks shown in Figure 8 is the one shown in Figure 9. This represents a typical crack existing in the plain concrete sections at the time of the 23 year survey. In general, almost all cracks occurring in Designs 5, 6 and 10 developed distressed concrete throughout the length of the crack. Also, faulting was commonly associated with cracks in these sections. However, faulting will be discussed later under another portion of this report. The sections containing an intermediate amount of reinforcement had a larger number of cracks resembling the one shown in Figure 9 than did the heavily reinforced sections. The same comment can be made for the still lighter reinforced sections of Designs 3 and 4.

Figure 9. Typical of the cracks occurring in the plain concrete sections (Designs 5, 6, 10 and 10-Tar Paper) and which shows a normal amount of concrete disintegration associated with most cracks in these sections. Faulting is also characteristic of most of these cracks.

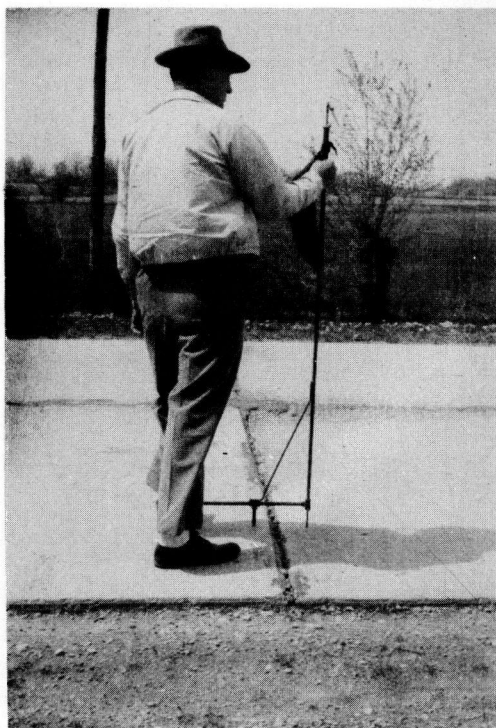
The instrument was fabricated in the Bureau's shops and was so designed that readings were made at eye level on a calibrated pointer gauge.

Figure 12. Instrument and method used to determine the amount of faulting at all cracks and joints.

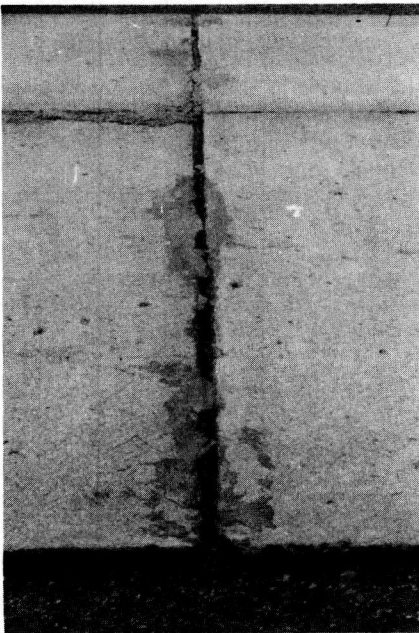
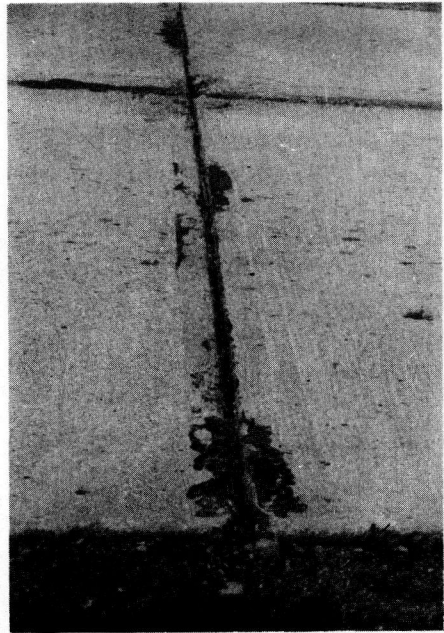
Figure 13. Typical of the condition of the expansion joints after 23 years of service. Lack of load transfer units at these joints resulted in severe early faulting at all expansion joints. After 23 years those joints constructed with metal air cushion fillers had less average faulting than did any of the three other types. General pavement condition adjacent to these joints have remained good except at the centerline where various degrees of deterioration existed.

The average condition of joints of each design is represented by those shown in Figures 13 and 14. Not all joints have remained as well preserved as those which are shown there. Several joints of each design developed badly disintegrated concrete adjacent to them and, in turn, some remained completely free of any associated disintegration. Much of the distress that developed at joints was located in the vicinity of the center joint. Many areas of badly disintegrated concrete were noted at this location.

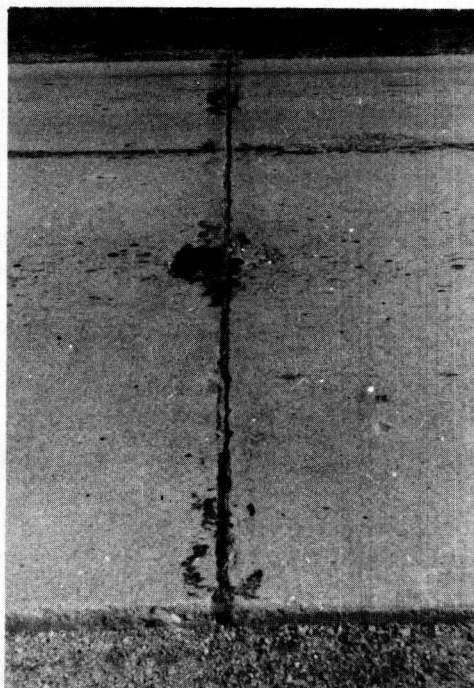
Figure 14. Contraction joints, all constructed with load transfer units, remained relatively free from any damage until after the 15 year survey. Between then and the 23 year survey almost all joints had developed some faulting; however, considerably less than at expansion joints. Most dummy or contraction joints have remained fairly well sealed and have usually developed only minor edge spalls.
