HIGHWAY RESEARCH BOARD
Bulletin 165

***Concrete Pavement Test Projects
In Connecticut and Indiana***

Numerous observations and at least two major surveys had been made of the test project prior to 1954. This report includes information from earlier reports, along with information obtained in 1954, after 23 years of service. Included in the 1954 observations were (a) the location of all transverse cracks, (b) measurement of faulting at all joints and transverse cracks, (c) pavement condition in the vicinity of joints and cracks, (d) general soil types encountered beneath the pavement, and (e) surface roughness indices for the various sections as measured by the Bureau of Public Roads' Road Roughness Indicator. Traffic data were furnished by the Highway Planning Survey of the State Highway Department of Indiana.

SCOPE OF THE 23 YEAR CONDITION SURVEY

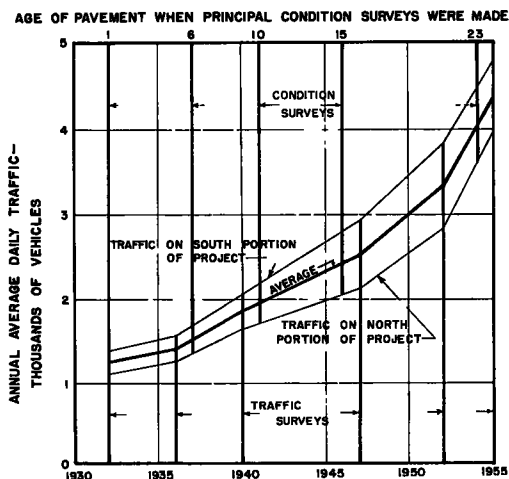
Figure 1. Traffic volume on SR 29 obtained at extremities of experimental project shown in relation to principal condition surveys.

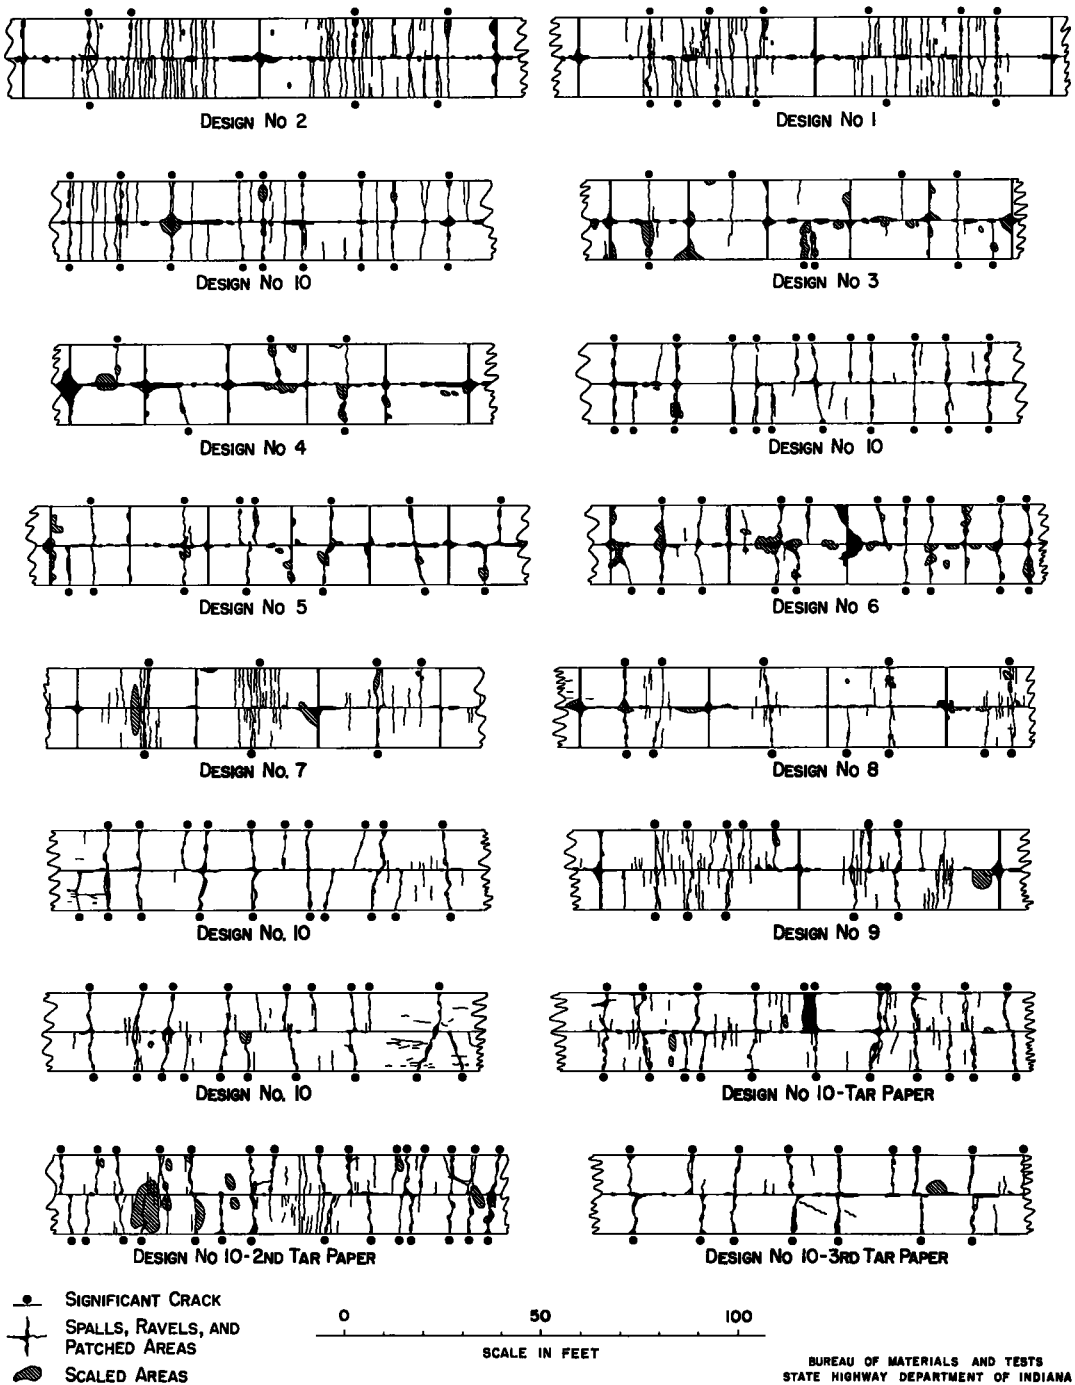
Figure 2. Test sections on state road No. 29 after 23 years' service.

Cracks patterns and pavement surface conditions for typical portions of each of the test sections are shown in Figure 2. The sections are arranged from left to right in the figure in the order in which they occur on the project. Each design developed a distinctive crack pattern, the

The formation of cracks in both reinforced and plain concrete pavement appears to be similar. Note in Figure 2 the large number of cracks that extend for only a short distance into the pavement lane from both the outside pavement edge and from the longitudinal center joint. In many of the reinforced sections, cracks were observed which, although they extended only part of the way across a lane of pavement, were closely associated with other similar short cracks but for which no surface crack could be traced connecting them. Apparently these cracks are similar to plastic shrinkage cracks since there is no evidence of complete structural failure of the concrete. Although all cracks which were in evidence on the surface were logged, only those which could be traced completely across a lane of the pavement are included in the analysis of this crack data. Since all joints function as a controlled crack, they were all included as cracks in this analysis.

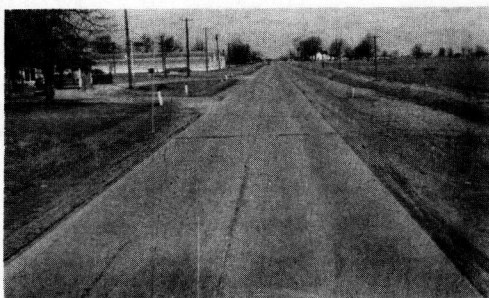
Figure 3. The general appearance of the heaviest bar mat (Design 1) and wire mesh (Design 2) reinforced sections with 60-ft joint spacing reflects the ability of the reinforcement to hold many of the cracks tightly closed and free from maintenance even after 23 years.

Figures 3, 4, 5, 6 and 7 show the typical surface condition of the various test sections as they appeared during the 23 year survey. These show distinctly how the pavement surface of the various designs have withstood the deteriorating effects of time, weather and traffic.

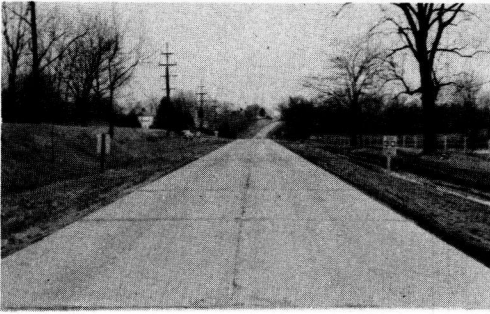
Figure 6. Designs 3 and 4 containing the least amount of bar mat and wire mesh reinforcement respectively, and with 20-ft joint spacing, have retained more slabs free of cracks than any other section on this project. There were still approximately 75 percent of the original slabs of the Design 4 section free of any cracks even after 23 years of service.

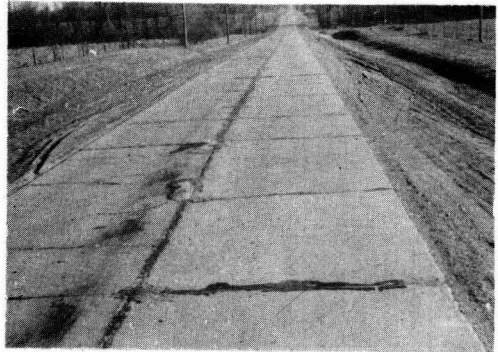
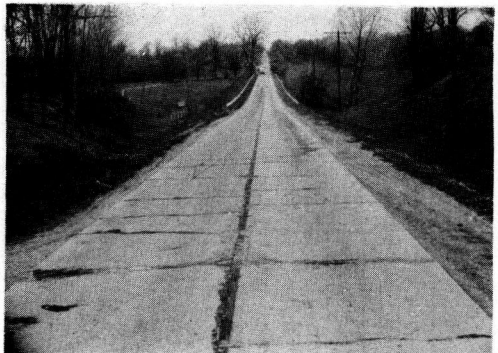
Figure 7. The effectiveness of including joints in the standard pavement design of 1931 (Design 10) is reflected in the somewhat better appearance of Design 5 with 20-ft joint intervals than any of the other similarly plain sections. The performance of the standard pavement (Design 10) was not greatly affected by either joint spacings of 30 ft (Design 6) or the substitution of a tar paper layer beneath the slab in lieu of sprinkling the subgrade.

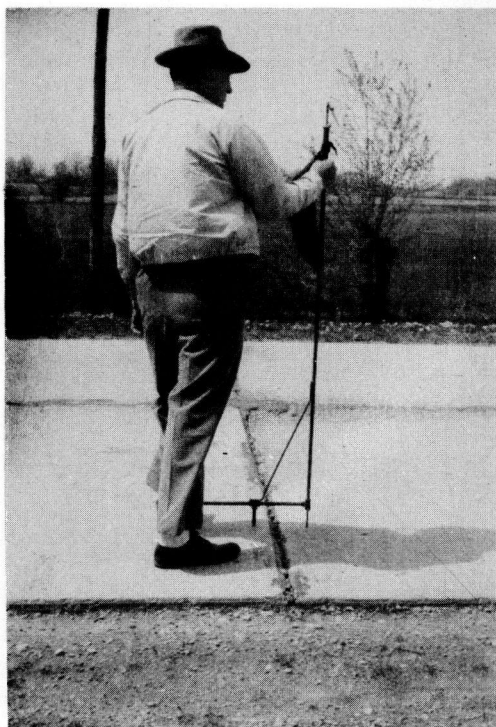
Figure 12. Instrument and method used to determine the amount of faulting at all cracks and joints.

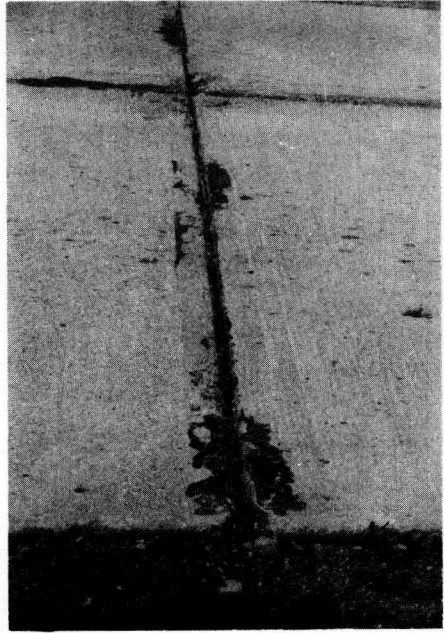
Figure 13. Typical of the condition of the expansion joints after 23 years of service. Lack of load transfer units at these joints resulted in severe early faulting at all expansion joints. After 23 years those joints constructed with metal air cushion fillers had less average faulting than did any of the three other types. General pavement condition adjacent to these joints have remained good except at the centerline where various degrees of deterioration existed.

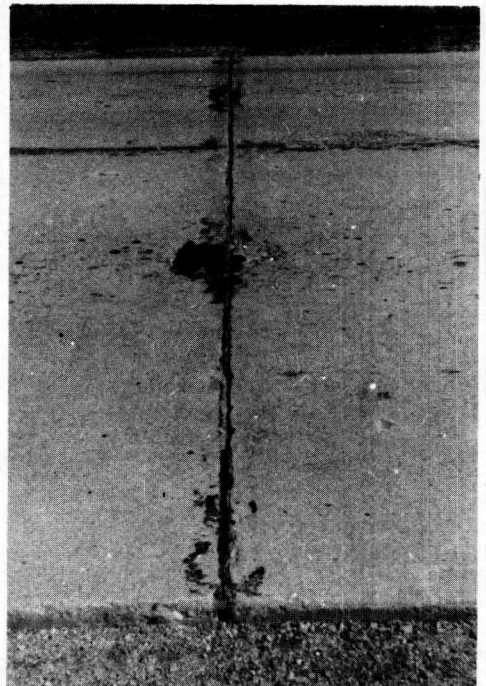
Figure 14. Contraction joints, all constructed with load transfer units, remained relatively free from any damage until after the 15 year survey. Between then and the 23 year survey almost all joints had developed some faulting; however, considerably less than at expansion joints. Most dummy or contraction joints have remained fairly well sealed and have usually developed only minor edge spalls.

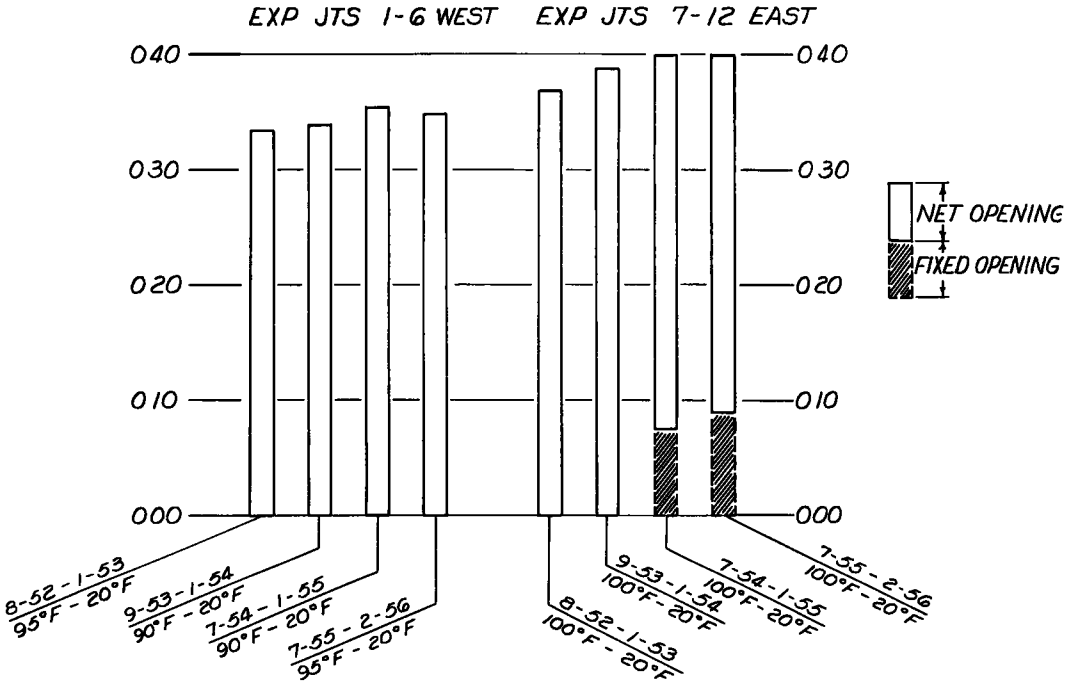
Figure 8. Seasonal expansion joint opening.
