**HIGHWAY RESEARCH BOARD**

**Bulletin 170**

***Traffic Behavior***  
***As Related to***  
***Several Highway Design Features***

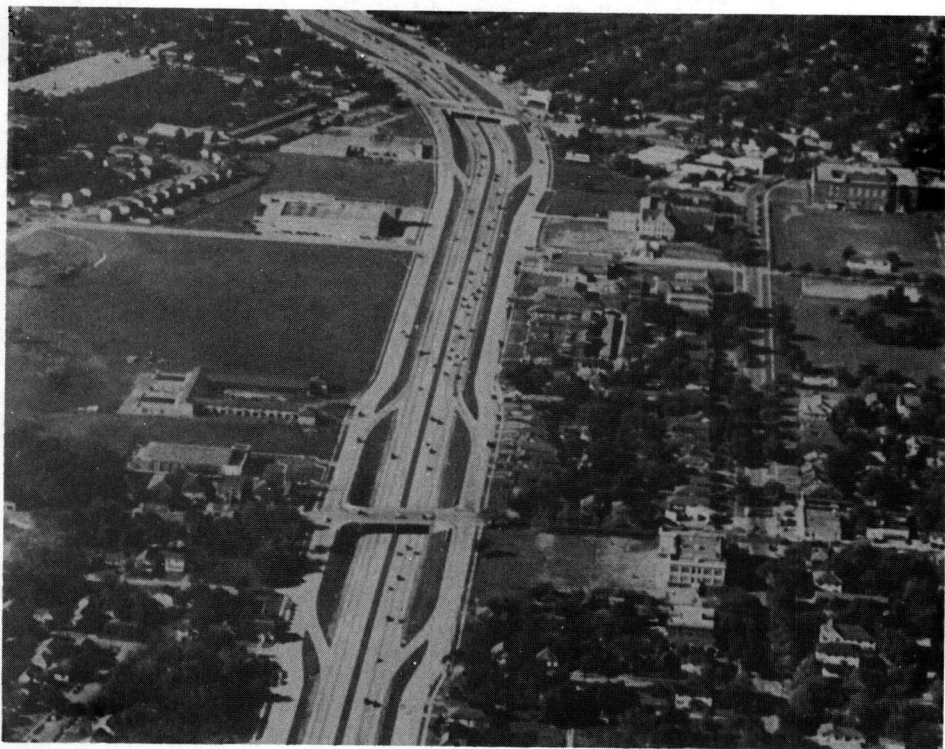
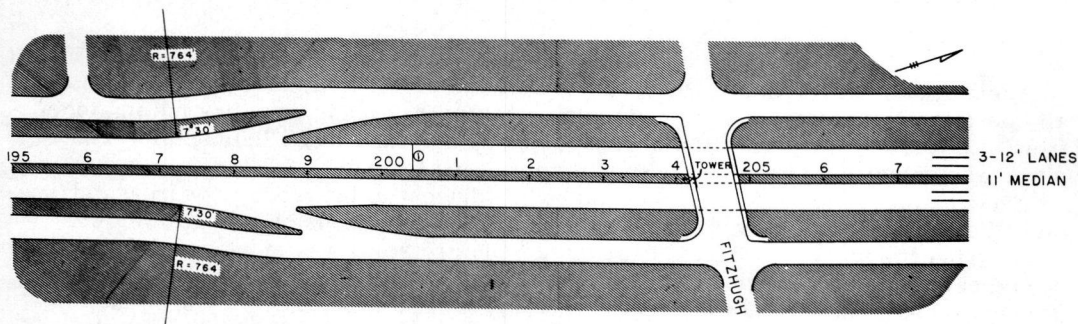
Figure 2. Central Expressway, Dallas, Texas.

On the Central Expressway in Dallas, it was possible to park a tower truck (Figure 3(d)) on an overpass structure overlooking the freeway. The truck was parked on the structure and personnel made observations from the tower during the peak traffic periods each day for one week before the motion picture study was made. Test film

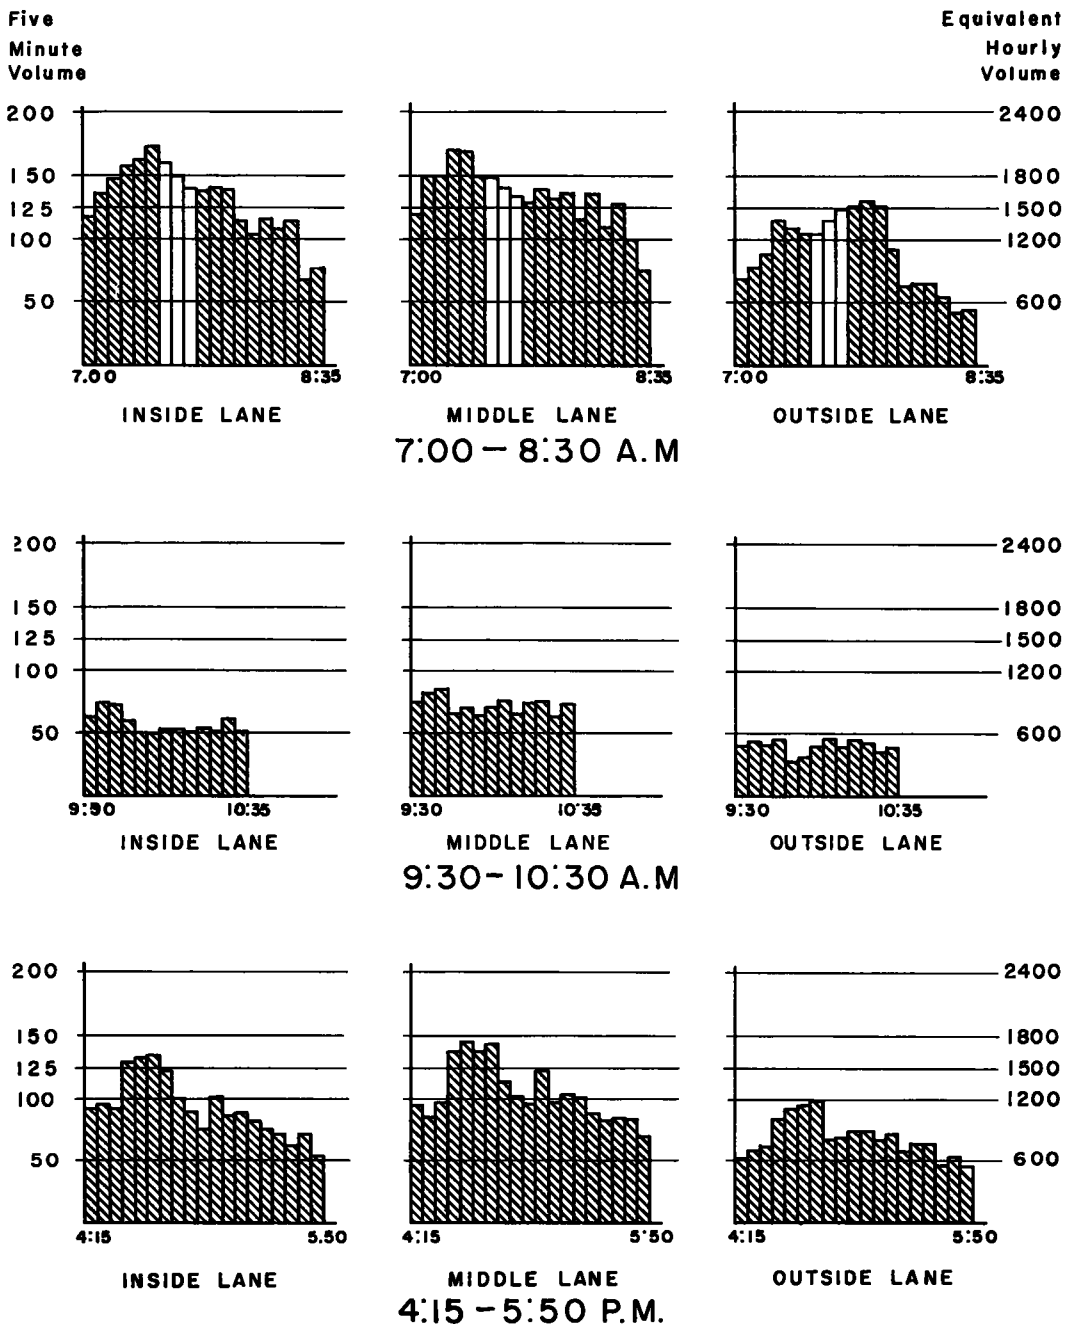
Figure 4. Five-minute volumes by lanes, inbound traffic, Gulf Freeway, Houston, Texas, Study No. 1, May 22, 1956 (volumes recorded in advance of entrance ramp).

**Gulf Freeway Volumes.** The 5-min. volumes by lanes for the time periods studied are shown in Figures 4, 5, and 6. These data show that the middle and inside lanes carry

approximately the same volume, with the middle lane volume generally slightly higher.

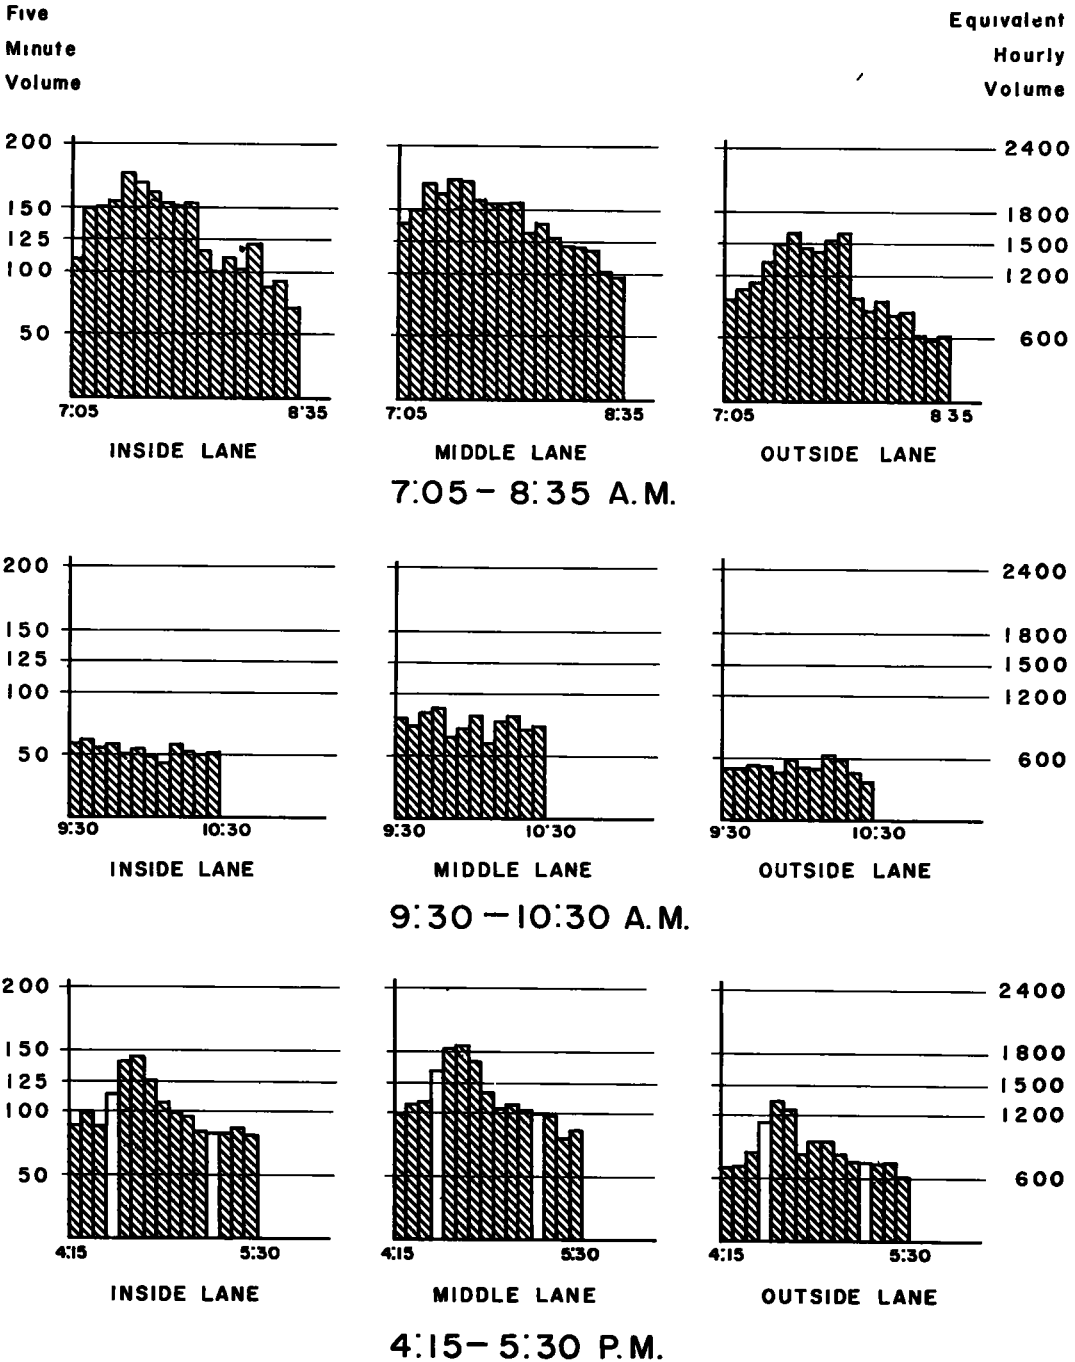
Figure 5. Five-minute volumes by lanes, inbound traffic, Gulf Freeway, Houston, Texas, Study No. 2, September 11, 1956 (volumes recorded in advance of entrance ramp).

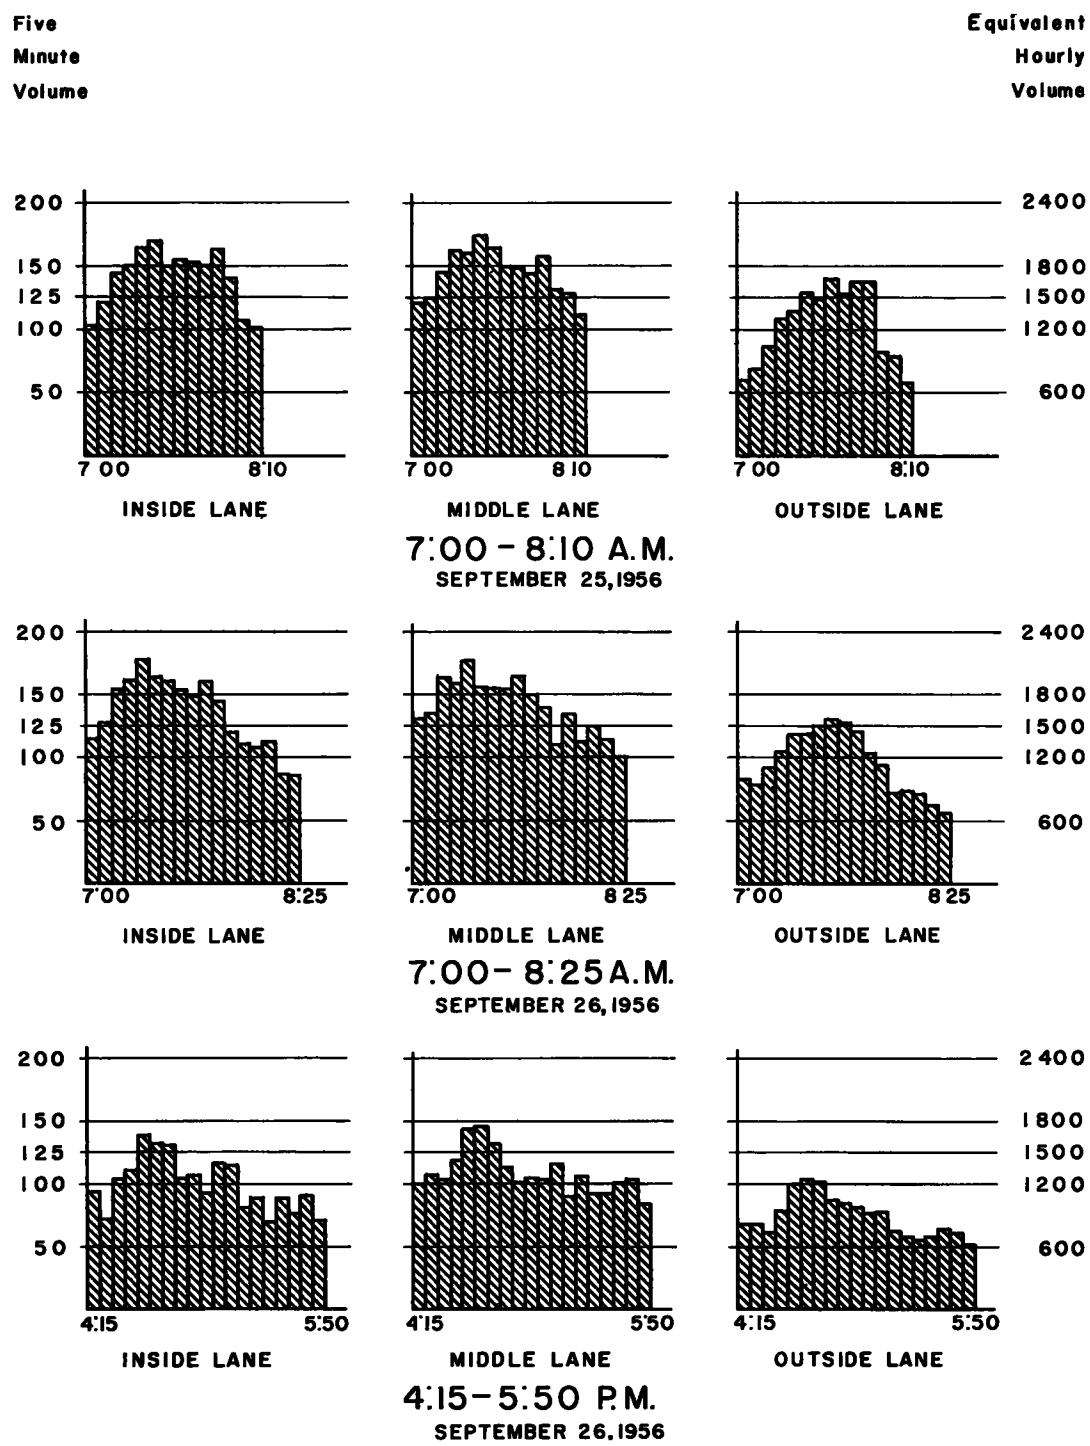
Figure 6. Five-minute volumes by lanes, inbound traffic, Gulf Freeway, Houston, Texas, Study No. 3, September 25 and 26, 1956 (volumes recorded in advance of entrance ramp).

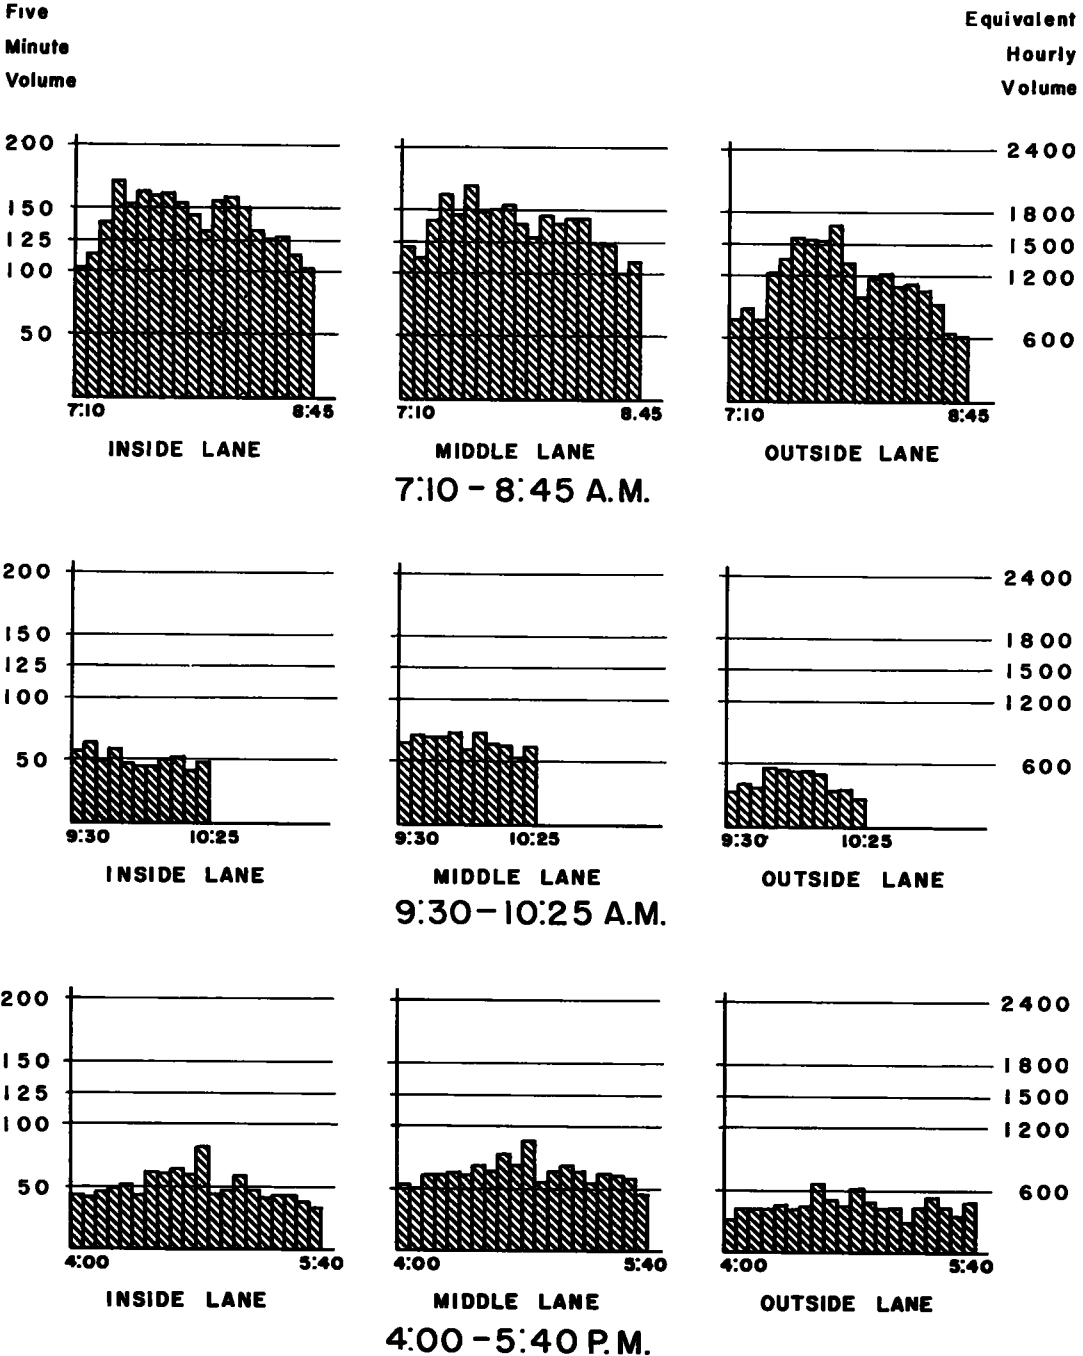
Figure 7. Five-minute volumes by lanes, inbound traffic, Central Expressway, Dallas, Texas, Study No. 1, August 14, 1956 (volumes recorded in advance of entrance ramp).

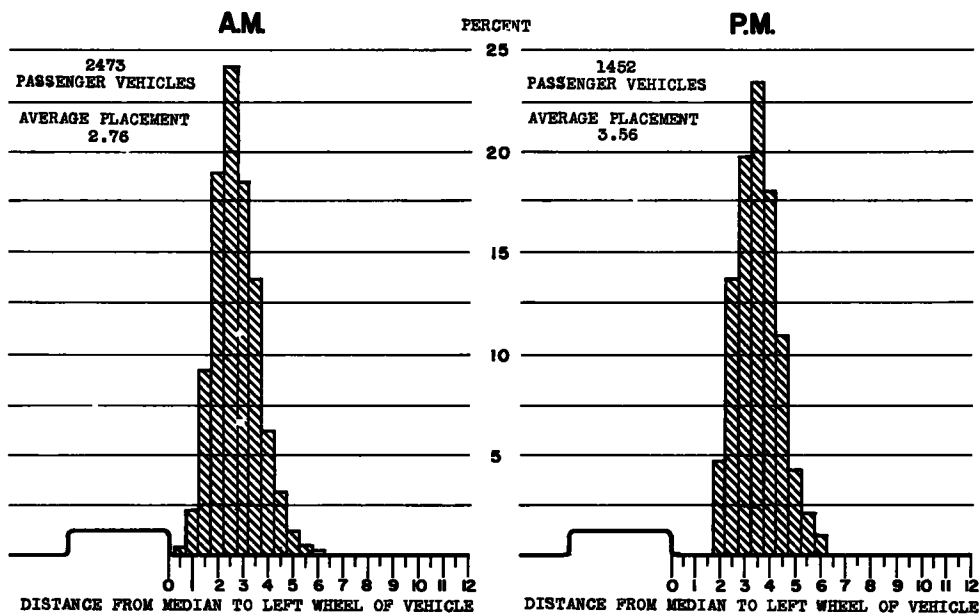
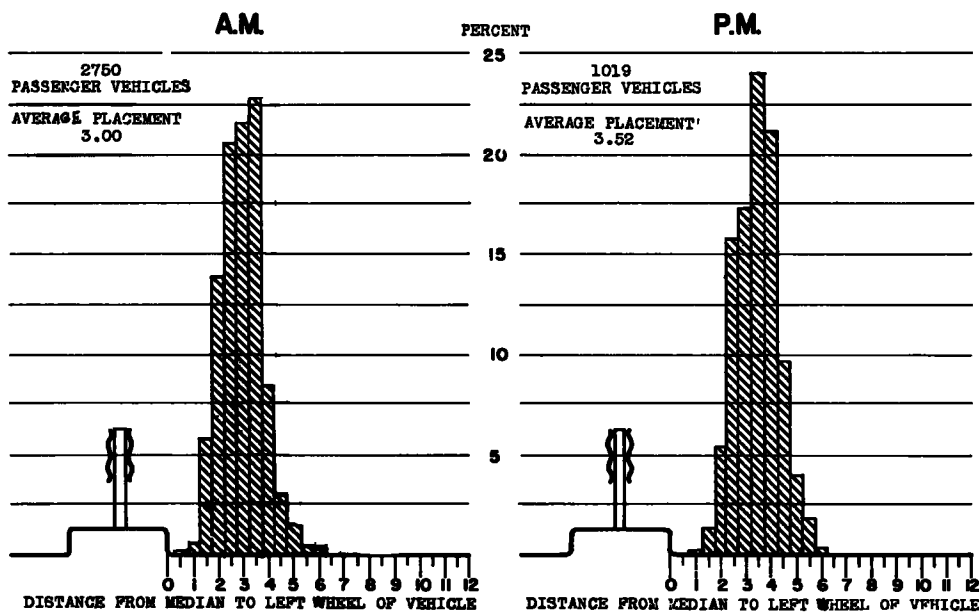
Figure 10. Influence of median barrier fence on inside lane placements.

Placements for passenger vehicles in the inside lane adjacent to the median are shown in Figure 10 for conditions before and after construction of the median barrier fence. Placements are shown separately for the morning and afternoon periods. The average placement of the left wheels with respect to the median during the morning was 2.76 ft before and 3.00 ft after construction of the barrier. This positioned the centers of the vehicles virtually in the center of the lane, with most of the traffic within 1 ft of the center of the lane. There was a slight shift away from the median during the afternoon peak periods, when the opposing outbound flow was heaviest. The average placement of the left wheels with respect to the median during the afternoon peaks was 3.56 ft before and 3.52 ft after construction of the barrier.

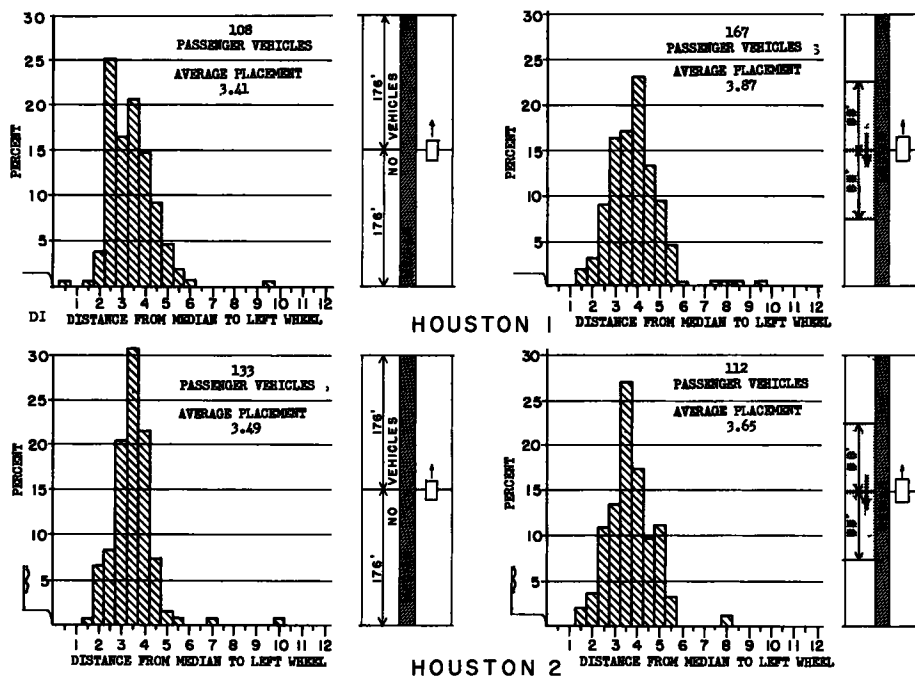
Figure 11. Influence of opposing traffic on inside lane placements, no vehicle in middle lane within 176 feet.

These data were taken for the condition of no vehicle in the middle inbound lane within 176 ft of the vehicle being studied. The results of the Houston 1 study, made before construction of the median barrier, and the results of the Houston 2 study, made after construction of the barrier, are shown in Figure 11.

For the study made before construction of the barrier, the average placement moves to the right 0.46 ft away from vehicles in the opposing lane. For the Houston 2 study, made after construction of the barrier, the average placement moves only 0.16 ft to the right for the condition of vehicles immediately to the left in the opposing lane.

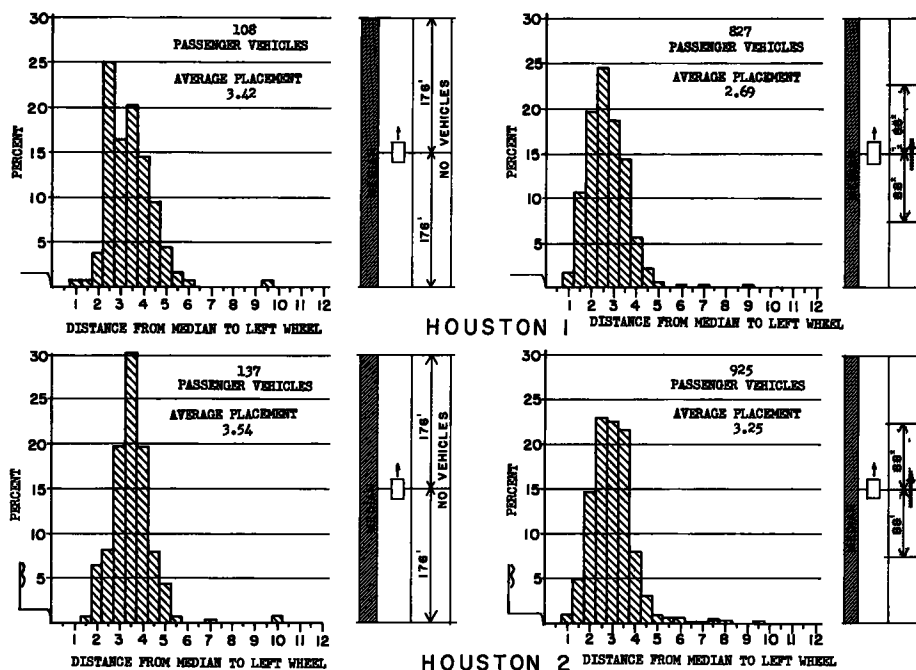
Figure 12. Influence of middle lane traffic on inside lane placements, no vehicle in opposing lane within 176 feet.

condition of no vehicle in the middle lane within 176 ft and secondly for the condition of a vehicle in the middle lane within 88 ft of the vehicle being studied. These data were taken for the condition of no traffic in the opposing inside lane within 176 ft. The results of the Houston 1 study and the results of the Houston 2 study are shown in Figure 12.

The results of the Houston 2 study show a change in average placement of only 0.29 ft toward the median for the same conditions.

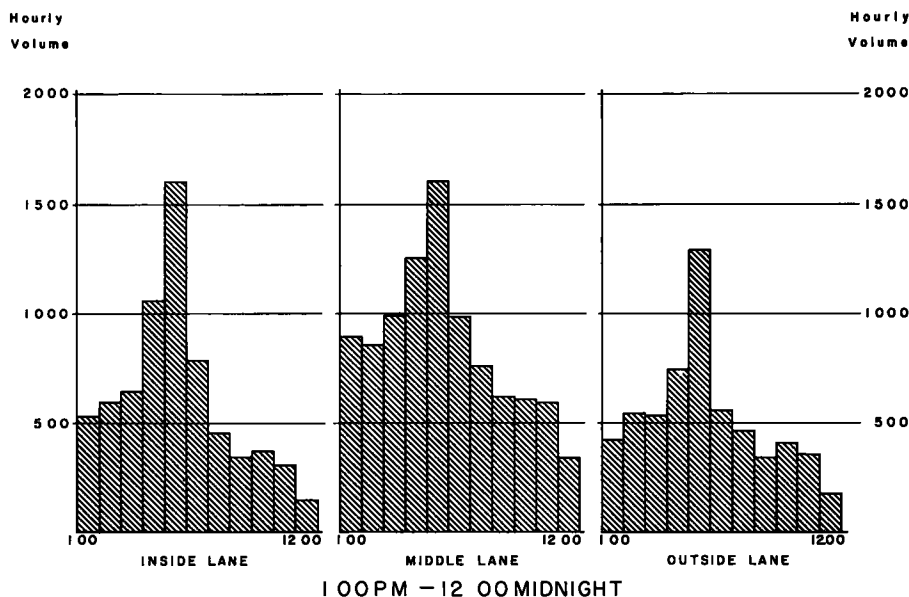
Figure 14. Hourly volumes by lanes, outbound traffic, Gulf Freeway, Houston, Texas (Bureau of Public Roads Survey, May 23, 1956).

The volumes by lanes obtained from the tape-placement survey are shown in Figure 14, which shows that the volume in the outside lane is less than that of the other two lanes except during extremely low volume conditions. A maximum hourly lane volume of 1,651 was recorded in the inside lane. A maximum volume of 192 was recorded in the inside lane during a 6-min. period, which represents an equivalent hourly volume of 1,920 vph.

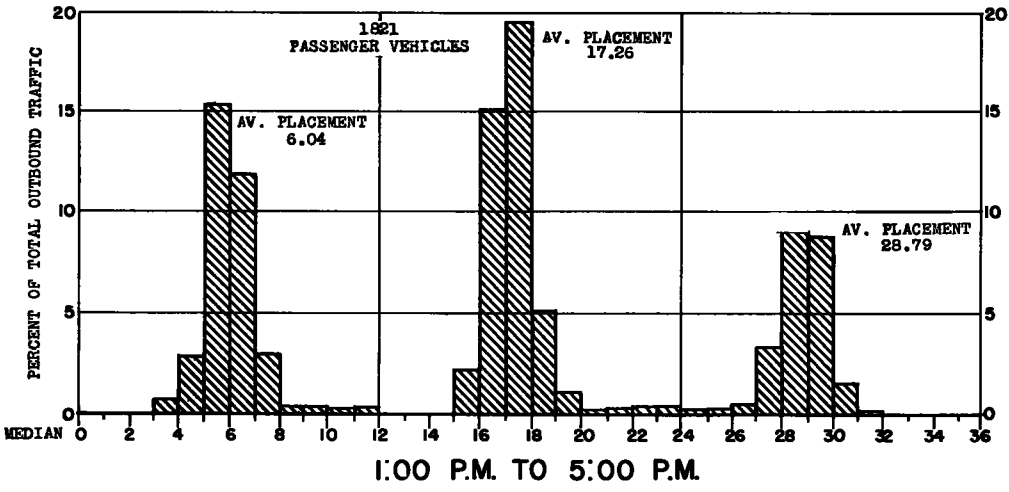
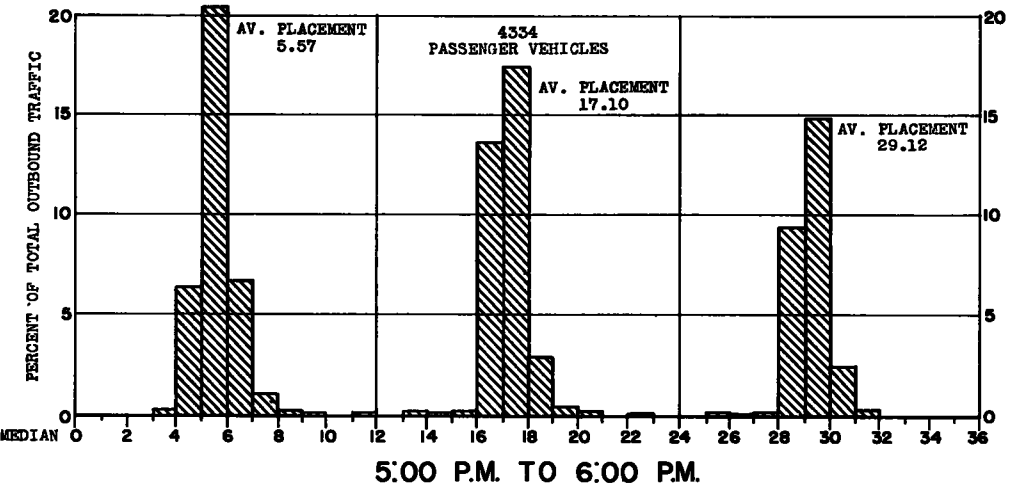
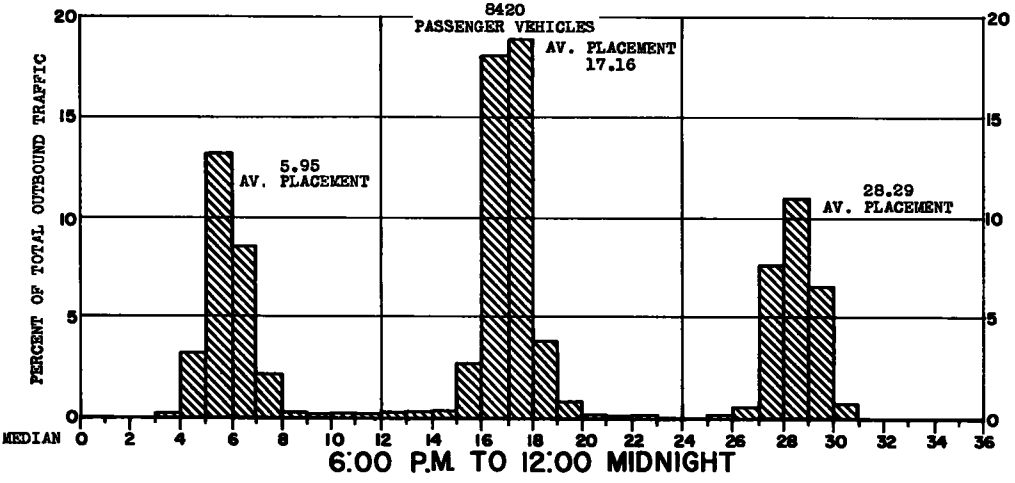
Figure 15. Vehicle placements and lane use, Gulf Freeway, Houston, Texas, May 23, 1956, outbound traffic, Bureau of Public Roads Survey (placements of centers of vehicles).

These data show that the average placement in the inside lane adjacent to the median was basically in the center of the 12-ft lane for conditions of both daylight and darkness. There was a slight shift toward the median during the afternoon peak traffic period.

The average middle lane placement was very nearly 17 ft for all conditions, which is 1 ft to the left (or toward the median) from the center of the middle lane.

The average placement in the outside lane was approximately 29 ft, which is 1 ft to the left (or away from the outside curb) from the center of the outside lane. During conditions of darkness the outside lane placements shifted slightly to the left. The average placement during this period was 28.29 ft, which is 1.71 ft to the left of the center of the outside lane.

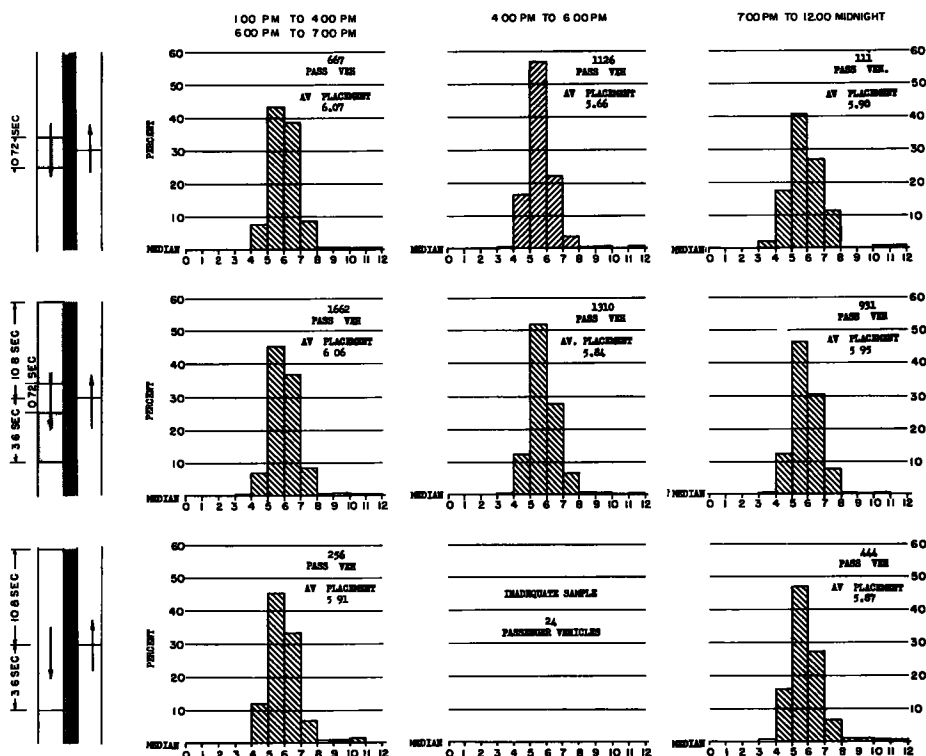
Figure 16. Influence of opposing traffic on inside lane placements, Gulf Freeway, Houston, Texas, Bureau of Public Roads Survey, May 23, 1956 (placements of centers of vehicles).

The placements for passenger vehicles in the inside lane are shown in Figure 16 for three conditions of traffic in the adjacent opposing lane across the median. These data are shown for afternoon, afternoon peak, and nighttime traffic conditions. Inside lane placements are shown for a vehicle or vehicles in the adjacent opposing lane within 0.72 sec. of the vehicle being studied. The second condition shown is for vehicles in approaching or passed positions in the opposing lane with no vehicle within 0.72 sec. The third condition shown is for no approaching vehicle in the opposing lane within 10.8 sec. and no passed vehicle within 3.6 sec.

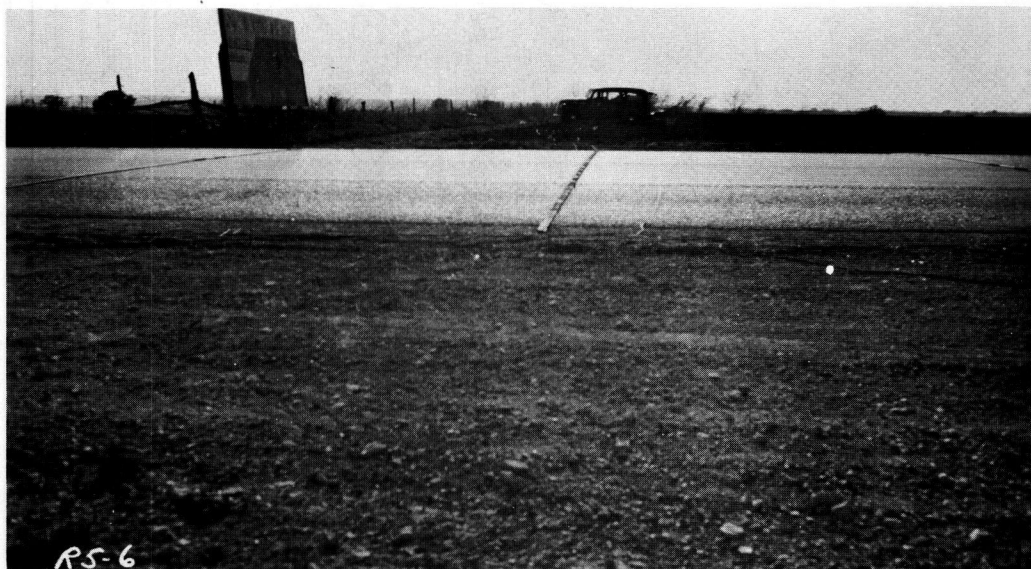
Figure 1. View of lateral placement and speed tapes with recording truck in the background.

An electro-mechanical tape which actuated a recording device was used to record the transverse placement. This tape was separated so that most vehicles actuated only two pins on the recorder thus giving an accurate location of the vehicle.

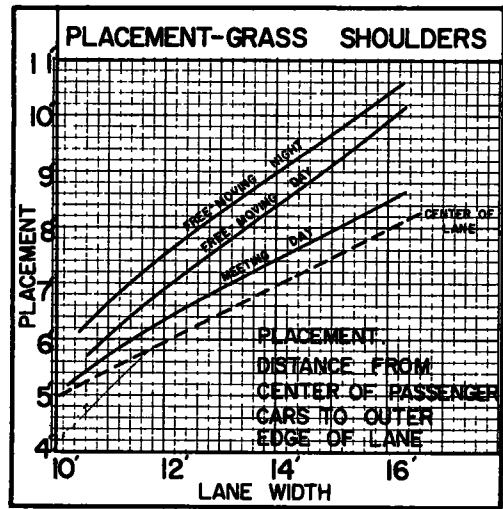
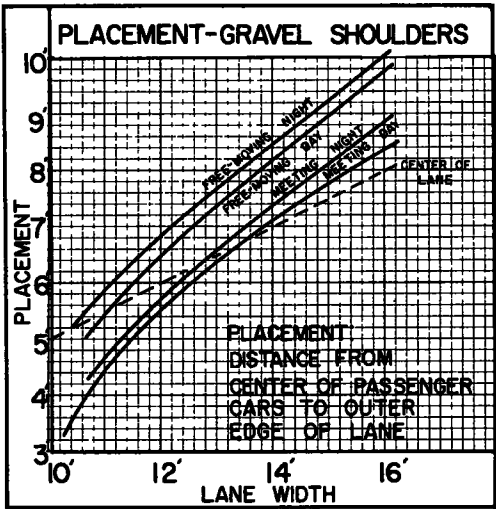
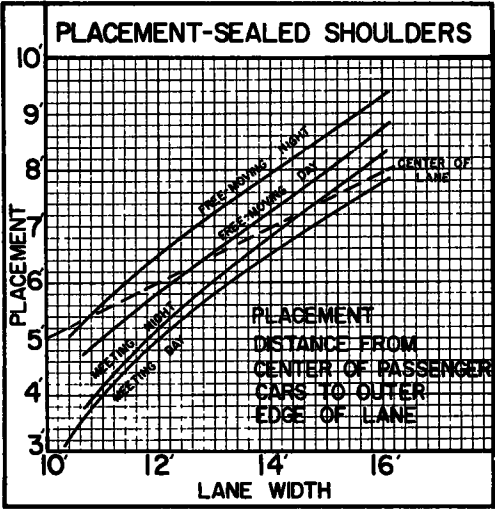
The relationship between lane width and vehicle placement is shown in Figures 5, 6, and 7. These are average curves taken from the original plottings (2). The figures

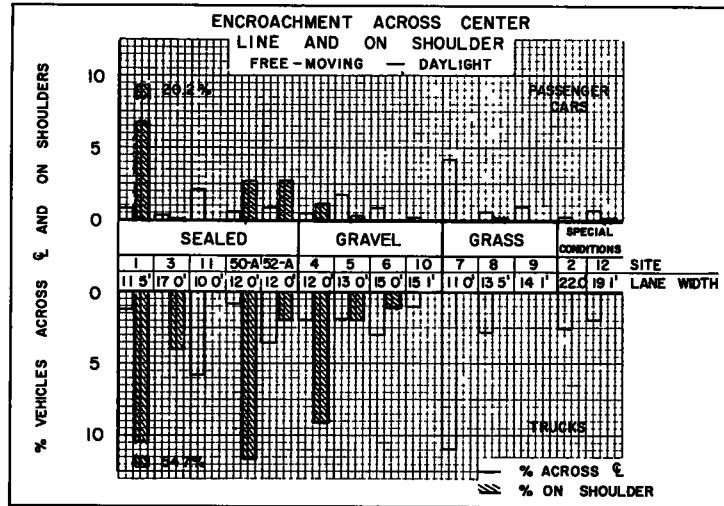
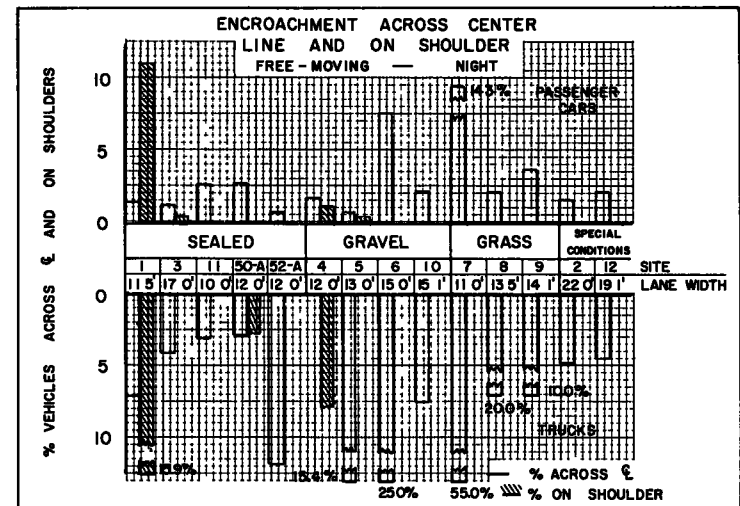
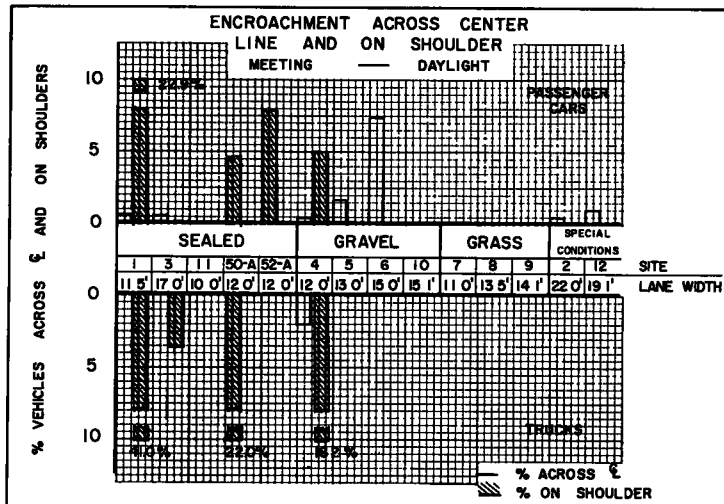
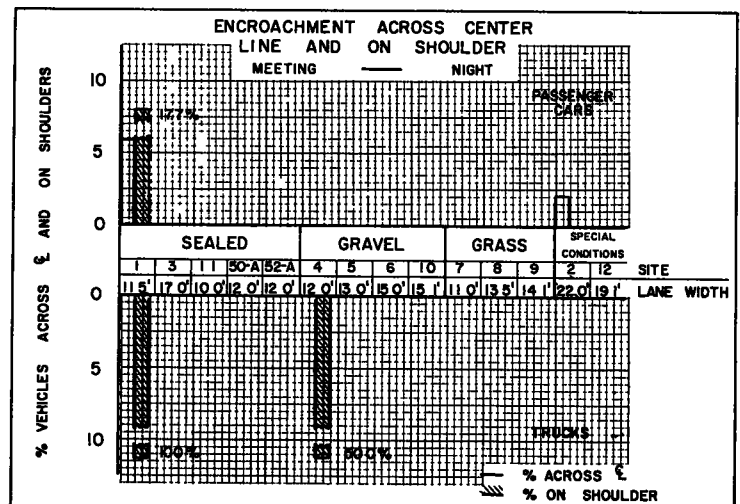
Considerable encroachment on both the shoulder and across the centerline was found. The percentage at the various sites is shown in Figure 10. Several attempts were made to correlate this data, but no consistent relationship was found. Several things are evident from the figures. Encroachment by meeting vehicles on both the shoulder and across the centerline is less than that for free-moving vehicles and is less at night than in the daylight. This could probably be taken to indicate that drivers are more alert when meeting and are consciously placing their vehicle in the lane. Figures 5, 6, and 7 show that meeting vehicles drive on an average 1 ft closer to the edge than do non-meeting vehicles.

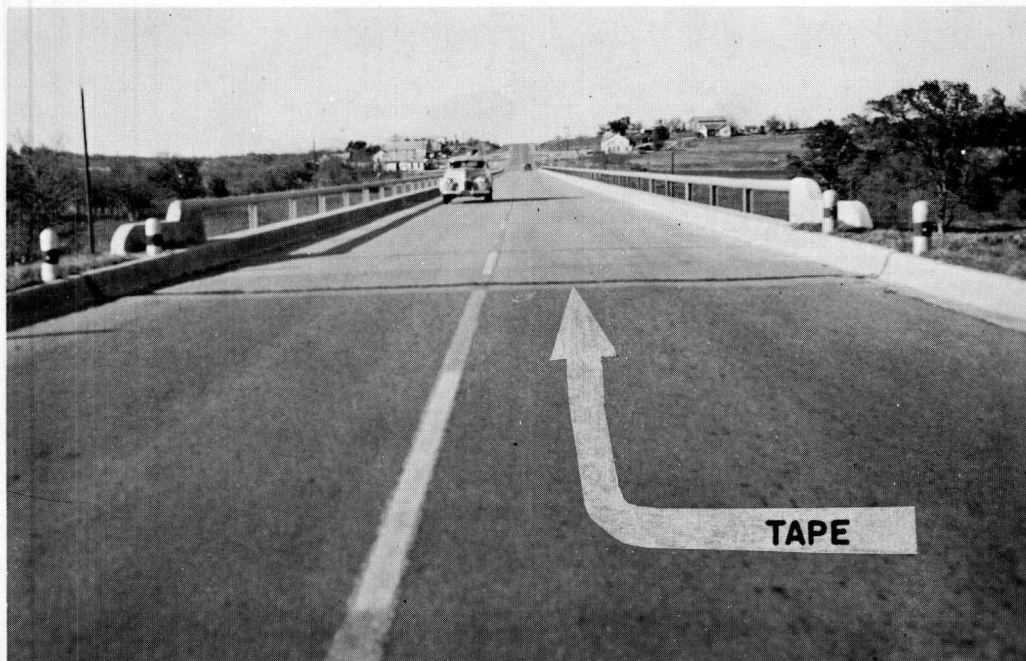
Figure 12. View of bridge showing tape for measuring lateral placement.

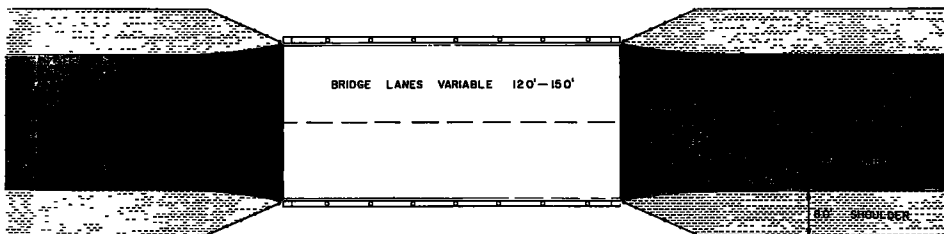
Figure 14. Typical bridge showing fixed and variable conditions.

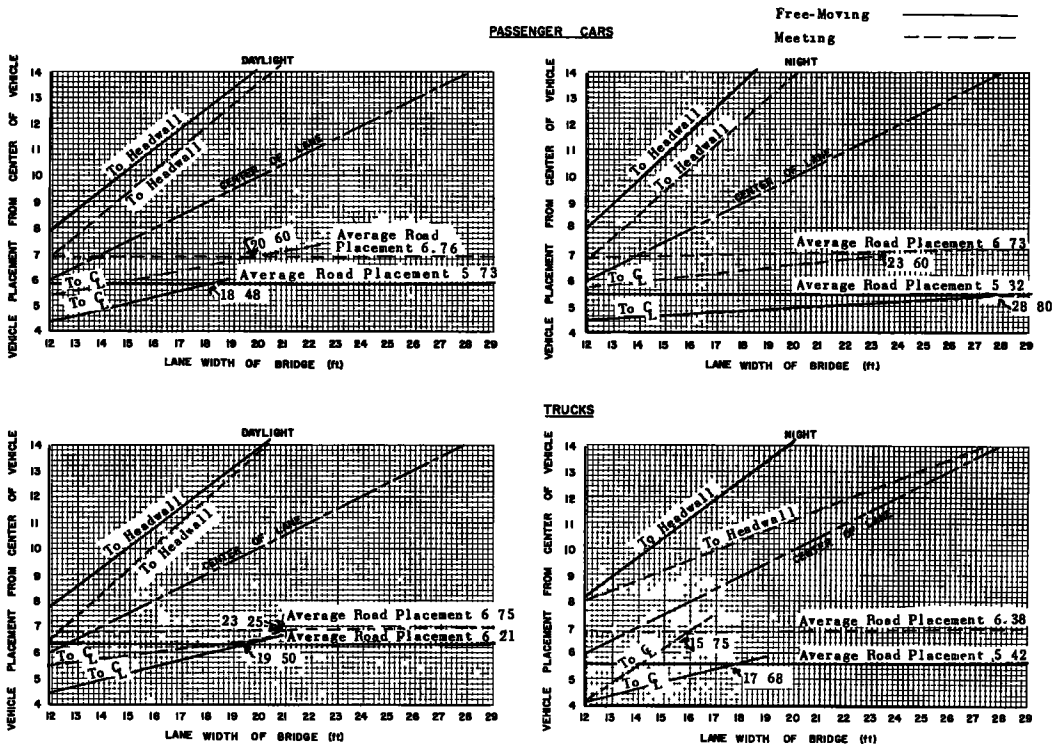
Figure 15. Placement of vehicles on bridges vs. bridge lane width.

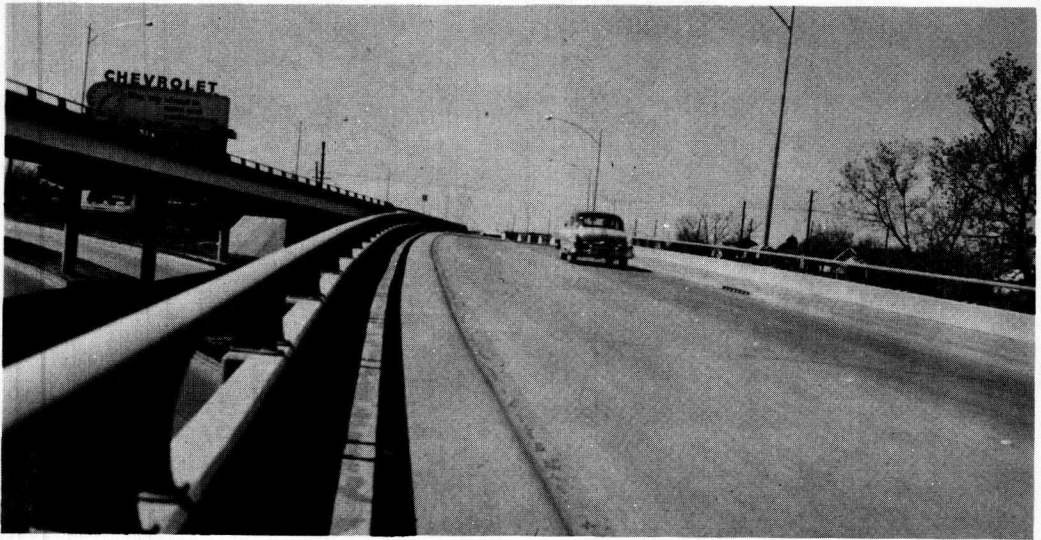
Figure 16. Site 25 — shoulder clear.

The conditions without and with vehicle on 6-ft emergency shoulder are shown in Figures 16 and 17.

The study was conducted from 7:00 a. m. to 12:00 midnight on March 19, 1956 and March 20, 1956. On the first day the 6-ft shoulder was clear (Fig. 16). On the second

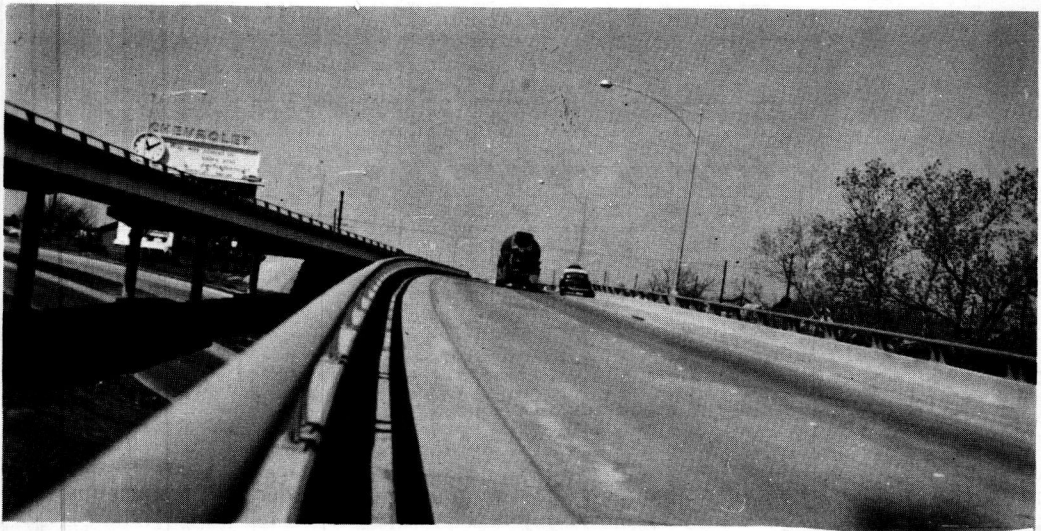
Figure 17. Site 26 — Passenger car parked on partial shoulder with nooa raised, simulating disabled vehicle.

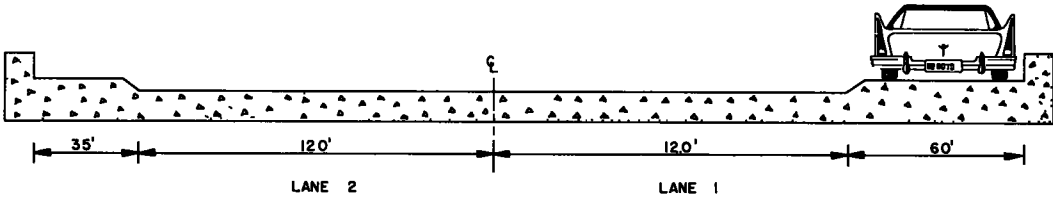
Figure 20. Cross-section of freeway bridge.

The freeway bridge roadway is 24 ft wide with standard guardrail, plus a 6-ft emer-

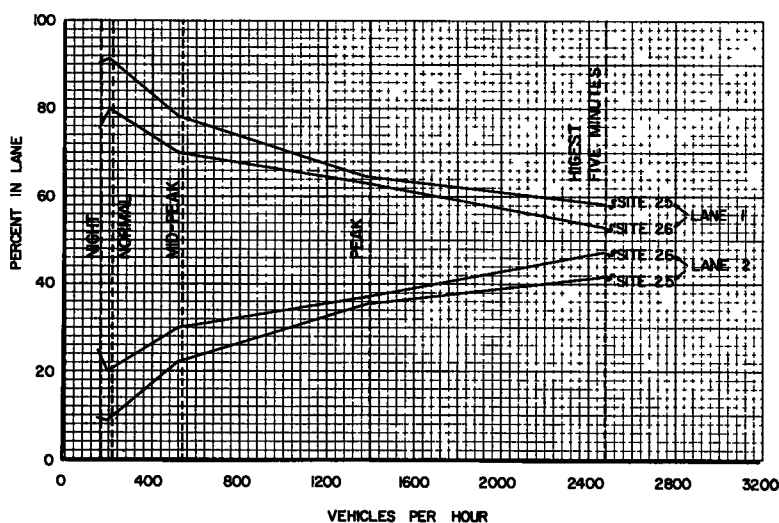
Figure 22. Percent of vehicles in lanes 1 & 2 vs. volume.

This movement became less pronounced as volumes increased, partly because it became more difficult to find a gap in the left lane to move into, and partly because vehicles traveling in a more dense stream of traffic did not become aware of the vehicle on the shoulder until after it was too late to take any action.

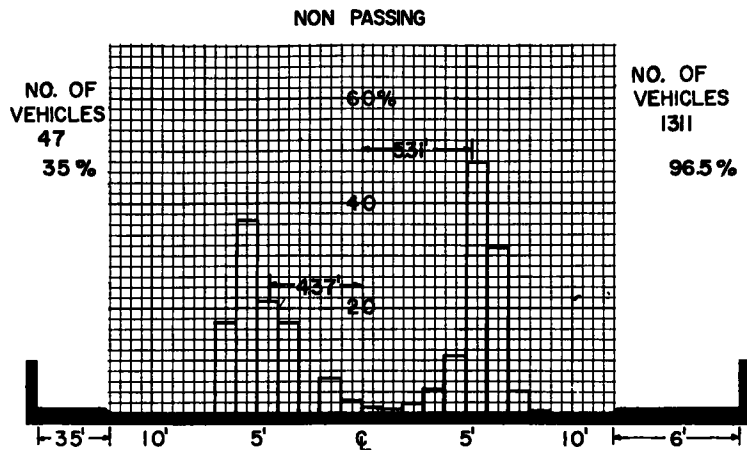
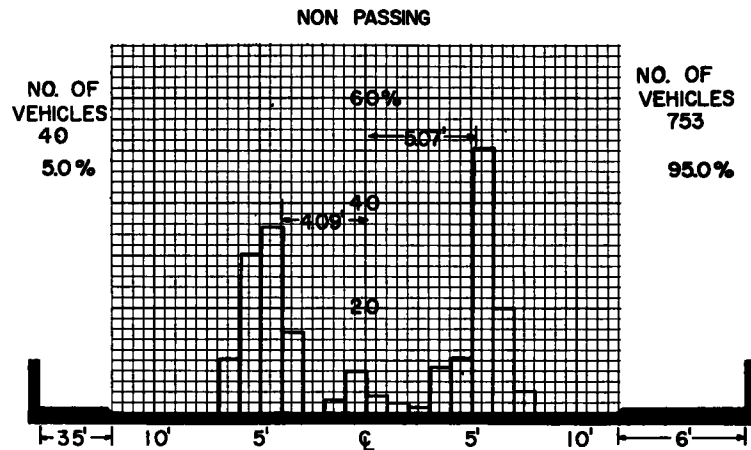
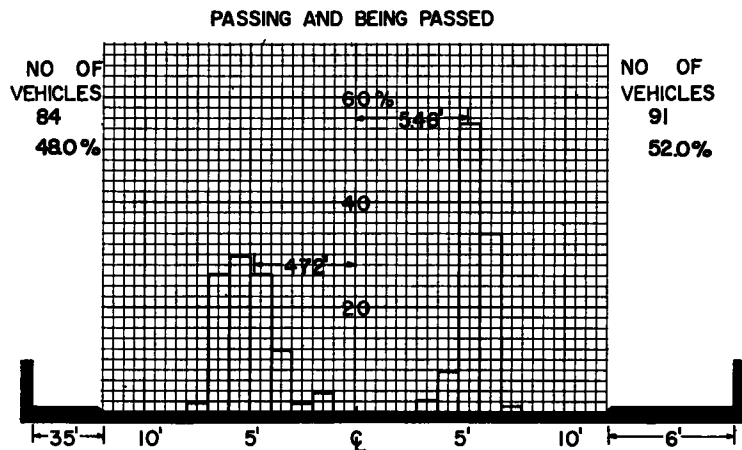
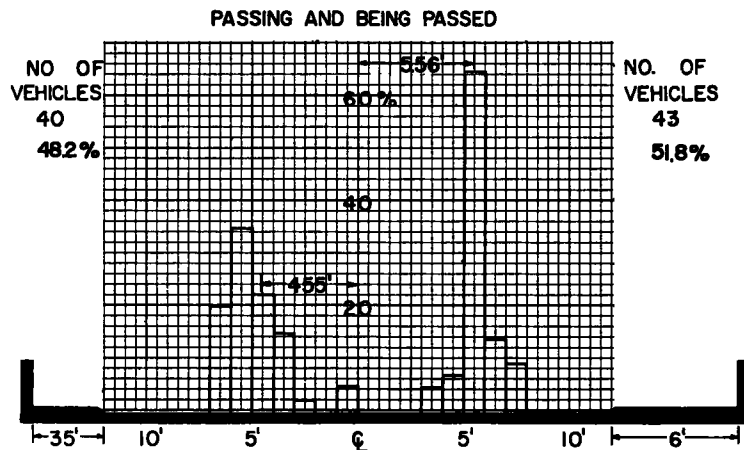
Figure 23B. Lateral placement of vehicles by lane - Site 25 (without vehicle).
