**HIGHWAY RESEARCH BOARD**

**Bulletin 170**

***Traffic Behavior***  
***As Related to***  
***Several Highway Design Features***

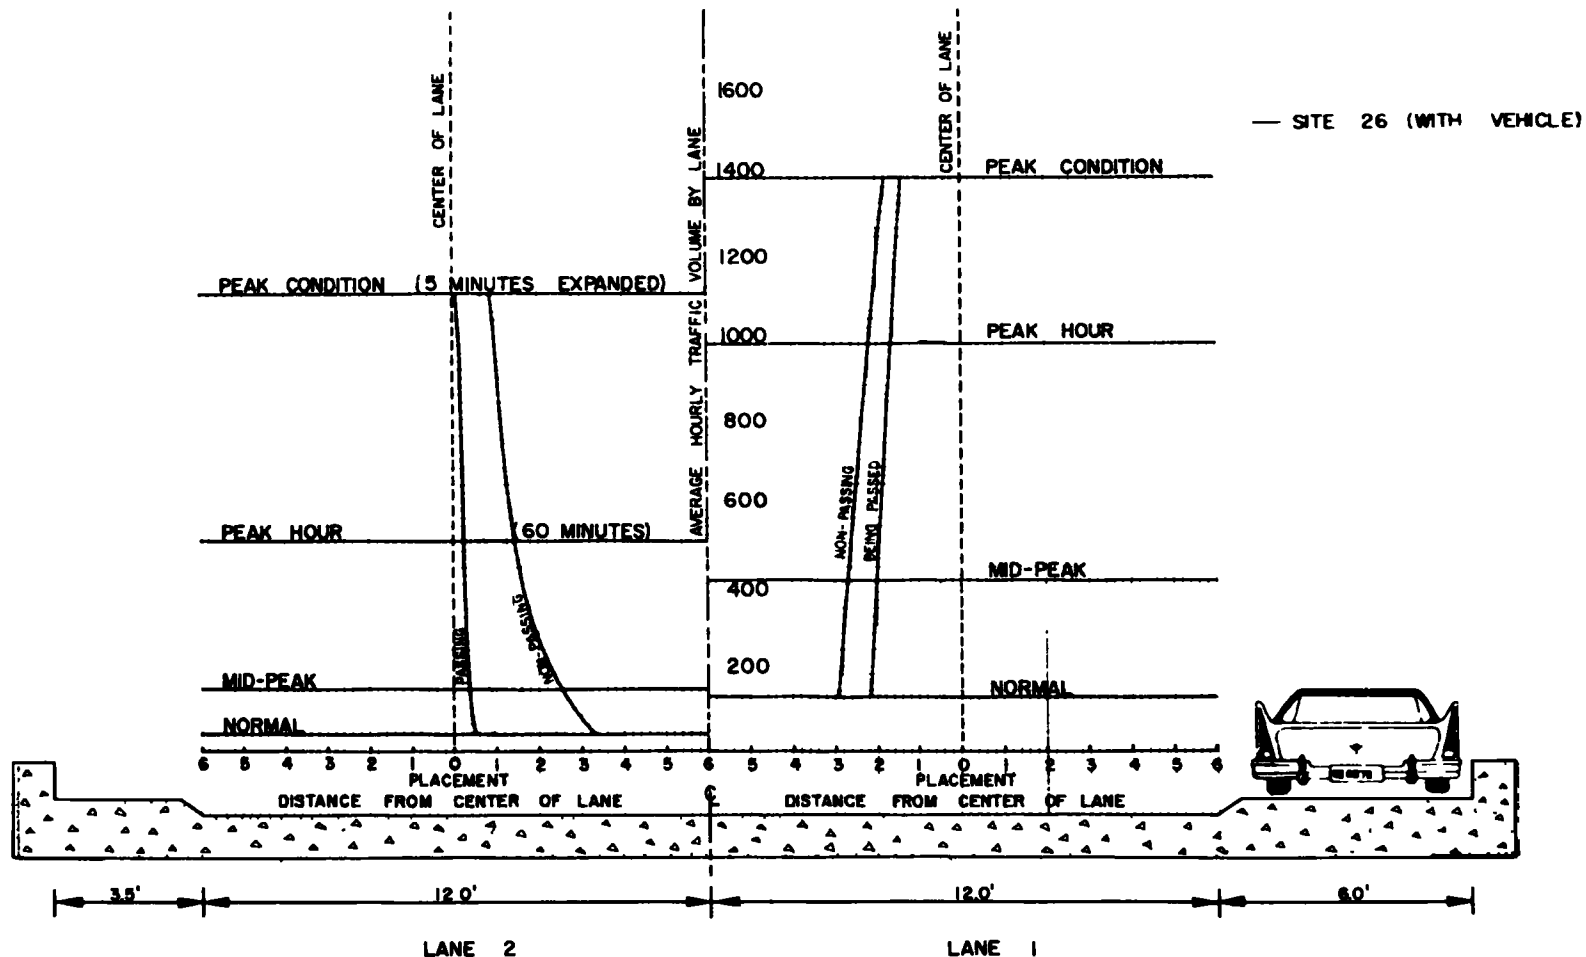
Figure 24A. Placement of vehicles on two-lane freeway bridge in relation to traffic volume with disabled vehicle on six-ft emergency shoulder.

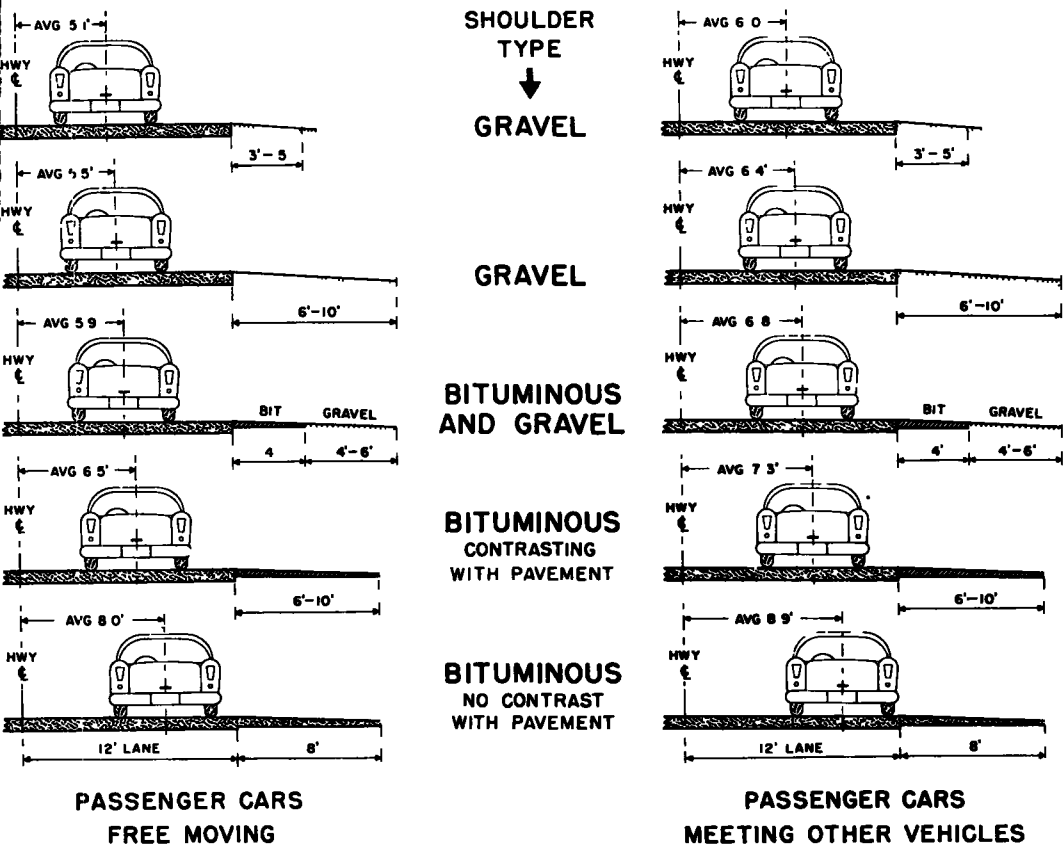
Figure 1. Average lateral position of passenger cars on rural 2-lane bituminous pavements.

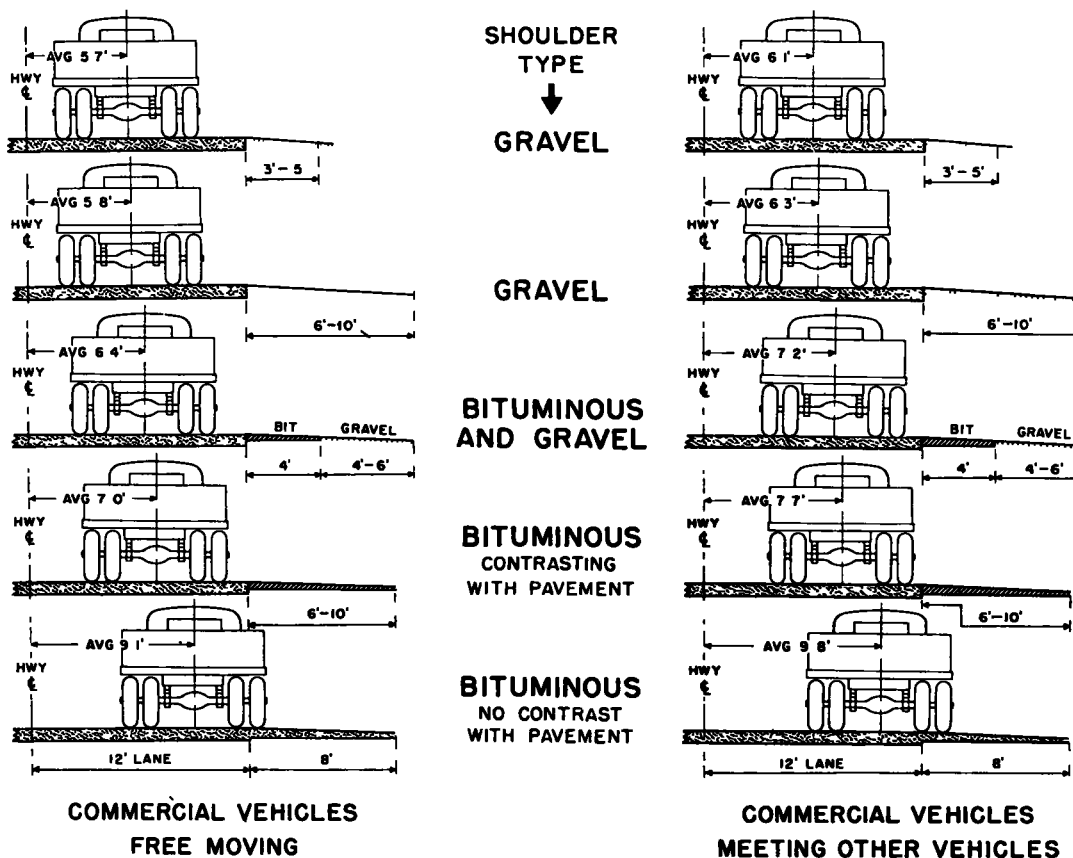
Figure 2. Average lateral position of commercial vehicles on rural 2-lane bituminous pavements.

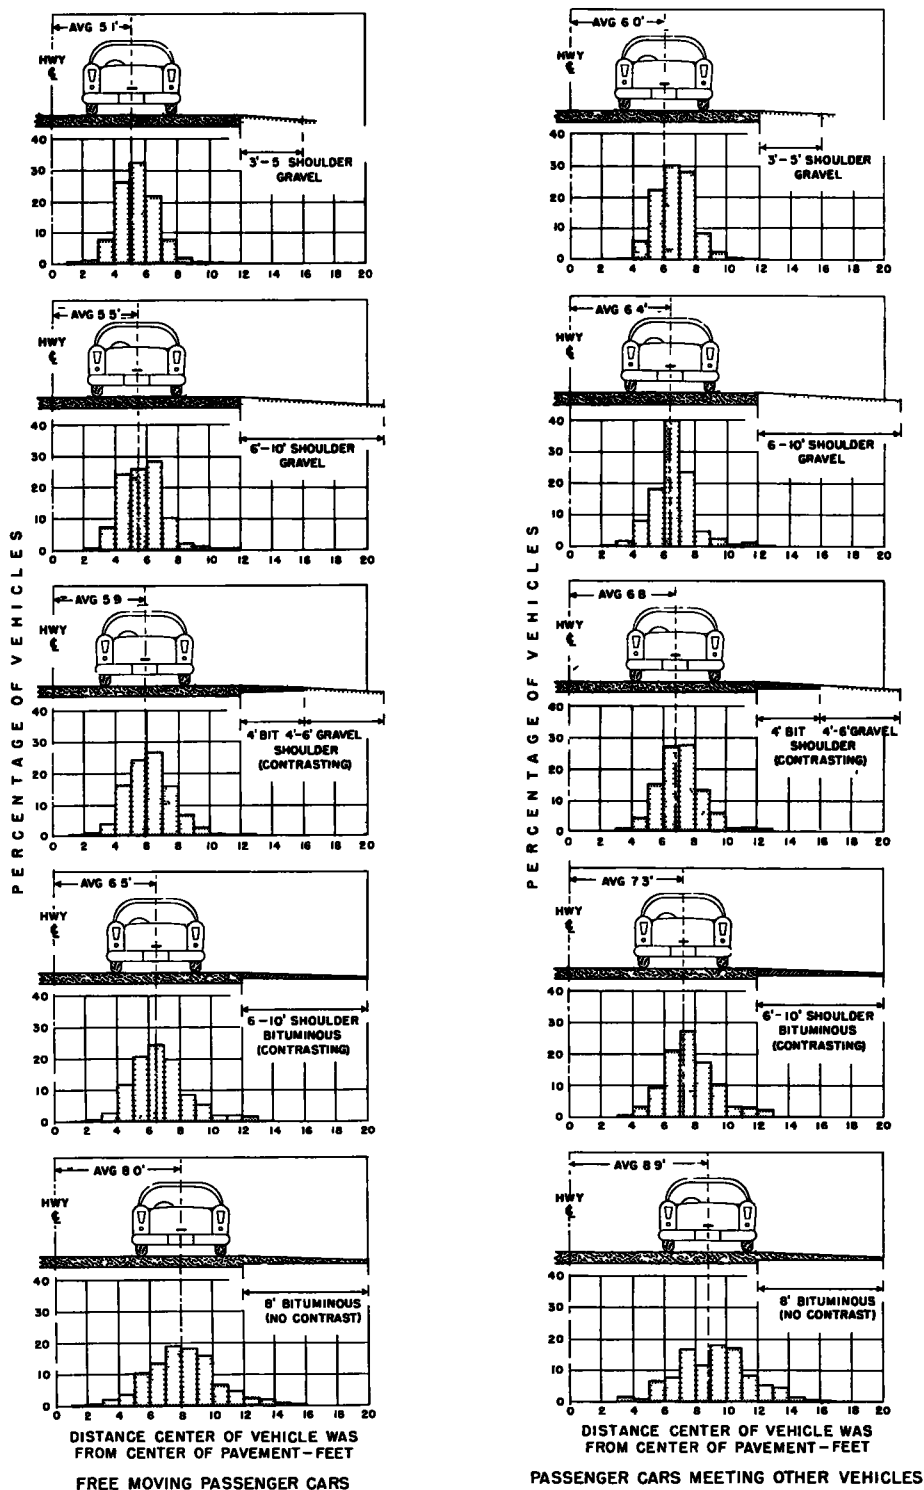
Figure 3. Distribution of lateral positions of passenger cars on rural 2-lane bituminous pavements.

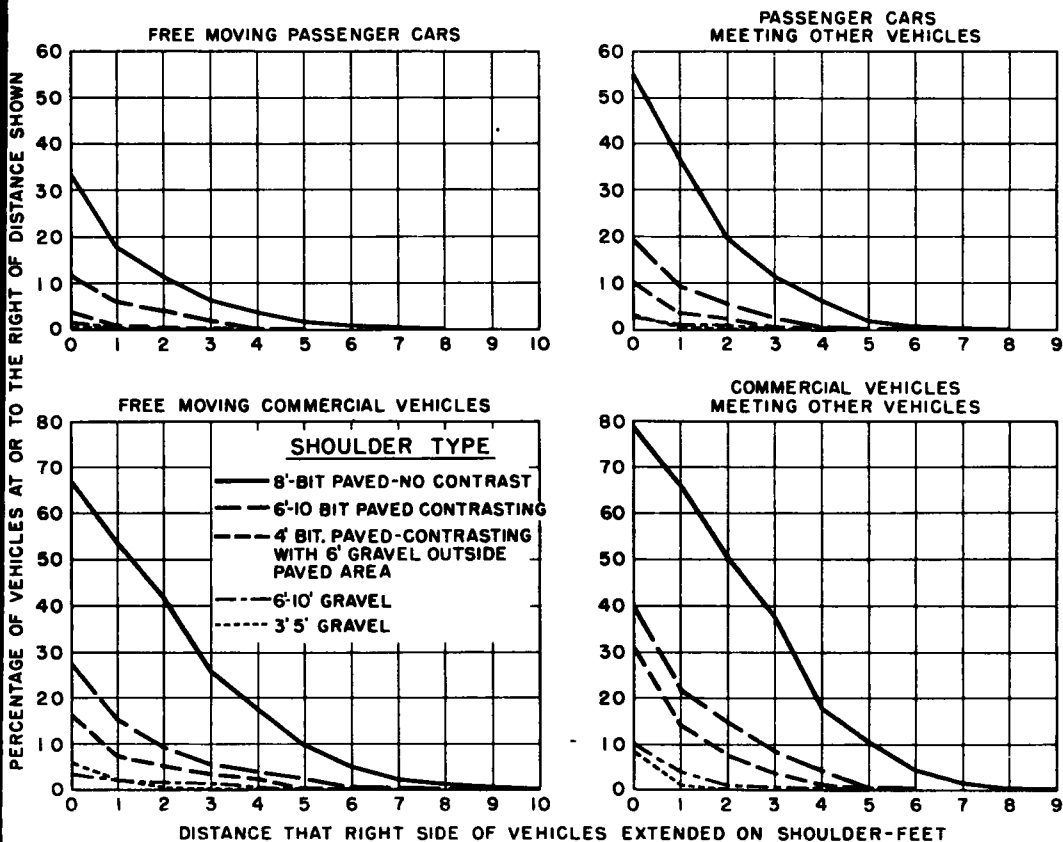
Figure 4. Shoulder encroachment on rural 2-lane bituminous pavements.

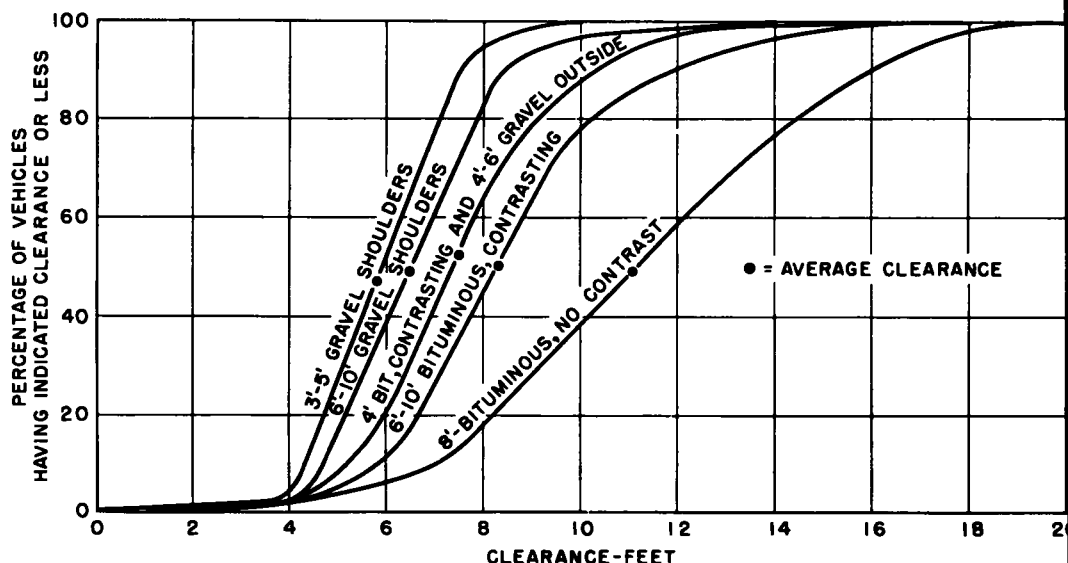
Figure 5. Cumulative distribution of clearances between bodies of meeting passenger cars as related to shoulder width and type on rural 2-lane bituminous pavements.

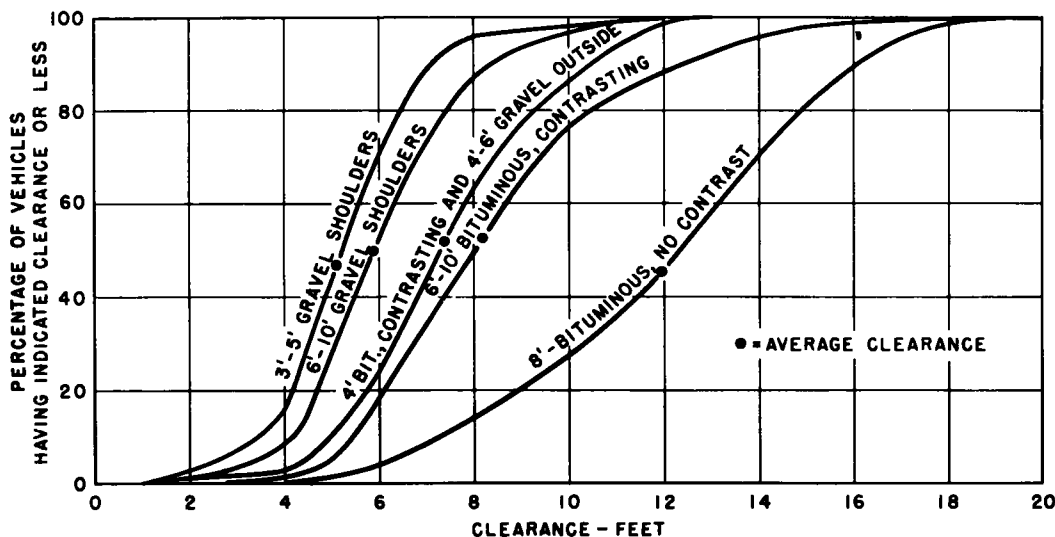
Figure 6. Cumulative distribution of clearances between bodies of passenger cars meeting commercial vehicles as related to shoulder width and type on rural 2-lane bituminous pavements.

Cumulative distribution of clearances between the bodies as passenger cars meet commercial vehicles are shown in Figure 6. Clearances were lowest on sections with gravel shoulders. On sections with 3- to 5-ft gravel shoulders, 16 percent of the meetings had clearances of 4 ft or less. On sections with 4-ft paved bituminous shoulders and 4- to 6-ft gravel outside the paved portion, however, only 3 percent of the clearances were below 4 ft. On sections where the shoulders were paved with 6 to 10 ft of

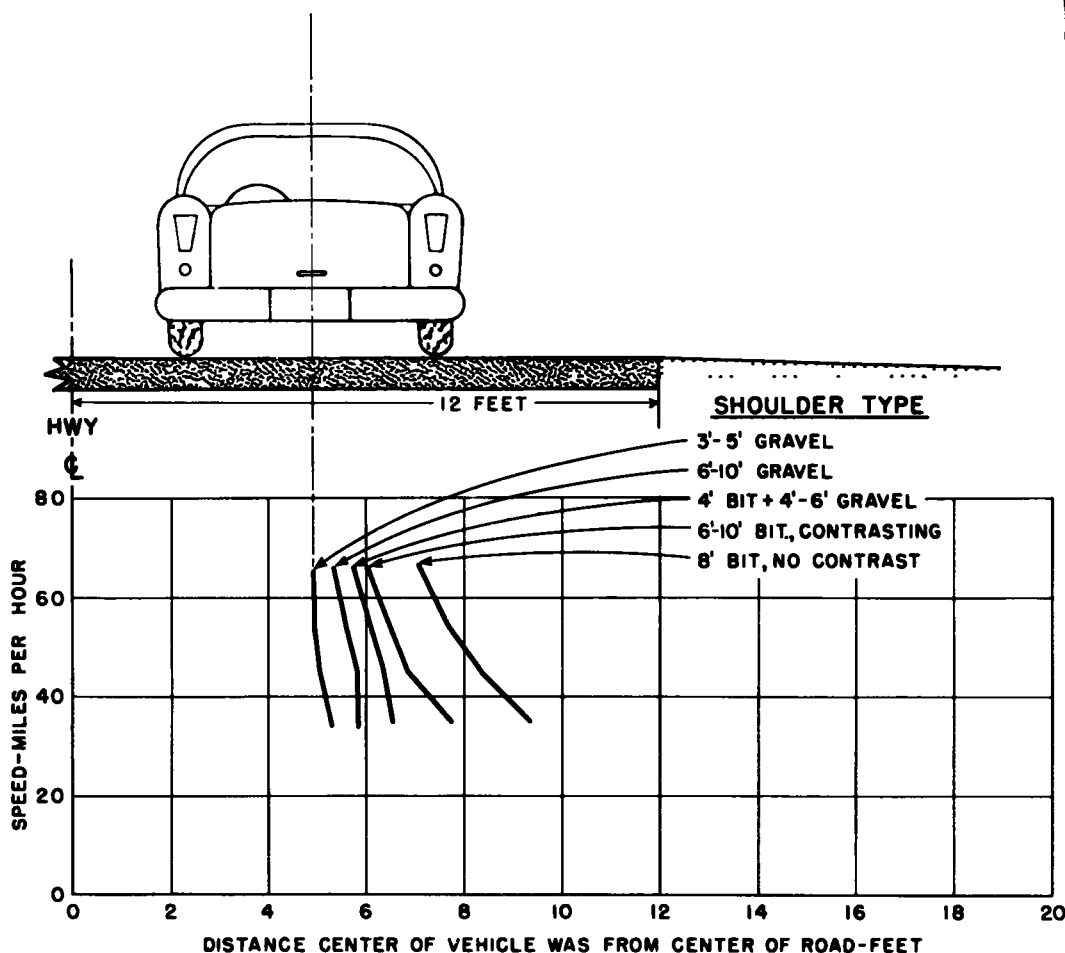
Figure 7. Average position of free moving passenger cars traveling at various speeds on rural 2-lane bituminous pavements.

A typical illustration of the results is shown by Figure 7. This figure shows the average position of free-moving passenger cars traveling at various speeds on 2-lane rural roads having the five shoulder widths and types. The ordinate shows the speeds at which the cars traveled and the abscissa shows the average position of the centers of the cars with respect to center of the road. It will be noted that on sections with gravel shoulders, there was only a very slight tendency for the slower moving vehicles to travel closer to the shoulder area than the faster moving vehicles. On the sections with the paved shoulders, however, the tendency was appreciably greater. On the sections where the pavement and shoulders were uniform in appearance for the entire width, the lateral position of the slowest group of drivers was more than 2.0 ft closer to the shoulder than the position of the fastest group of drivers. In other words, the slower passenger cars utilized the full width of paving to a greater degree than the

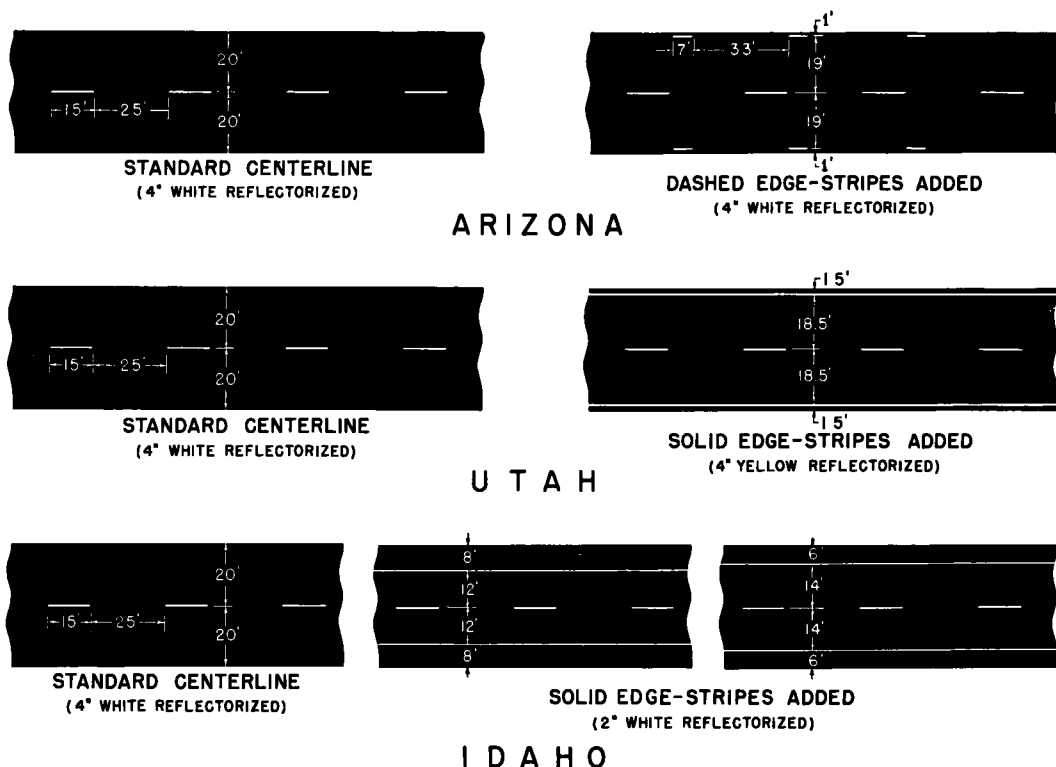
Figure 8. Edge striping on sections paved to their full shoulder width on rural 2-lane bituminous pavements.
