Preliminary Report on Continuously Reinforced Concrete Pavement Research in Pennsylvania

R. L. SCHIFFMAN, Assistant Professor of Civil Engineering, I. J. TAYLOR, Instruments Associate, Fritz Engineering Laboratory, and W. J. ENEY, Professor of Civil Engineering, and Director of Fritz Engineering Laboratory, Lehigh University, Bethlehem, Pa.

In the Fall of 1956, the Pennsylvania Department of Highways constructed the first of two experimental continuously-reinforced concrete pavements. This paper is a preliminary report on the construction procedures and investigatory details of these research pavements.

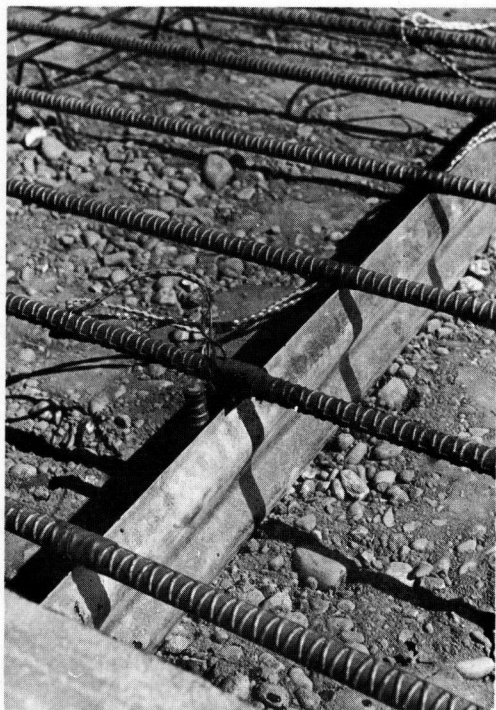
Figure 5. Installed instrumented bar-mat, showing instrumented bars, uninstrumented bars, and crack-former in place.

The installation procedure was to place the instrumented bars on chairs in the test area. The lead wires were pulled through a flexible conduit, which led underground from the edge of the pavement to a control box at the edge of the right-of-way. When the instrumented rods were placed, a bar-mat with spaces for the instrumented bars was dropped over the loose bars, which were then tied to the mat to form a standard bar-mat. The instrumented steel at the crack is shown in Figure 5.

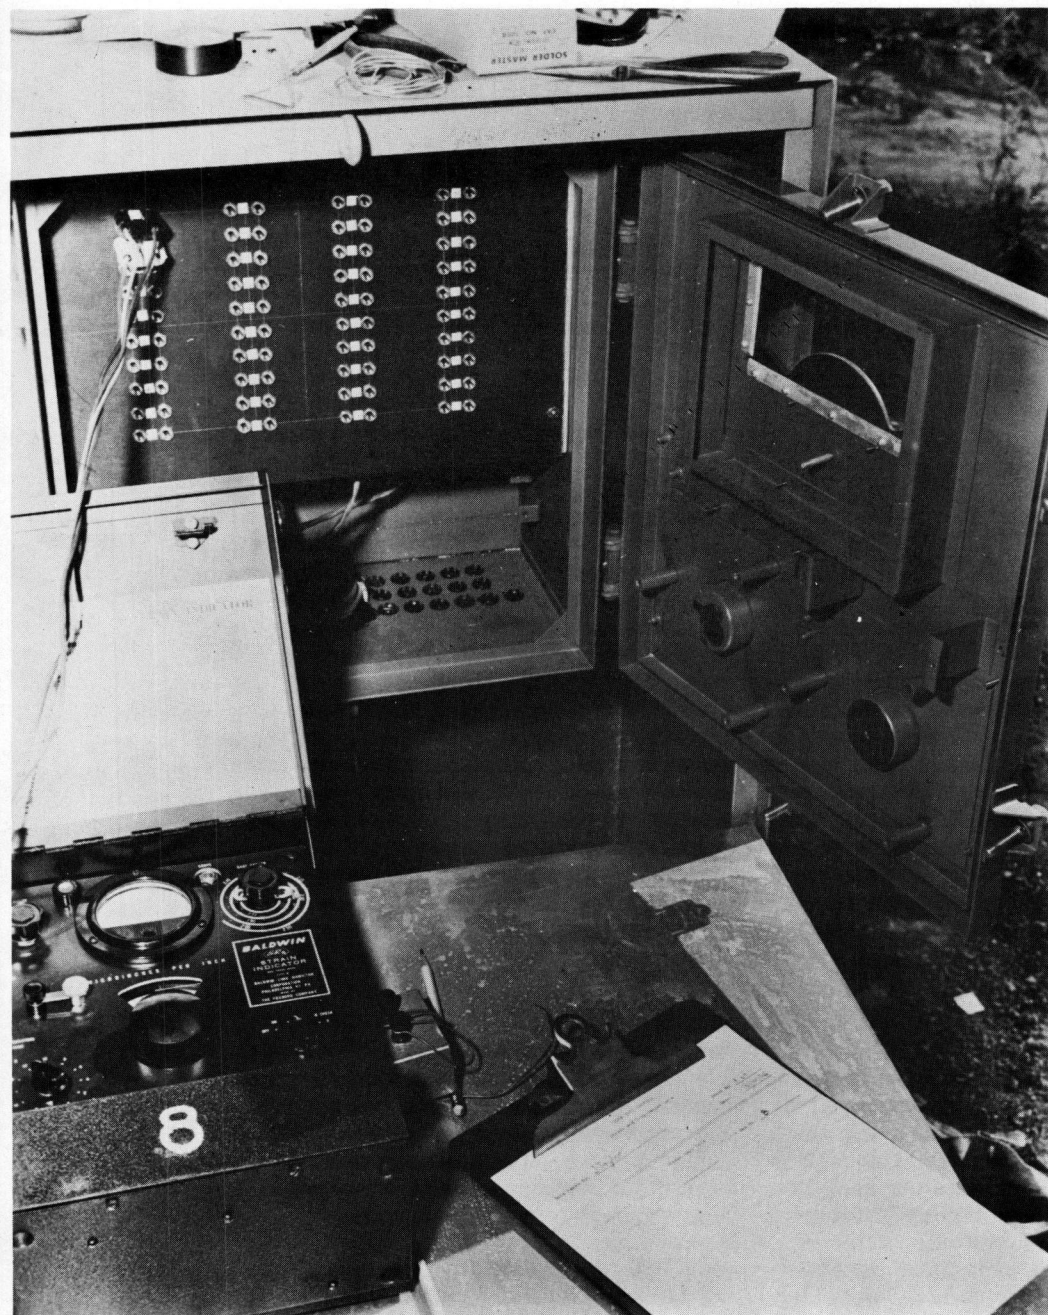
Figure 9. Terminal board ready for gage reading, showing indicator box and jack plugs inserted into board.
