Bulletin 184

## *Development of New Non-Skid Road Surface Treatment*

## THE DEVELOPMENT OF RESINOUS SKID-RESISTANT SURFACES FOR HIGHWAYS

## APPLICATION OF A NEW NON-SKID SURFACE TREATMENT ON CONNECTICUT STATE HIGHWAYS

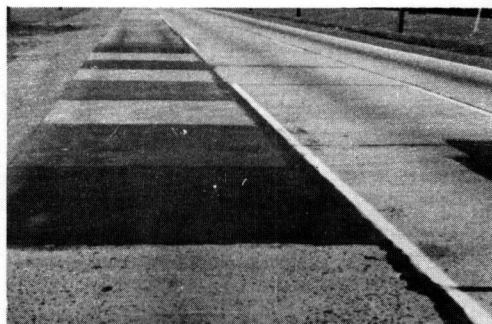
Figure 8. Test applications on U. S. Highway.

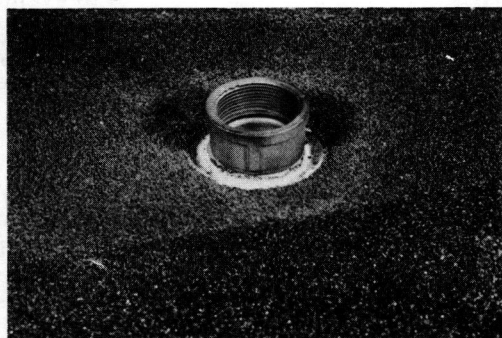
Figure 8. Machine faced pipe cap bonded to cored disc.

This test method consists of drilling a core through the surfacing layer just down to the concrete surface by means of a 2-in. drill fitted with a carbide tipped core bit (Fig. 6). A view of the resulting cored disc is shown in Figure 7. A 2-in. diameter pipe cap, machine faced on the bottom, is then bonded to the resulting cored disc by means of an EPON resin adhesive (Fig. 8). This pipe cap is then heated with a gasoline blow torch to promote rapid hardening of the adhesive in such a way that the Relcote to
