Types and Causes of Failure in Highway Pavements

F. N. HVEEM, Materials and Research Engineer, California Division of Highways

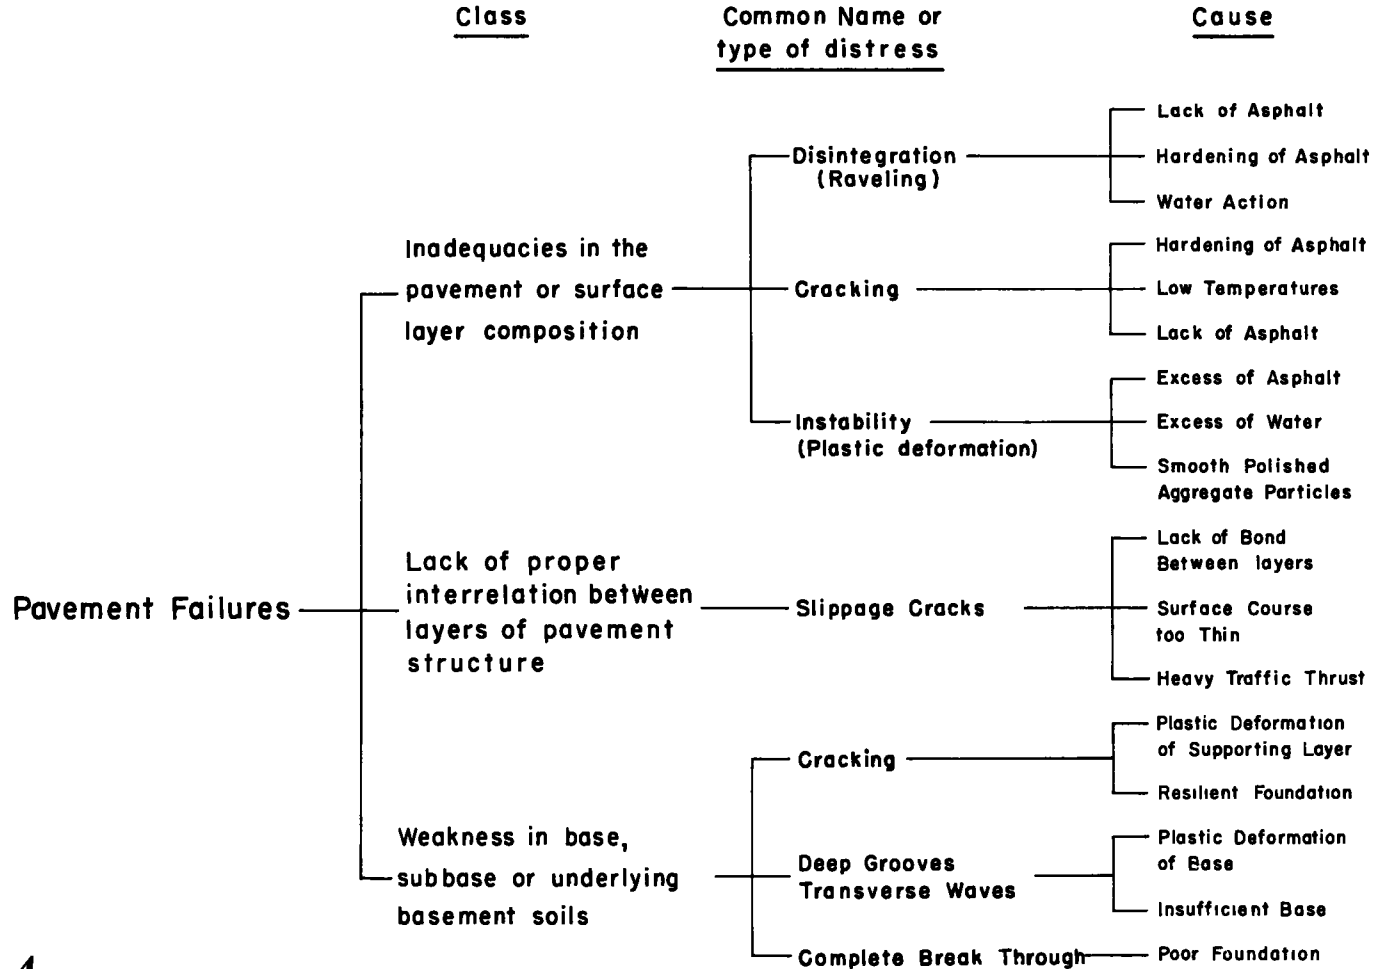
Chart A

ANALYTICAL CHART
Classification of Failures in Bituminous Road Surfaces

Figures 1 to 12, inclusive, show types of failure or unsatisfactory performance that are attributable solely to the quality of the pavement itself.

Figures 13 to 17, inclusive, show types of distress caused by lack of bond or lack of friction between layers of surface and/or level course or base.

Figures 18 to 36, inclusive, show failures and distress appearing in the surfacing, but primarily due to weakness and instability in the base or underlying soil.

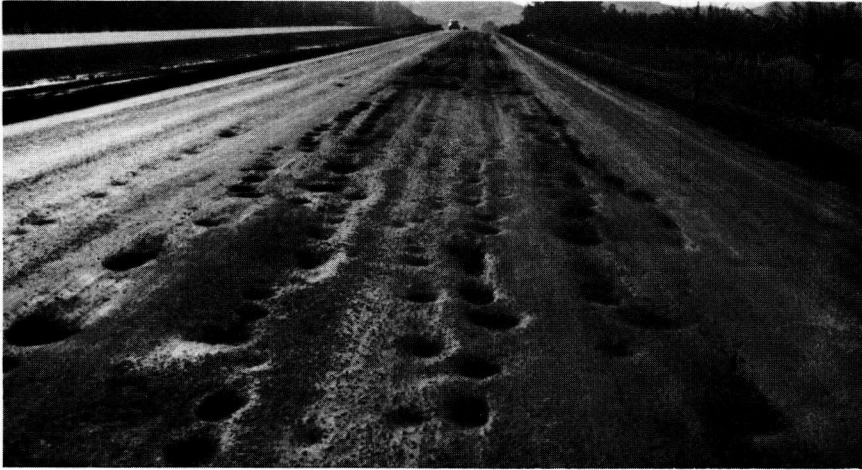
Figure 4. Extensive deterioration of new plant mixed dense graded bituminous surface. Hot mix material with 85-100 pen asphalt.

Cause: Surfacing was spread and compacted with steel tired roller in October but was not open to traffic until a month later and was subjected to a heavy rain and heavy high speed traffic on the opening day before a "traffic seal" could be developed by the pneumatic tires; or aggregate particles were coated with fine clay-like material. Total amount passing No. 200 was within specification limits but material would not pass the Sand Equivalent Test.

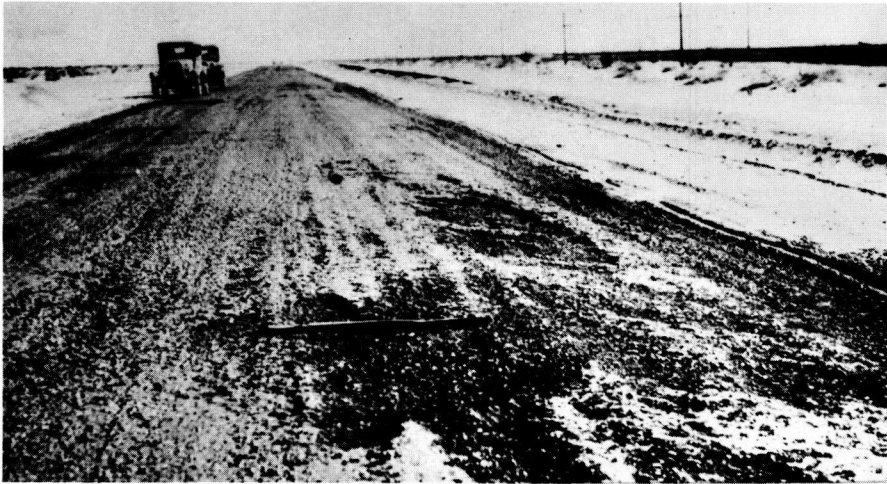
Cause: Insufficient amount of asphalt aggravated by a coating of colloidal clay on all sand grains. An initially high percentage of moisture caused the mix to appear well oiled when first laid down.

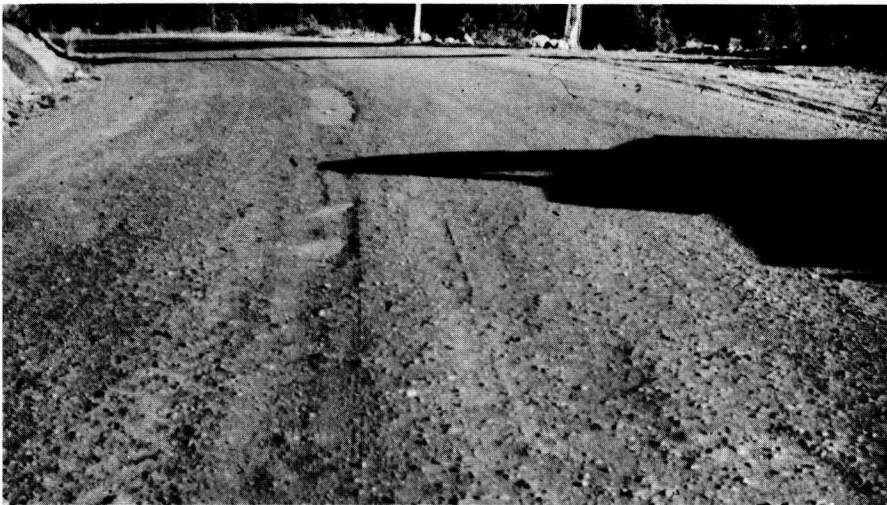
Figure 6. Extensive raveling of a dense graded mix using liquid asphalt placed as resurfacing over an existing pavement.

Cause: Insufficient quantity of asphalt in the mix.

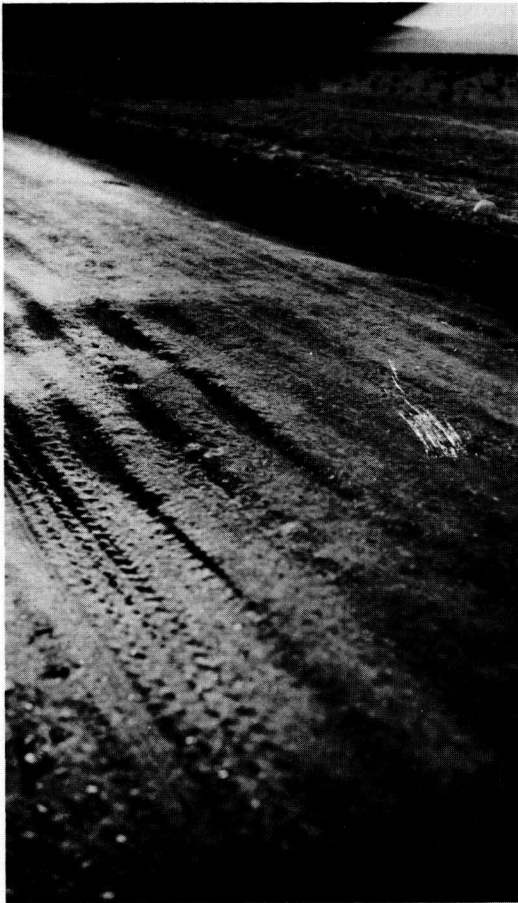
Figure 10. An unusual example of an unstable distorted surface which is also raveling under the action of traffic.

Cause: Same project as Figure 5. Aggregate contained a high percentage of colloidal clay of the montmorillonite type and from 3 percent to 4 percent moisture. The total liquid content of asphalt plus moisture was too high for a stable mix and surface developed transverse waves and grooving under the initial traffic. As moisture on exposed surface was dried out under the hot desert sun, surface began to ravel due to deficiency in amount of binding agent.

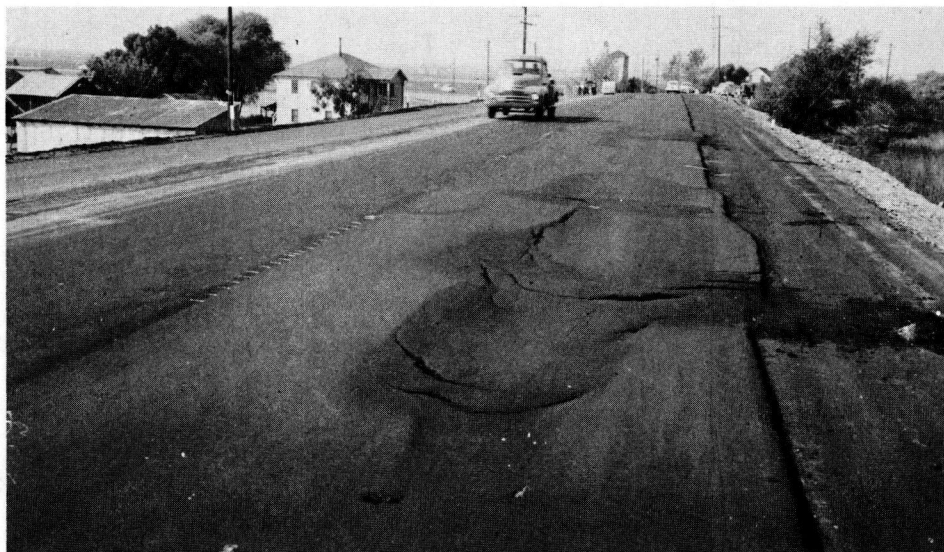
Figure 15. Another example of slippage failure illustrating the lateral movement that frequently occurs where shoulder support is weak or non-existent.

Cause: Primary cause same as for Figure 12.

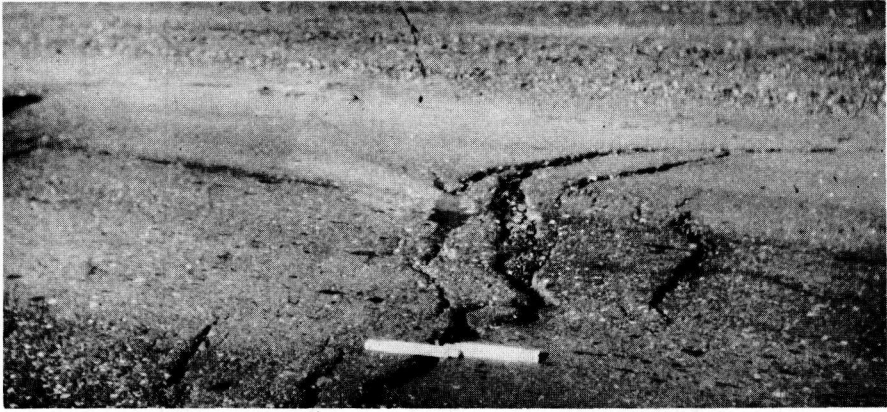
Figure 17. A close-up view of large cracks caused by slippage.

Note: It is useless to seek to prevent this type of failure by changes in the surface mix design or composition.

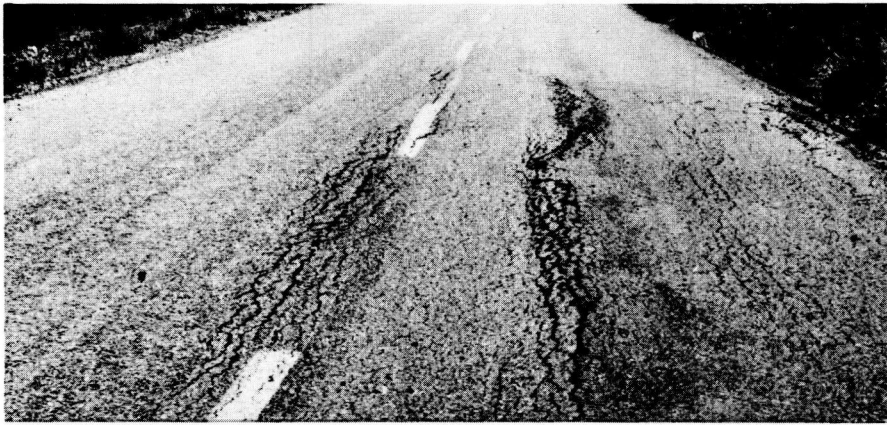
Figure 18. Depressions in the wheel path and upheavals along-side causing breaking and rupture of the asphalt surfacing.

Cause: An unstable base and poor foundation saturated with water.

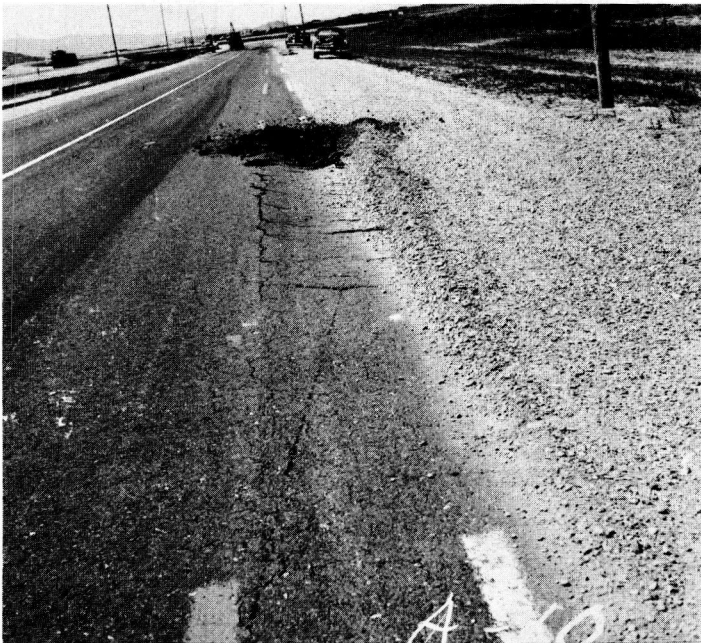
Figure 19. Failures in the outer wheel lane on WASHO test track showing depression and breakup of surfacing accompanied by up-thrusts of the uncemented granular material on the shoulder.

Cause: Inadequate thickness (for the wheel loads) of pavement and base over plastic foundation soil; or lack of lateral support in shoulder material.

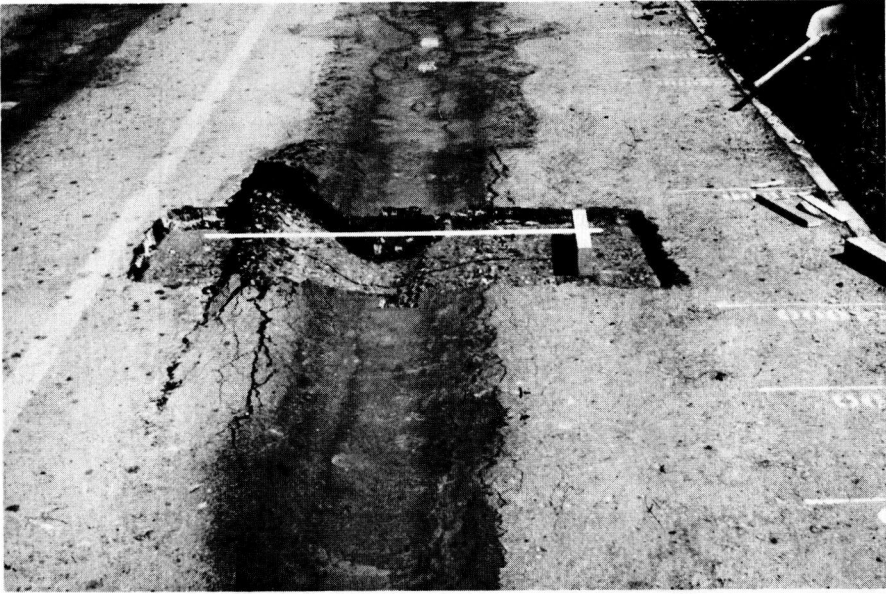
Figure 20. Failure in the wheel path on the Brighton test track.

Cause: Lateral and upward movement of the gravel base which was not sufficiently stable to resist the heavy truck loads on the thin bituminous surface.

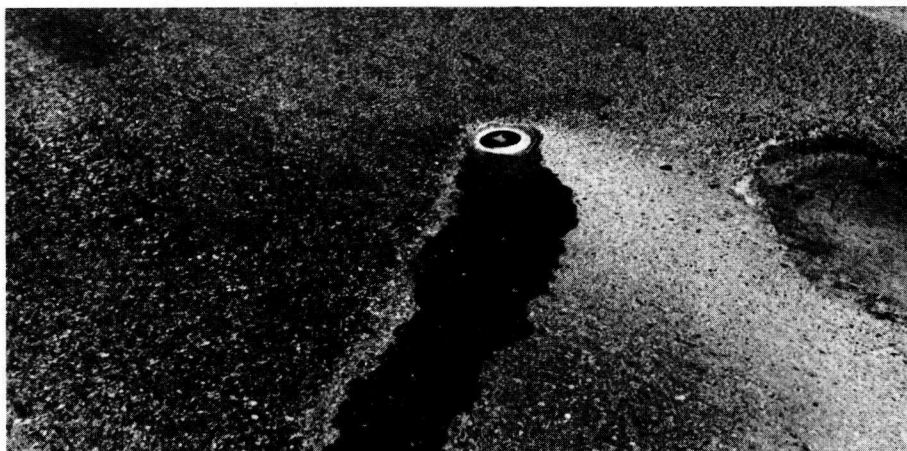
Figure 26. Same as Figure 25. Local failure in a bituminous surface at right of photo.

Note: Water flowing out through a core hole cut through the bituminous surface and cement treated base.

Cause: Water under pressure beneath the base due to impervious soil beneath base and a steep grade with superelevations.

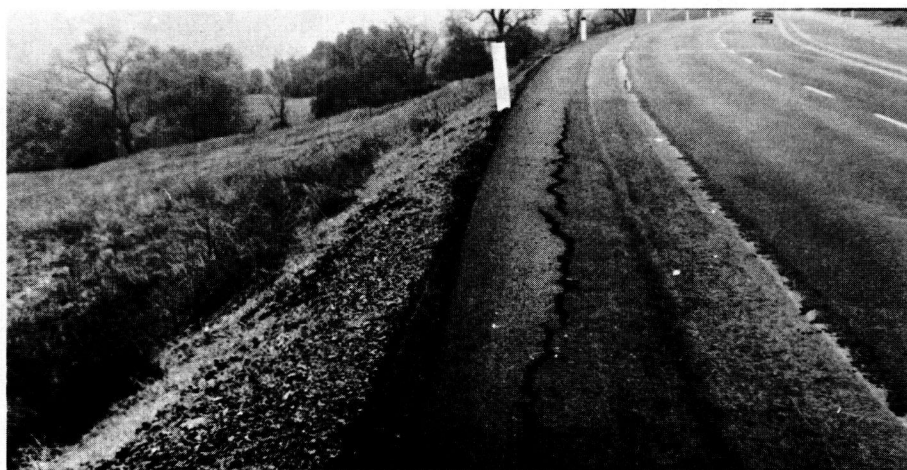
Figure 27. Longitudinal crack in the outer shoulder parallel to the pavement.

Cause: Fill settlement involving both downward and lateral movement.

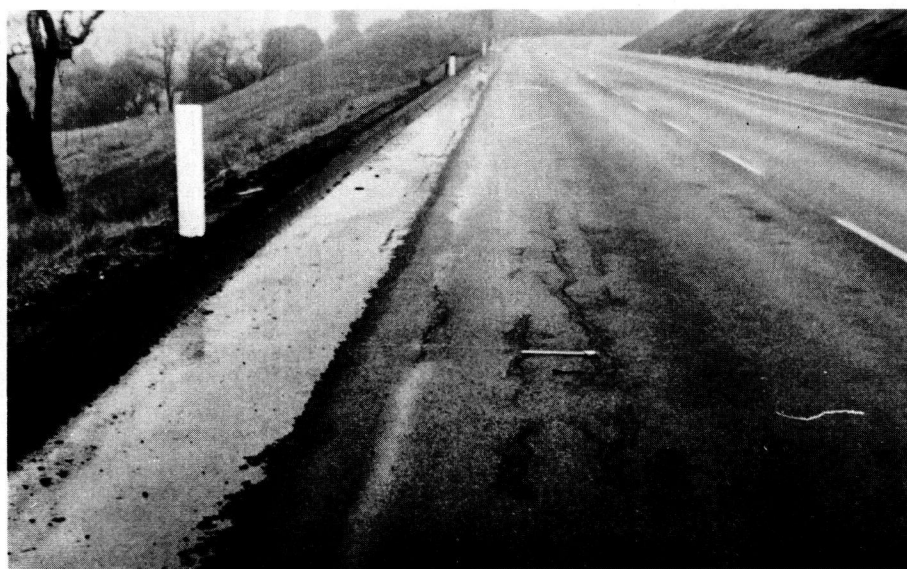
Figure 28. Longitudinal cracks in the outer traffic lane.

Cause: Deep seated movements involved in fill settlement.

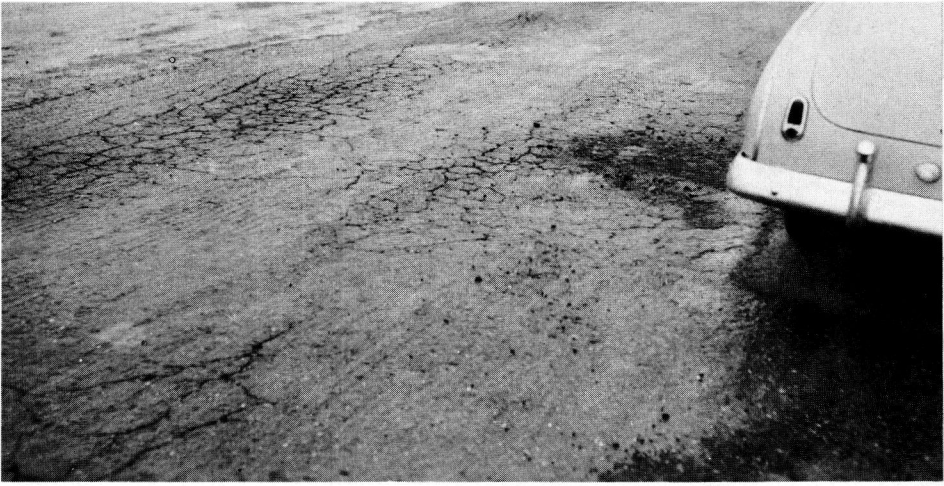
Figure 29. Alligator cracking and extensive distress in a thin bituminous surface over a cement treated base in an arid region subjected to irrigation.

Primary Cause: Alkali attack which weakened and destroyed the slab strength of the cement treated base.

Secondary Cause: Insufficient thickness of surface and weakened base over a poor base-cement soil.

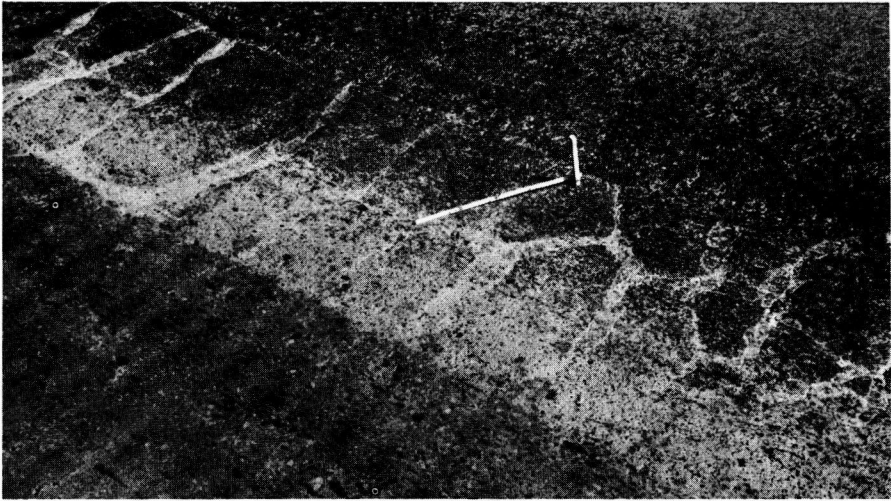
Figure 30. Wide double cracks near edge of pavement over cement treated base. Surface has been sealed and material in cracks has settled slightly.

Cause: Cracking in a cement treated base which was of insufficient thickness and strength to support heavy traffic over a weak foundation.

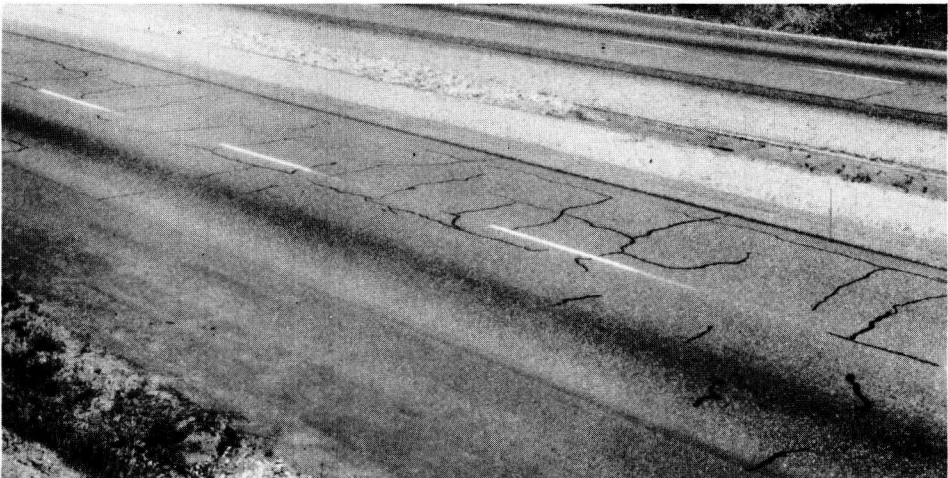
Figure 31. Typical crack pattern in a bituminous surface reflecting cracks in a cement treated base.

Cause: Shrinkage of cement treated base.

Note: Cracks in this area are more numerous in the passing lane than in the outer lane that is subjected to heavy traffic. Obviously, this cracking is not due to heavy loads or lack of support.

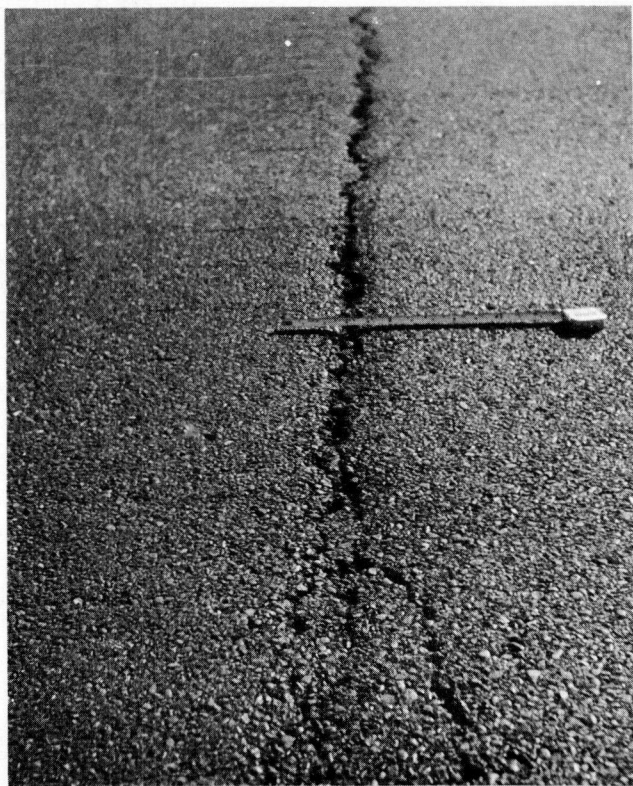
Figure 32. Longitudinal crack in asphalt pavement coinciding with longitudinal construction joint in cement treated base.

Cause: Weak vertical plane created by a juncture of two spreads of cement treated base material. Neither base nor surfacing had sufficient tensile strength to prevent separating along this line. Could be prevented by better construction techniques.

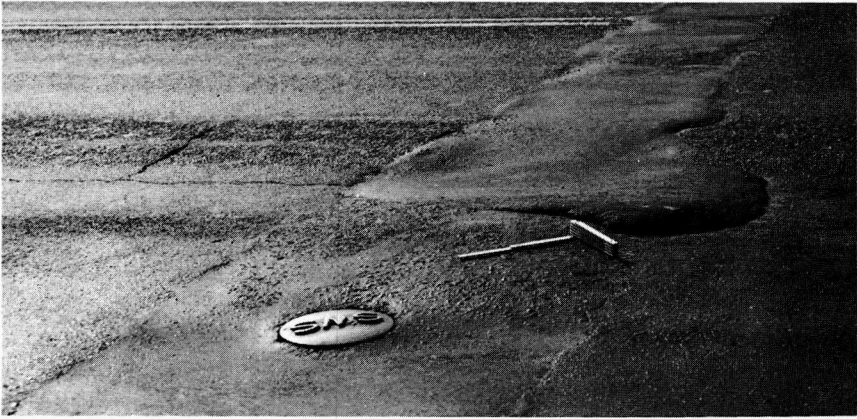
Figure 34. Localized distortion of patching material used to resurface a trench excavation across pavement.

Cause: Unstable mix containing too much asphalt.

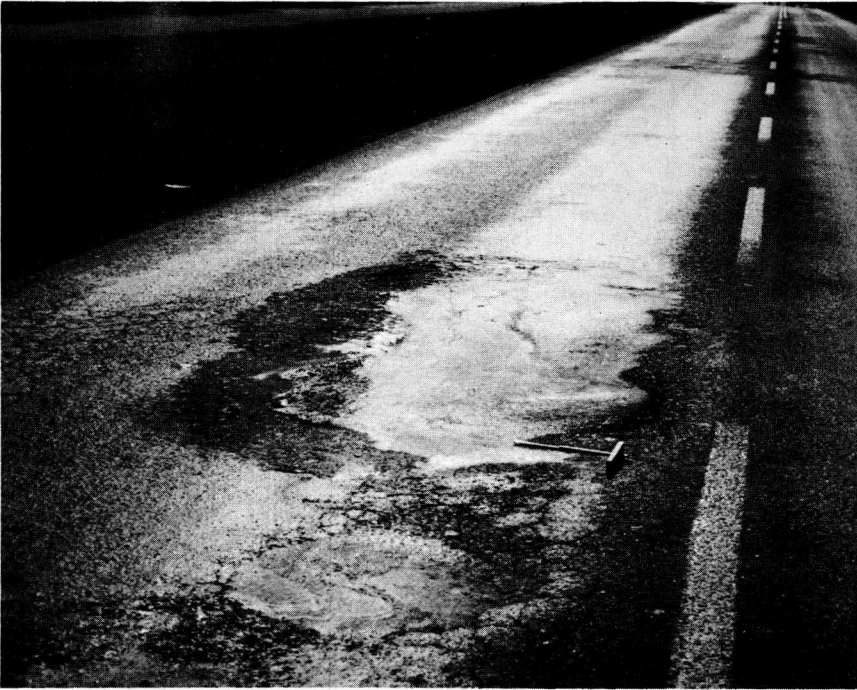
Figure 35. Poor repair of a pavement failure.

Primary Cause: Trying to correct a base failure with a thin surface patch.

Secondary Cause: Over-rich unstable material used for patching. (An example of an all too common bad maintenance practice.)

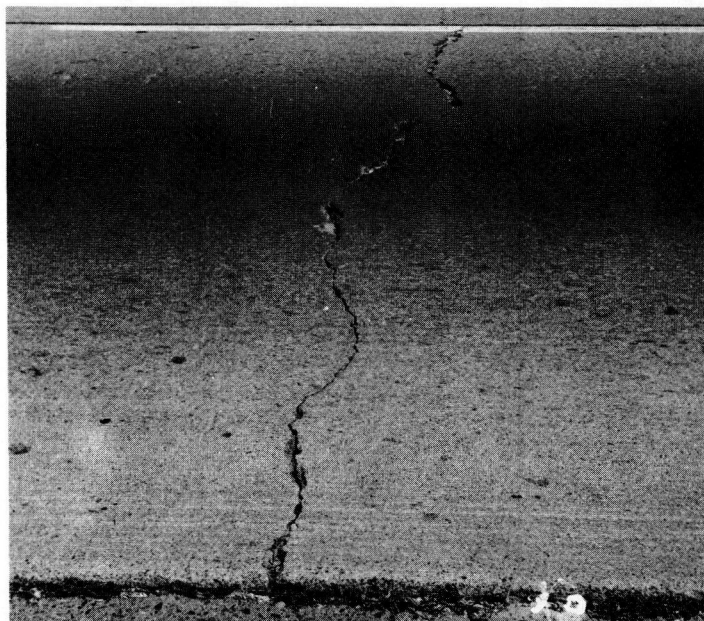
Figure 37. A random crack showing slight spalling.

Cause: The primary cause for such cracks is shrinkage and expansion of the concrete. Whether or not such a crack is serious is debatable. Its unsightly appearance is probably the chief reason why engineers insist on cutting contraction joints at close intervals. Cracks of this type are probably more annoying to the engineer than to the traveling public. Many old concrete pavements have given excellent performance over a long period of years where all "joints" were of the type shown here.

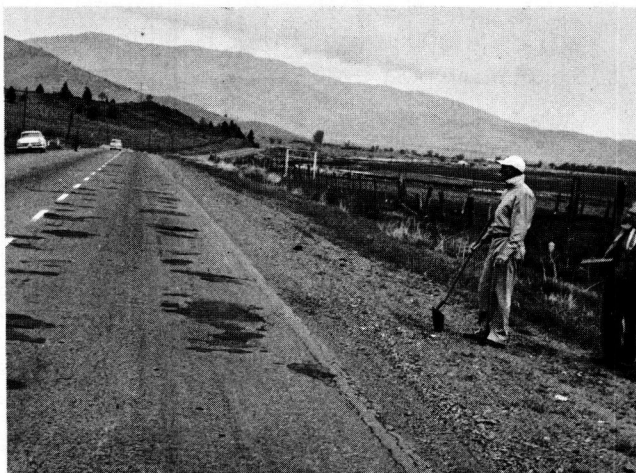
Figure 42. Extensive patching of a thin bituminous pavement "second story" subject to low temperatures in northern California at an approximate elevation of 3,000 ft.

Cause: Failures in the old concrete pavement beneath.

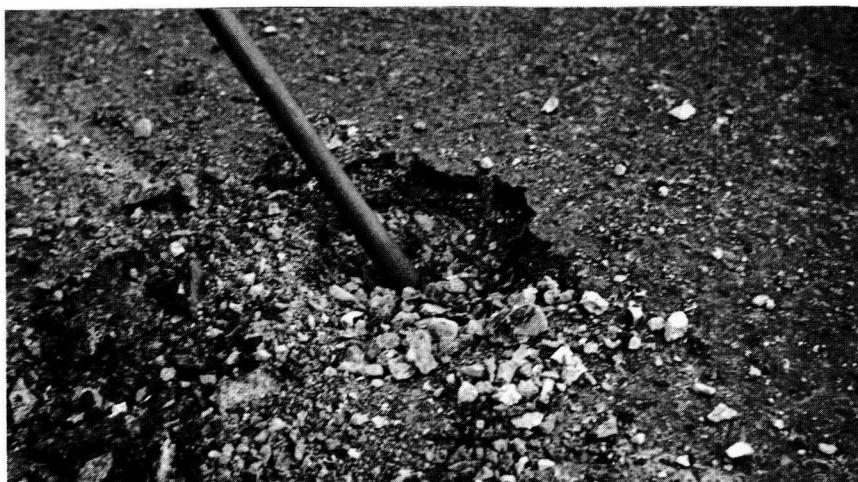
Figure 43. Close-up of failed highway. Same project as Figure 61 showing disintegration of concrete beneath a bituminous surface.

Cause: Freezing and thawing action on concrete without air-entrainment.

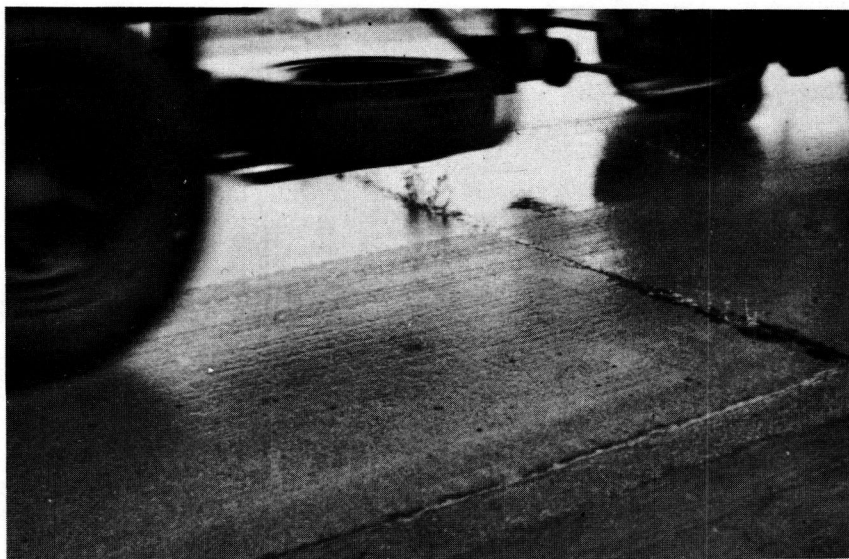
Figure 44. Water being ejected through a joint in a concrete pavement. This is the phenomenon called pumping. Strictly speaking, it is not a failure. It simply indicates a condition which may lead to distress or failure of a pavement.

Cause: Under the influence of differential moisture and/or temperature pavement slabs curl upward in the vicinity of a joint leaving a void space between pavement slab and subgrade for the accumulation of water. Entrapped water is subjected to considerable pressure with each passage of heavy axle loads. Water flows laterally at high speed and exerts considerable erosive action upon subgrade; muddy water is ejected with considerable force through transverse cracks and along edge of slab. Characteristics of both subgrade and concrete slabs contribute to this condition.

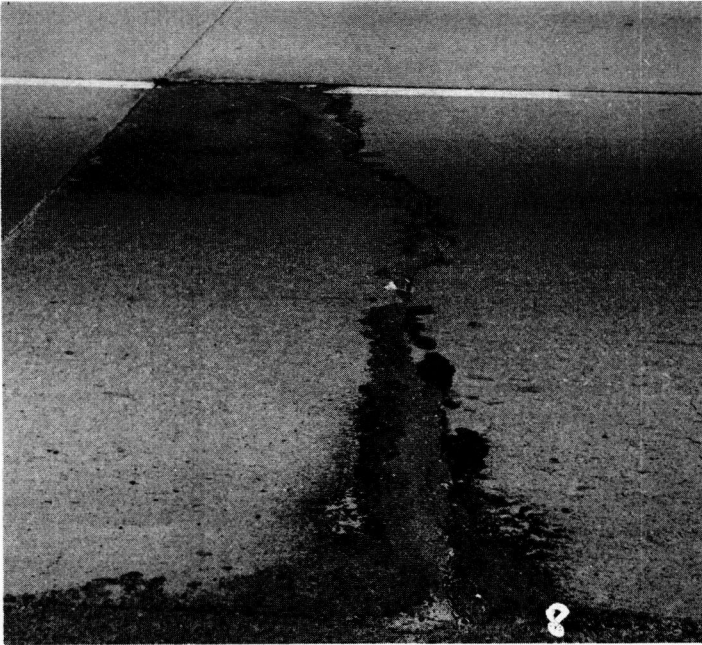
Figure 47. Characteristic transverse break that develops under heavy axle loads just beyond a transverse joint. These cracks are generally from 5 to 7 ft beyond the joint.

Cause: Long continued pumping action of a slab erodes and removes subgrade material leaving a deep void space beneath the slab. Pavement slab becomes an unsupported cantilever which finally breaks under load.

Note: The end of the slab approaching the joint is often supported or bolstered in its elevated position by the accumulation of coarser particles pumped from beneath the slab beyond the joint.

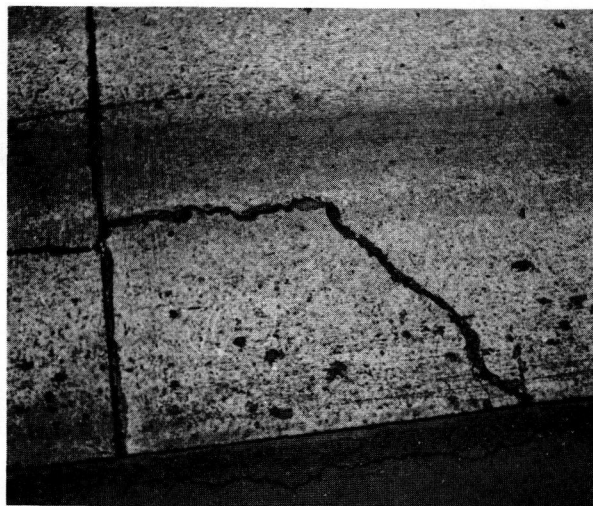
Figure 50. A corner break at the junction of a longitudinal and transverse joint.

Cause: Probably due to the effects of heavy load on an unsupported corner of the curled or warped slab.

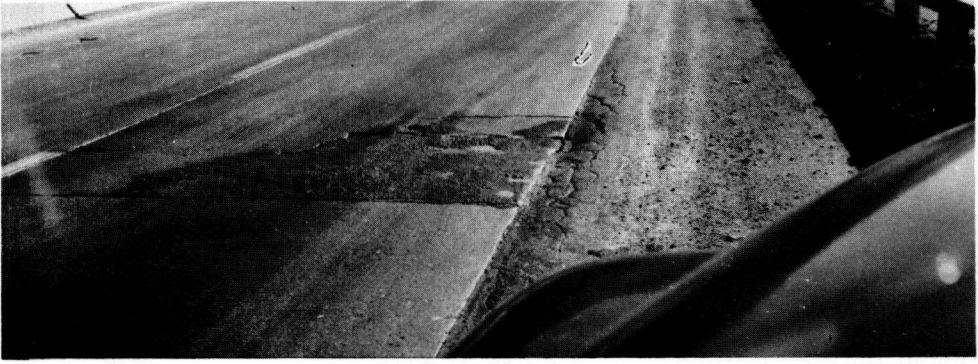
Figure 51. A more extensive corner break.

Cause: In this example, it appears that there is a local weak spot of poor soil beneath the pavement as evidenced by failure in the bituminous shoulder alongside.

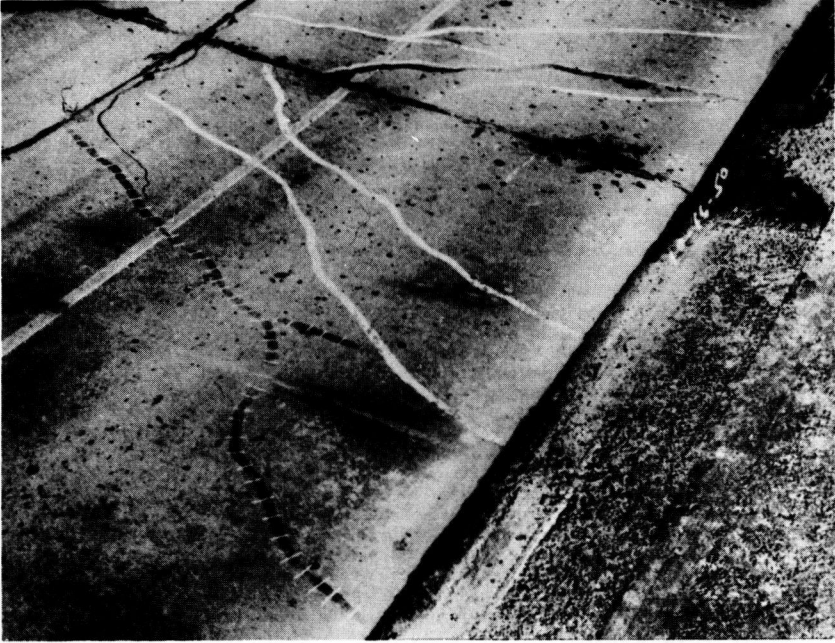
Figure 52. Diagonal cracks that have developed in the vicinity of a pavement joint.

Cause: Slab curling followed by pumping out of the subgrade support soil. Slabs broken by heavy truck loads on the unsupported slab ends. Photograph from report on Test Road One-MD.

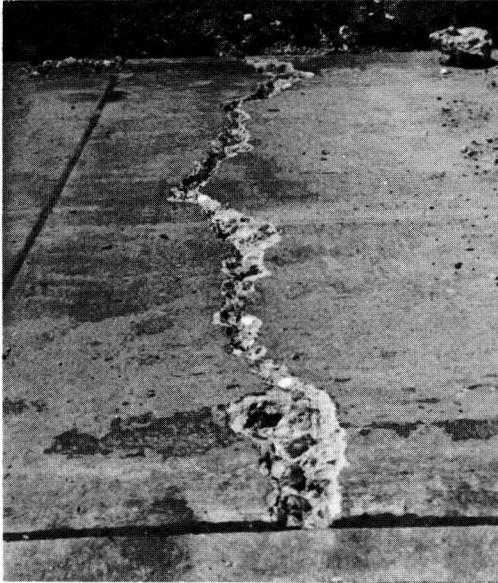
Figure 55. Badly spalled random crack close to and approximately parallel to a contraction joint 2 in. in depth. Crack occurred before pavement was subjected to traffic.

Cause: Expansion and contraction of the concrete due to temperature changes. It must be inferred that the strength of the full 8-in. slab along the irregular line of the crack was less than the 6-in. net section under the contraction joint. The spalling appeared to follow "planes" of weakness along the surfaces of the coarse aggregate. Bond between the cement paste and the siliceous, glassy, coarse gravel is relatively poor: or movement possibly facilitated by bituminous treated sand subgrade with low friction. Cracks ultimately opened 1 or 2 in.

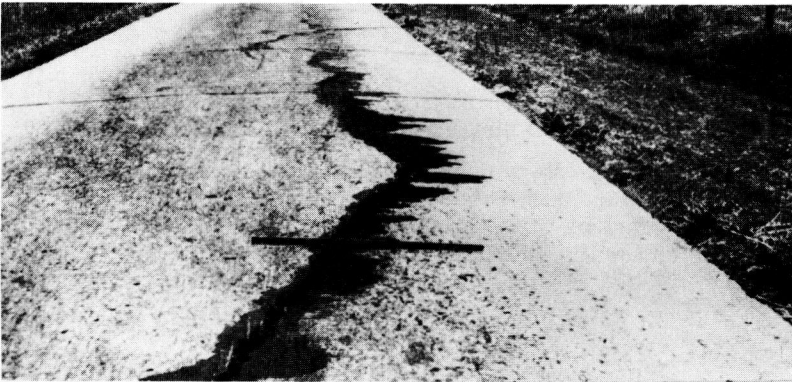
Figure 56. Longitudinal crack in a thin concrete pavement constructed in 1917.

Cause: Vertical and lateral alternate expansion and shrinkage of a heavy clay soil.

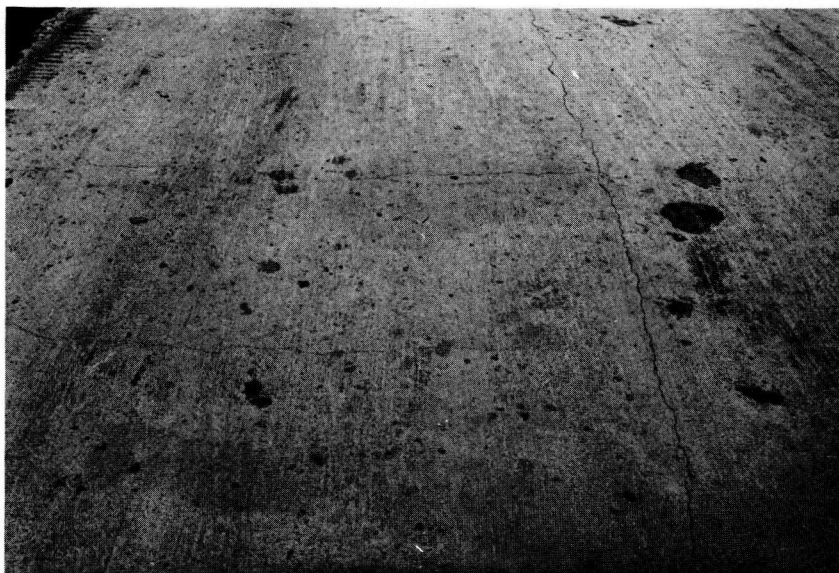
Figure 57. Longitudinal and transverse cracks in a modern 8-in. concrete slab constructed in 1955.

Cause: Abnormal expansion of imported borrow material secured from waste piles at a magnesium plant.

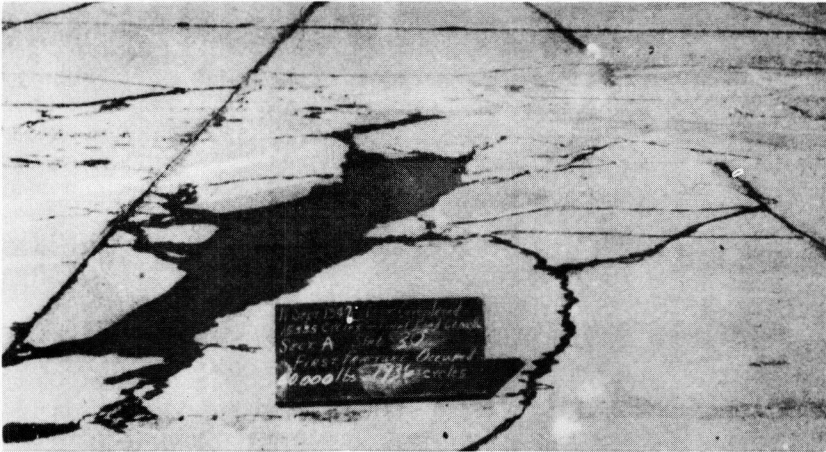
Figure 60. Distress and serious breakup of an airfield pavement used as a test track.

Cause: Heavy wheel loads and poor subgrade support.
