Bulletin 187

Pavement Performance

Methods for Evaluation

Types and Causes of Failure in Highway Pavements

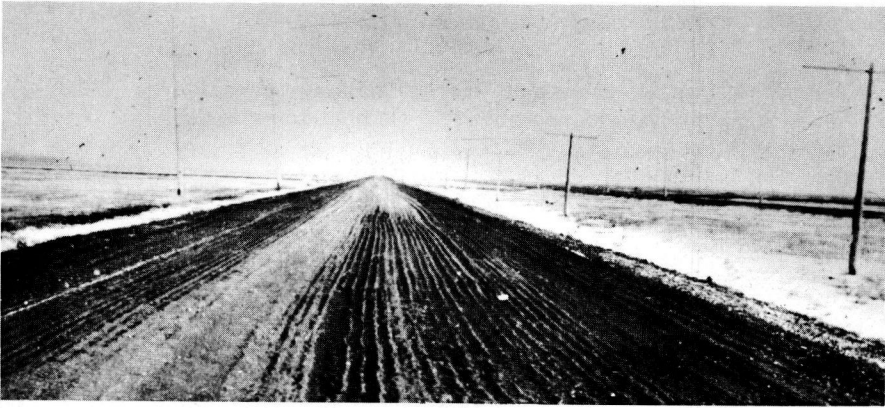
Figure 3. Disintegration of a level course consisting of hot plant mix using 120-150 pen asphalt.

Cause: Hydrophilic fine material in a mixture subjected to rain shortly after construction. Traffic whipped out fine material leaving the mosaic of coarse aggregate particles.

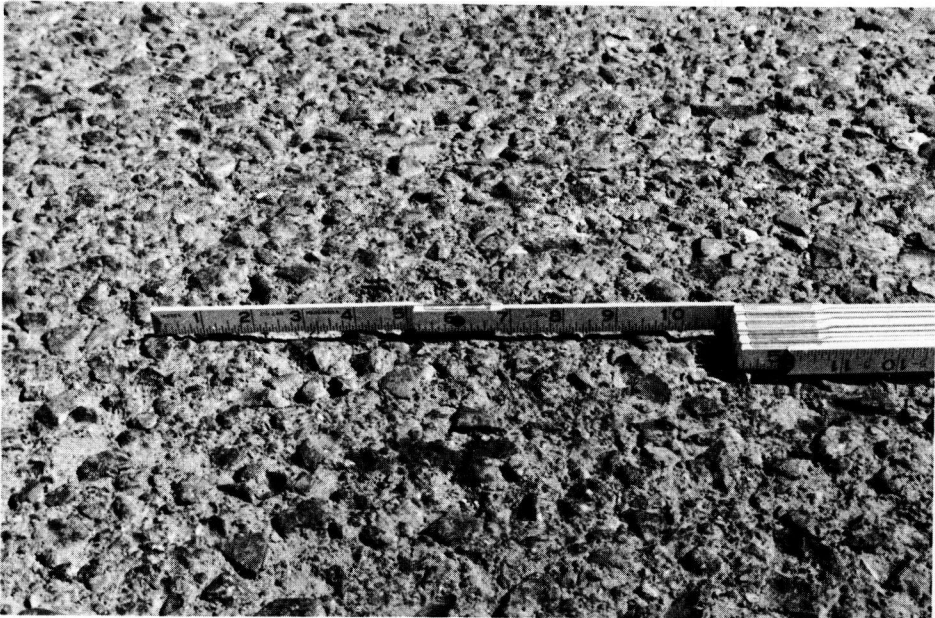
Figure 4. Extensive deterioration of new plant mixed dense graded bituminous surface. Hot mix material with 85-100 pen asphalt.

Cause: Surfacing was spread and compacted with steel tired roller in October but was not open to traffic until a month later and was subjected to a heavy rain and heavy high speed traffic on the opening day before a "traffic seal" could be developed by the pneumatic tires; or aggregate particles were coated with fine clay-like material. Total amount passing No. 200 was within specification limits but material would not pass the Sand Equivalent Test.

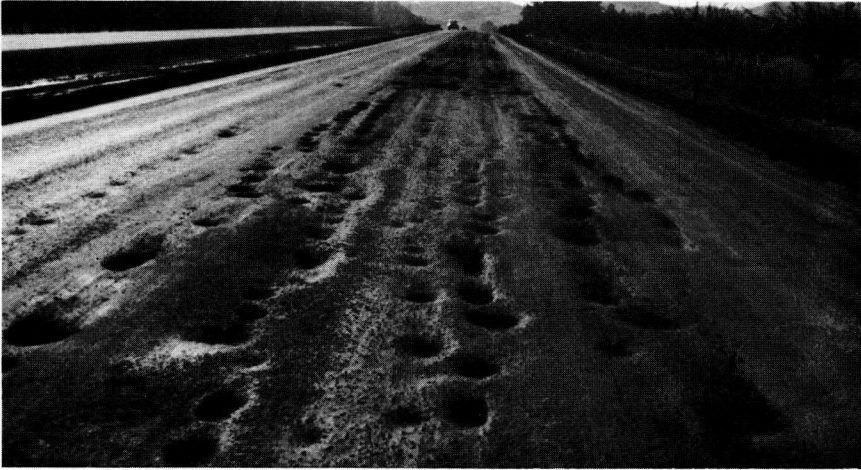
Figure 6. Extensive raveling of a dense graded mix using liquid asphalt placed as resurfacing over an existing pavement.

Cause: Insufficient quantity of asphalt in the mix.

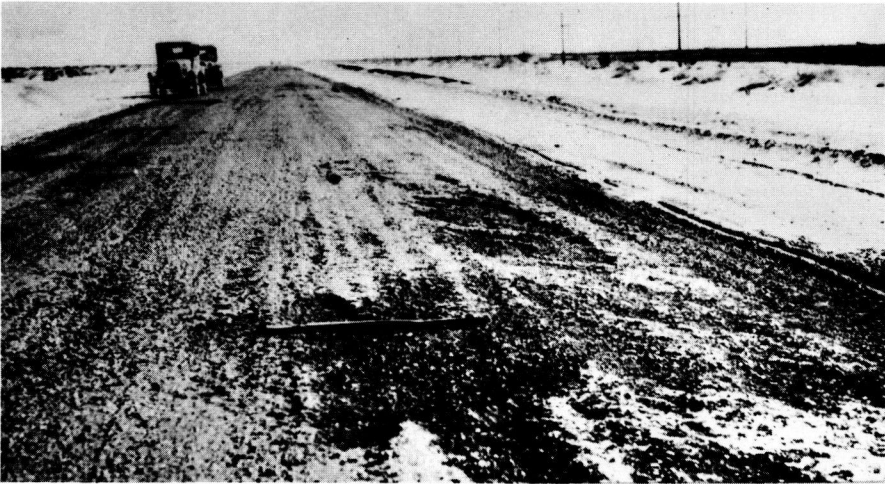
Figure 7. Unstable pavement. Deformation evidenced by distortion in traffic stripe. Surface scarred by attempts to blade off the bumps.
Cause: Too much asphalt in the mix.

3. The author cannot agree that shoving or rutting of mixtures laid on concrete bases, due to excessive asphalt or inherently weak aggregate mixtures is in any important sense different from distortion of asphalt mixtures on any other type of support. Observations in California have indicated that, other things being equal, unstable mixtures may have less tendency to distort on a rigid concrete base than if resting directly upon a resilient soil. The type of instability shown by Figure 7 or Figure 9 is not essentially different from that which may occur over a concrete base. Shoving or rutting means a mixture having insufficient stability; this is usually attributable to an excessive amount of asphalt, excess moisture content, or both.

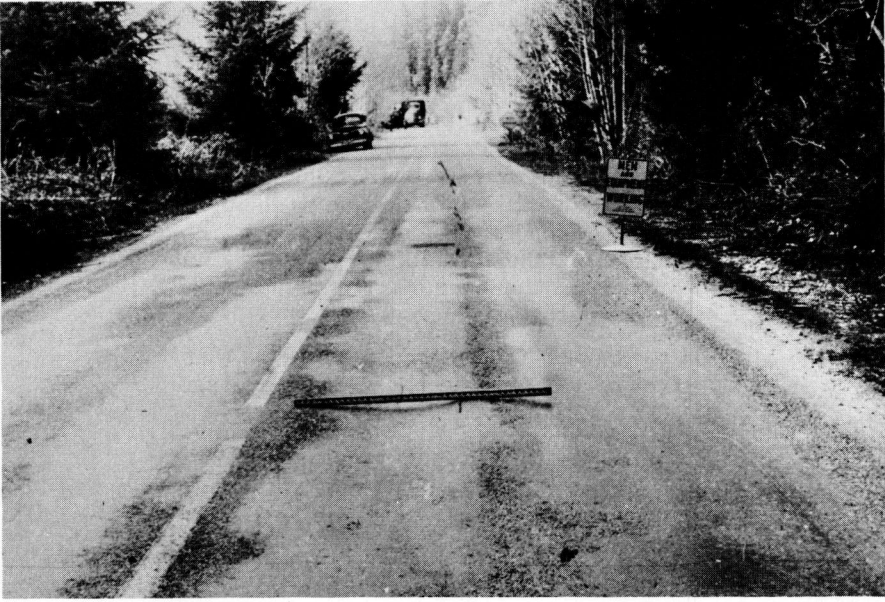
Figure 11. Shrinkage cracks in a sheet asphalt pavement characteristic of mixtures containing a relatively high content of low penetration asphalt and subject to little or no traffic.

Cause: Shrinkage due to the volume change characteristics of the asphalt. Shrinkage cracks are usually distinguished by the primary and secondary sequence of crack formation and by the shape of the polygons which tend to have sharp corners and angles—many of which approach 90 degrees.

Note: Asphalt has about four times the thermal coefficient of expansion of the average stone or sand particle. Such cracks are characteristic of rich mixtures subjected to insufficient traffic to close the cracks and to offset thixotropic hardening.

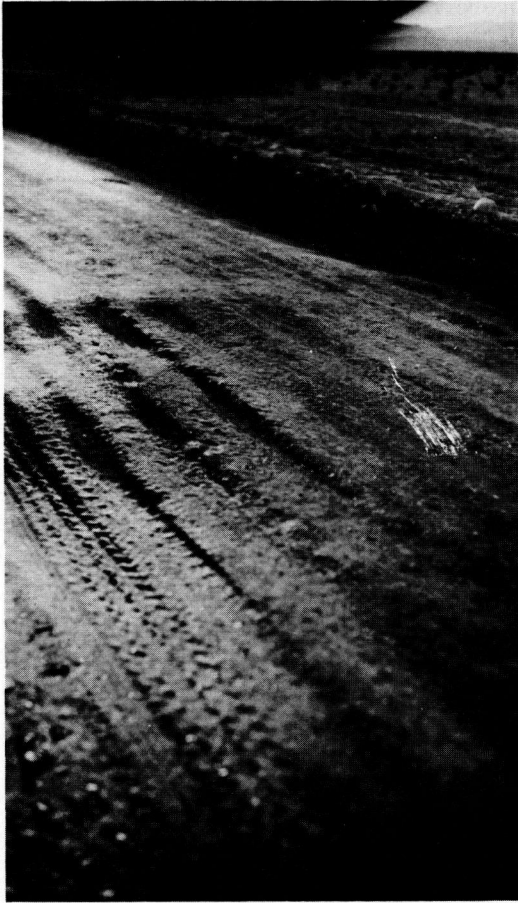
Figure 12. Another example of shrinkage cracks in a mixture containing coarser aggregates. Even though separated into small blocks, such road surfaces may remain quite smooth with little signs of distortion indicating that the cracking is not caused primarily by poor foundation, or heavy loads.

Cause: Shrinkage and drying out of the mix.

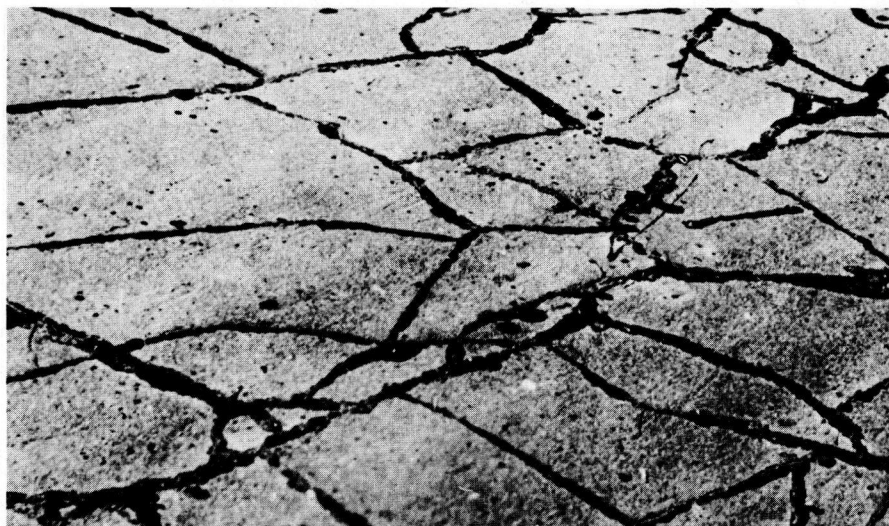
Figure 13. Crescent shaped cracks in a stable surfacing over a sound base.

Note: The larger cracks have been patched.

Cause: Slippage of the surface course on a smooth textured asphalt base or level course. Lack of bond between the two layers frequently caused by a layer of fine dust, moisture or both.

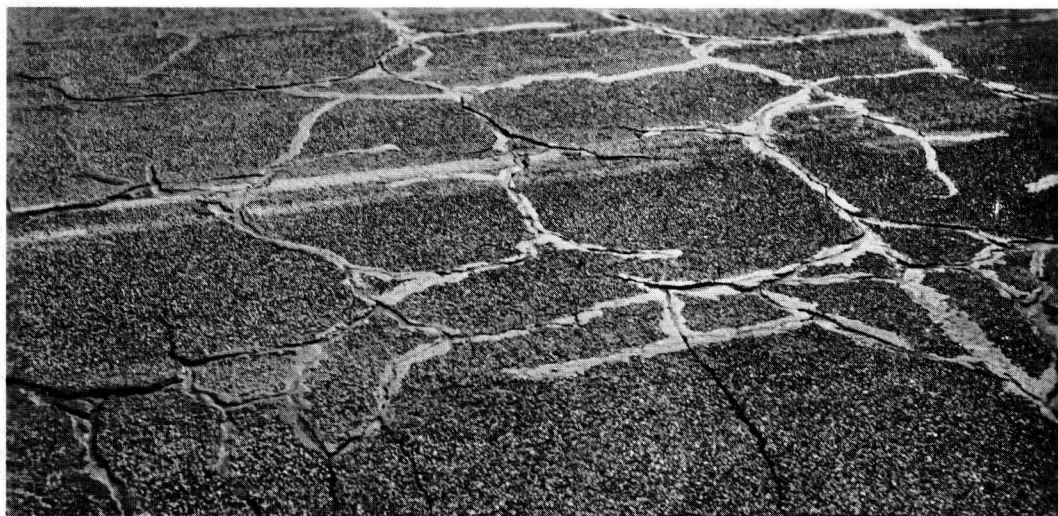
Figure 14. Another example of slippage. Movement of pavement is indicated by distortion in transverse paint stripes. Traffic moves to the left in the far lane and to the right in the lane just beyond the longitudinal stripe.

Cause: Vehicle wheels form a depression however slight in all pavements. Wheels tend to push a wave before the wheel in the direction of travel. Surface may slide if bond is too weak. Braking and deceleration of heavy loads may also cause slippage.

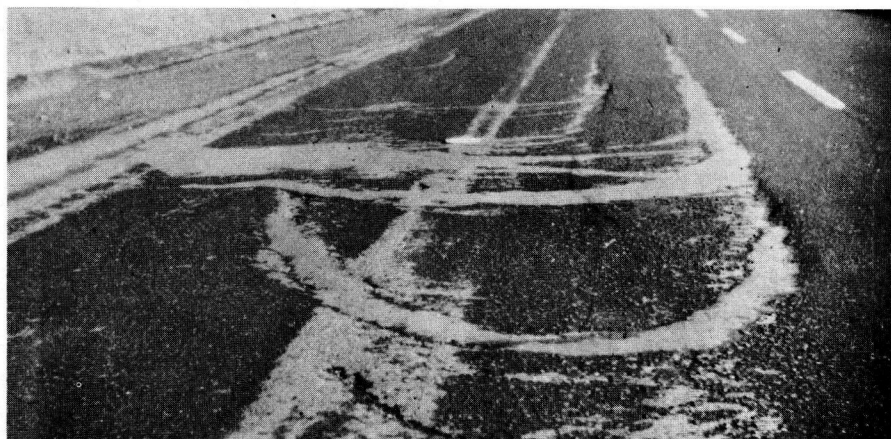
Figure 15. Another example of slippage failure illustrating the lateral movement that frequently occurs where shoulder support is weak or non-existent.

Cause: Primary cause same as for Figure 12.

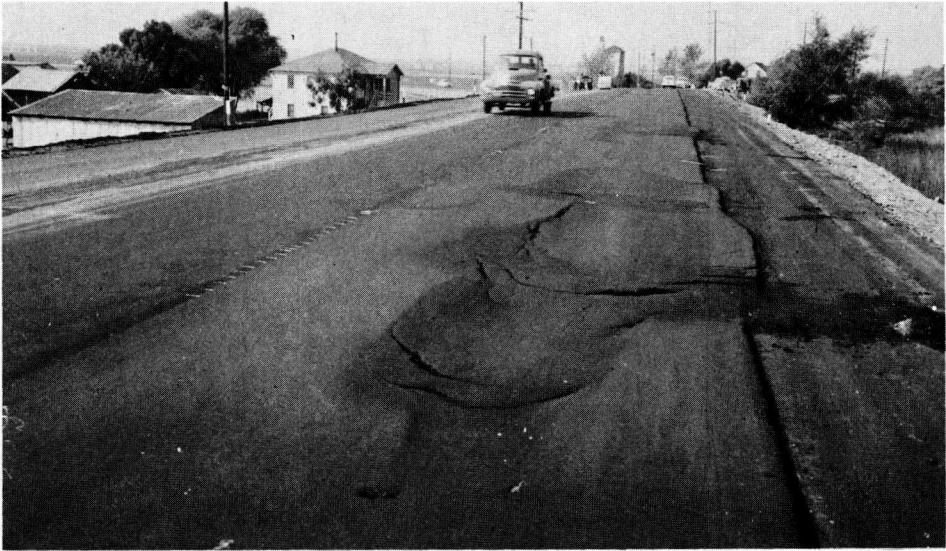
Figure 17. A close-up view of large cracks caused by slippage.

Note: It is useless to seek to prevent this type of failure by changes in the surface mix design or composition.

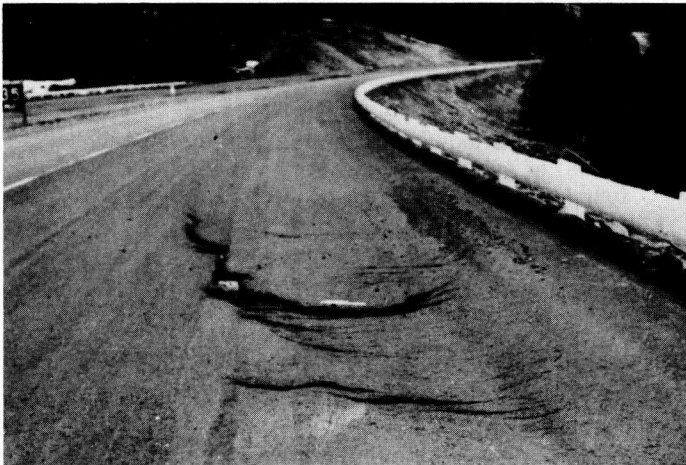
Figure 18. Depressions in the wheel path and upheavals along-side causing breaking and rupture of the asphalt surfacing.

Cause: An unstable base and poor foundation saturated with water.

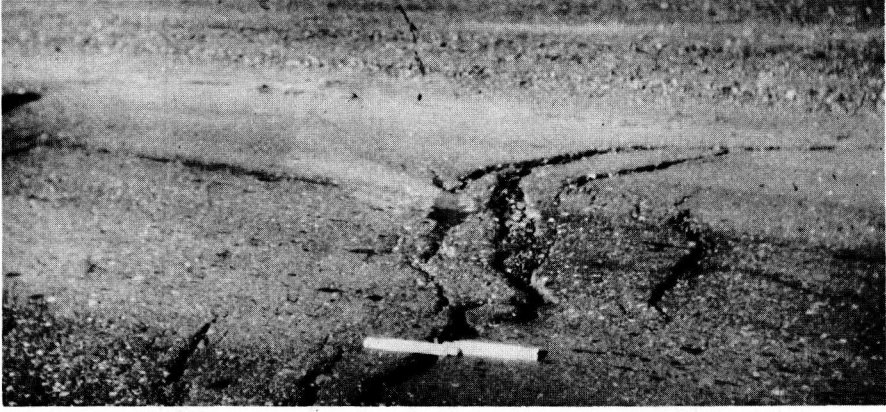
Figure 19. Failures in the outer wheel lane on WASHO test track showing depression and breakup of surfacing accompanied by up-thrusts of the uncemented granular material on the shoulder.

Cause: Inadequate thickness (for the wheel loads) of pavement and base over plastic foundation soil; or lack of lateral support in shoulder material.

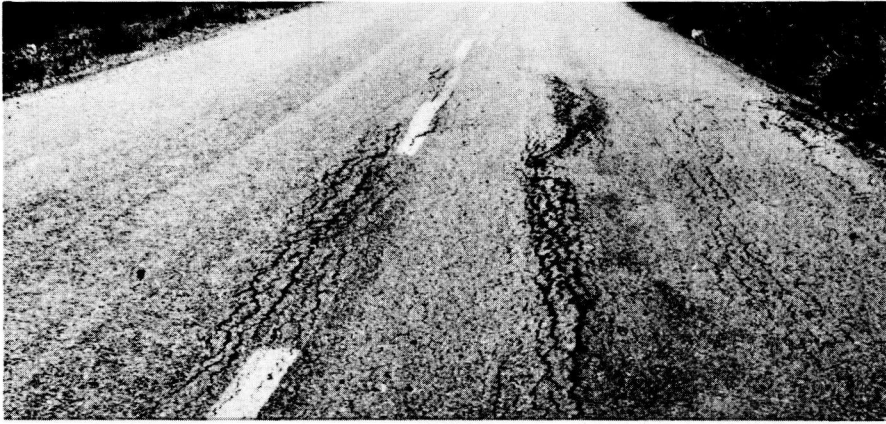
Figure 20. Failure in the wheel path on the Brighton test track.

Cause: Lateral and upward movement of the gravel base which was not sufficiently stable to resist the heavy truck loads on the thin bituminous surface.

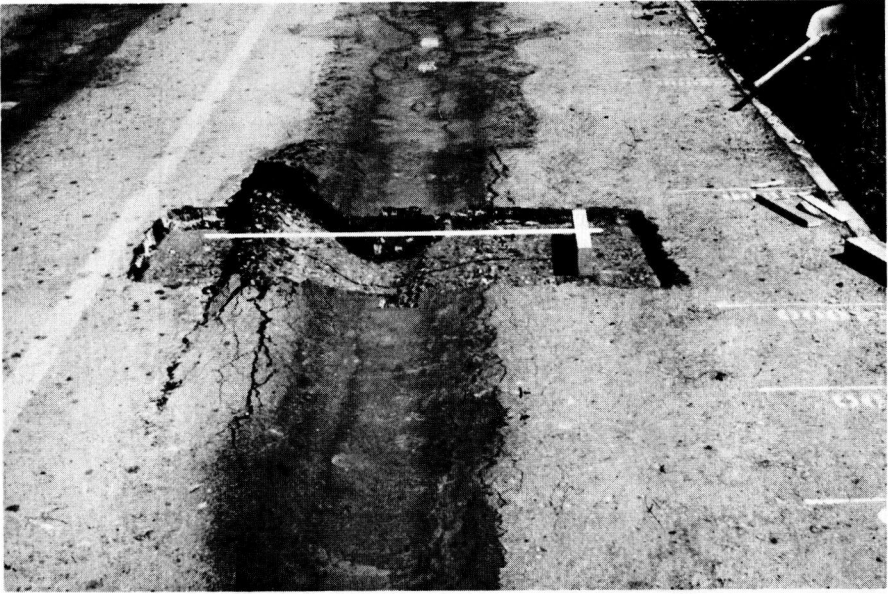
Figure 22. Typical "alligator" type crack pattern characteristic of failures in a stable asphalt pavement when subjected to heavy wheel loads over yielding foundations.

Note: Foundation may be unstable (plastic) or resilient (springy).

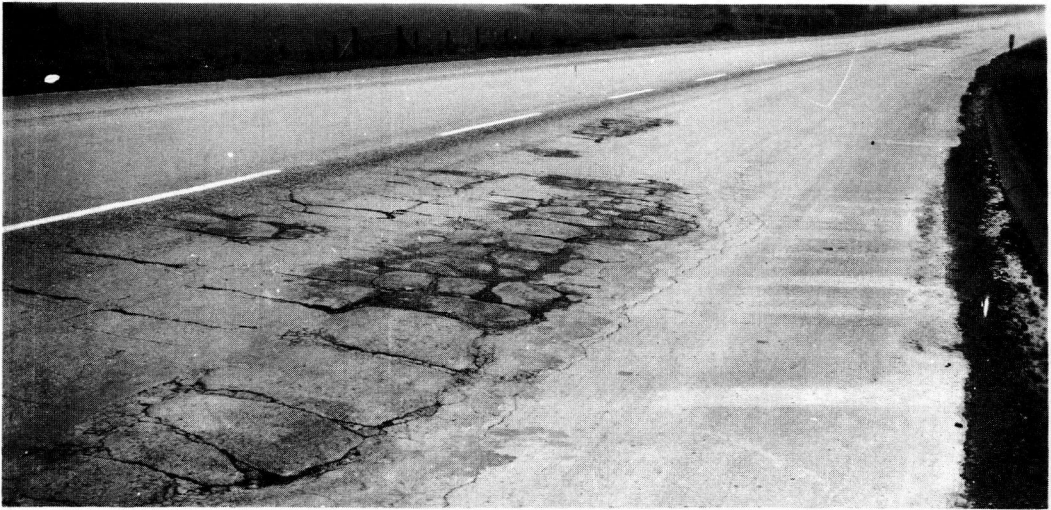
Figure 26. Same as Figure 25. Local failure in a bituminous surface at right of photo.

Note: Water flowing out through a core hole cut through the bituminous surface and cement treated base.

Cause: Water under pressure beneath the base due to impervious soil beneath base and a steep grade with superelevations.

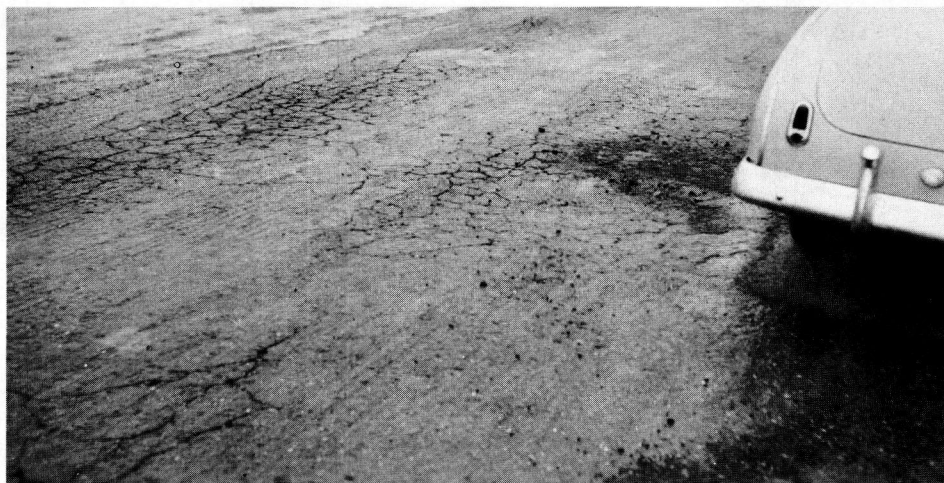
Figure 31. Typical crack pattern in a bituminous surface reflecting cracks in a cement treated base.

Cause: Shrinkage of cement treated base.

Note: Cracks in this area are more numerous in the passing lane than in the outer lane that is subjected to heavy traffic. Obviously, this cracking is not due to heavy loads or lack of support.

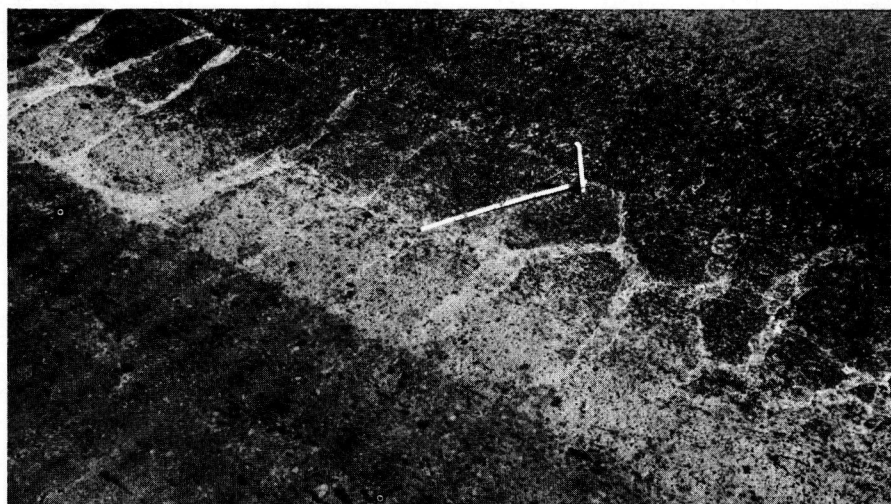
Figure 32. Longitudinal crack in asphalt pavement coinciding with longitudinal construction joint in cement treated base.

Cause: Weak vertical plane created by a juncture of two spreads of cement treated base material. Neither base nor surfacing had sufficient tensile strength to prevent separating along this line. Could be prevented by better construction techniques.

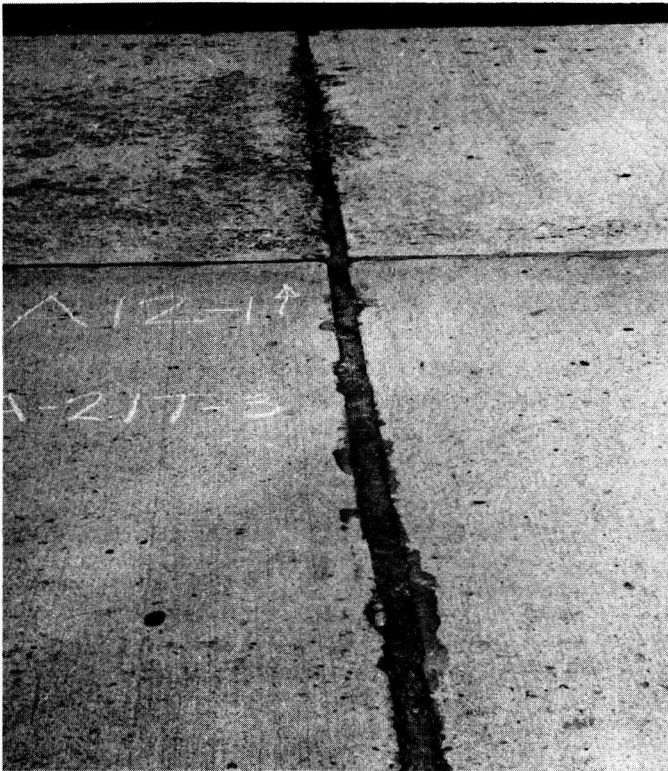
Figure 41. Contrasting performance of adjacent pavement slabs subjected to freezing conditions. Foreground shows slab in good condition; upper portion is slab showing surface scaling. Both subjected to chemically treated abrasives for traffic safety.

Cause: Action of salt and freezing temperatures.

Note: Concrete in lower slab is protected by an air-entraining agent, upper slab is not.

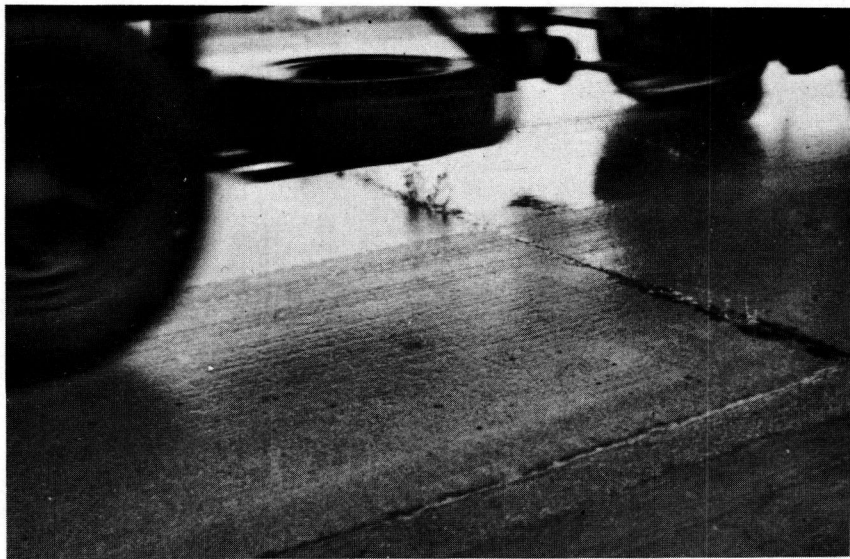
Figure 47. Characteristic transverse break that develops under heavy axle loads just beyond a transverse joint. These cracks are generally from 5 to 7 ft beyond the joint.

Cause: Long continued pumping action of a slab erodes and removes subgrade material leaving a deep void space beneath the slab. Pavement slab becomes an unsupported cantilever which finally breaks under load.

Note: The end of the slab approaching the joint is often supported or bolstered in its elevated position by the accumulation of coarser particles pumped from beneath the slab beyond the joint.

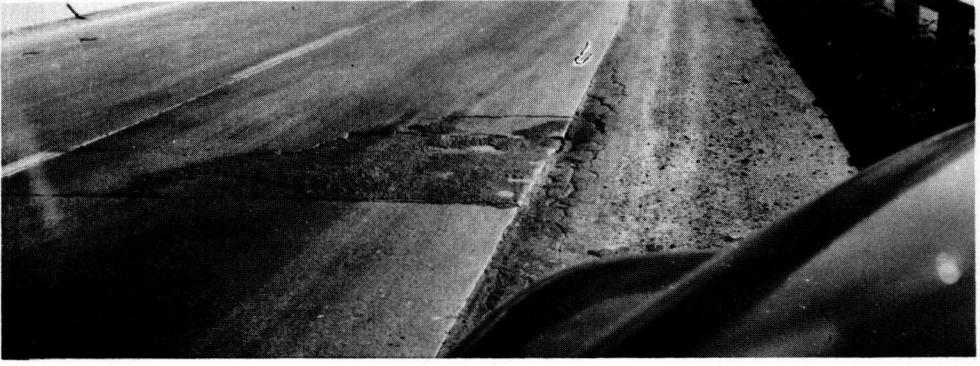
Figure 54. A "blow-up" in a concrete pavement. Photograph taken a few minutes after pavement broke. Loose material is still lying on the surface.

Cause: Expansion of the concrete exceeding the available joint space.

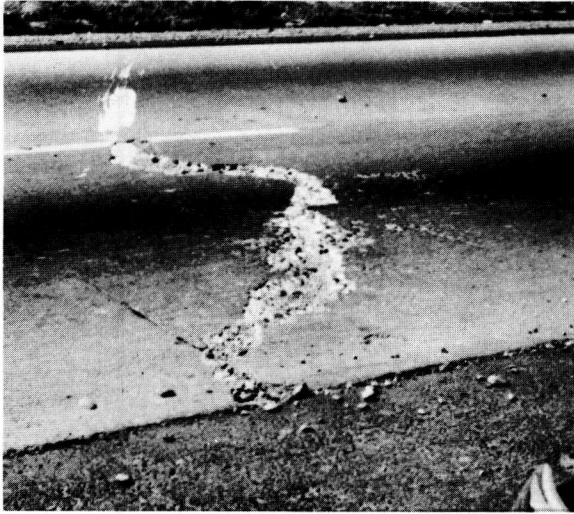
Figure 57. Longitudinal and transverse cracks in a modern 8-in. concrete slab constructed in 1955.

Cause: Abnormal expansion of imported borrow material secured from waste piles at a magnesium plant.

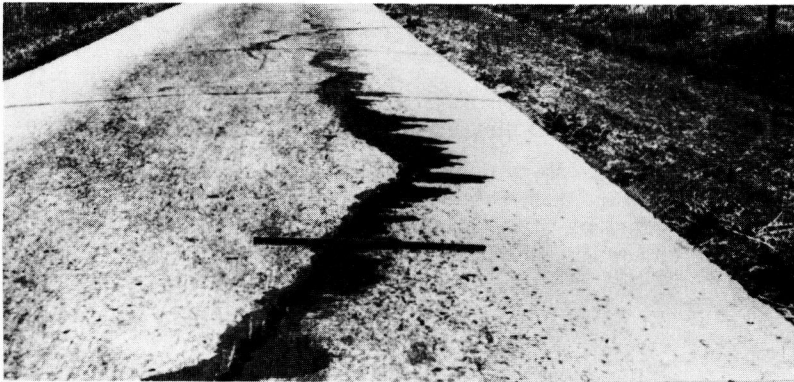
Figure 58. A more recent view of the cracked pavement shown in Figure 57.

Cause: Same as Figure 57. Note two approximately parallel cracks and greater width of opening.

Note: Material was secured from waste piles of a magnesium plant. Expansion developed slowly and was not detected in preliminary tests. See Figures 57 and 58 for effect on concrete pavement.

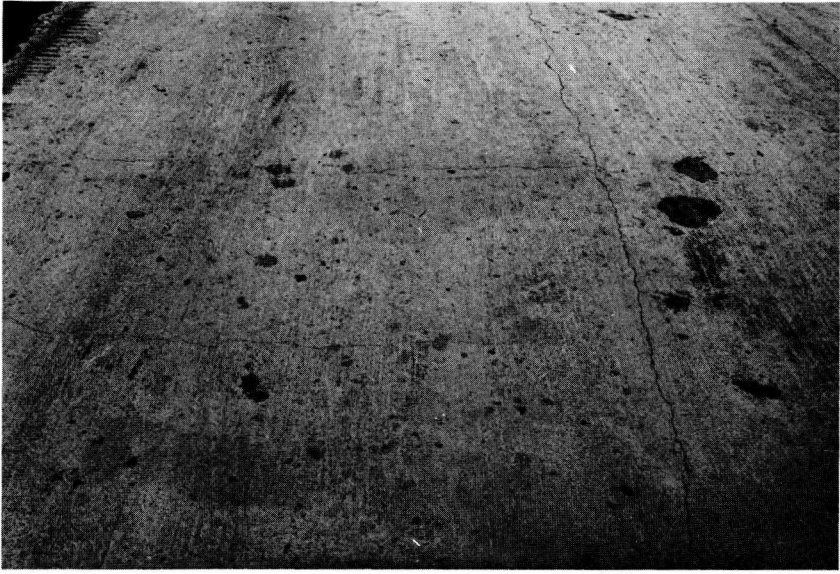
Figure 60. Distress and serious breakup of an airfield pavement used as a test track.

Cause: Heavy wheel loads and poor subgrade support.

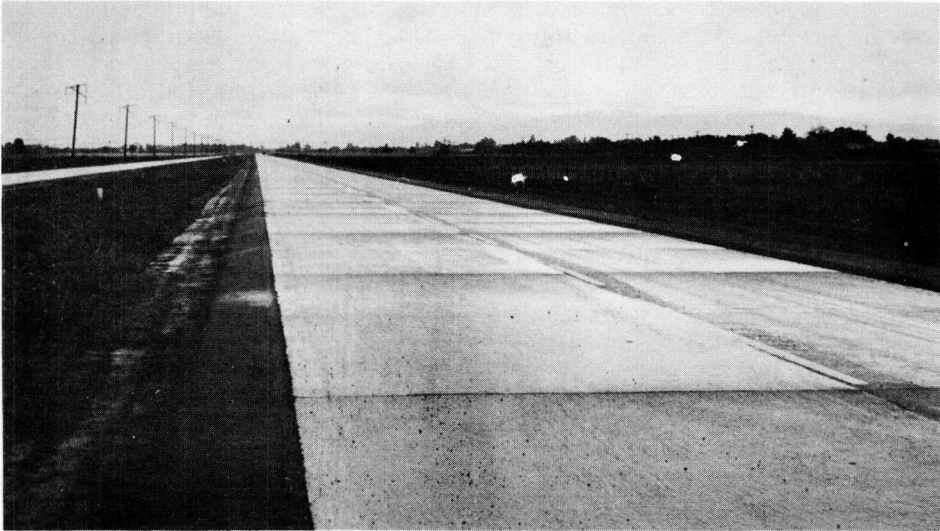
Figure 62. Profilogram to illustrate magnitude of curling and uplift at the joints of pavement shown in Figure 61.

Note: For much of the section the initial uplift occurred at 45-ft intervals or at every third joint. Later, intermediate joints were elevated. Roughness was markedly alleviated by boring a number of holes in the central zone of each slab as stated above.

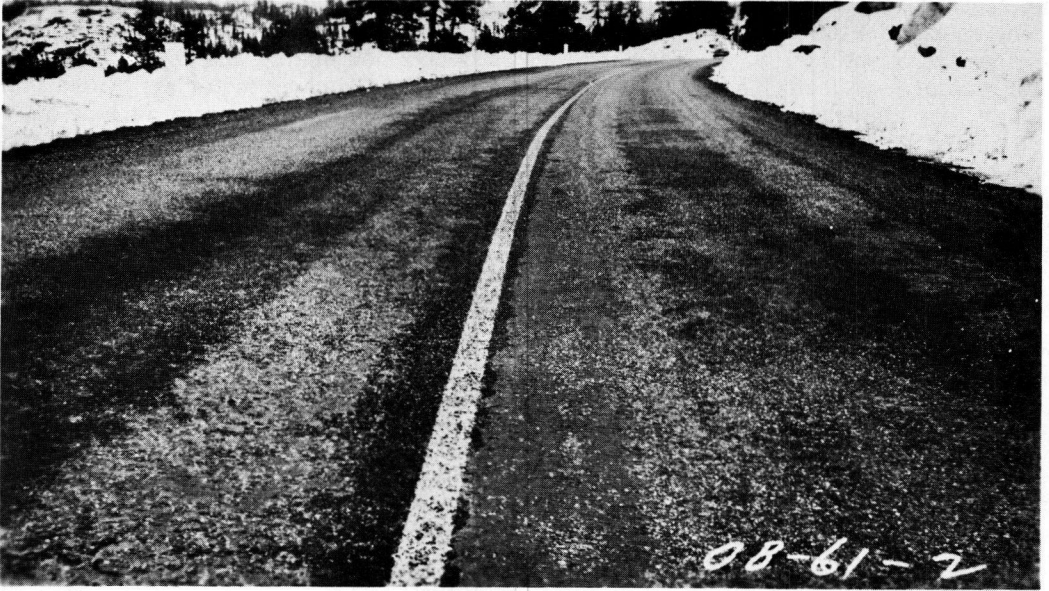
Figure 63.

2. Failures or distress caused by rapid wear resembling raveling but due to the action of snow chains on coarse asphaltic mixtures have been noted. Wear from this source has not been a frequent cause of trouble in California, although examples have been known. This type of problem was simply overlooked in the paper. Figure 63 shows surface loss attributed to action of tire chains.

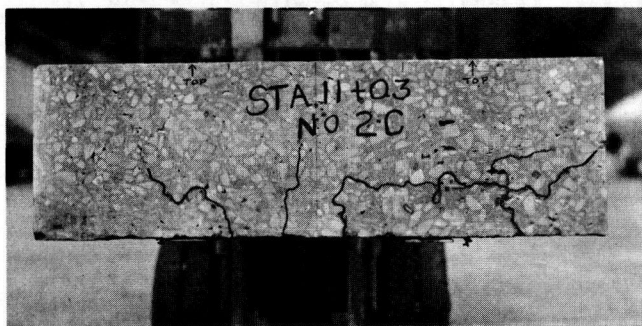
(a) Cracking in base of 14-in. pavement slab after 30,000 coverages of 100 kip twin wheel load traffic.

In the case of long-time over-loading the degree of over-loading is a problem because of the manner in which failure occurs. The failure is a function of the fatigue strength of the concrete as it fails in flexure at the base of the pavement slab. Minute cracks form which may extend up into the pavement about an inch, leaving the surface of the slab intact. Figures 1(a) and 1(b) show such cracking found in a beam cut from a 14-inch thick plain concrete pavement slab near a joint. This pavement had been subjected to 30,000 cycles of stress repetition by a 100 kip twin-wheel traffic loading. Figure 1(b) shows a close-up view of an unmarked crack extending upward 6 inches from the base of
