**Bulletin 188**

***Applications of  
Skid-Resistant Surfaces  
To Highways***

# Test Installations of Silica Sand Resurfacing

# Development of Techniques for Applying Resinous Skid-Resistant Surfaces to Highways

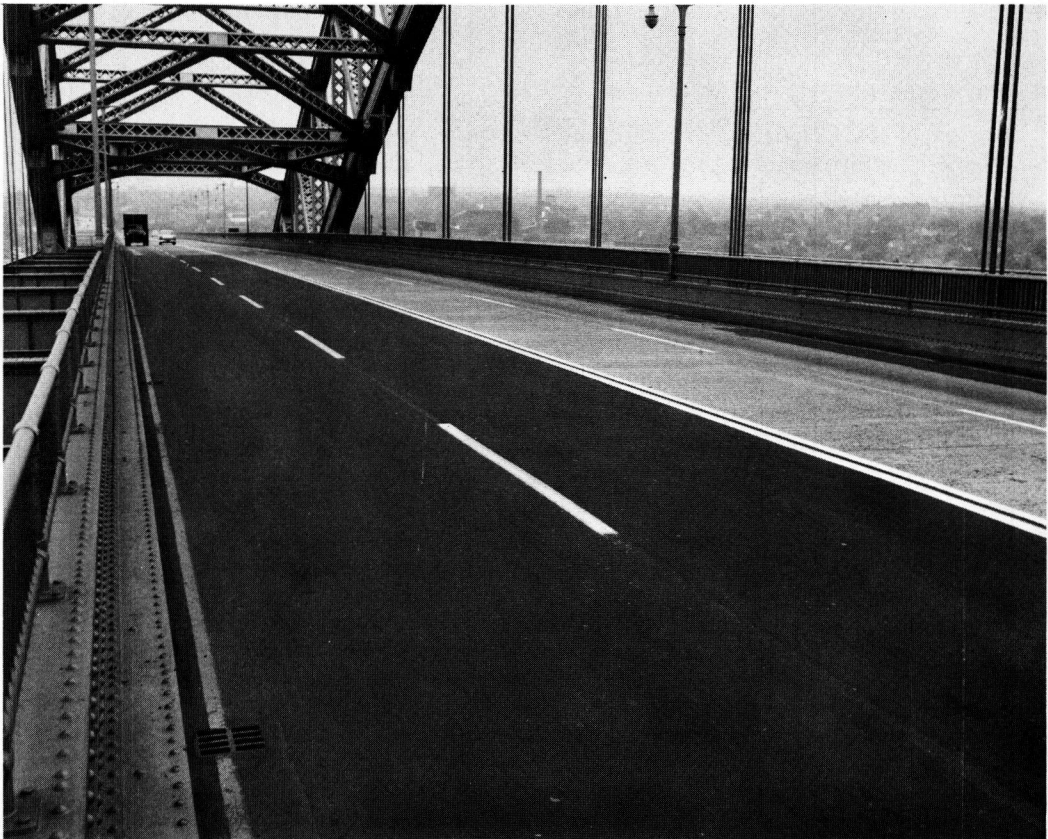
Figure 3. Bayonne Bridge, test section of silica sand asphalt after 10 months of service 7,000 cars per day.

The Port Authority put their test section over one-half the width of a 500 ft long section of the concrete pavement on the Bayonne Bridge. It was put down by a contractor, using his normal asphalt crew and equipment. It was feather-edged at the centerline, at the transverse expansion joints and at the curb scuppers. Resurfacing procedures were the same as on Route 440, except that the thickness was held constant at  $\frac{1}{2}$  in. and the concrete pavement was blown with compressed air prior to applying the tack coat in order to remove any dust which might tend to prevent good adhesion. As of last month, this test section was still in excellent condition.

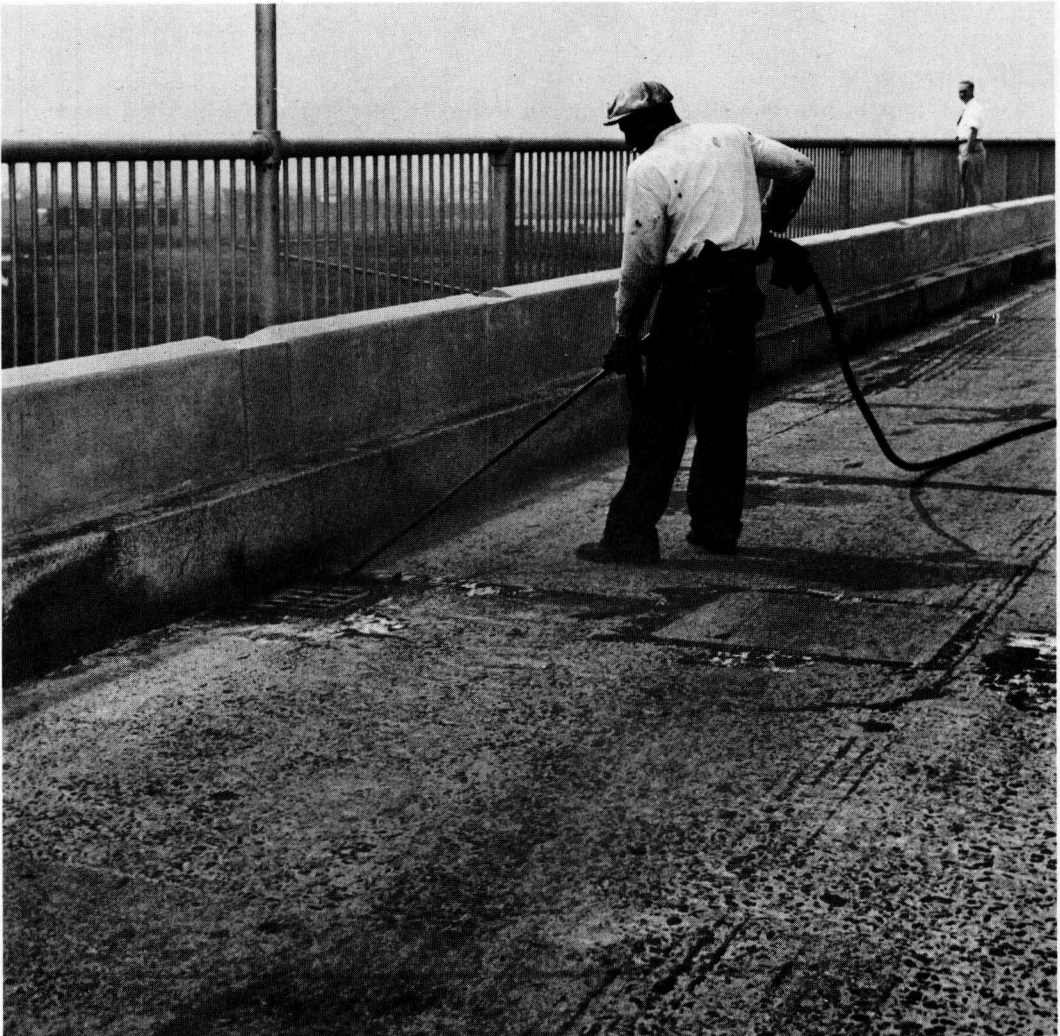
Figure 5. Goethals Bridge, cleaning concrete pavement with compressed air prior to applying tack coat.

sand-asphalt should not be laid until the tack coat has had at least 30 minutes to "set" or "break". Also, care must be taken when laying. A 1/2-in. thick course compresses very little under the roller. It cools quickly and must be rolled as soon as the roller can get on it. A word of warning at the start of the work, a cold roller wheel may pick the material up. It must be put down by machine. Hand work should be kept to a minimum. You cannot get a satisfactory job by hand placing. Materials broadcast over a machine laid area will not "knit" as normal asphalt pavement does. Cleaning the existing surface with compressed air prior to tack coating appears to be advantageous.

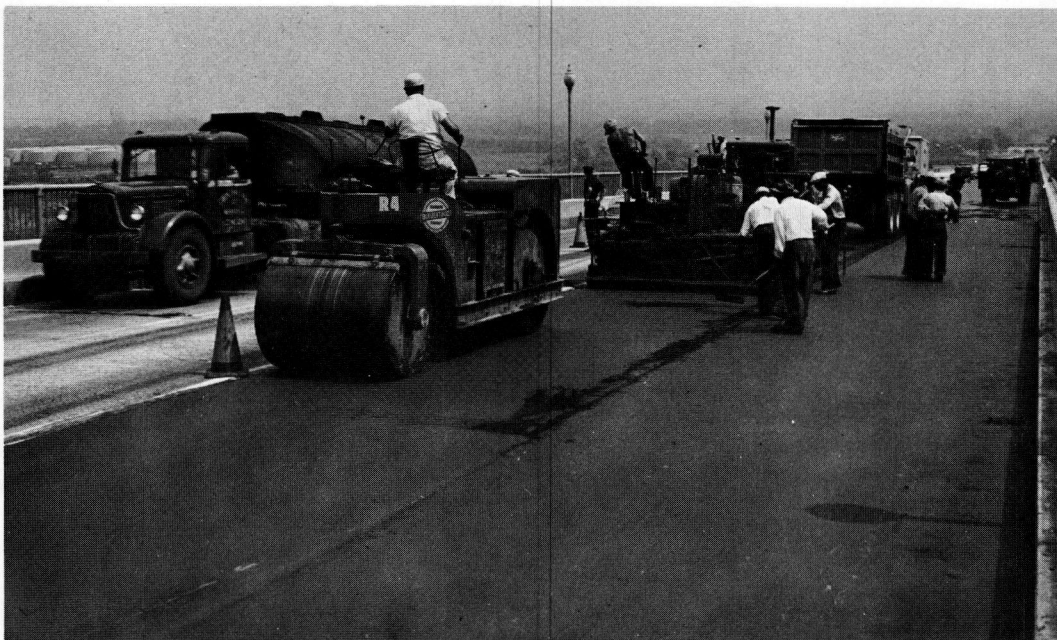
Figure 6. Goethals Bridge, laying silica sand asphalt  $\frac{1}{2}$  in. thick using standard asphalt equipment.

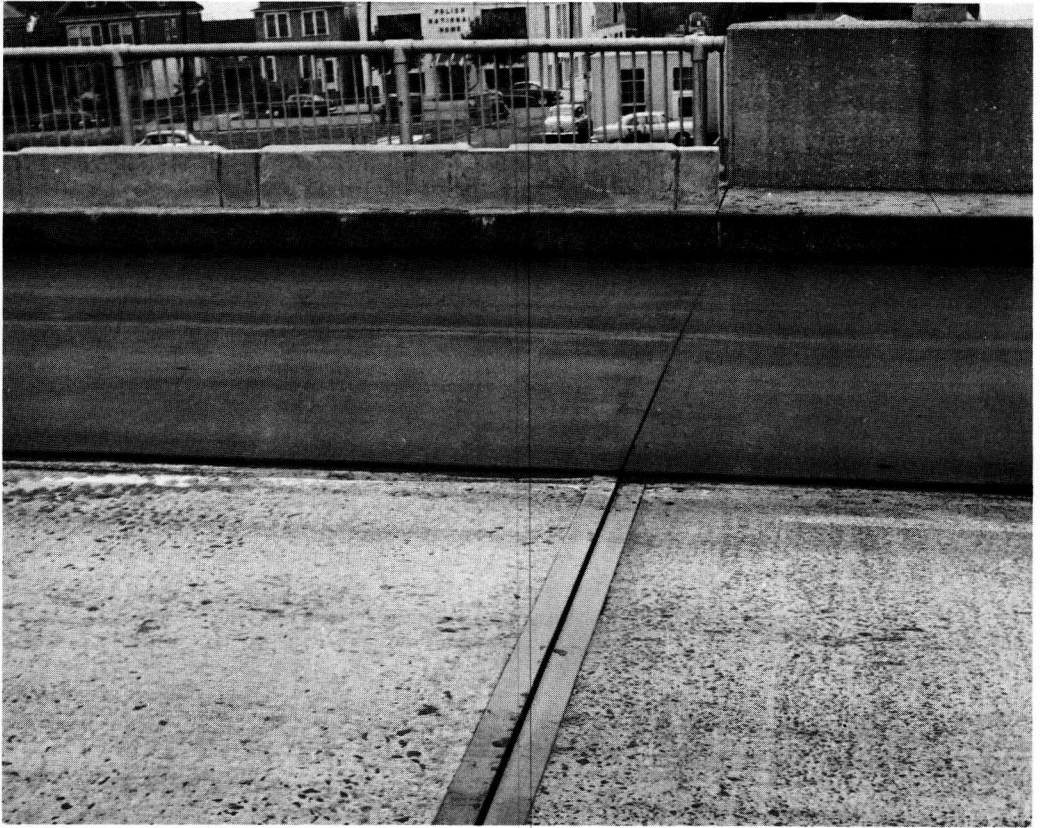
Figure 8. Goethals Bridge, 1/2 in. silica sand asphalt resurfacing at abutment joint.

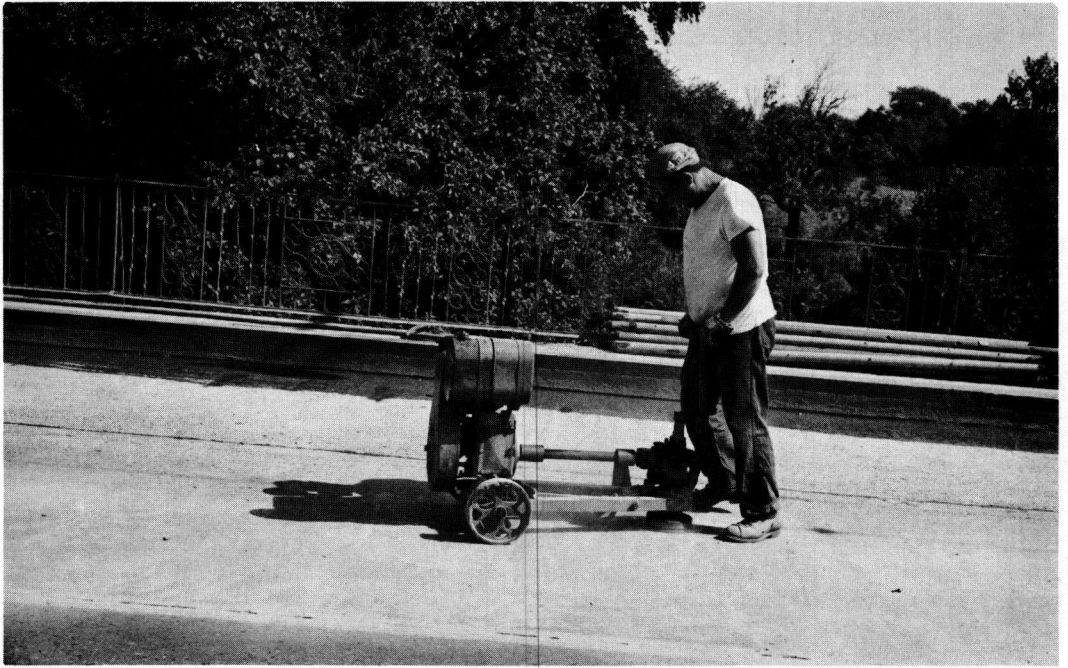
Figure 1. Removal of heavy tar and grease spots.

1. Heavy tar and grease spots were removed with a Tennant machine, Figure 1.
2. The entire surface was etched with hydrochloric acid to insure a lasting bond between the resinous binder and the concrete.

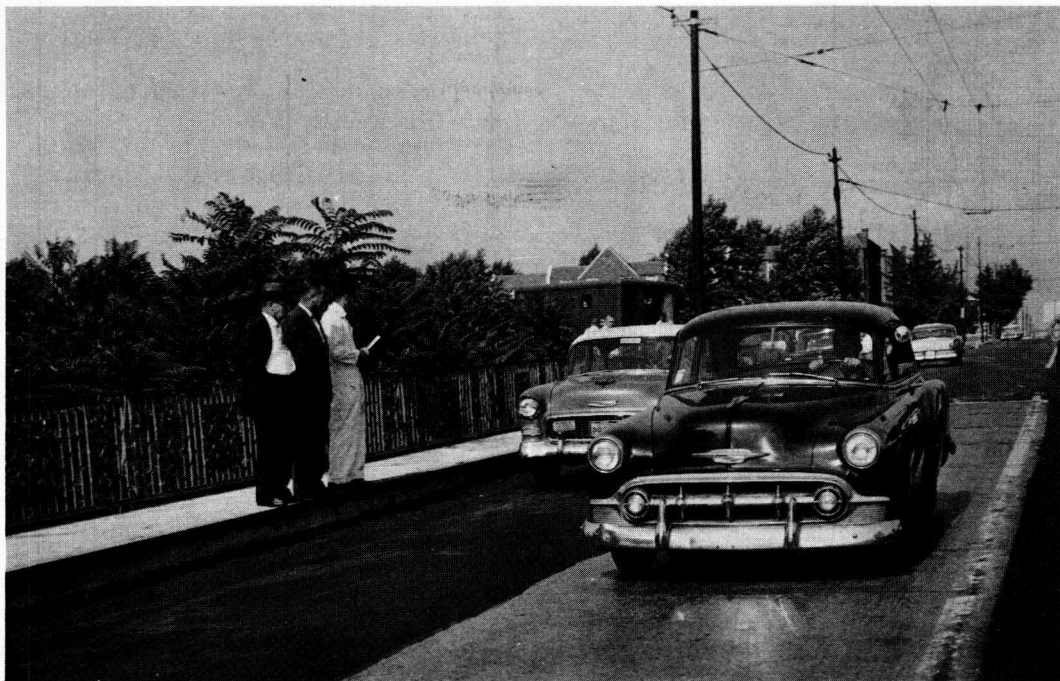
Figure 7. Skid test.
