# Concrete Pavement Subbase Study in Ohio

L. D. CHILDS, Development Engineer, Portland Cement Association, and  
F. E. BEHN, Assistant Research Engineer, Ohio Department of Highways

A 4-mi length of concrete surfaced arterial highway built in 1952 was designed as a test road with subbase treatment and slab length as variables. Subbases included dense-graded and open-textured crushed stone 3, 5, and 8 in. thick; cement-treated clay soil 6 in. thick, and clay soil-cement 3 and 5 in. thick. Slab lengths were 20 ft and 100 ft. Observations on performance of the road were made several times each year for five years. The periodic condition surveys were supplemented by moving load tests to observe differences in deflections and strains in the concrete slabs as related to the controlled variables.

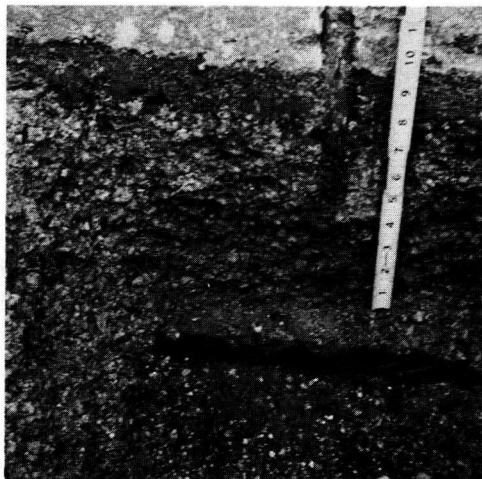
8-in. open-textured stone at 1127 + 00

Figure 2. Typical subbases.

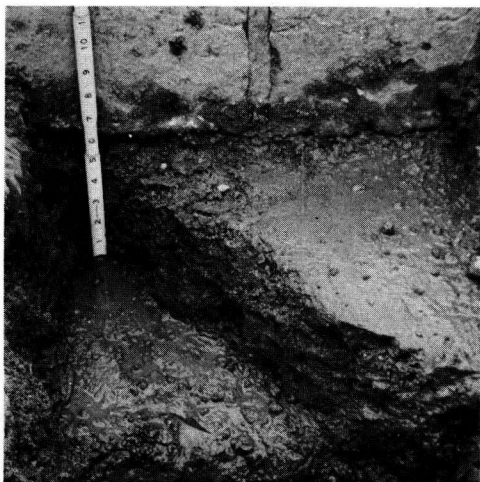
11 percent cement-modified soil at  
1159 + 20

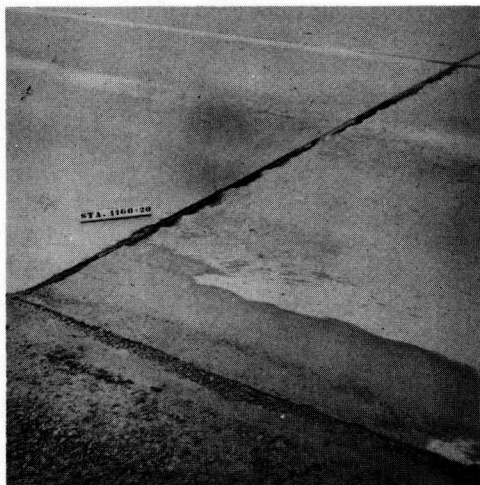
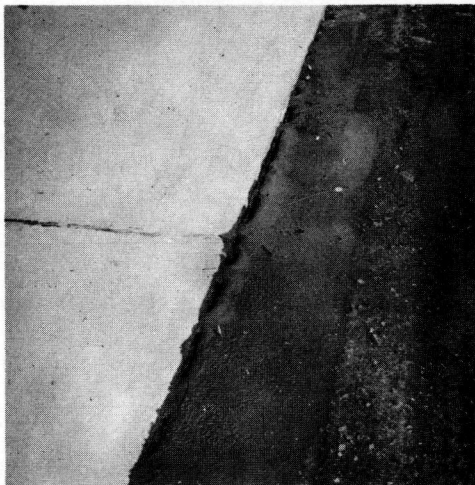
Examples of pumping at joint and edge.

Figure 3. Evidence of action at slab edge.

Visual examinations of the slab joints and edges were made in the early spring of each year and supplemented by fall and winter surveys in 1955 and 1956. It was apparent immediately that concrete gutters and aprons inhibited the edge and joint action. Although records were maintained on these areas, the analysis attempted here is based on uncurbed lengths of pavement where edge and joint action were readily observable. Summaries of the number of pumping joints, occurrences of edge pumping, occurrences of edge blows, and lineal feet of continuous blowing—all based on 100 ft of uncurbed slab length are given in the Appendix. Some of the conditions previously described are shown in Figure 3.

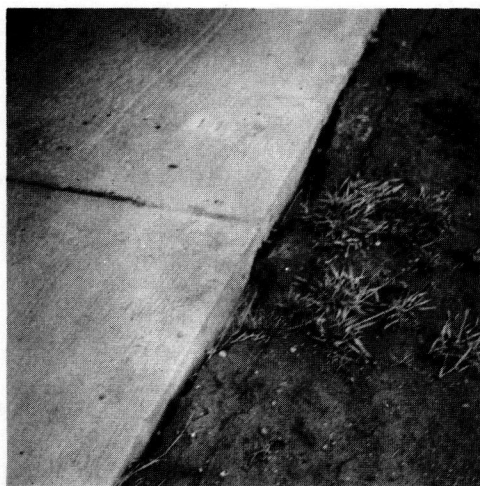
Blowing along edge--at joint and near mid-slab.

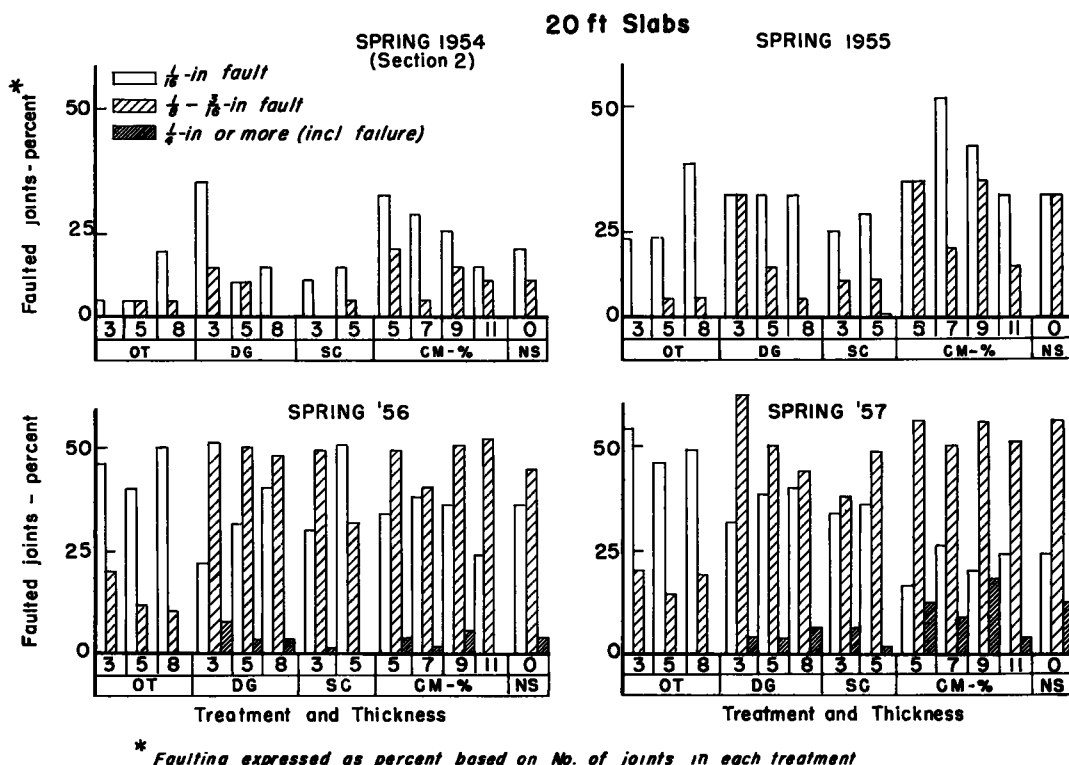
Figure 10. Joint faulting.

Figures 10 and 11 are too complicated to permit satisfactory analysis by inspection, but a few general remarks may be in order. Slabs on open-textured subbases developed less Class 2 faults than on other subbases in the 20-ft slab sections and there were no Class 3 faults. In sections with 100-ft slabs the faulting in areas with open-textured subbases was more severe than in similar areas with 20-ft slabs, but open-textured subbases were still among the treatments with least faulting. Soil-cement appeared to be slightly better in fault resistance than dense-graded material.

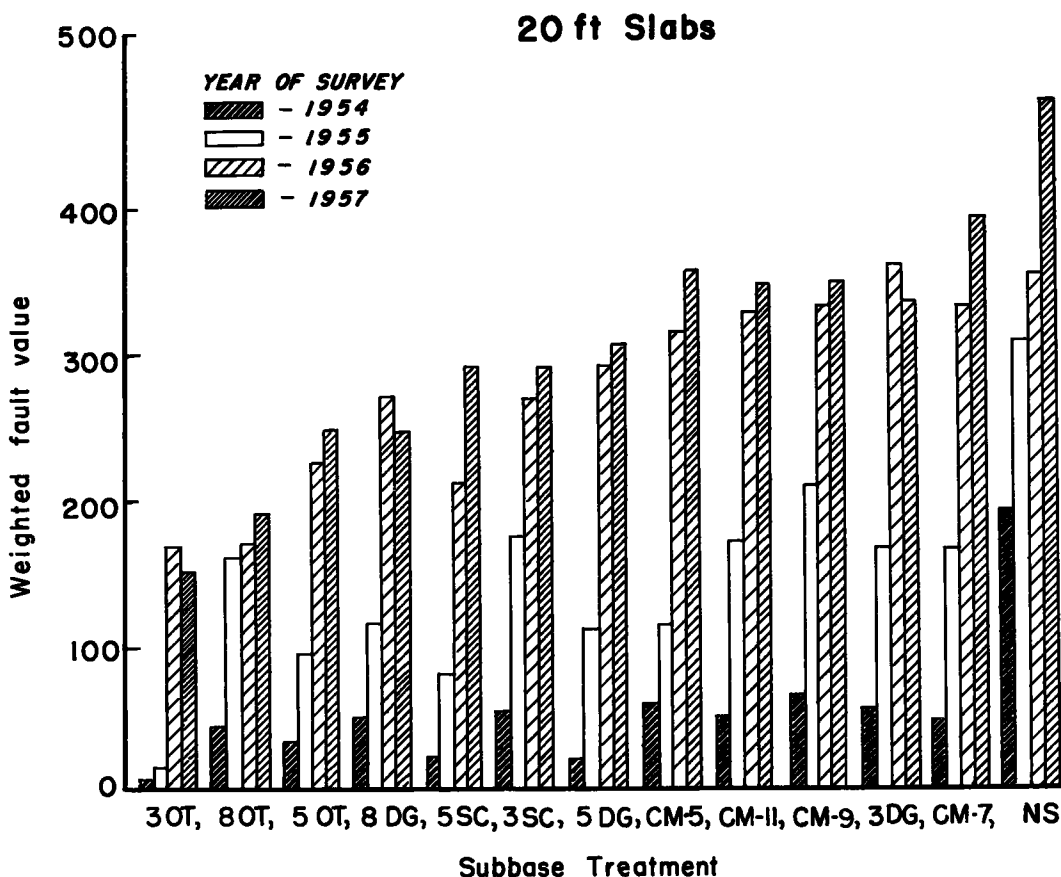
Figure 12. Effect of subbase on faulting.

On the basis of weighted fault value, it is possible to rank the subbases in order of their resistance to faulting. Figure 12 is drawn with emphasis on the weighted fault values for the last two years. Comparisons are made with the reservation that the faulting on the project is not representative of standard pavement construction.
