Laboratory Tests of Sealers for Sawed Joints

WILLIAM H. KUENNING, Senior Development Engineer
Products and Applications Development Section,
Portland Cement Association, Chicago, Illinois

The performance of sealing materials for sawed joints is being studied by a laboratory test in which the joints are opened and closed at speeds of the order of $\frac{1}{32}$ in. per hr. The sealers are applied to sawed joints which are initially $\frac{1}{8}$ or $\frac{3}{16}$ in. wide and which are usually opened an additional $\frac{1}{8}$ in. at 0 F during the tests. This test procedure appears to be more severe than method 223.11 of Federal Specification SS-R-406C. Tests have been conducted on conventional sealers as well as on materials which are still in the development stage or which have been developed for other applications.

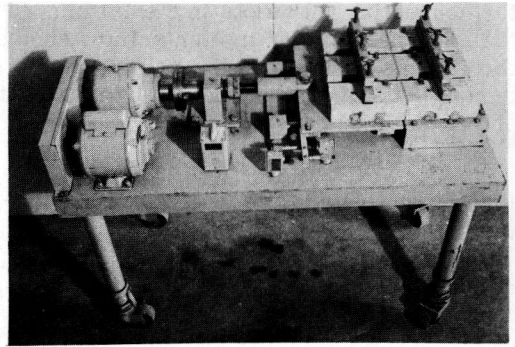
Figure 1. Machine for testing joint sealers.

Figure 1 shows a testing machine built in the PCA laboratory for testing sealers for sawed joints. By means of a 28,736-to-1 speed reducer, a 32-thread-per-inch screw, and an appropriate pulley combination, the speed of a 1750-rpm motor is translated into a speed of approximately $\frac{1}{32}$ -in.-per-hr travel in the movable bed. One end of each of three $2\frac{1}{2}$ - by 4- by 16-in. concrete blocks is clamped to a fixed bed, and other end being clamped to the movable bed. The blocks contain sawed joints, which were in most cases $\frac{1}{8}$ in. wide and 2 in. deep. Micrometer heads mounted in the arm on the side of the carriage, which come to bear against the two limit switches in the foreground, control the ultimate distance of travel in either direction. The machine, mounted on casters for ease of transfer, may be operated either in laboratory air at 73 F or in a walk-in freezer at 0 F. The speed of $\frac{1}{32}$ in. per hour was chosen because it represents a travel rate per hour of 25 percent of the initial joint width, which is comparable to that used in the standard ASTM and Federal specification bond tests for joint sealers. The speed can, however, be modified by changing the pulley combinations.

top connecting with slots in the bottom. The slots were fitted over cross-bars of the testing machine, and molten sulfur, such as used for capping cylinders, was poured through the openings in the top to obtain a snug fit to the cross-bars. The blocks were then held down against the bed by means of the leather-faced steel bars in the assembly shown in Figure 1.

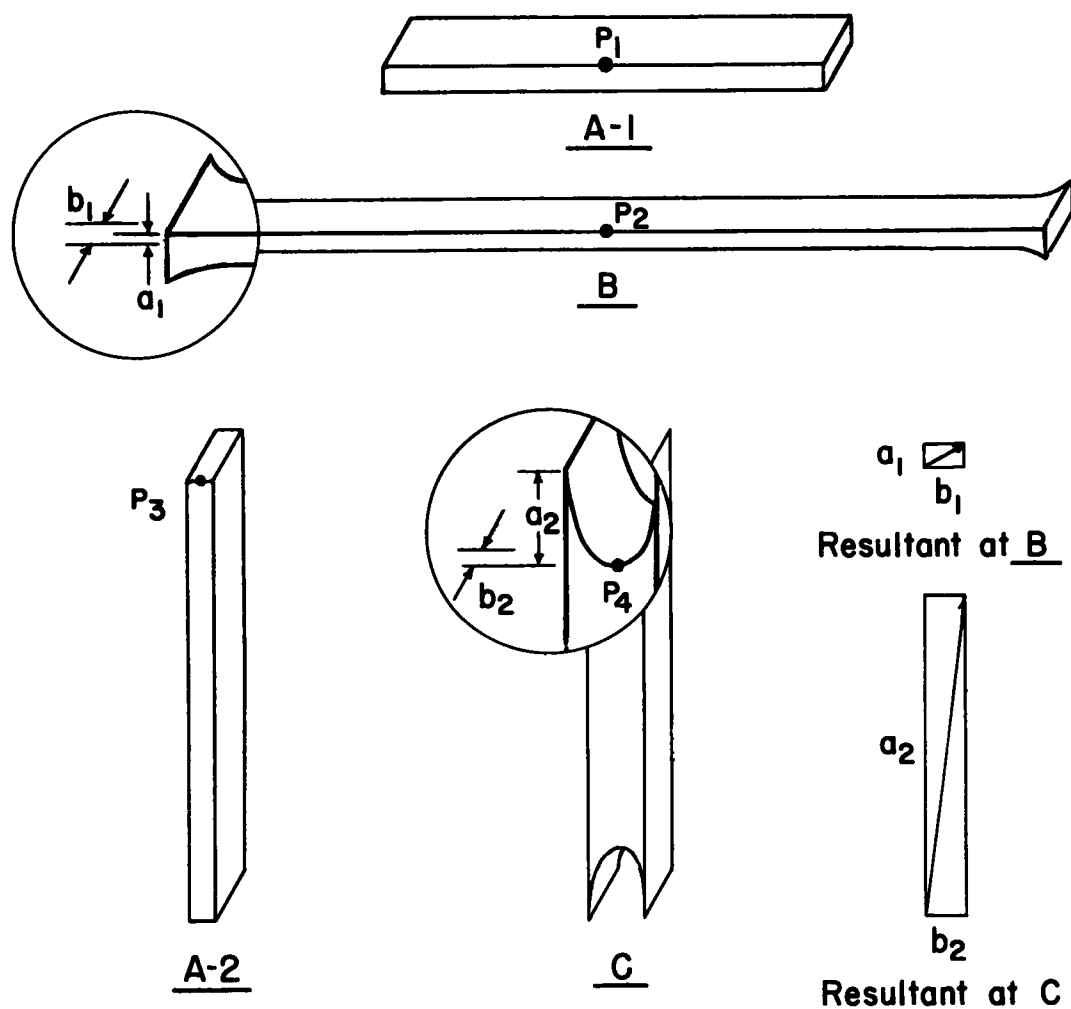
Figure 3. Shape factor: effect of shape on tensile strain of elastic materials.

Figure 3 represents one concept of the effect of the shape factor on the tensile strain of elastic materials. If a rubber shape such as A-1 is to be stretched 100 percent longitudinally, the point P_1 will then appear at the position P_2 in B. To get to this point

it has moved through the resultant of the vertical distance a_1 and the horizontal distance b_1 . If these two distances were magnified six times and the resultant plotted, it would be as shown in the small rectangle. However, if this same piece of material is tipped up on end, as at A-2, and a new point, P_3 , is chosen on a top edge, stretching this material in a direction parallel to the shortest dimension of the piece moves P_3 to the point P_4 . It has traveled through the resultant of the vertical distance a_2 and the horizontal distance b_2 . If these distances also are magnified six times and plotted, the new resultant shown in the lower rectangle is obtained. This resultant is tremendously large compared to the resultant in B. In both cases the material has been stretched 100 percent, but in the second case the stress concentrations at P_4 and at any point on the surface are very great.

From this illustration, it is obvious that in pavement joints the materials are being stretched in the least favorable direction. Extensibility of elastomers and other materials, determined by stressing them longitudinally, may be referred to as "elongation." To avoid confusion with this type of measurement, the term "deformation" has been used herein when referring to the stretching of sealers in concrete joints.

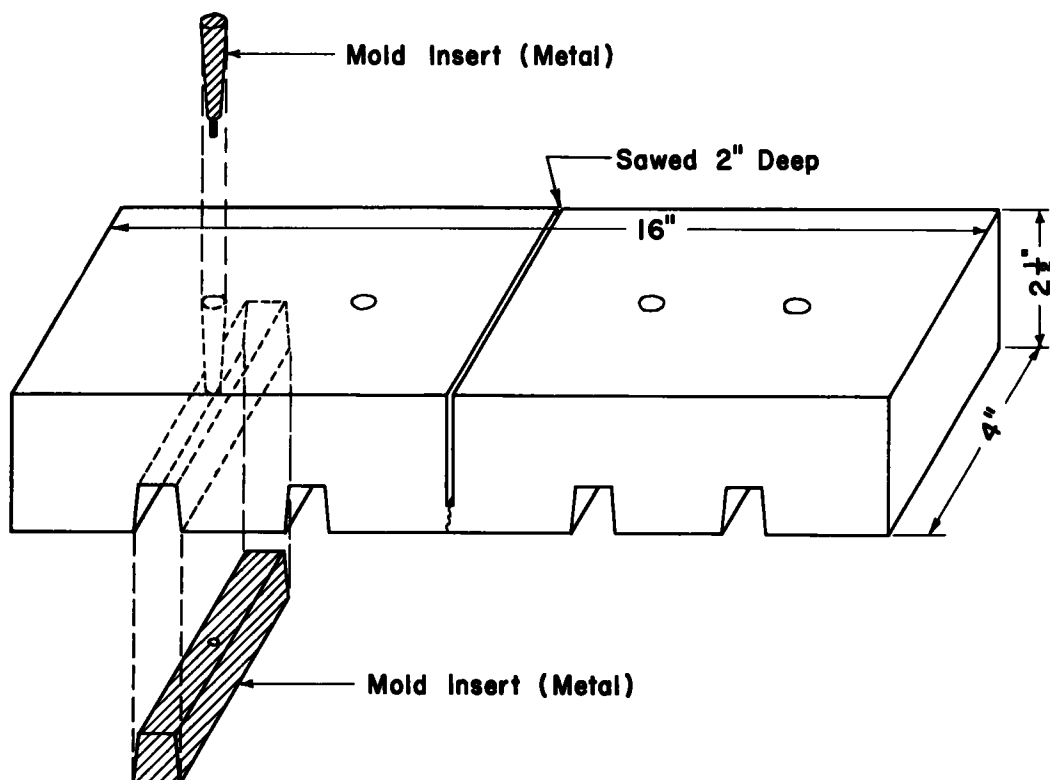
Figure 4. Concrete block with mold inserts.

Concrete blocks, $2\frac{1}{2}$ - by 4- by 16-in. (Fig. 4) were made of a 6-sack mix using an aggregate of $\frac{3}{4}$ -in. maximum size. The concrete, with a slump of 2 to 4 in. and an air content of 3.5 to 7 percent, was placed in the molds with vibration. The blocks were cured 7 days in the moist room, then stored at 73 F and 50 percent relative humidity. Flexural strengths of 29 batches of concrete at 7 and 28 days were in the ranges 480 to 610 psi and 520 to 880 psi, respectively, and compressive strengths were in the ranges 3,250 to 4,460 psi and 5,000 to 6,520 psi, respectively.

The concrete blocks were lightly reinforced with $\frac{1}{4}$ -in. steel wires in each end but not crossing the joint. The blocks were made in wood molds containing metal inserts of the shape shown in Figure 4. The finished blocks contained tapered openings in the

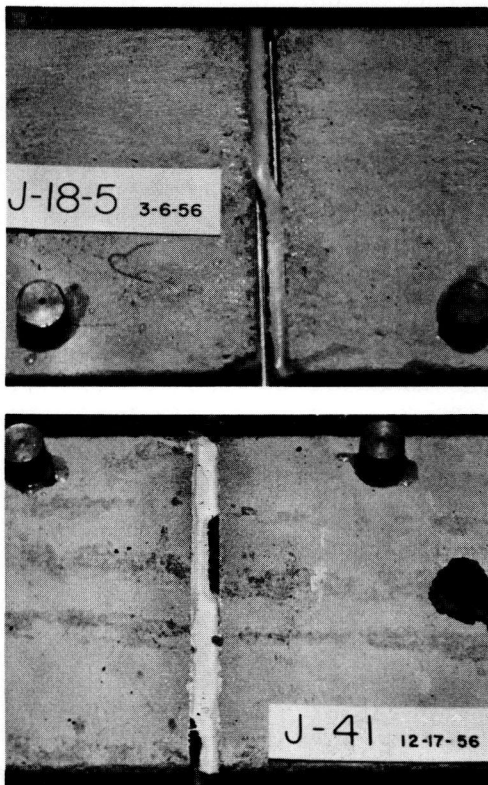
Figure 5. Adhesion failures of silicone rubber (J18-5) and Neoprene putty (J41).

Typical failures are shown in Figures 5, 6, 7 and 8. The condition of each of the time of photographing is given in Table 7. Adhesion failures of silicone rubber (J18-5) and Neoprene putty (J41) are shown in Figure 5. The silicone rubber in this picture was placed to a depth of $\frac{3}{8}$ in., and the light lines seen below the failure are the top edges of thin sheets of aluminum. In Figure 6 is seen the cohesion failure of a polysulfide rubber (J44-1). A sealer which failed both in adhesion and cohesion is shown in Figure 7. A high-modulus sealer which underwent a total deformation of only 2 percent and caused failure of the concrete is shown in Figure 8.

TABLE 7
CONDITION OF FAILED SEALERS WHEN
PHOTOGRAPHED FOR FIGURES 5 to 8

Sealer	Series	Depth of Fill (in.)	Deformation When Pictured ¹ (%)	History
(a) Adhesion Failures				
J18-5	D	$\frac{3}{4}$	100	1 cycle at 0 F ²
J41	D	2	114	1 cycle at 0 F
(b) Cohesion Failure				
J44-1	C	$\frac{1}{4}$	100	6 cycles at 73 F, 1 cycle at 0 F
(c) Adhesion-Cohesion Failure				
J53	B	2	40	1 cycle at 73 F
(d) Concrete Failure				
J31	B	2	2 ³	1 cycle at 73 F

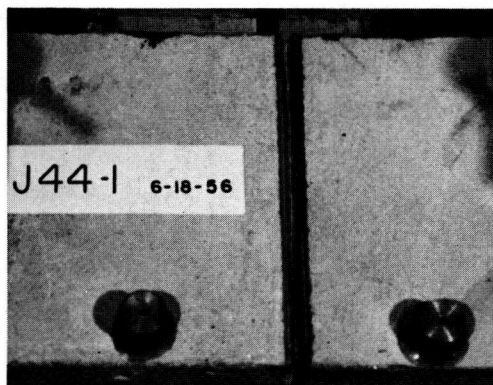
Figure 6. Cohesion failure of polysulfide rubber.

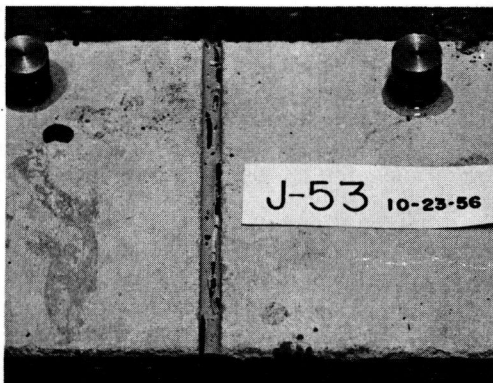
Figure 7. Failure of modified epoxy sealer in both adhesion and cohesion.

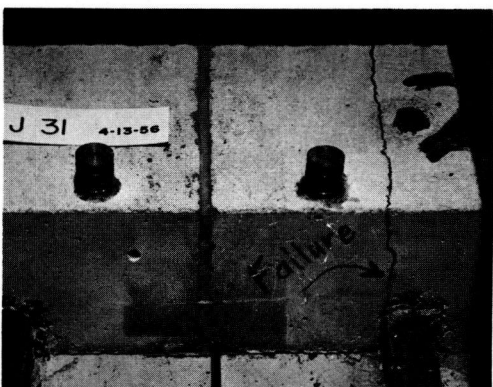
Figure 8. Failure of concrete resulting from high tensile bond strength and high tensile modulus of urethane sealer.

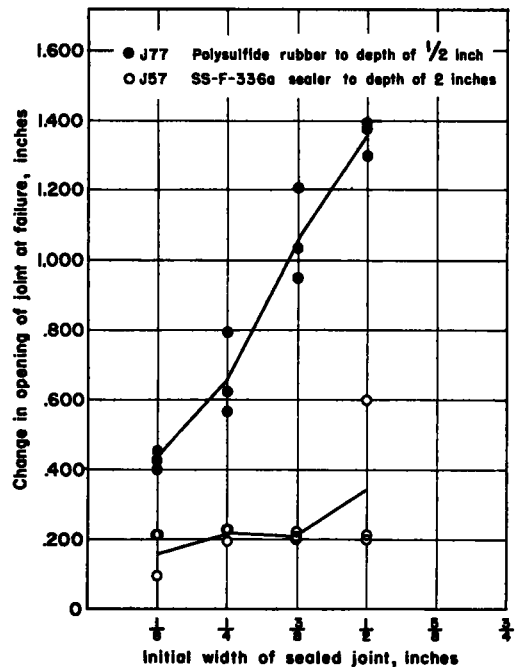
Figure 9. Relation of ultimate deformation of sealer to initial joint width (rate of opening, $\frac{1}{8}$ in. per hr).

It has been suggested that initial joint width should be dictated by the maximum change in joint opening expected and by the type of sealer used. A series of tests was planned to determine the relationship between deformability of sealer and initial joint width. Joints which were initially $\frac{1}{8}$, $\frac{1}{4}$, $\frac{3}{8}$, and $\frac{1}{2}$ in. wide were sealed to the full depth with a rubber-asphalt passing Federal Specification SS-F-336a. Three specimens were sealed for each initial width, making a total of twelve specimens. Another set of twelve specimens was sealed with a polysulfide rubber to the same widths, but to a depth of only $\frac{1}{2}$ in. The specimens were then tested to failure in a single cycle, opening the joint at a rate of $\frac{1}{8}$ in. per hr at 0 F. The increases in joint width at failure are recorded in Table 8 and plotted in Figure 9.

The values for the rubber-asphalt sealer are not only much more erratic than those for the polysulfide rubber, but they also are considerably lower. It is believed that the irregular shape of the curve for rubber-asphalt may be the result of defective specimens. Further tests of this kind are planned to determine the position and shape of curves for a variety of materials. If the concept of the shape factor is correct, the lines for any elastomer placed in the joint to the full depth should curve slightly upward. However, the lines for sealers placed in the joints to shallow depths may be essentially straight.
