HIGHWAY RESEARCH BOARD
Bulletin 214

***Continuous Steel Reinforcement for
Experimental Concrete Pavements***

PRESENTED AT THE
Thirty-Seventh Annual Meeting
January 6-10, 1958

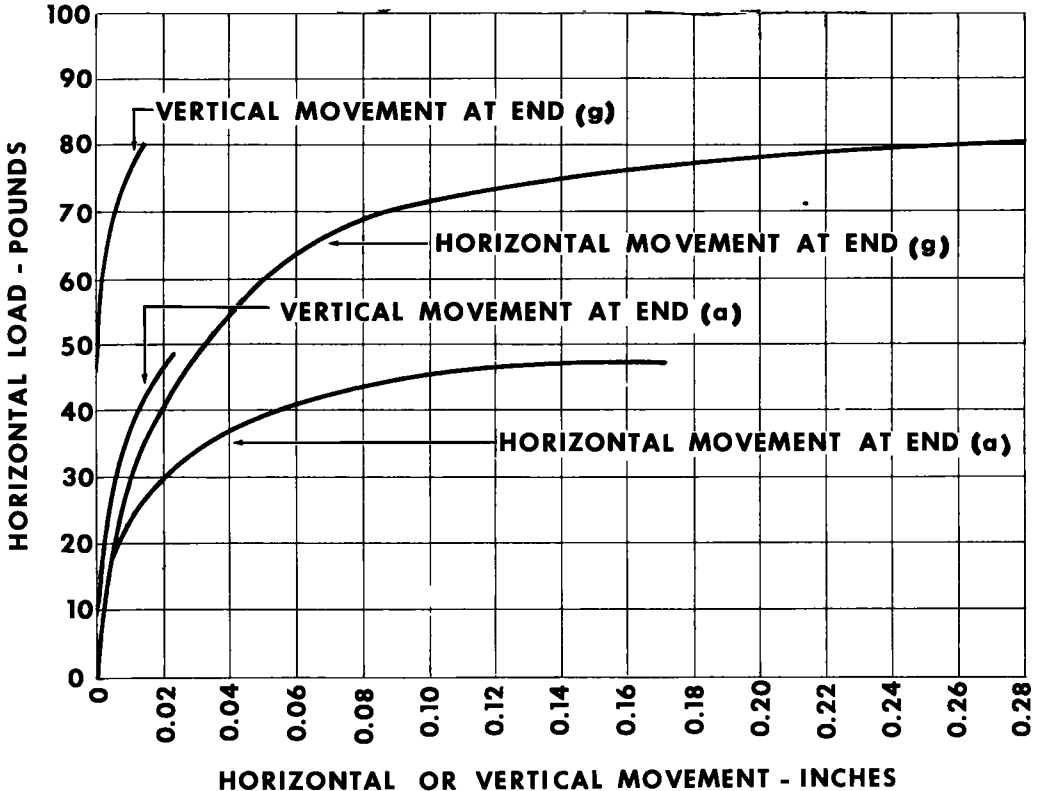
Figure 15. Load-Movement curves for anchorage configuration as in Figure (12 A) and (12 g) (4" Model Depth).

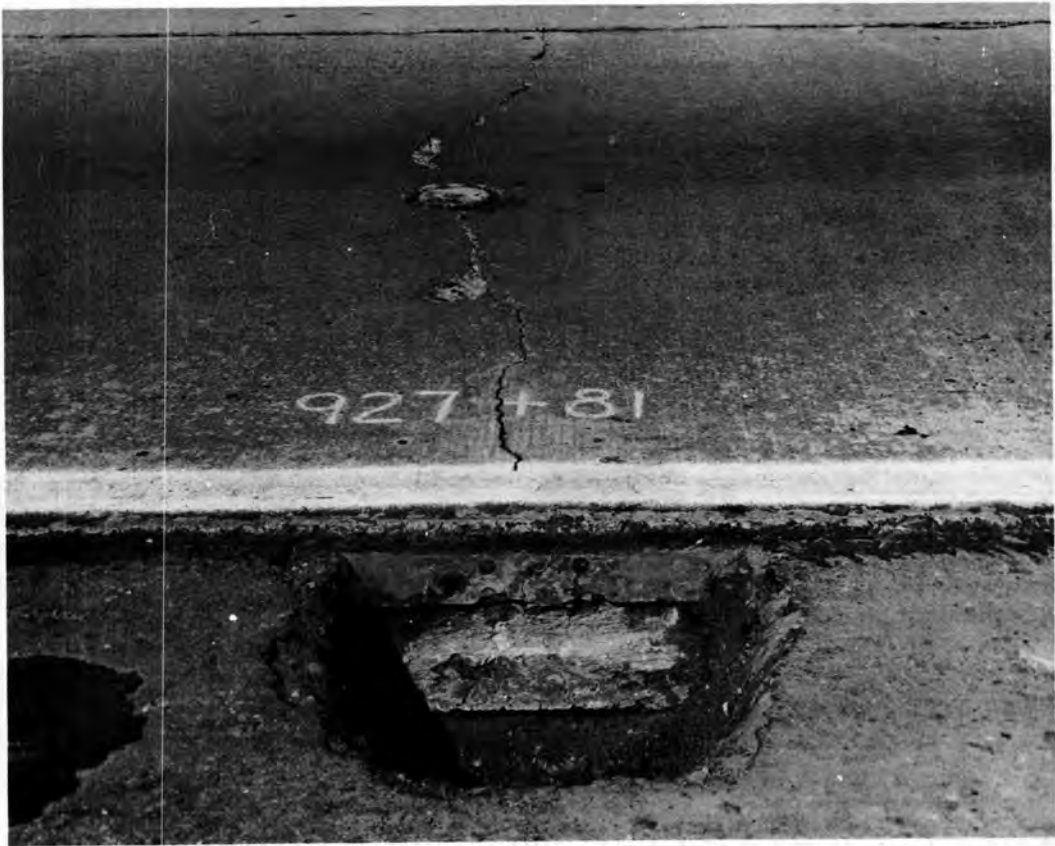
Figure 10. Crack in 10-in. section, Sta. 927+81.

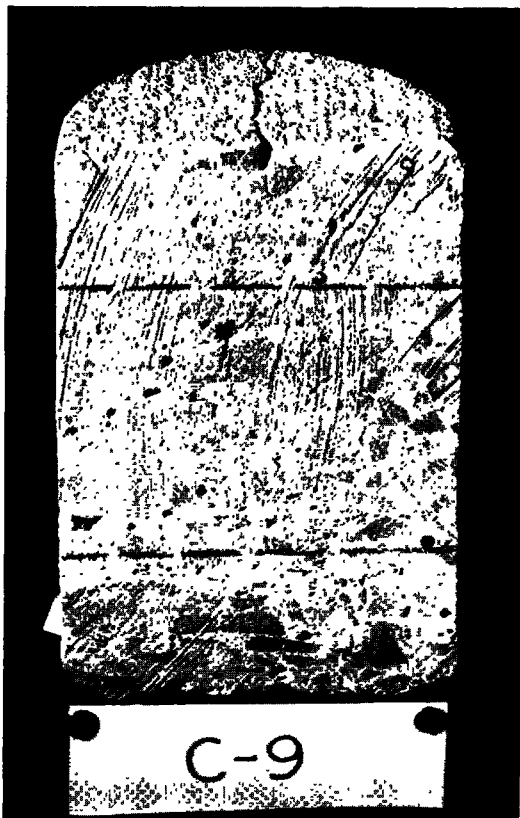
Figure 14. Core at crack in 10-in. section, Sta. 894+88.

Figure 14 shows a core (C-9) obtained at a crack at 894+88 in the inside lane of the 10-in. section. Although this crack was about 0.025 in. wide at the surface, it was of only microscopic width throughout practically the entire depth of the pavement.

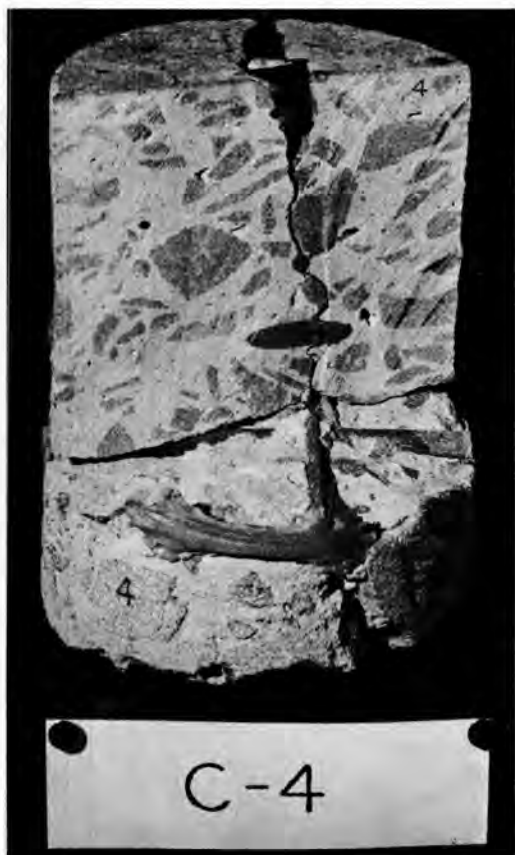
Figure 18. Core at crack near construction joint, 8-in. section.

Figure 18 shows a core (C-4) obtained at a badly ravelled crack, which had been sealed, about 4 ft north of a construction joint at 849+34 in the outside lane of the 8-in. section. This core broke in two during the drilling operations. As will be noted, the crack is quite wide in the upper third of the pavement (above the upper line of steel). In the lower two-thirds, however, the crack was found to be only about 0.01 in. wide. It is apparent that the conditions at this crack are none too good. In addition to rather serious raveling at the pavement surface, appreciable rusting was found in connection with the lower line of steel, especially of the transverse member.

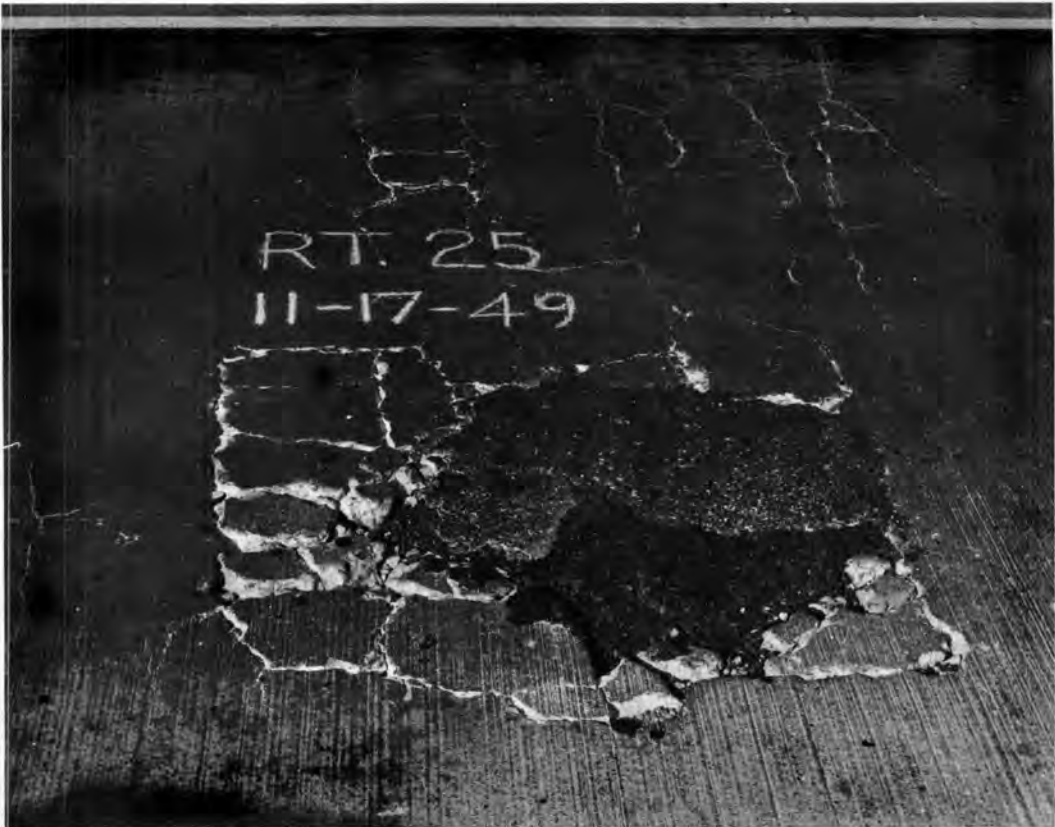
Figure 20. Failure in 10-in. section, Nov. 17, 1949.

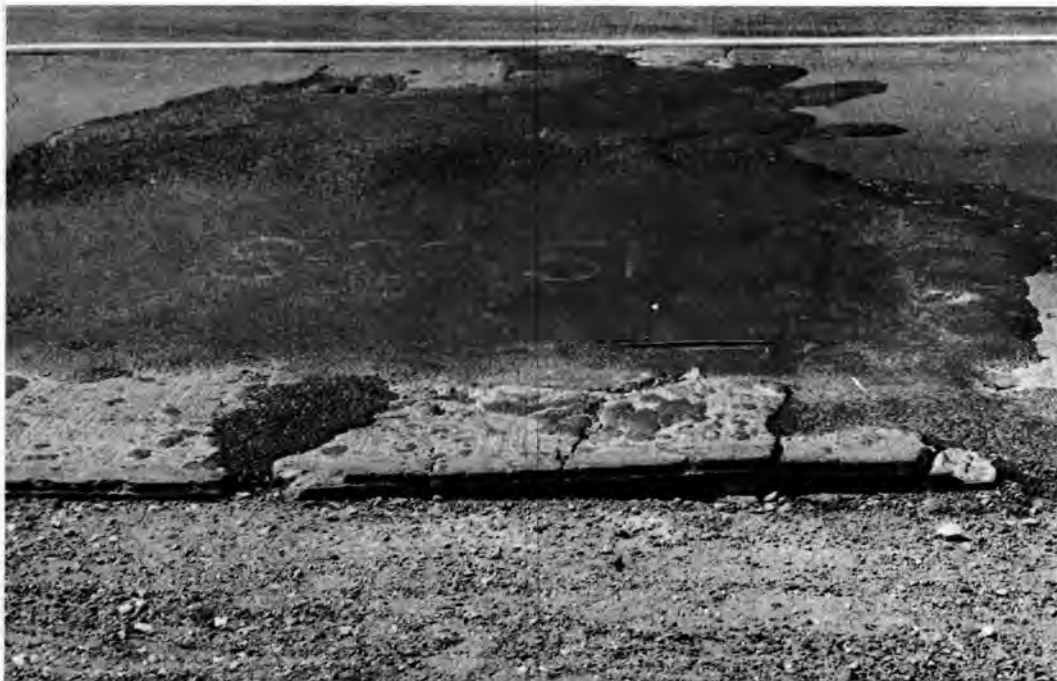
Figure 21. Failure in 10-in. section, Aug. 23, 1951.
