Soil and Foundation Investigations on the Patapsco Tunnel Project

ROBERT B. BALTER, Chief Soils Engineer, and
S. MURRAY MILLER, Soils Engineer, J. E. Greiner Co., Baltimore, Md.

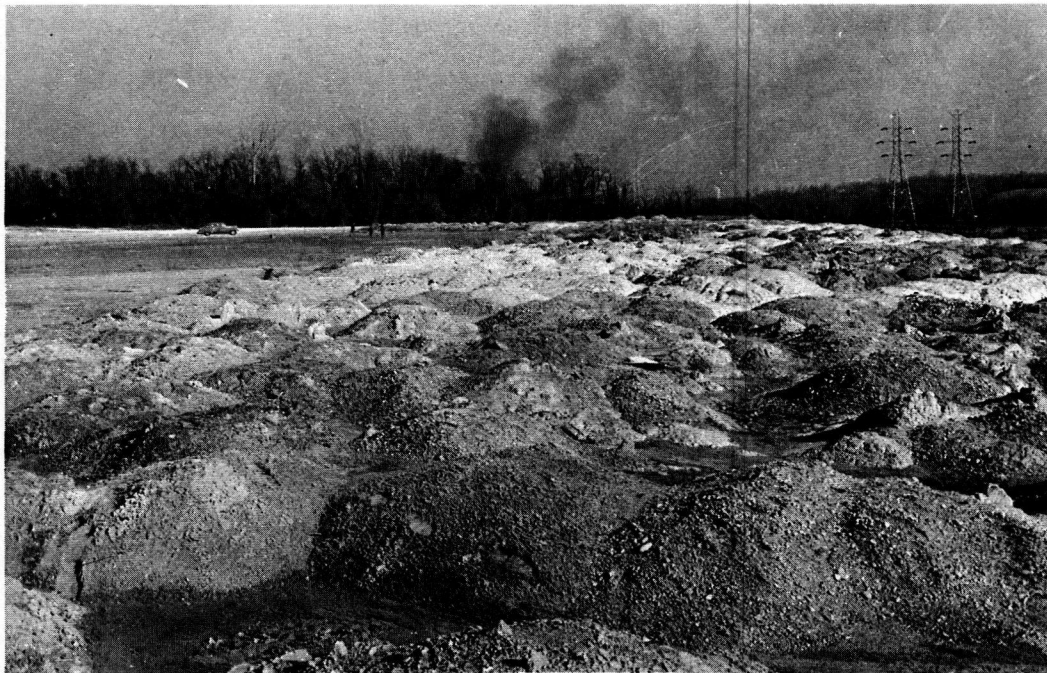
Figure 5. Unconsolidated Kaiser fill.

The Kaiser fill immediately east of the valley was composed of 30 ft of granular materials, which had been placed by a bottom dumping operation. At the time of this operation, it had not been anticipated that the area would be utilized in the future for an expressway. Figure 5 is a view of the unconsolidated fill material.

Contract borings through this area, which extended for 1,000 ft, indicated that the very loose deposits had a resistance of 2 to 5 blows per foot on a standard penetration spoon driven by a 140-lb weight falling 30

in. This poor resistance was consistent through the entire 30-ft depth of the deposit. In-place density tests disclosed the average fill density to be 75 pcf. When compacted by the standard Proctor density test, the same soil had a dry unit weight of 120 pcf. The Highway Research Board Classification for this material was A-2-4.

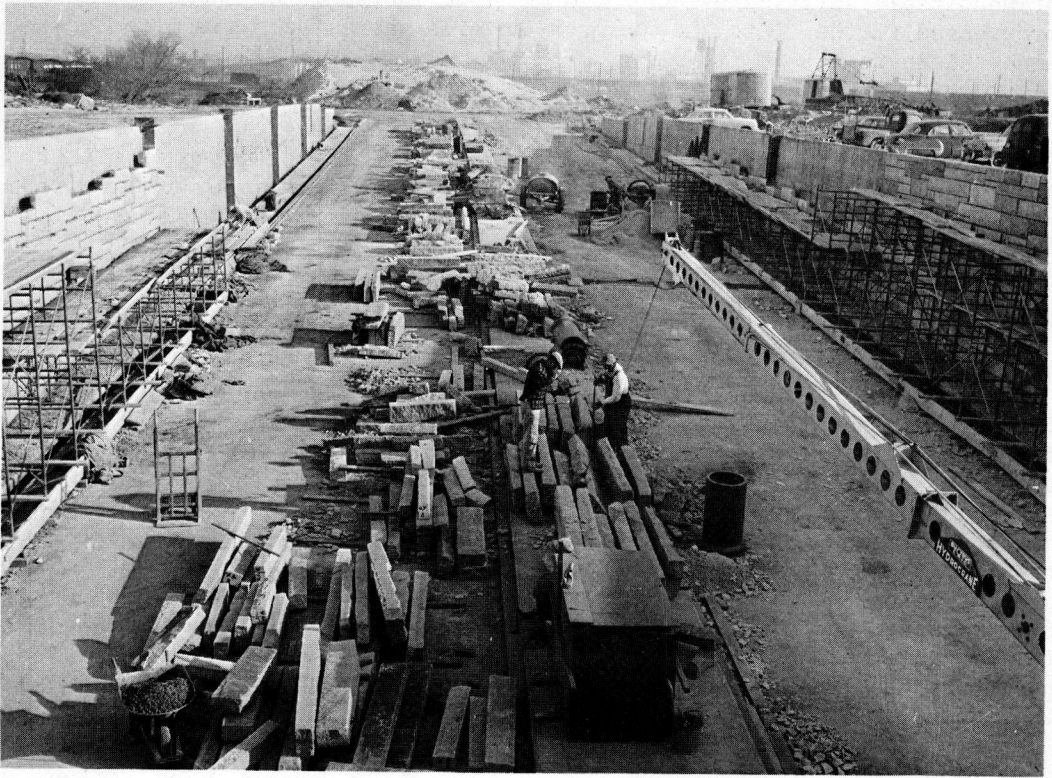
Figure 8. Open ramp near north portal of tunnel.

The compressible soils north of the tunnel are discussed briefly to emphasize the desire of designers to keep substructure and superstructure costs in economic balance. The roadway in this area ascends from the tunnel to the original ground surface and then to an elevated viaduct which crosses the railroad yards in Canton. Soft organic clays were the predominant soil throughout this portion of the alignment and were underlain by intermittent organic deposits to great depths. Design studies of the various foundation types indicated that retaining walls less than 9 ft in height could be founded on spread footings whereas higher walls required cast-in-place concrete pile foundations. Figure 8 indicates the open ramp north of the tunnel. The northernmost 400 ft of the walls on either side of the roadway are less than 9 ft in height.

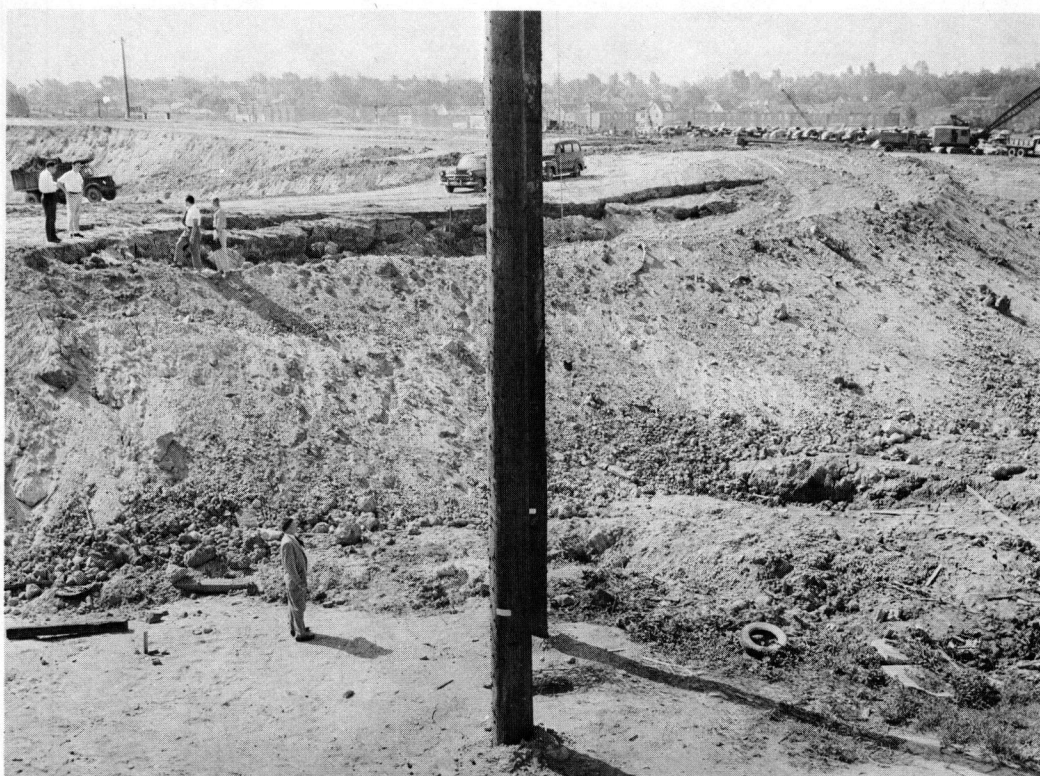
Figure 12. Off-ramp slide failure.

The operations continued for the off-ramp according to plan until the elevation of the fill was within 2 ft of the profile grade line. At this time tension cracks were noted in the fill and a slide occurred toward the Patapsco River. The earth mass continued its movement for about 2 hr after which time it reached a stable condition. Figure 12 is a view of the failed embankment. Because of a forecasted rain storm, the General Consultant and the design engineer immediately decided to have the contractor grade the slide material to obtain proper drainage of the storm flow toward the river. The contractor was also requested to remove some of the undisturbed embankment to relieve the pressure on the underlying stratum which had sheared. This material was not wasted but utilized by the contractor in other areas which required borrow material.

After reviewing the original plan and profile for the off-ramp, it was the opinion of the engineers that a realignment of the ramp within the standards set forth in the design criteria of the project would allow a safe and economical rehabilitation of the area. This was done as shown in Figure 11. Certain advantages were gained from this design change. The horizontal realignment placed the roadway and shoulders on embankment not influenced by failure planes, and the lowering of the grade line made it possible to consider as surcharge, soils which initially were below grade.

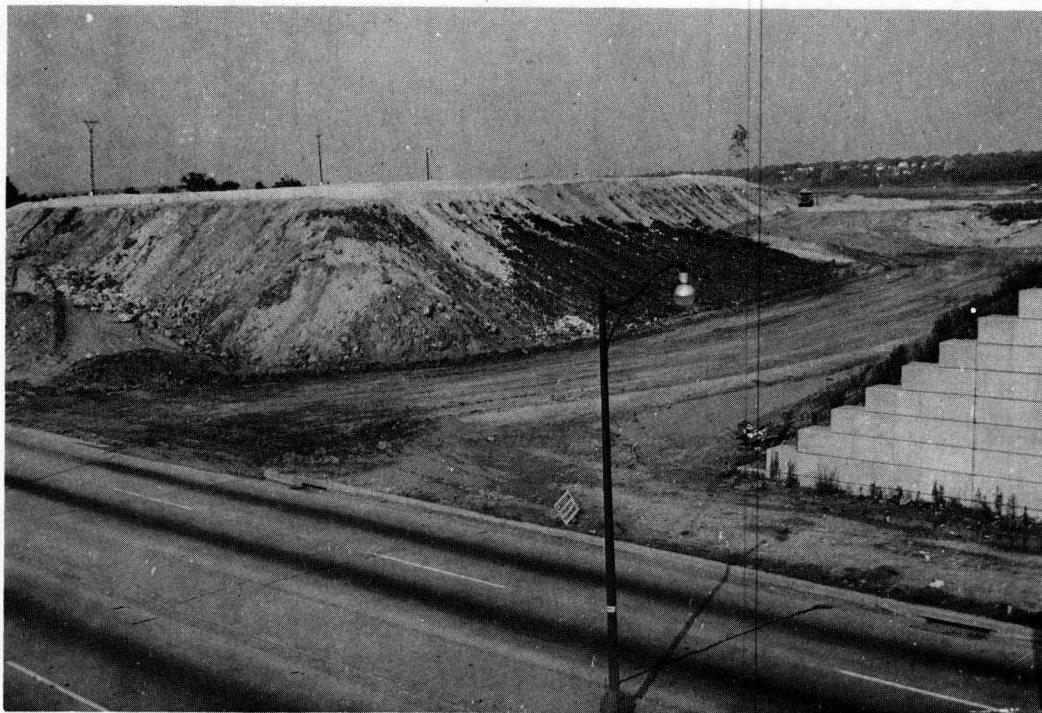
Figure 16. Station 325—embankment and surcharge.

The fill placement along the expressway was watched very carefully after the difficulties encountered in the area. It was decided on the basis of field observations that 13 ft of surcharge would be adequate to obtain the desired results rather than the 20 ft originally thought necessary. No further difficulties were experienced during or after the construction at this location. Figure 15 shows the curves obtained from the readings made on three settlement plates during the construction of the embankment and surcharge, the period of no change in surcharge, and the removal of surcharge. The embankment and surcharge are depicted in Figure 16. From field results obtained within the construction schedule, it was evident that rigid pavement could be used in conformance with the standard pavement section for the project.

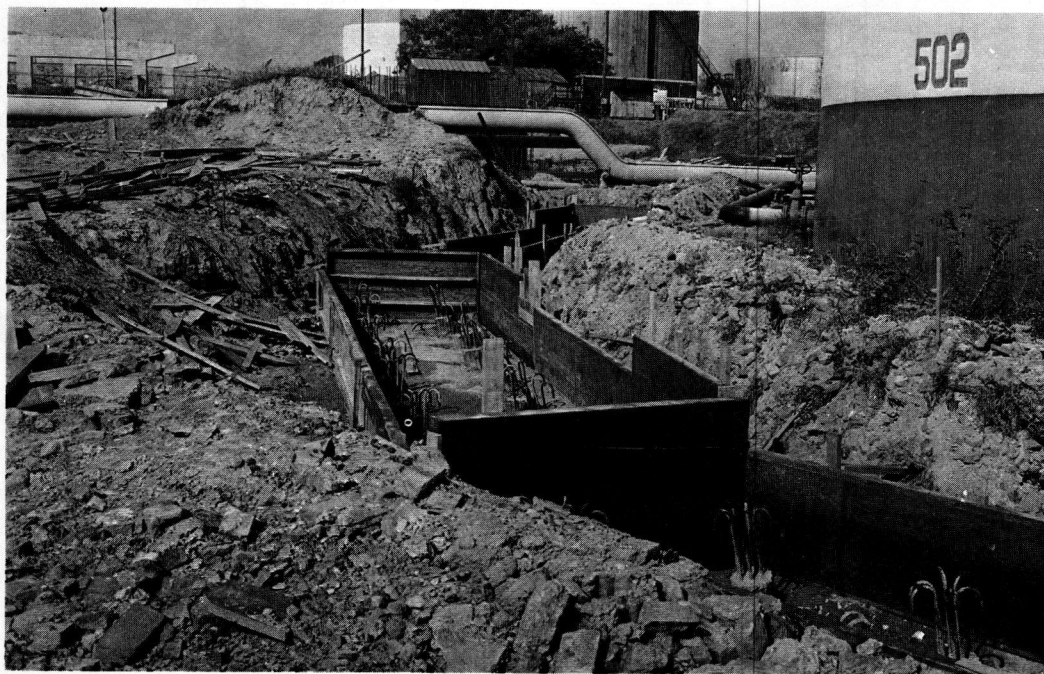
Figure 17. Retaining wall at Esso Tank 502.

The final subject to be discussed is a miscellaneous fill near the Esso tank farm. The problem here arose during the excavation for a retaining wall which was to contain the fill around Tank 502. This wall, which attained a maximum height of 11 ft, was designed for a spread-footing foundation, but the excavation for the footing revealed the presence of unsuitable fill material.

Cast-in-place concrete piles with an average depth of 25 ft were required to support the wall after this disclosure. It should be noted that Tank 502 had experienced some differential settlements in the past and the location of the retaining wall around this tank required, therefore, that all precautions be taken so as not to aggravate this situation. This is shown in Figure 17. An additional boring study of the site was made which disclosed that the southbound lanes passed over satisfactory soils while the northbound lanes were over unsuitable materials. The presence of bedsprings and brickbats combined with soft clays made the sampling operations quite difficult and it was decided that actual removal of these materials should be undertaken. With careful and continuous field supervision, the entire area of unsuitable soil which was found to be of limited extent, was removed by bulldozer and dragline. The removal of this material was most important because the fill over this area was approximately 20 ft in height and differential movements would have been quite serious.
