HIGHWAY RESEARCH BOARD

Bulletin 266

***Pavement Edge Markings,
Shoulders and Medians***

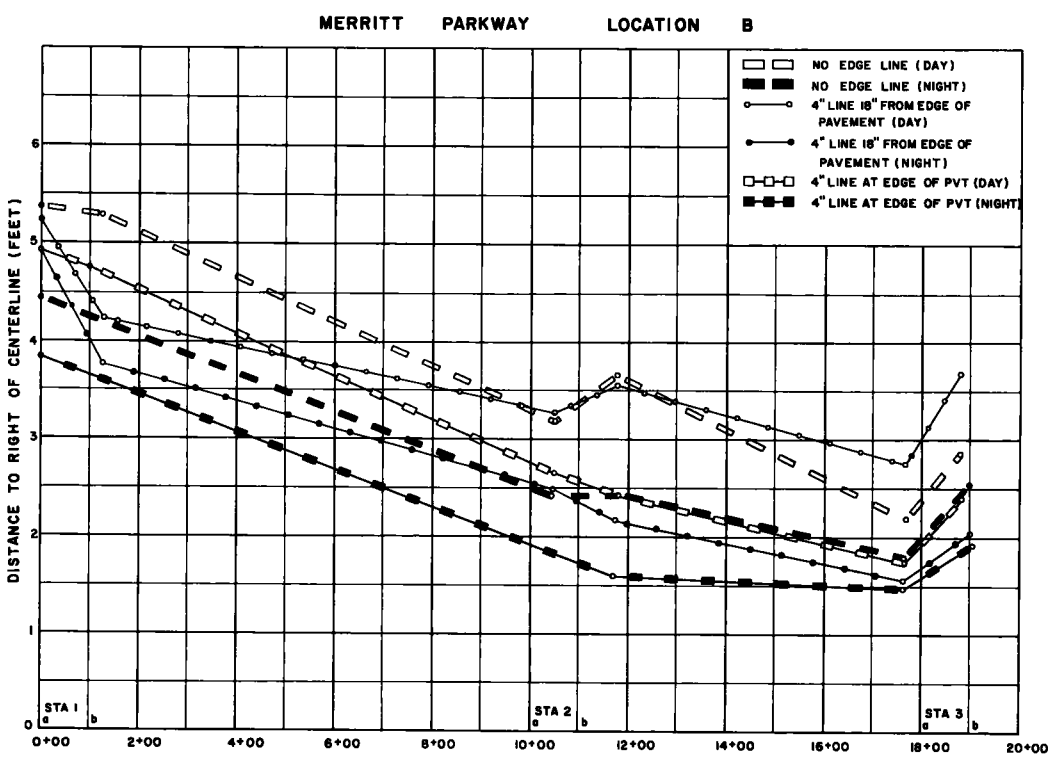
Figure 10.

Figure 10 shows that in the daytime vehicles are positioned closer to the center of lane when the 4-in. white line was painted 18 in. away from the edge of shoulder. At night, vehicles traveled nearer to the lane line with the line painted at the edge of pavement.

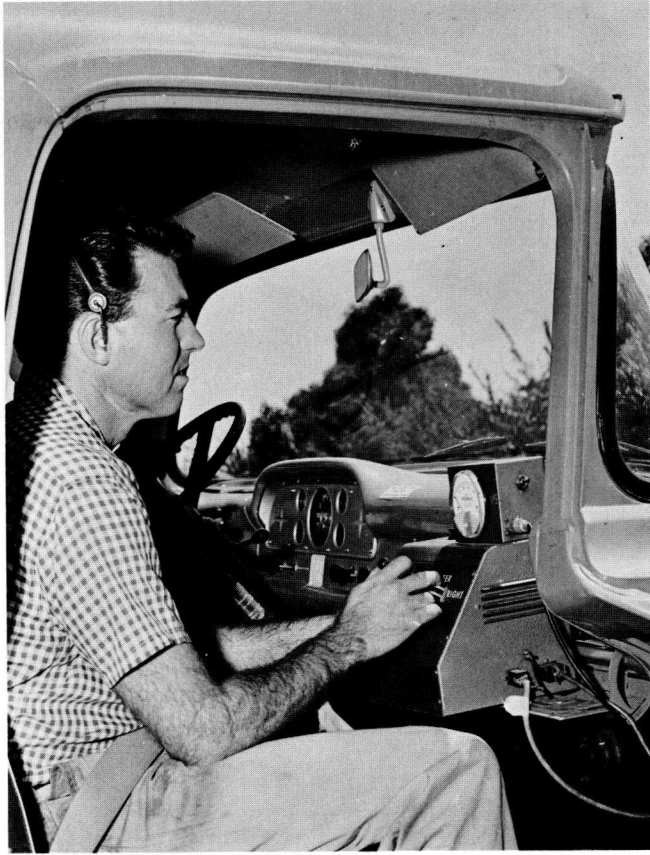
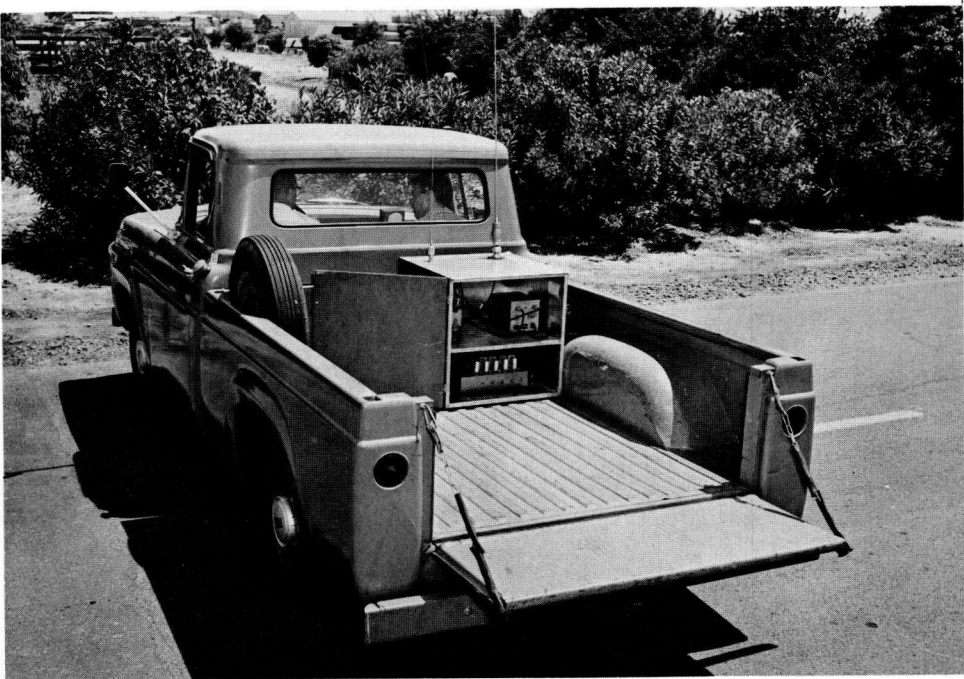
Figure 35. Photographs of control car instruments.
