HIGHWAY RESEARCH BOARD

Bulletin 274

*Concrete Pavement Design
And Performance Studies:
1960*

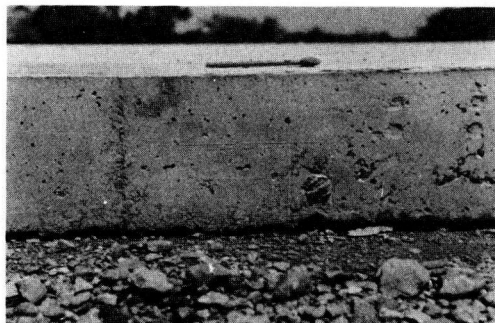
Figure 5. Edge view of typical crack at the age of 10 days (Falls-McLennan County Project).

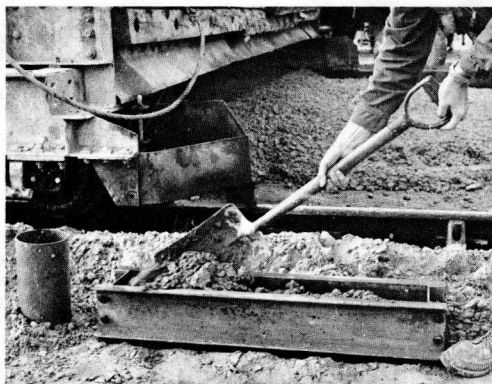
Figure 28. Taking beam samples for modulus of rupture tests.

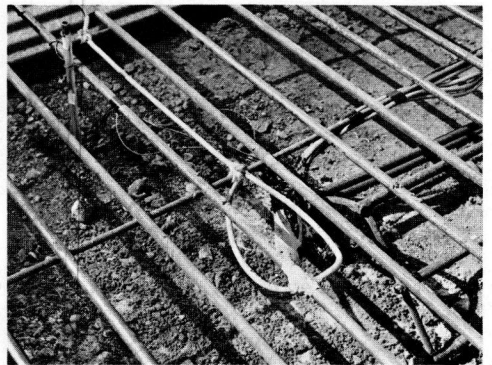
Figure 34. Instrumented wire mesh reinforcement with corrugated crack former and thermocouples.

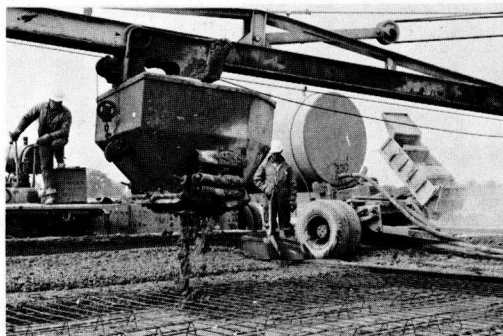
Figure 36. Spreading concrete from bucket behind instrumented standard mesh reinforcement.

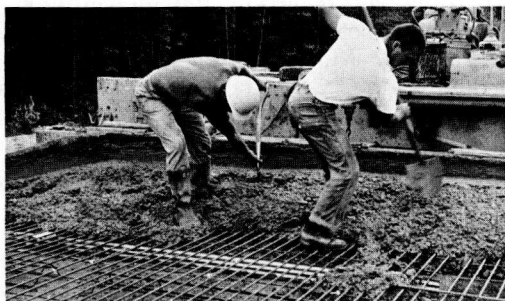
Figure 37. Placing concrete around corrugated crack former in heavy mesh reinforcement.

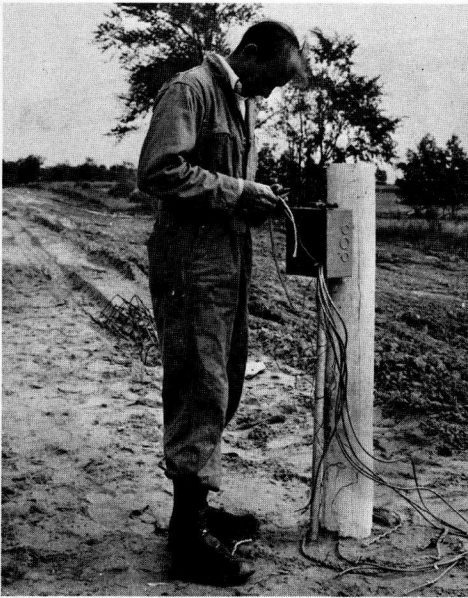
Figure 40. Wiring strain gage and thermocouple leads at junction box.

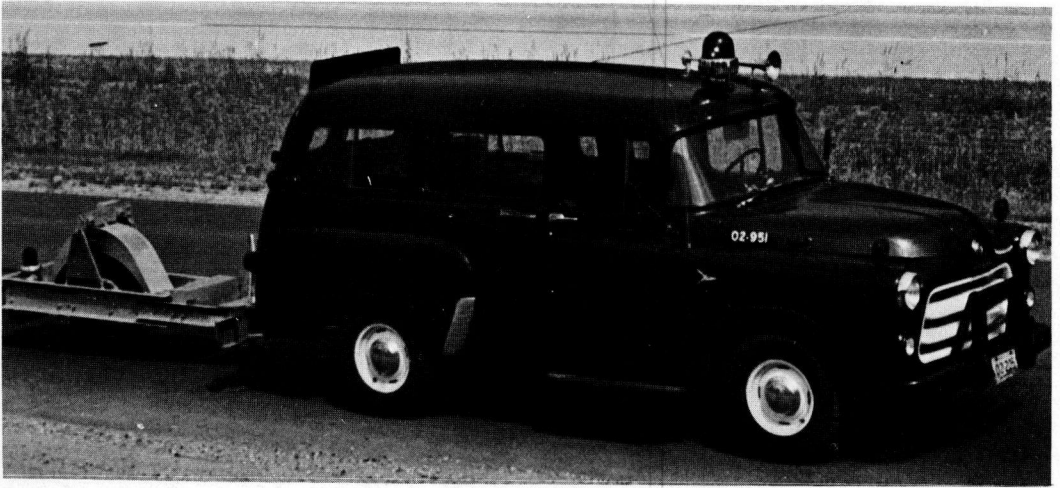
Figure 48. MSHD roughometer truck.

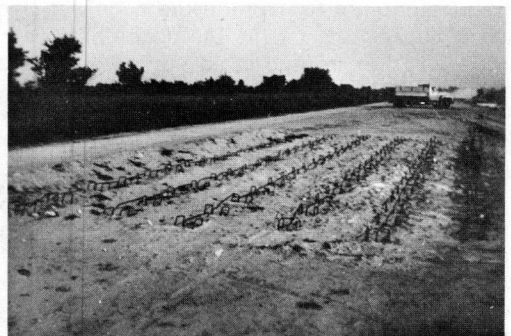
Figure 2. Test Road between Zwartberg and Meeuwen, Belgium: One of the abutments—fins poured and reinforcements placed. Slab will have to be poured afterwards.

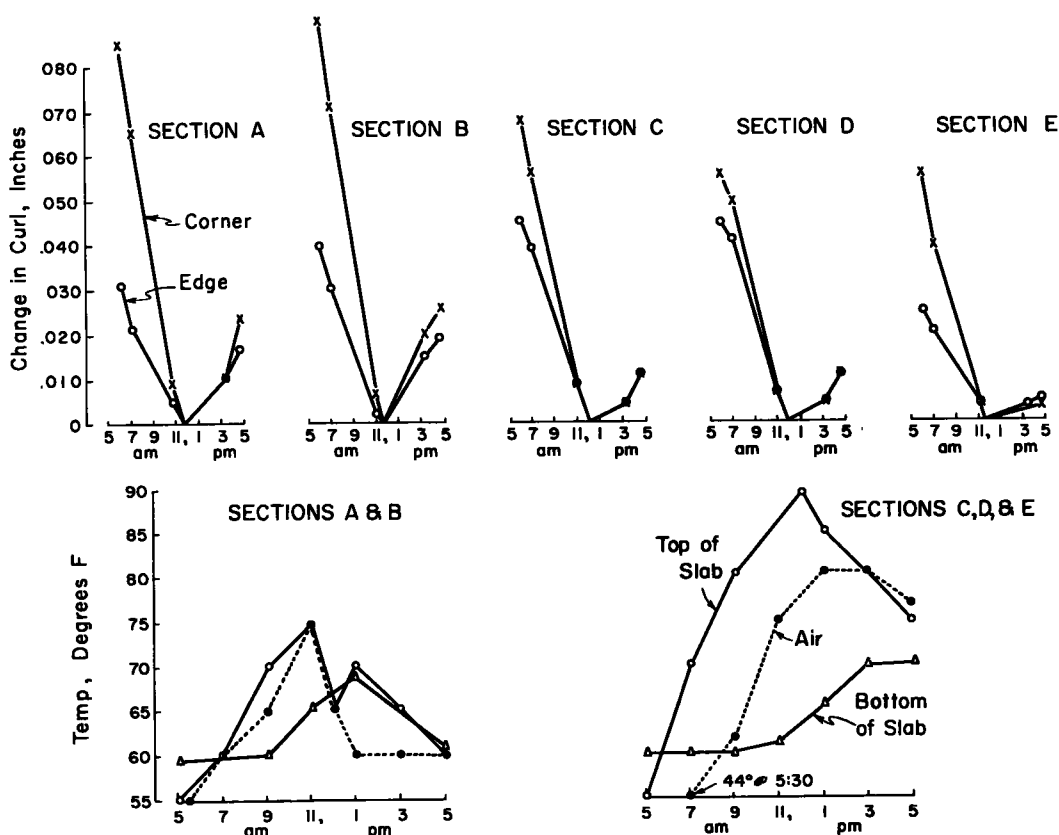
Figure 5. Temperature and curl vs time.
