Bulletin 332

*Rigid Pavement Design Studies*

***Rigid Pavement Design Studies***

# Laboratory Studies of Progressive Bond Failure In Continuously-Reinforced Concrete Slabs

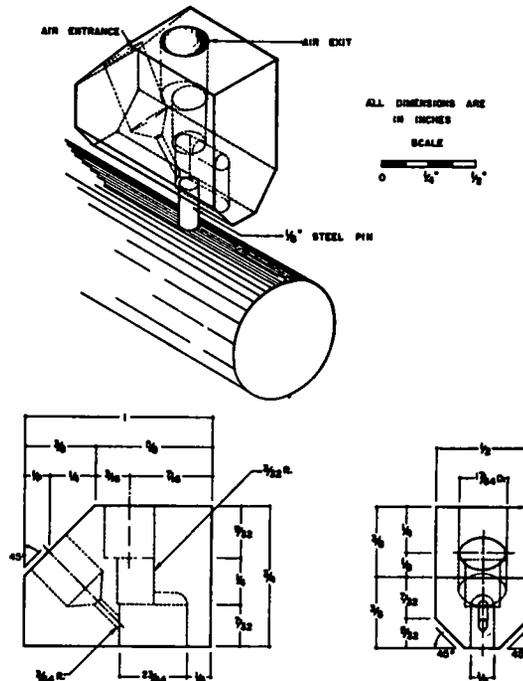
Figure 1. Plastic gage.

such breakage, a plastic gage was developed, which when coupled with an air flow meter provides an accurate measure of the longitudinal movement of the bar with respect to the concrete. In this paper this type of movement is referred to as "slip." Although no attempt is made to define the amount of slip required for bond failure, the plastic gages were used to measure slip along a bar in the vicinity of a transverse crack. The point at which the slip became zero was determined from a plot of the slip values recorded at the gages located along a bar.

The plastic gage was positioned along the longitudinal ridge, two of which are present on any reinforcing bar, so that the air entrance hole was plugged by a  $\frac{1}{8}$ -in. stainless steel pin that had previously been set into a  $\frac{1}{8}$ -in. hole drilled into the longitudinal ridge of the bar. The groove in the bottom of the plastic gage into which the stainless steel pin fitted was machined with a  $\frac{1}{8}$ -in. end mill to obtain a snug yet workable fit. The tubing from the air exit hole of the gage extended to the exterior of the concrete to provide a path for the flow of air as the pin was moved with respect to the plastic gage.

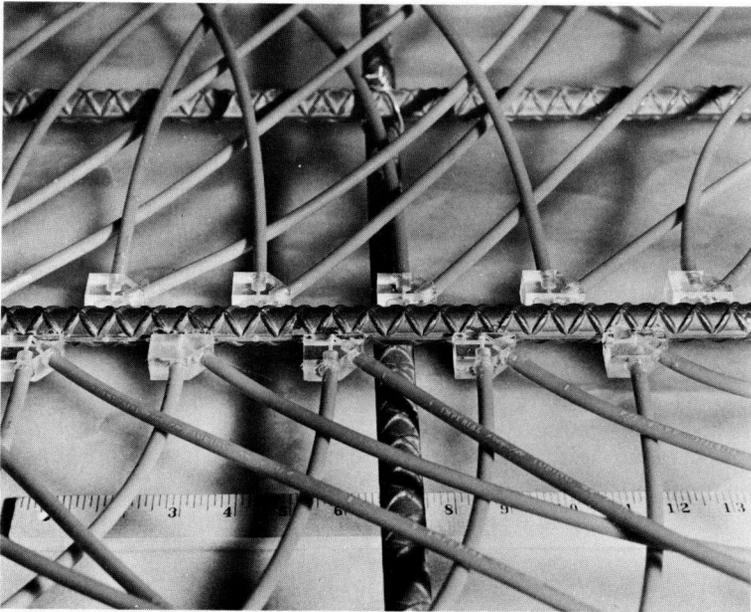
Figure 4. Plastic gages glued in position on reinforcing bars.

After calibration, the plastic gages were cemented to the reinforcing bars with Duco cement. Long steel guide plates and tape were used to hold the gages in alignment and in their "home" position for 24 hr. Additional thin coatings of Duco cement were then added to seal any small openings along the milled groove between the under side of the gage and the reinforcing bar to exclude cement paste. Figure 4 shows several gages cemented to a bar before placement of the concrete.

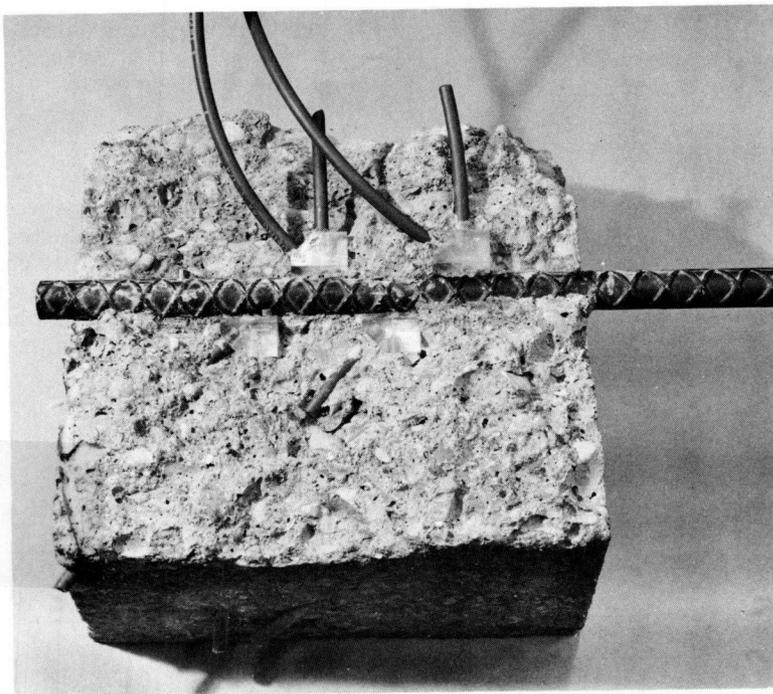
Figure 5. Plastic gages in pull-out specimen after a test.

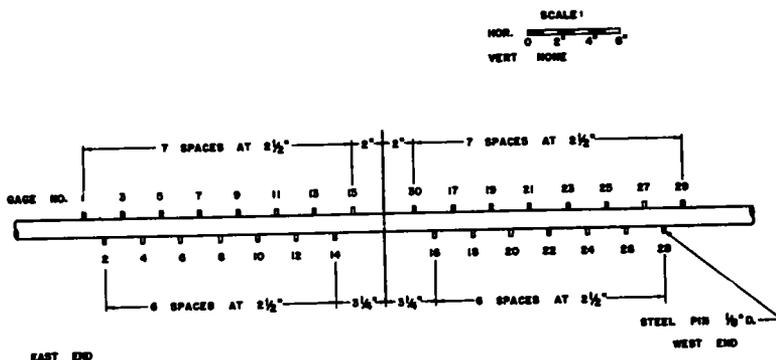
Figure 7. Bar C.

Plastic gages were arranged in a staggered pattern on two sides of bar C (see Figs. 6 and 7). The midpoint of the bar was placed at the location of the prepared weakened plane in the slab. Steel plugs were also embedded in the surface of the wet concrete at 10-in. intervals on lines 7 in. from the longitudinal edges of the slab. Other gage plugs were cemented to the side of the slab at the elevation of the longitudinal steel after the slab was poured. A 10-in. Whittemore strain gage was used to make surface strain and crack width measurements on all slabs except slab 1.

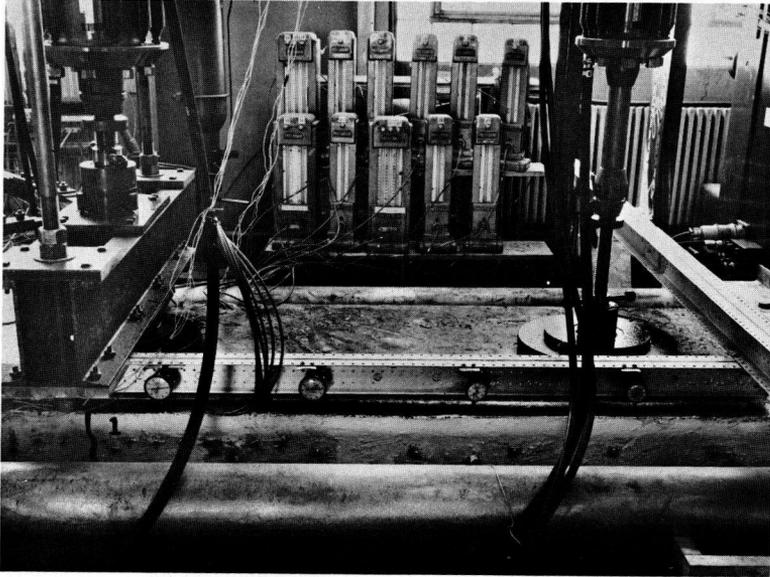
Figure 9. Crack pattern for slab 8.

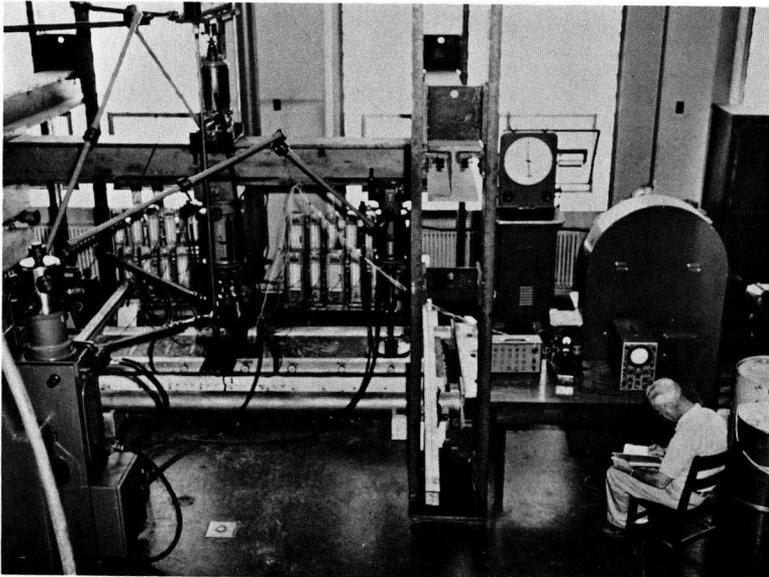
Figure 10. General view of longitudinal and vertical loading arrangement, slab 8.

Three Amsler jacks were used to obtain the out-of-phase sine-wave loadings at the two load points. The larger jack, shown over the east or left load point in Figure 10,

was connected to the dynamometer shown by the window at the right. The dynamometer supplied a constant force to this jack. The reaction for this jack, as well as for the other two, was provided by a heavy steel beam supported by girders connected to columns. The jack over the west load point (see Fig. 10) was connected to the Amsler pulsator shown at the left. The pulsator was operated at 250 cycles per min to produce a sine-wave loading between some minimum and some maximum value. In general this minimum was 1 kip and the maximum was 9 kips. This type of loading is referred to as 9K-1K. Some slabs were loaded with a vertical loading of 17K-1K. The dynamometer

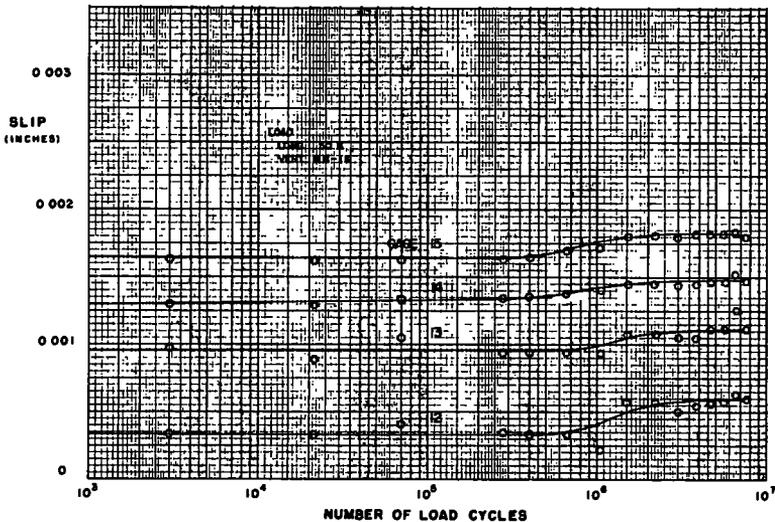
Figure 11. Slip vs number of load cycles, slab 8.

Although each slab cracked in a somewhat different pattern from the others, the data obtained from the plastic gages mounted on bar C had common characteristics for all slabs. Figure 11 shows the small amount of additional slip which might be attributed

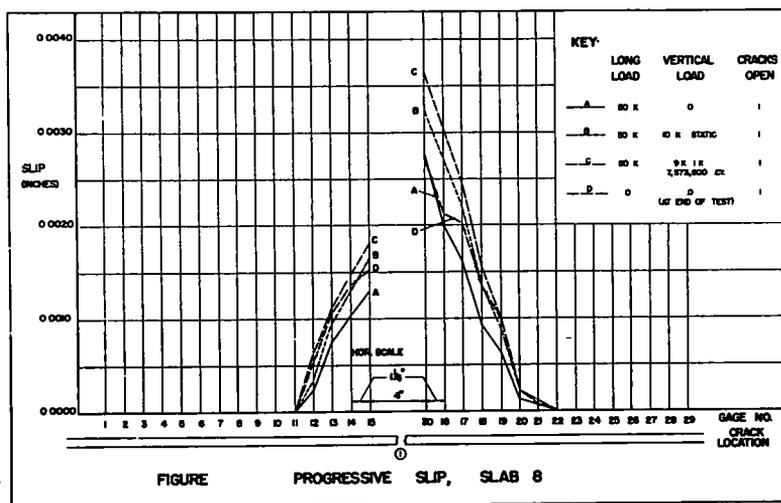
Figure 12. Progressive slip, slab 8.

A comparison of curves A and C in Figure 12 reveals more clearly the progressive movement of the steel with respect to the concrete. The crack ① occurred at the weakened plane in this slab and was therefore approximate 2 in. from gages 15 and 30. From the nature of the curves it is apparent that the crack was nearer gage 30 than gage 15. It is also apparent that with only the longitudinal force the maximum observed slip was the nature of about 0.0027 in. (at gage 30), and that gages beyond Nos. 11 and 22 recorded 0 slip. After 7, 573, 800 cycles of 9K-1K loading the maximum slip had increased to about 0.0037 in. at gage 30, and the values for slip were still recorded as 0 at gages 11 and 22.

Figure 12 is typical of the information obtained from experiments with the other slabs. Because the plastic gage functions only in a positive direction, any crack occurring between gages 1 to 15 or between gages 30 to 29 causes some slip in the negative direction for certain gages and therefore they become useless.

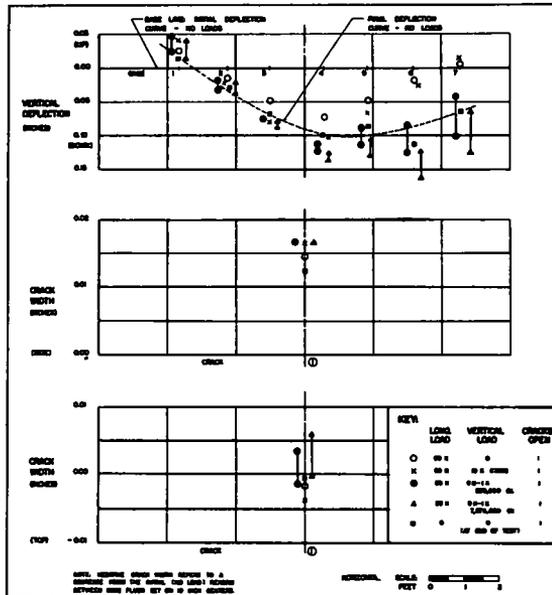
Figure 13. Vertical deflections and crack widths, slab 8.

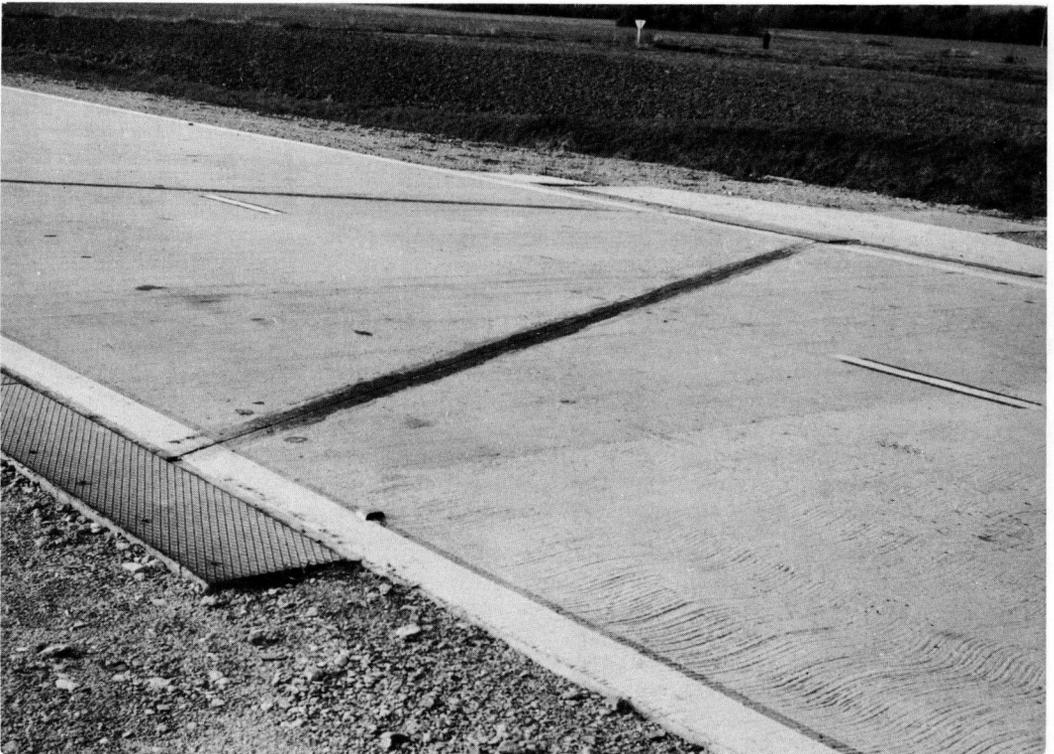
Figure 1. Transverse wedge section for applying longitudinal prestress to section of experimental highway pavement near Fontenay-Tresigny, France.

France has built several prestressed projects, first on the Orly Airport (Fig. 1) and an airfield near Algiers (Fig. 2) and later in 1960 on a highway near Paris. The highway project is an experimental road  $1\frac{1}{2}$  mi long consisting of 38 demonstration or test sections. Five different contractors built prestressed pavements of their own design to provide a specified amount of prestress in the longitudinal direction. Slabs were built with both longitudinal and transverse prestress and with only longitudinal prestress. Prestressing was accomplished by various combinations of longitudinal, transverse, diagonal, and peripheral tendons and by longitudinal post-stressing obtained by applying external longitudinal compression against either fixed or elastic abutments without the use of internal longitudinal tendons. (Post-stressing is a term

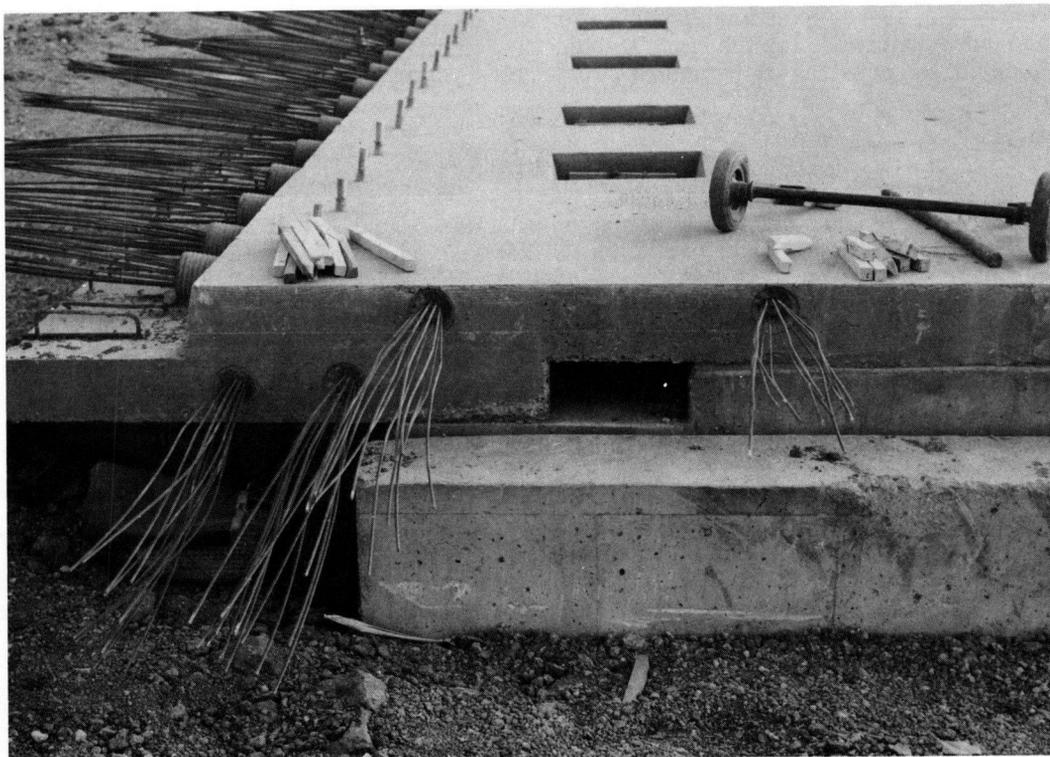
Figure 2. Details of anchorages for prestressed runway under construction at Maison Blanche Airport near Algiers during 1960. Longitudinal wires at left are part of elastic underground abutment which is post-tensioned. The wires in foreground are transverse prestressing for elastic abutment.

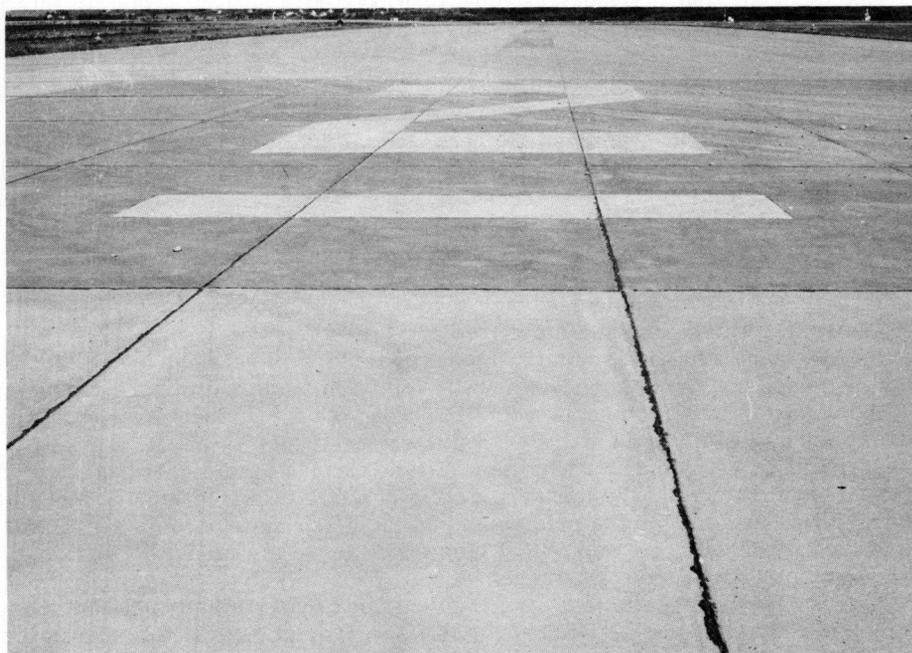
Figure 3. Concrete runway, Zurich Airport, Switzerland, illustrating use of colored concrete to form runway numbers. This eliminates need for special traffic paint.

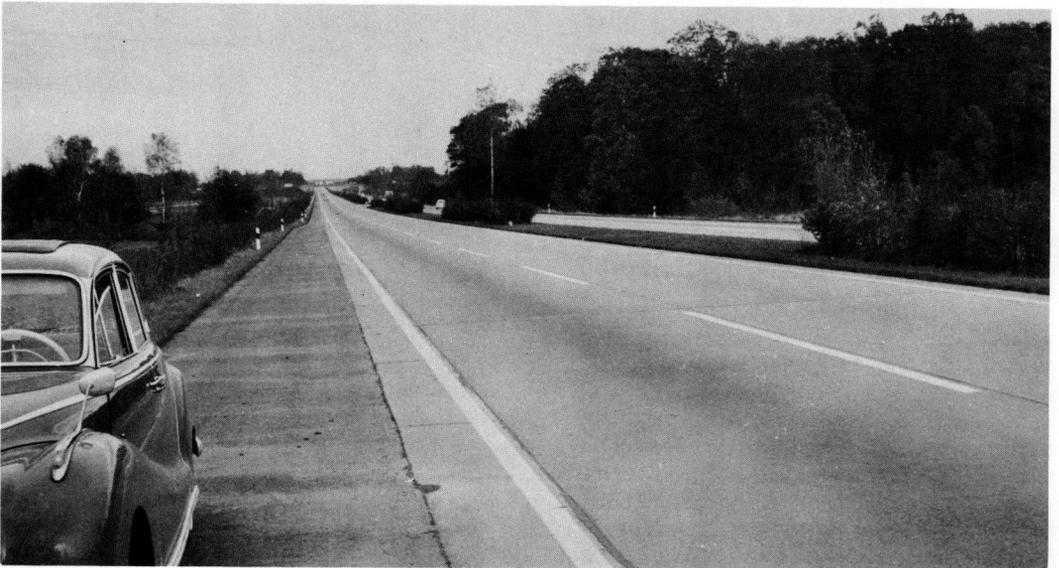
Figure 5. Concrete Autobahn near Baden-Baden, Germany, showing use of black concrete shoulder, white concrete strip for edge marking, and normal colored concrete roadway.

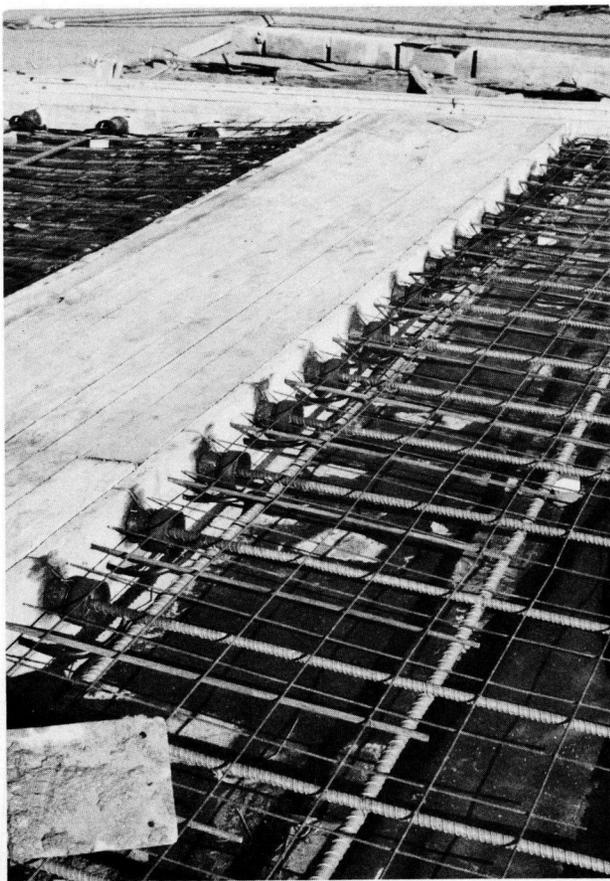
Figure 6. Details of slab end reinforcing and conduit placement for post-tensioning tendons in runway slab under construction at new Wahn Airport serving Cologne and Bonn.

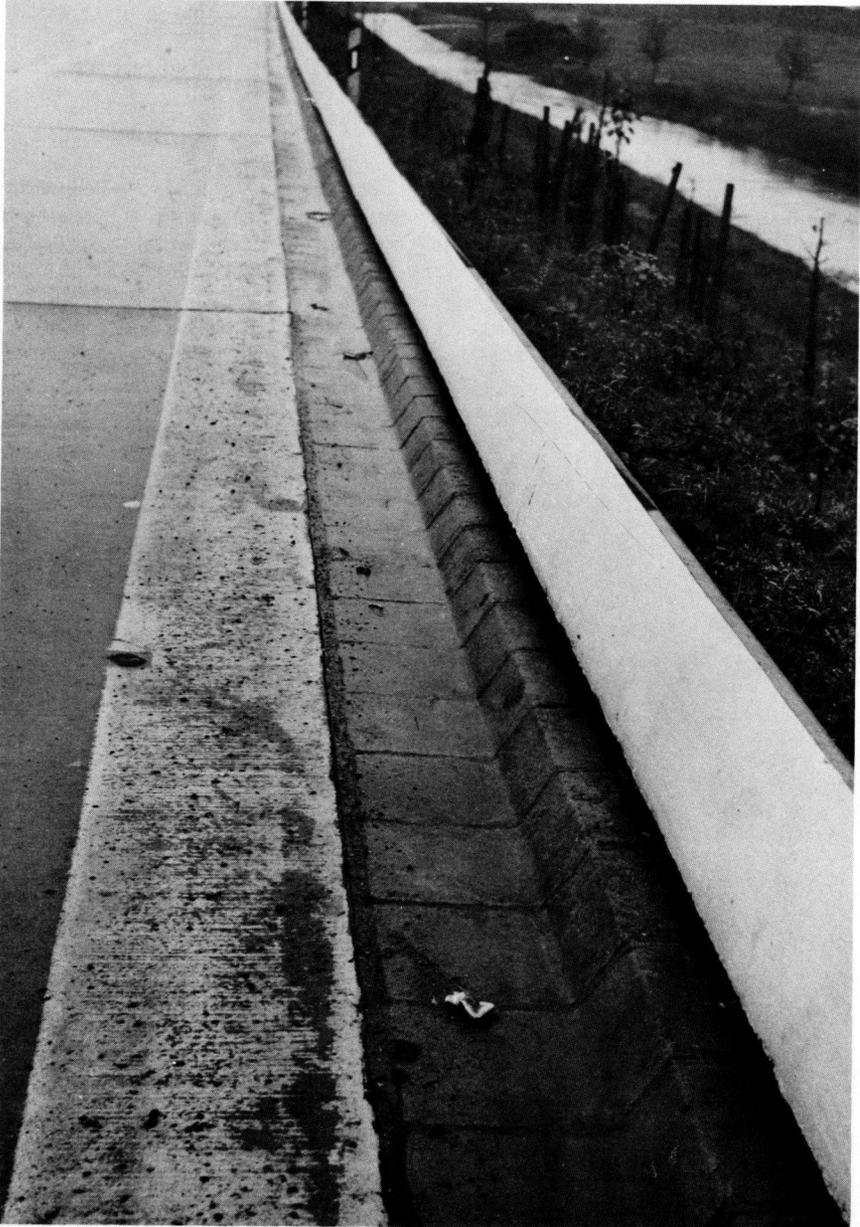
Figure 7. Precast concrete curb and gutter sections and precast concrete guardrails used adjacent to prestressed highway section near Bingen, Germany.

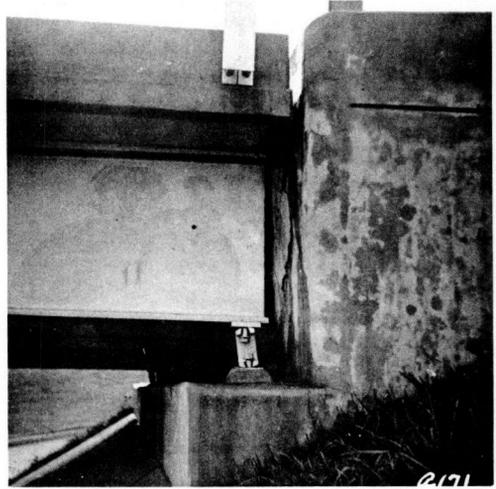
Figure 1. Bridge abutment showing damage resulting from concrete pavement growth pushing on bridge abutment.

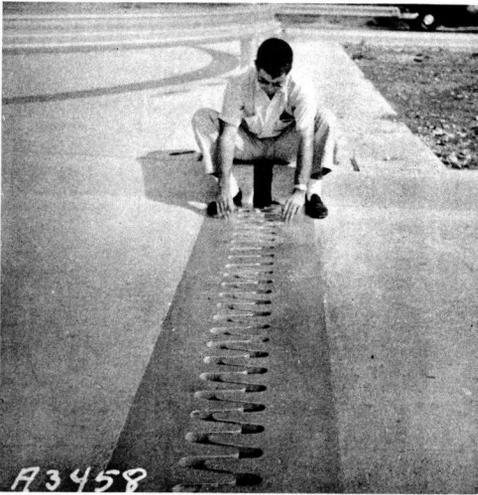
Figure 2. Finger joint at terminal of continuously reinforced concrete pavement.

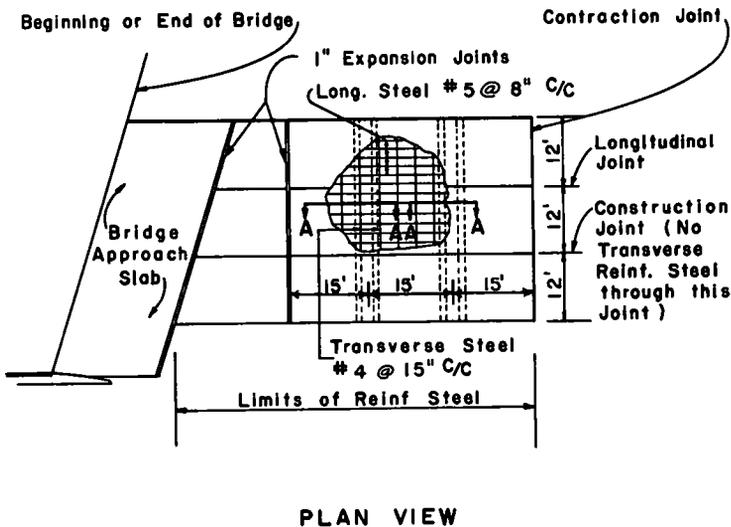
Figure 3. Typical district 12-lug design-jointed pavement.

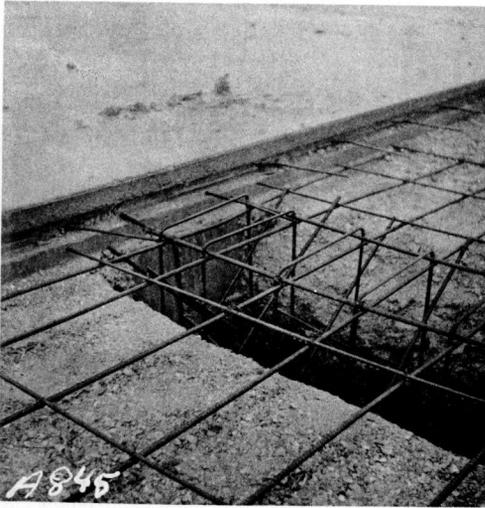
Figure 4. Trench showing lug reinforcement.

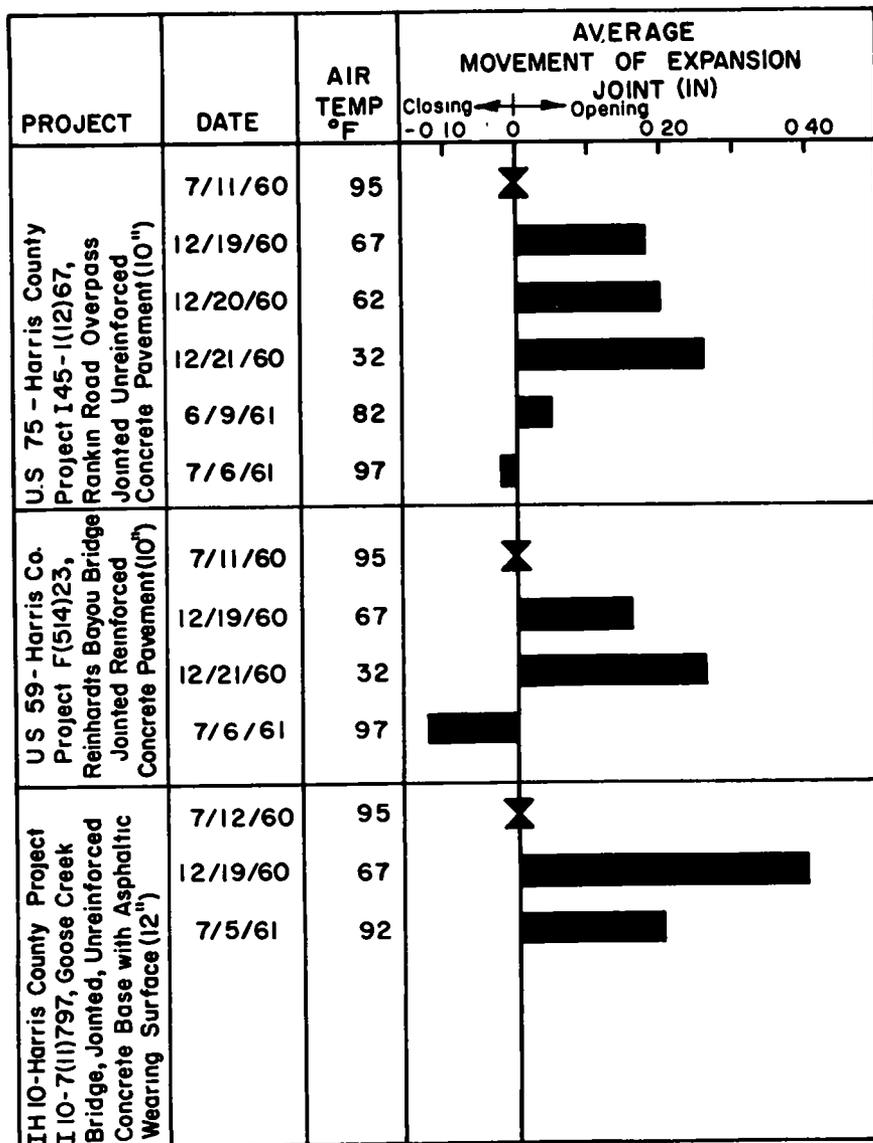
Figure 5. Jointed concrete pavement measured terminal movements.

Three projects (References 1, 2, and 11, Table 1) were selected for close observation and expansion joint measurements. Brass gage plugs were installed on either side of selected expansion joints on each of these three projects. These three projects, all being among the first to employ a terminal anchorage system, were selected for study because they represent the three most commonly used jointed pavement designs in Texas. With these gage plugs, joint movements to the nearest 0.01 in. can be accurately measured. The plugs were installed in July 1960, and measurements made during the next twelve months are reported. Figure 5 shows the results of the measurements

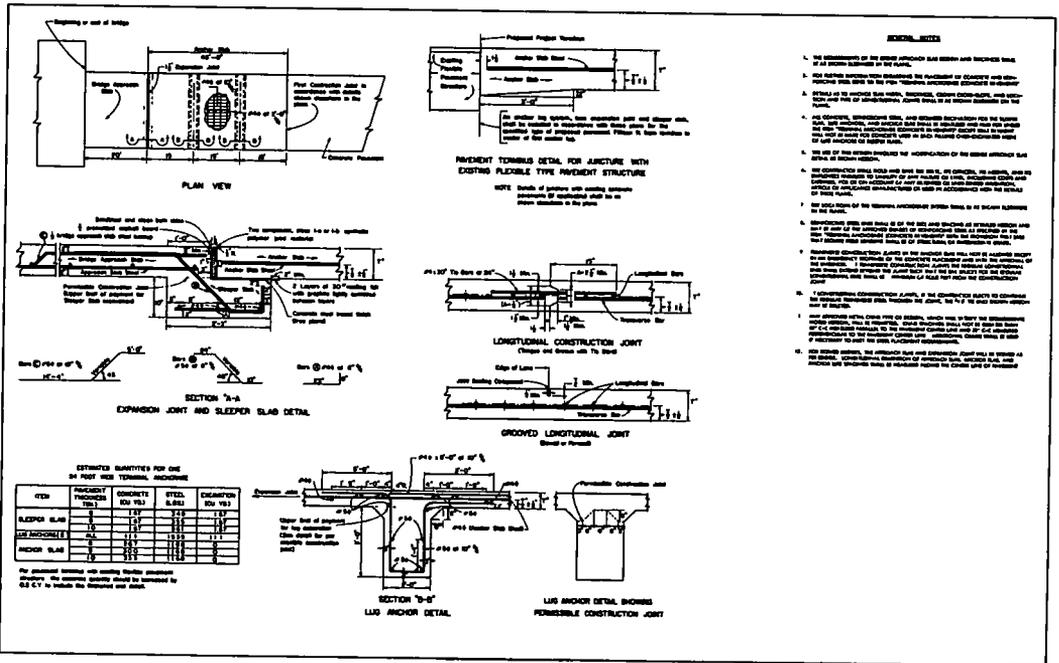
Figure 6. Terminal anchorage for concrete pavement jointed, TA(CPJ)-61, Texas Highway Department.

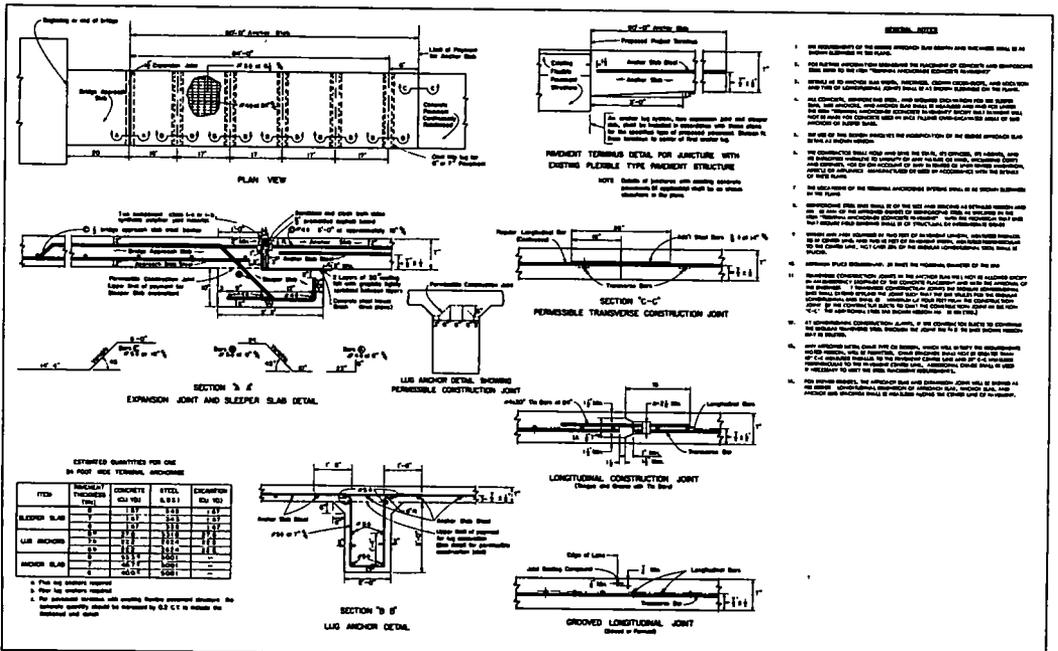
Figure 7. Terminal anchorage for concrete pavement continuously reinforced, TA(CPCR)-61, Texas Highway Department.

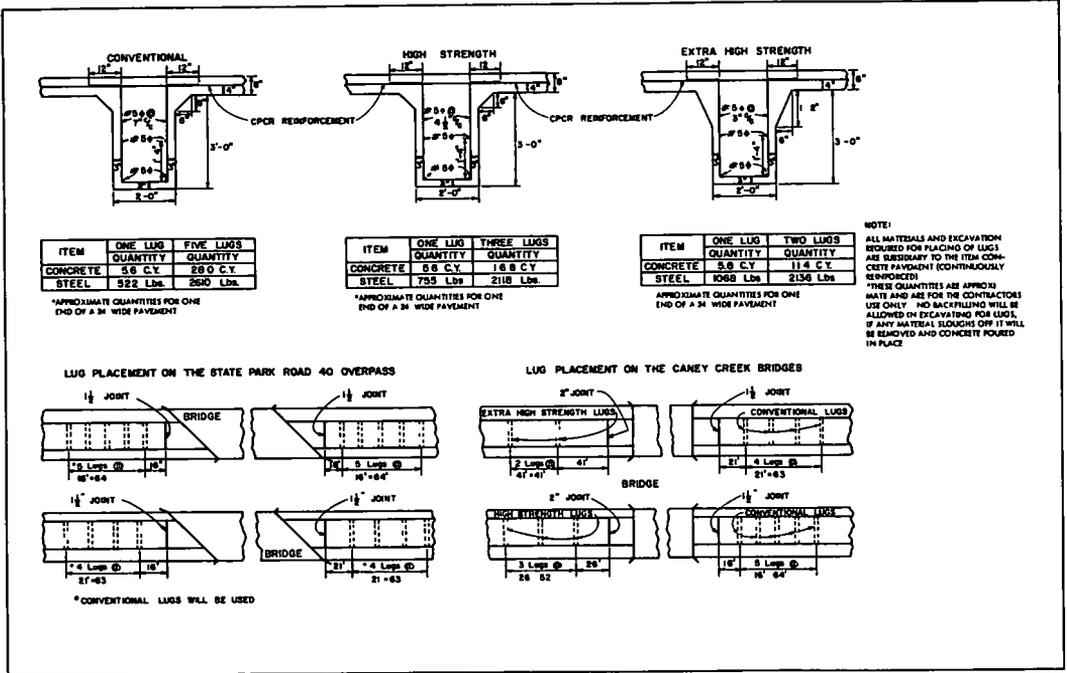
Figure 8. Lug details for Walker Co. CPCR experimental project I45-2(3)-102.

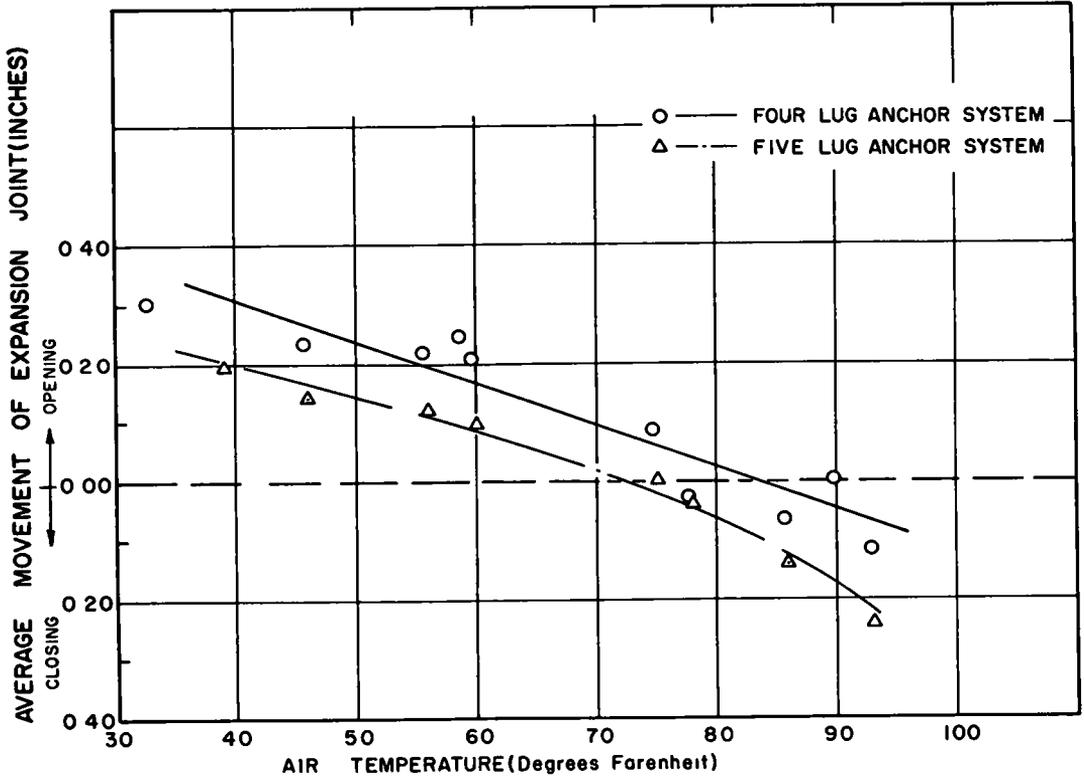
Figure 9. Average terminal joint movements for various air temperatures at the State Park Road overpass (project I45-2(3)102, Walker Co.).

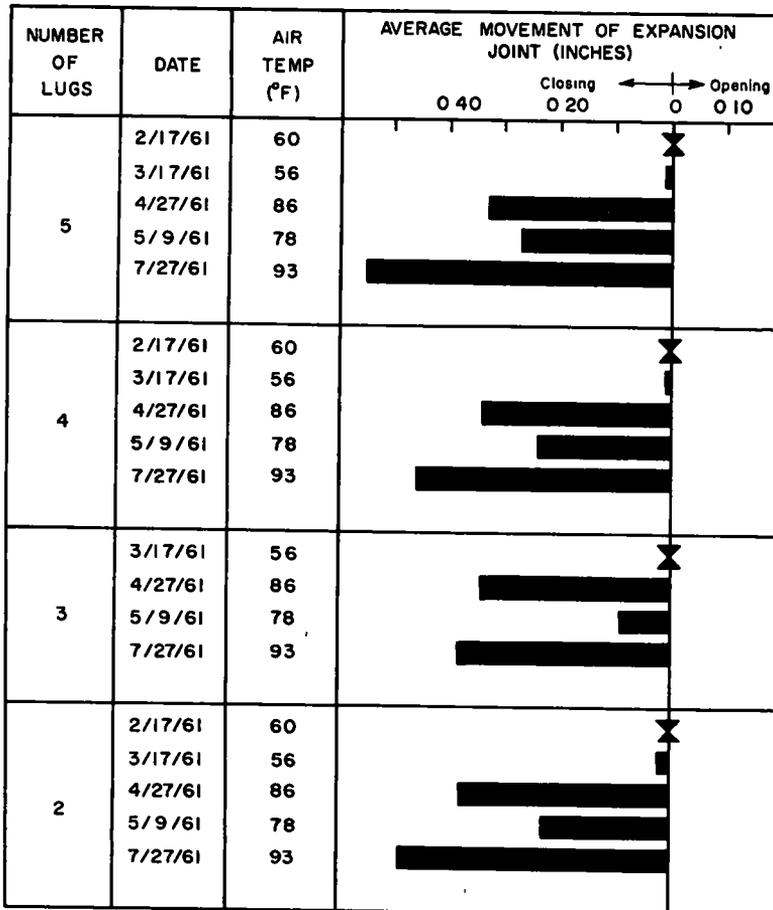
Figure 10. Continuously reinforced concrete pavement measured terminal movement at the Caney Creek Bridge (project 145-2(3)102, Walker Co.).

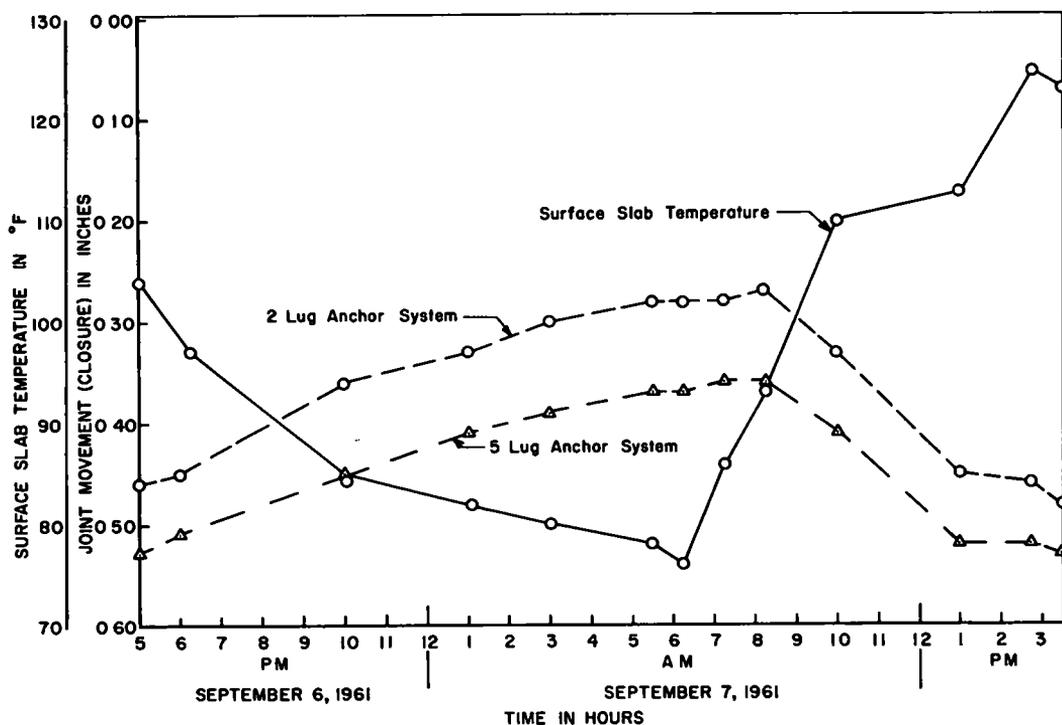
Figure 11. Joint movement vs time for a selected short period at the Caney Creek Bridge (project I45-2(3)102, Walker Co.).

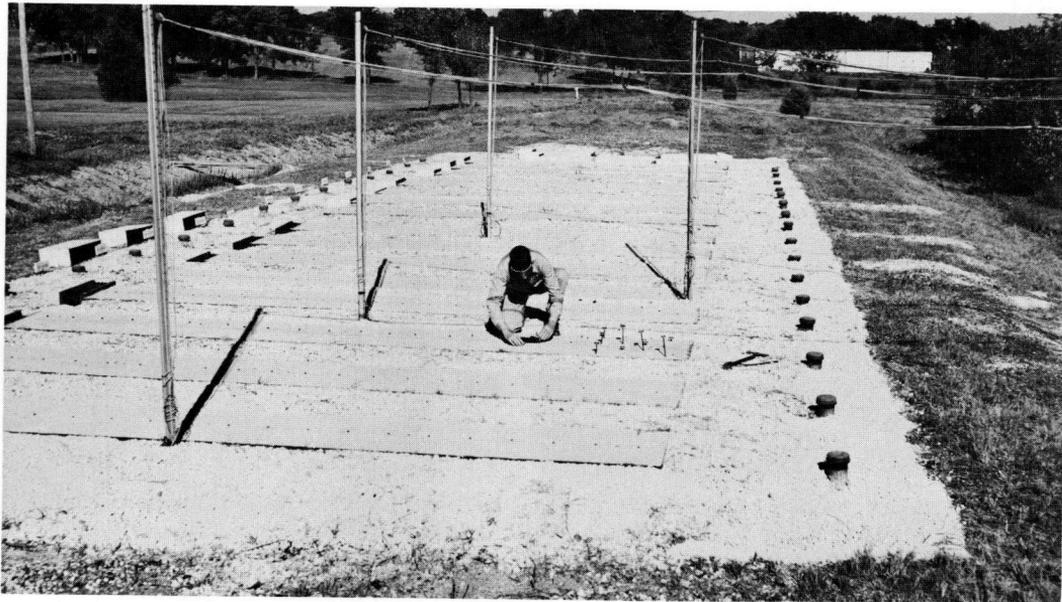
Figure 1. General view of test slabs from west.

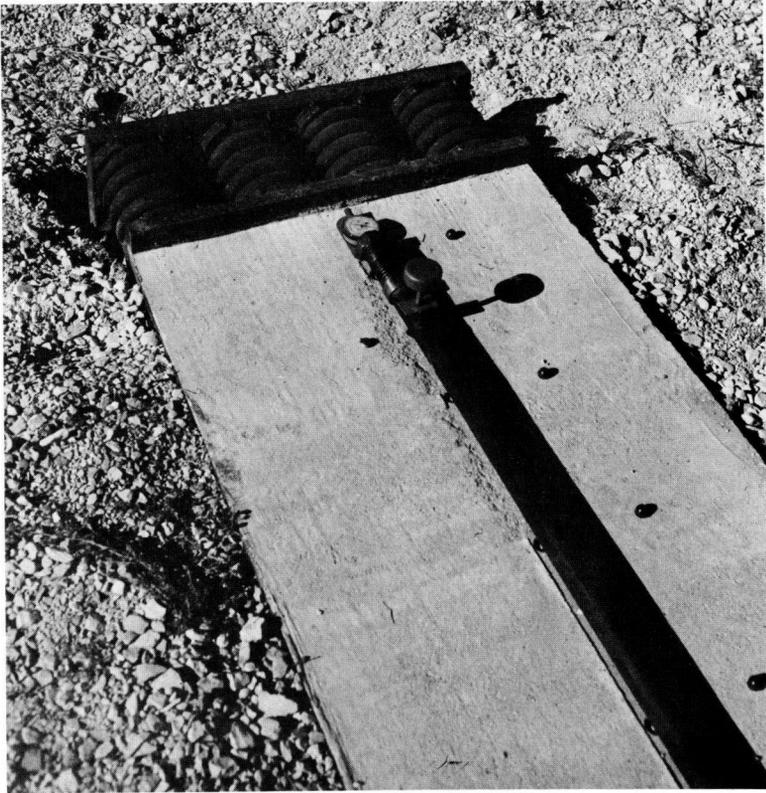
Figure 2. Steelplate and spring assembly at north end of slab prestressed to 500 psi, showing 200-in. gage in place.

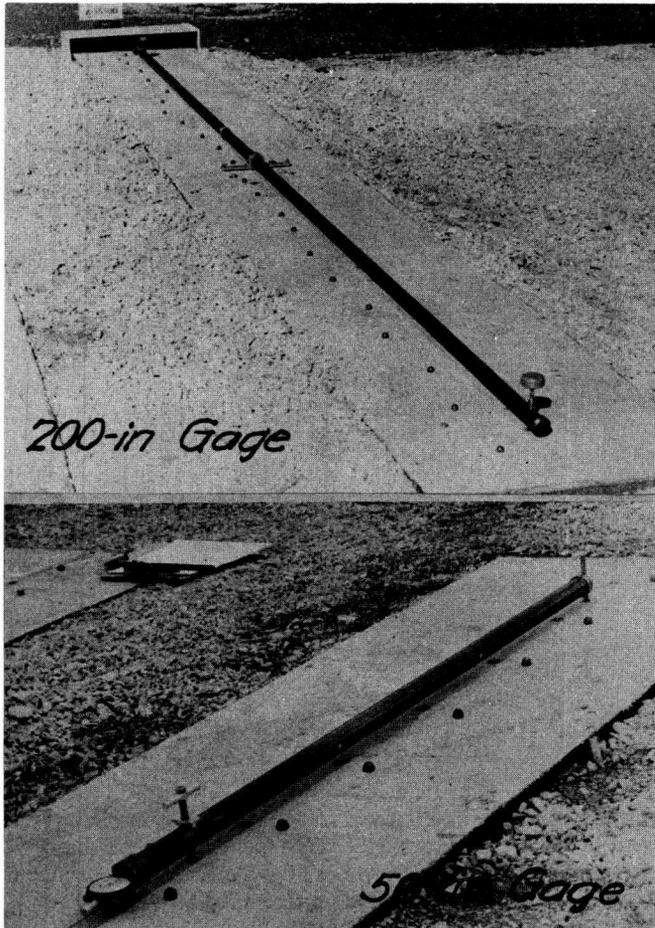
Figure 3. Temperature compensated length-change gages in place on slabs.

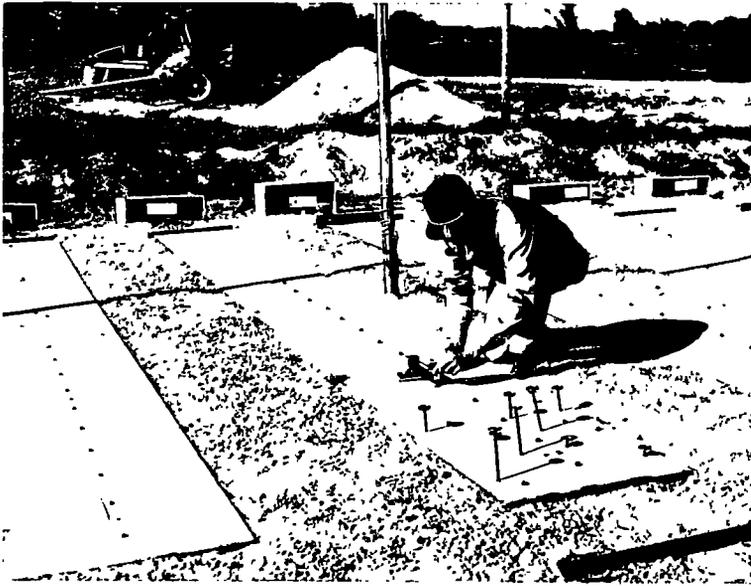
Figure 4. Clinometer measurements—thermometers in temperature wells; acorn nuts protecting clinometer points between measurements.

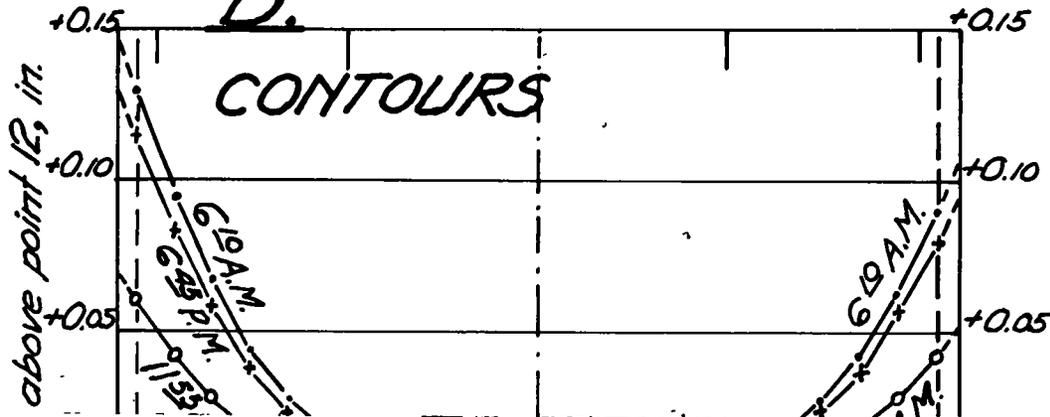
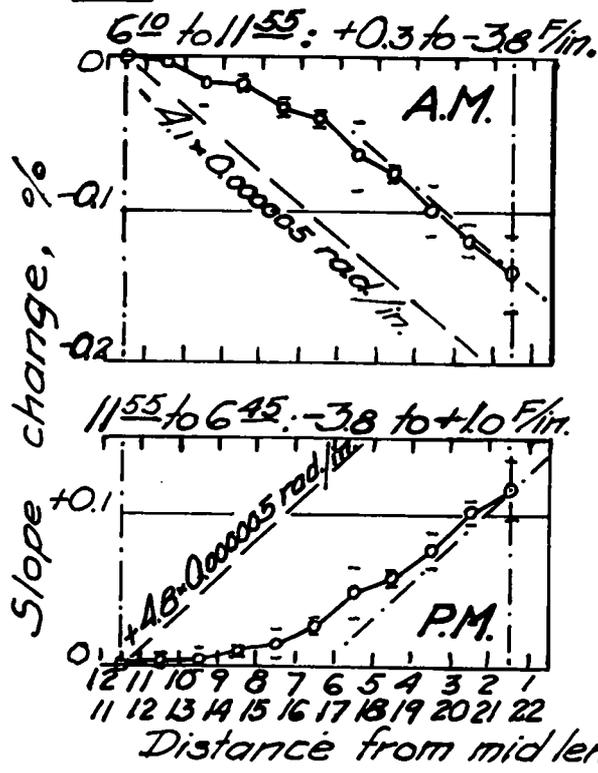
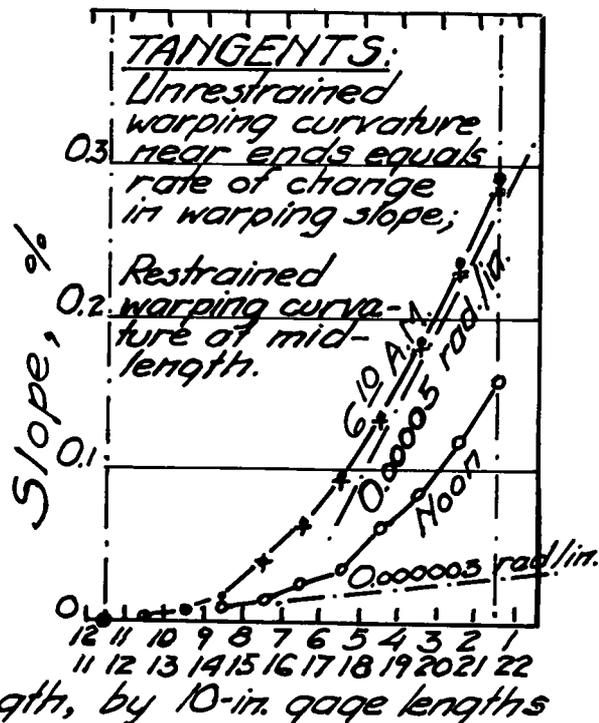
Figure 5. Experimental record for slab A 553 on September 15, 1956: (A) Temperature and length change data; (B) Contours, from clinometer readings; (C) Curling slope changes for morning and afternoon temperature change; (D) Warping slopes, averages for south and north halves.
