Bulletin 332

*Rigid Pavement Design Studies*

***Rigid Pavement Design Studies***

# Laboratory Studies of Progressive Bond Failure In Continuously-Reinforced Concrete Slabs

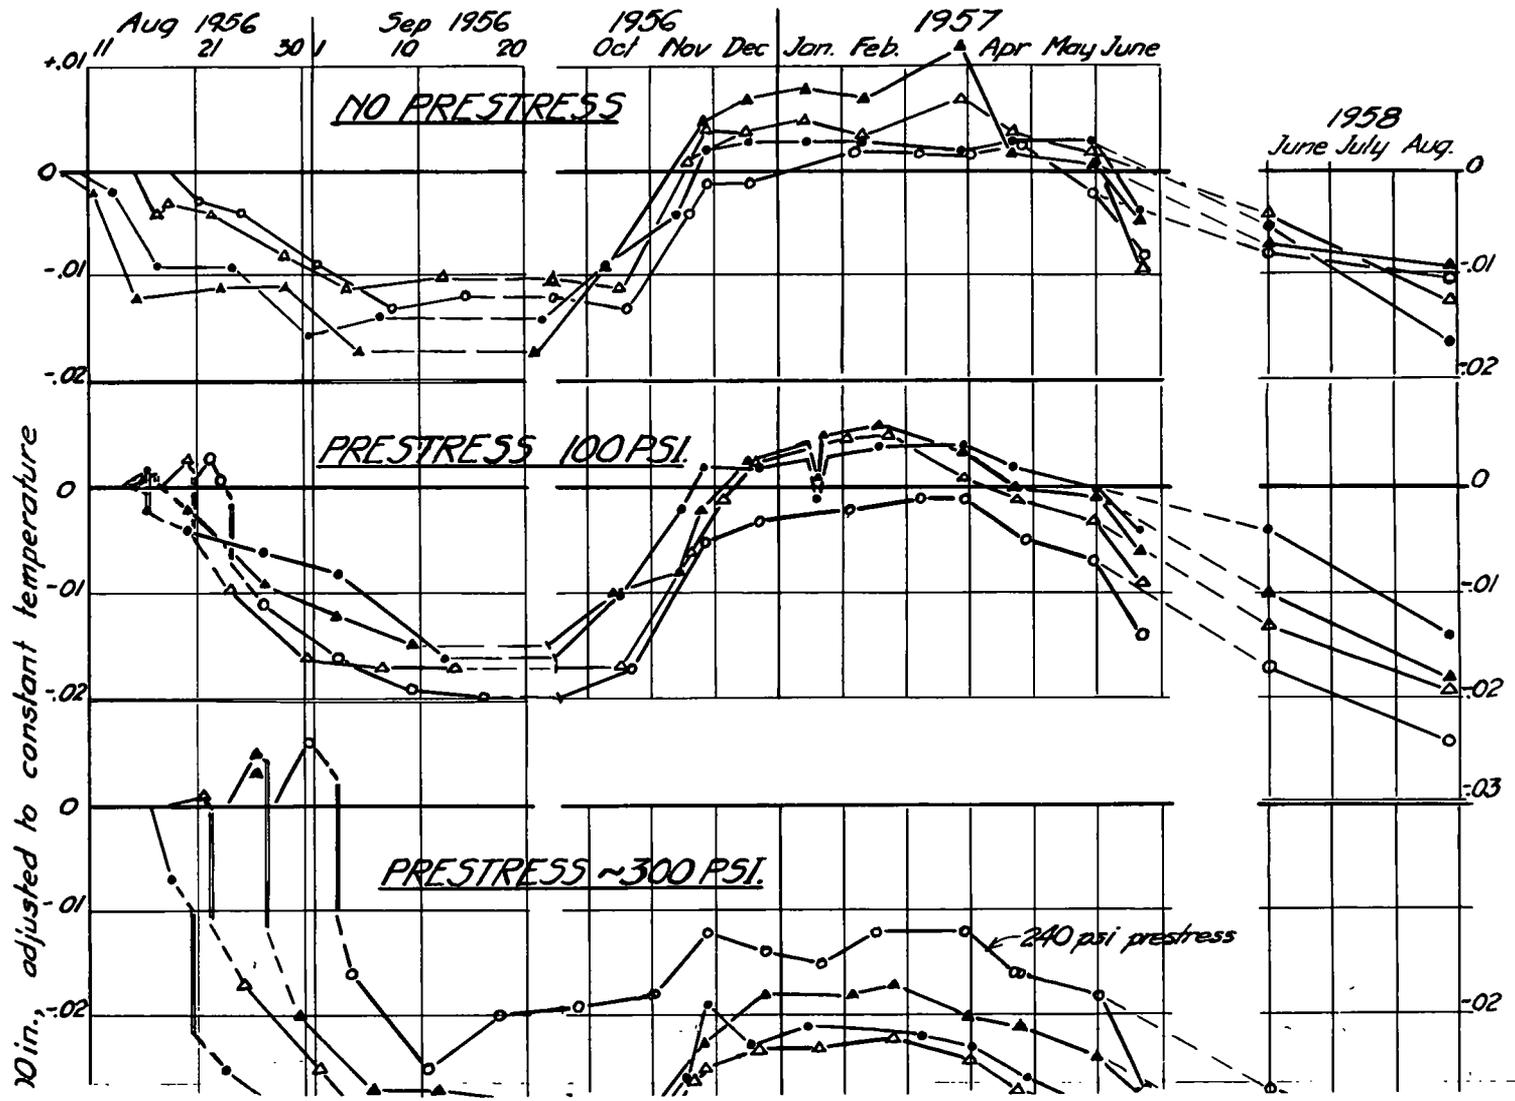
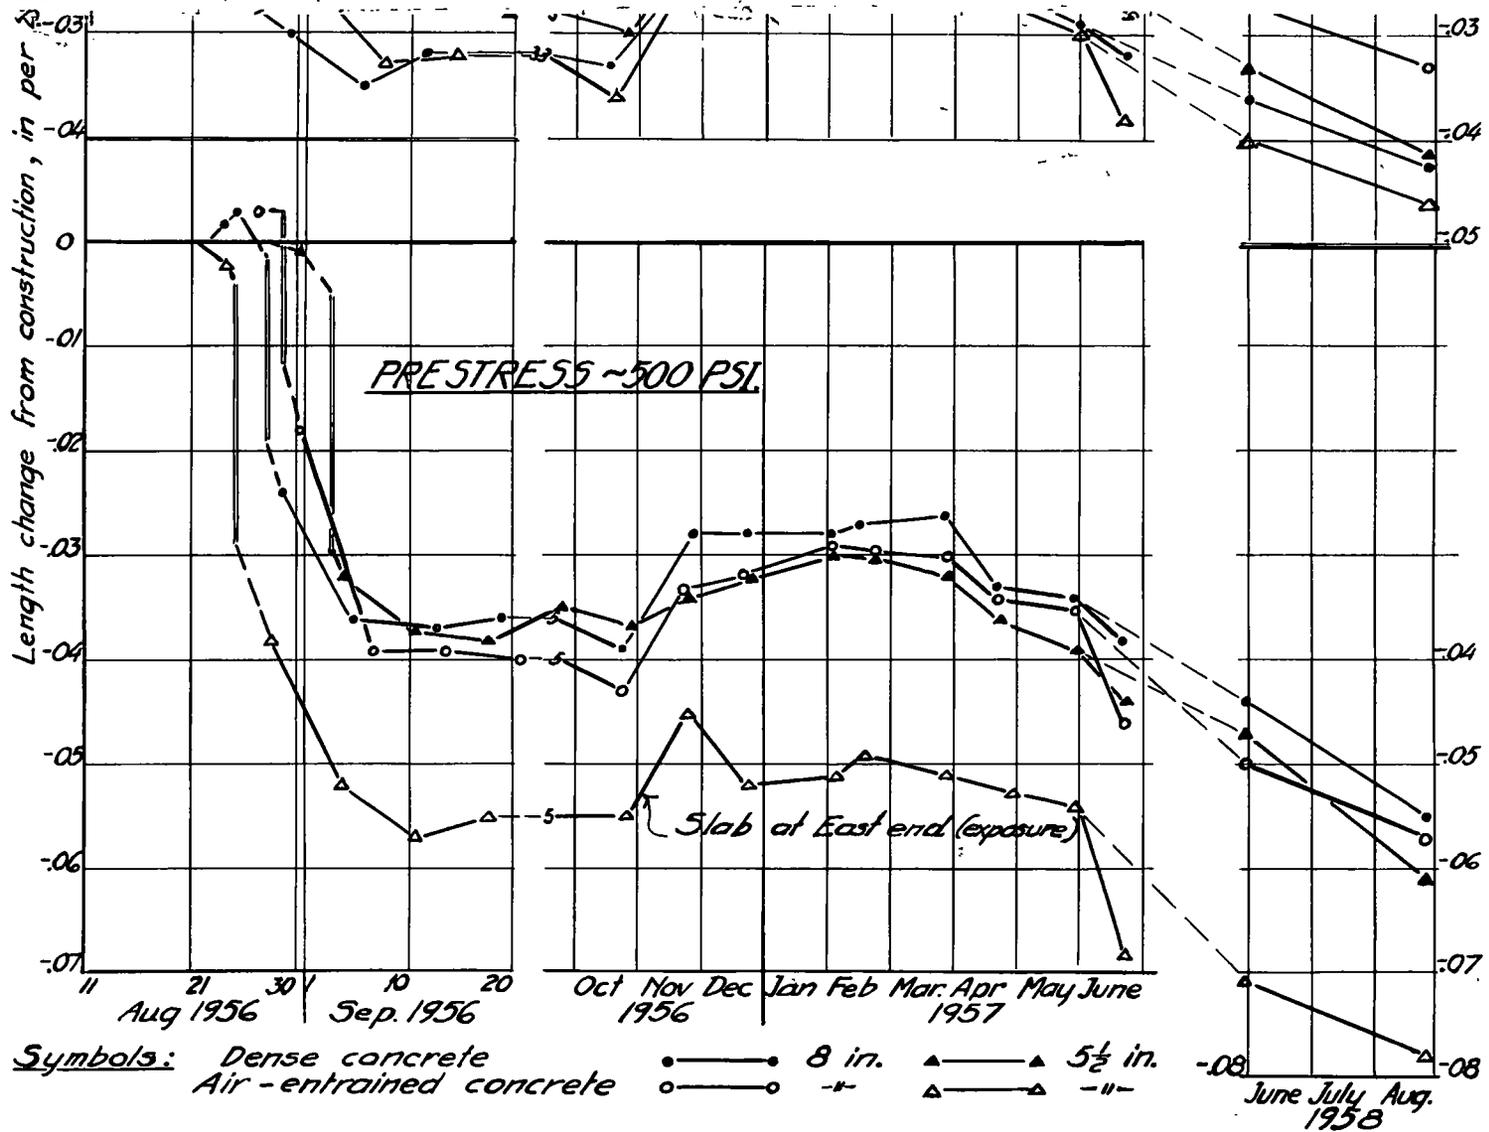
Figure 6. Progressive length changes of all field slabs to two years, adjusted to mid-depth and to 70 F temperature.

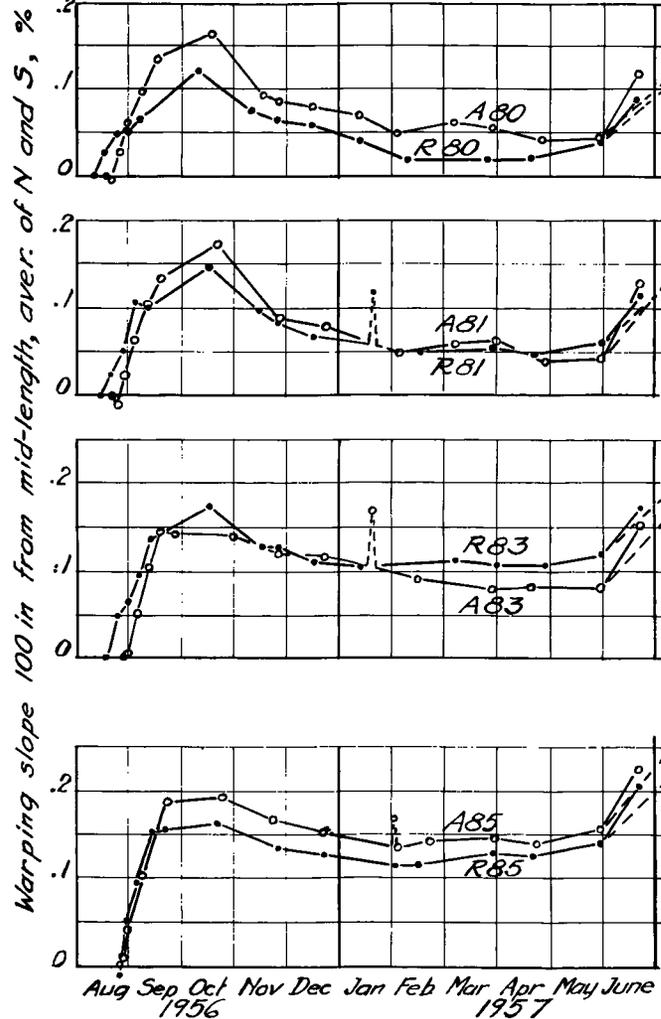
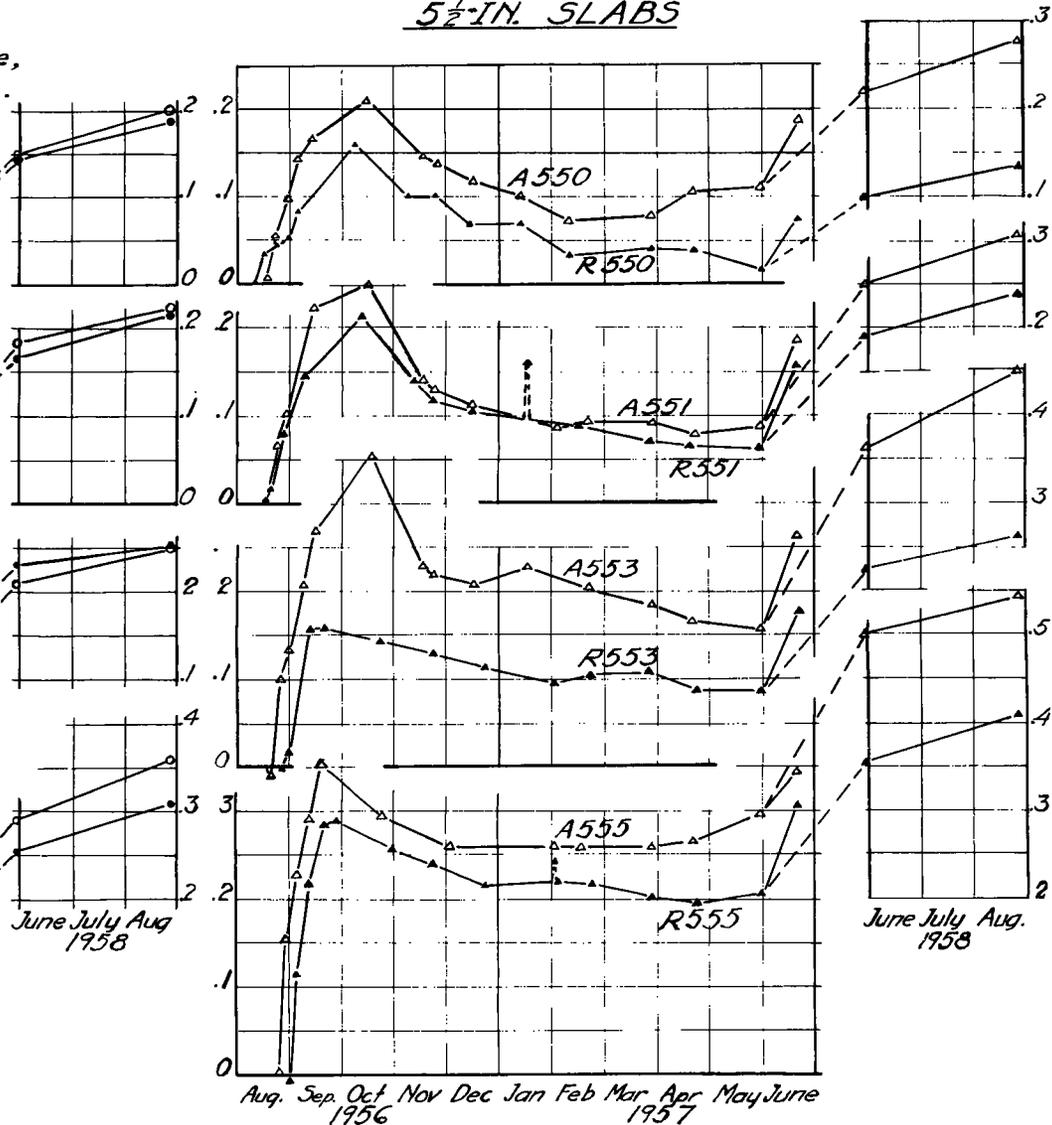
Figure 7. Progressive warping to two years; warping slopes average of north and south slopes, 100 in. from midlength.

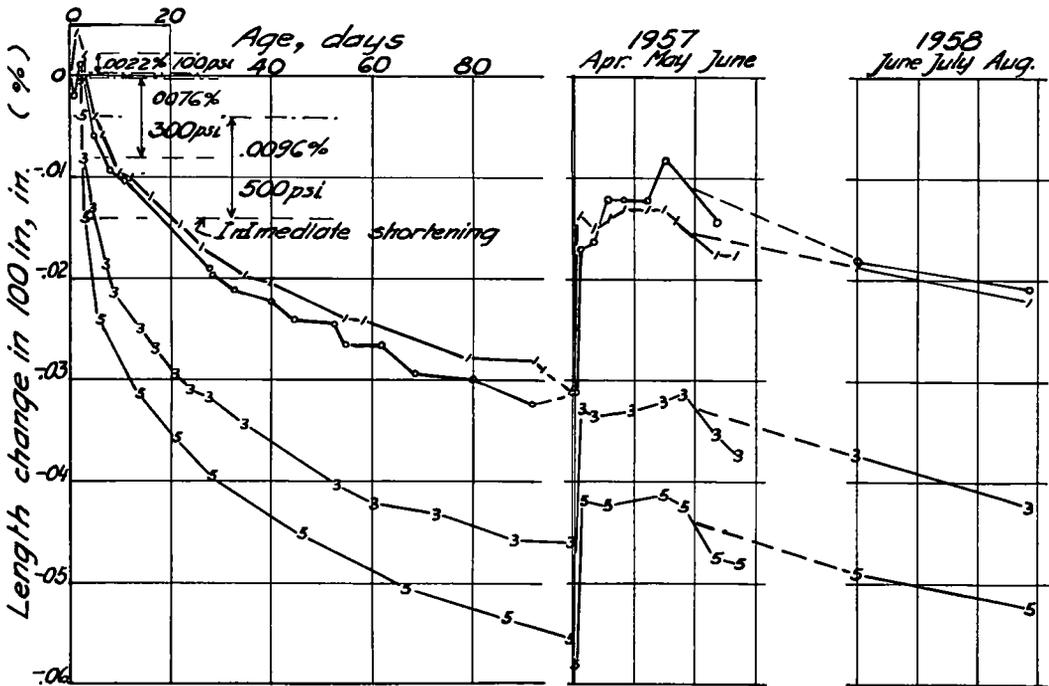
Figure 8. Length changes of correlation slabs during indoor exposure and on grade after April 1, 1957.

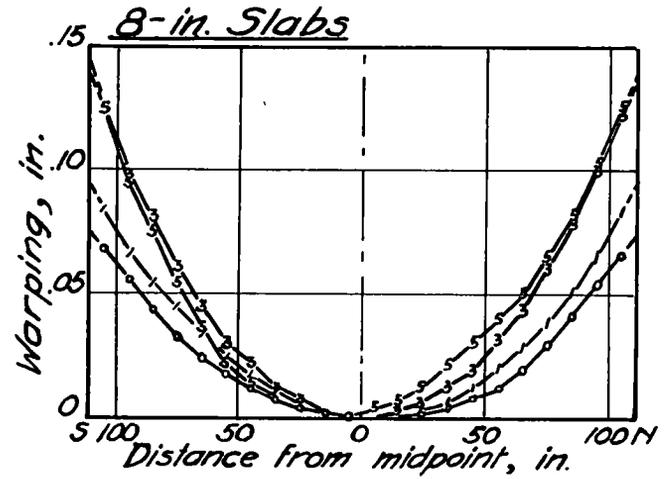
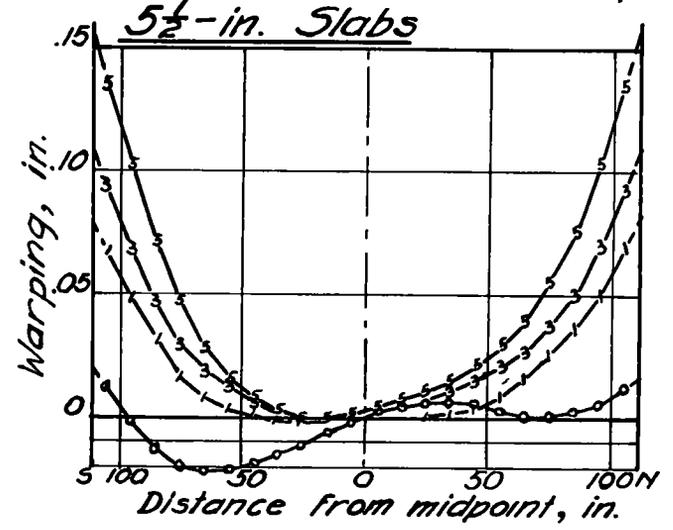
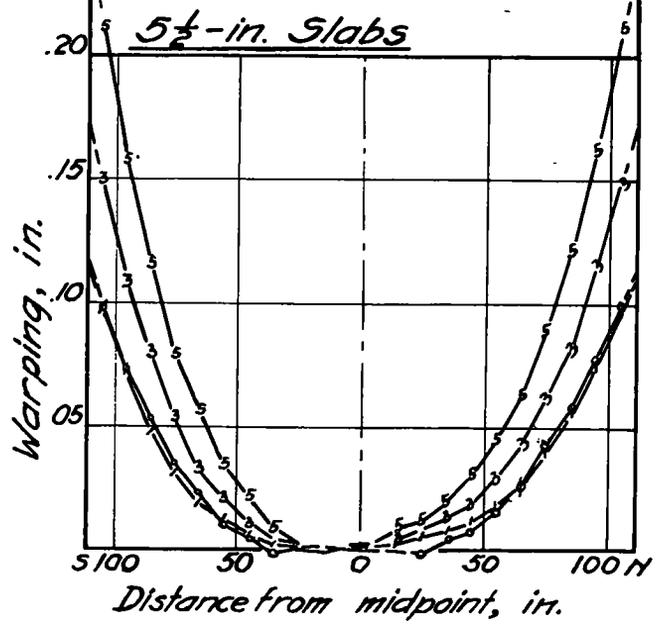
Figure 9. Warped contours at 21-month age, adjusted for slab tilt.

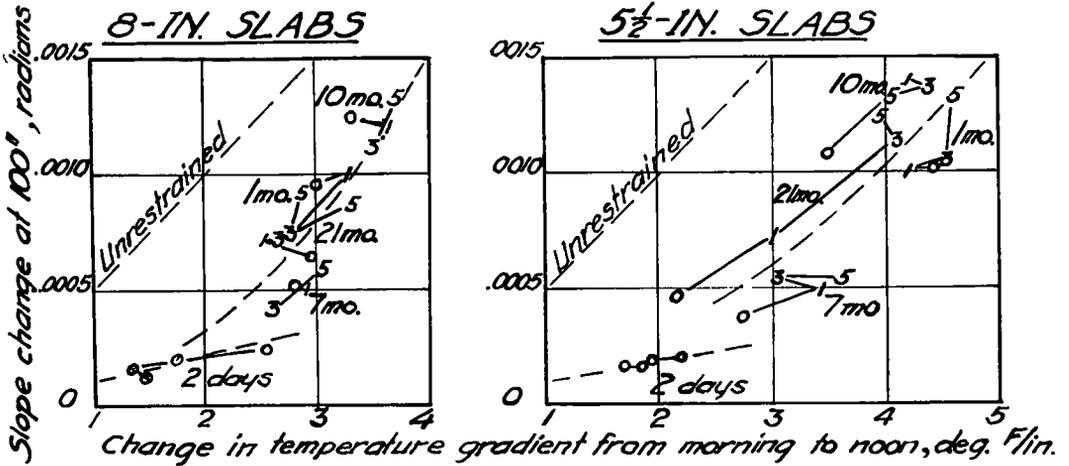
Figure 10. Curling slope change related to change in temperature gradient, at different ages up to 21 months.

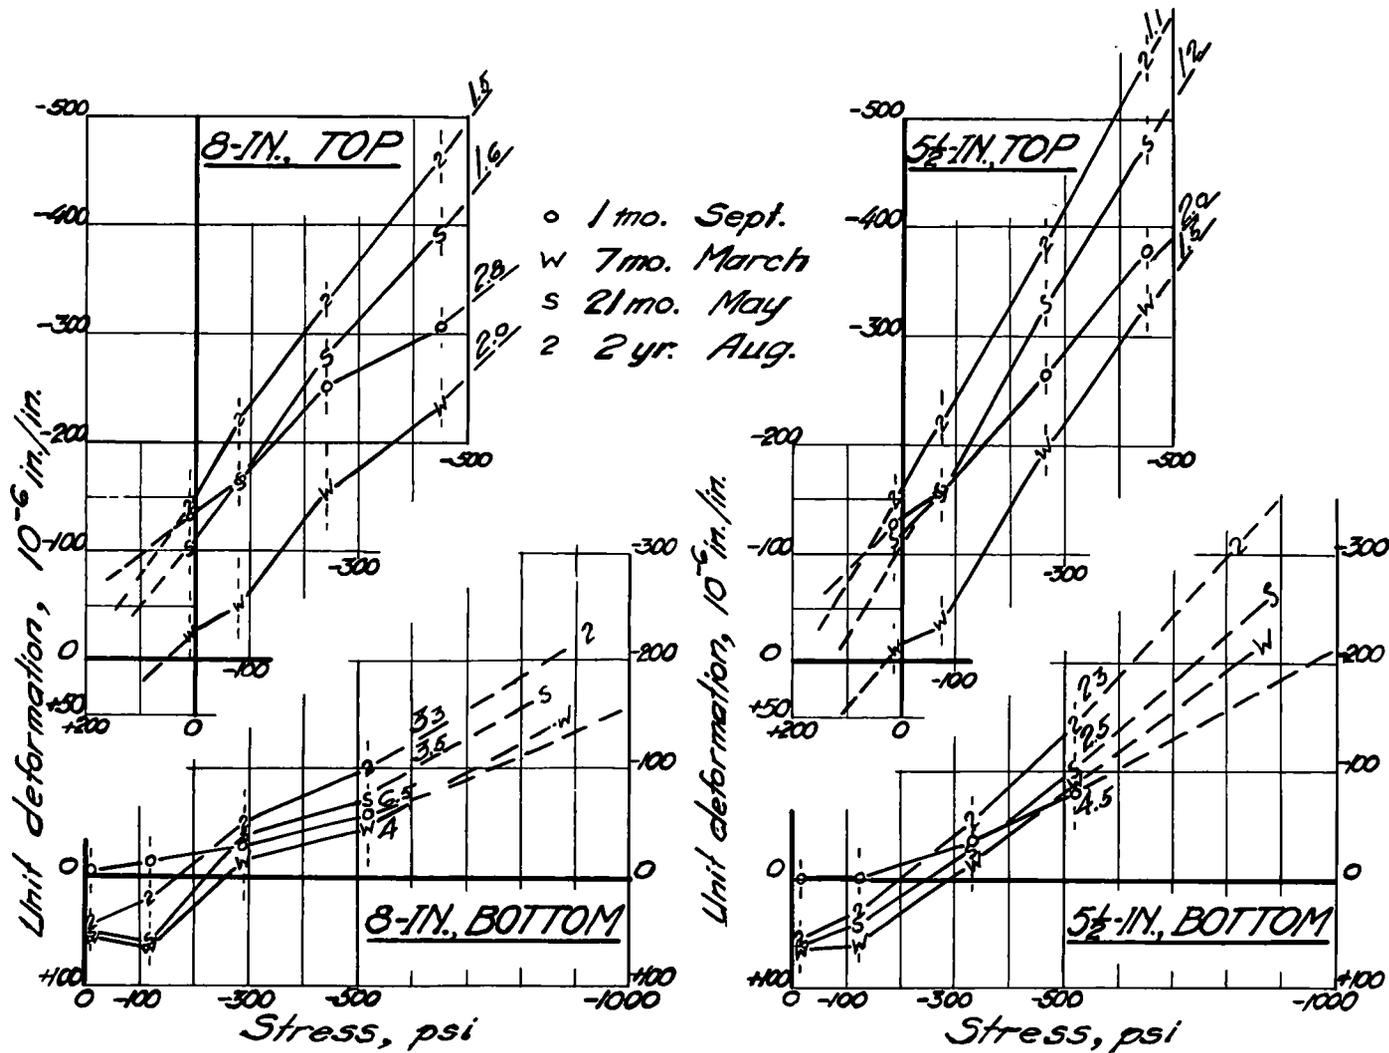
Figure 11. Observed unit deformations related to known stresses at top and bottom near ends, at different ages to 2 years. Inclinations of curves show modulus-of-deformation values in millions psi.

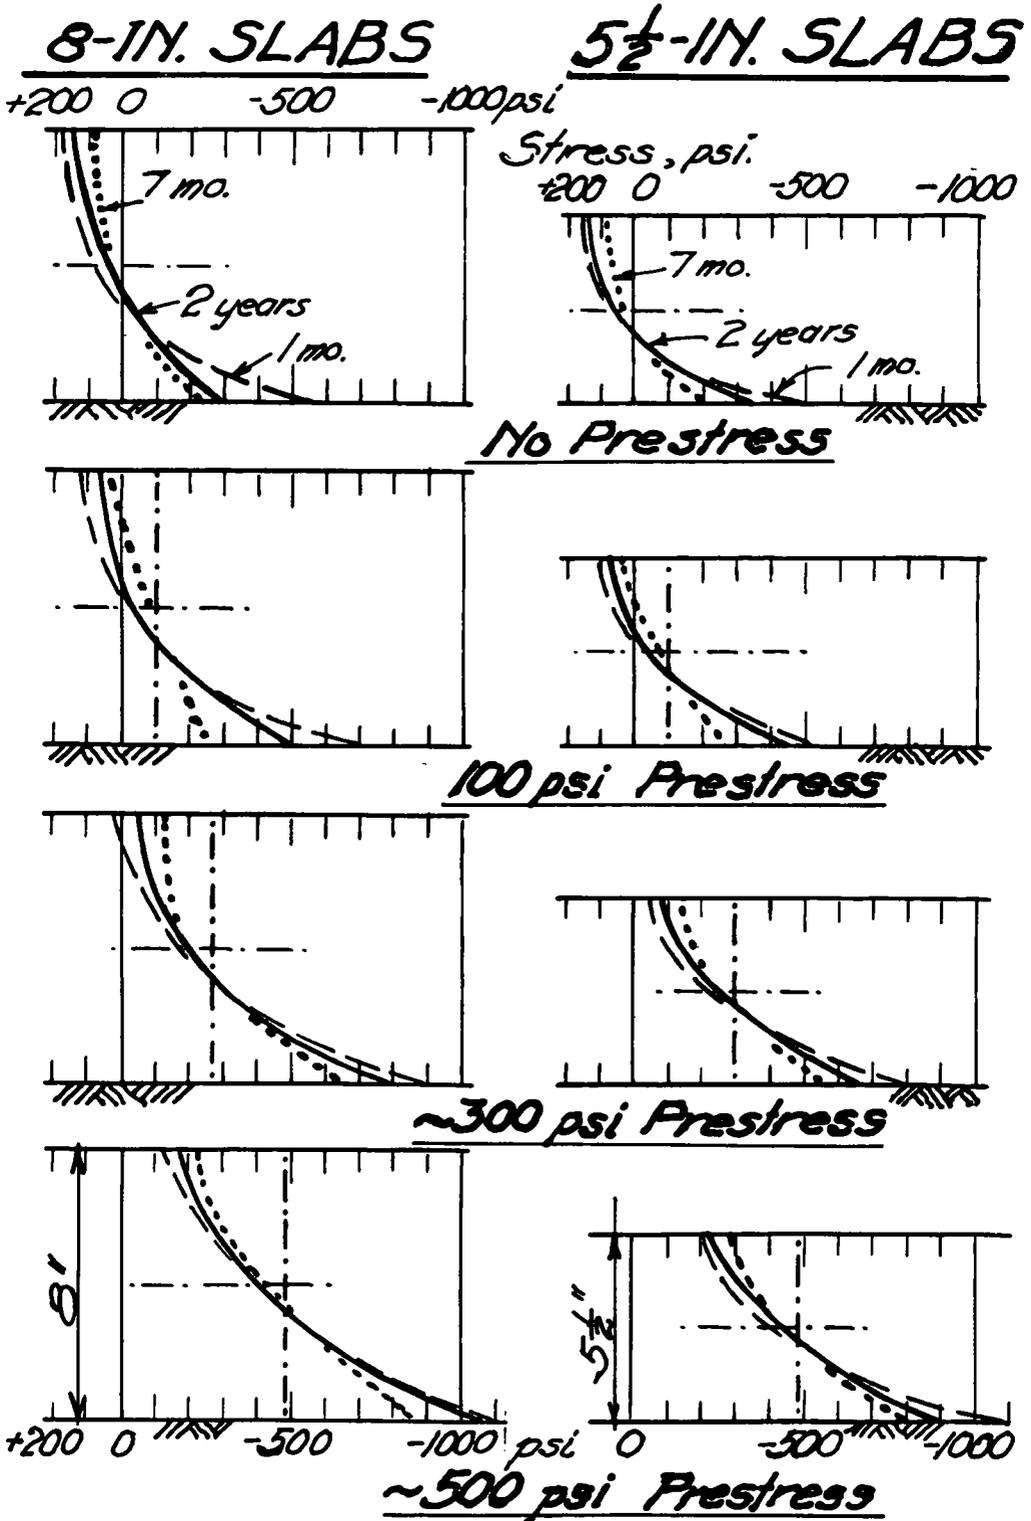
Figure 12. Stress distribution from top to bottom for full restraint of warping, based on unit deformations observed in the field slabs.

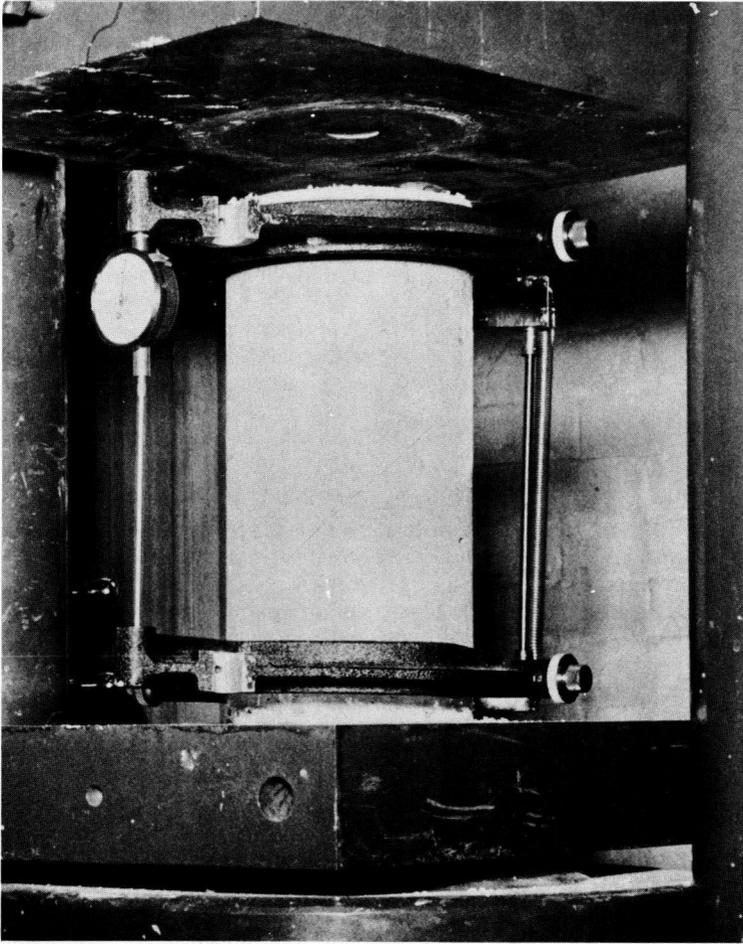
Figure 13. Compression cylinder with Riehle compensating compressometer in place in testing machine.

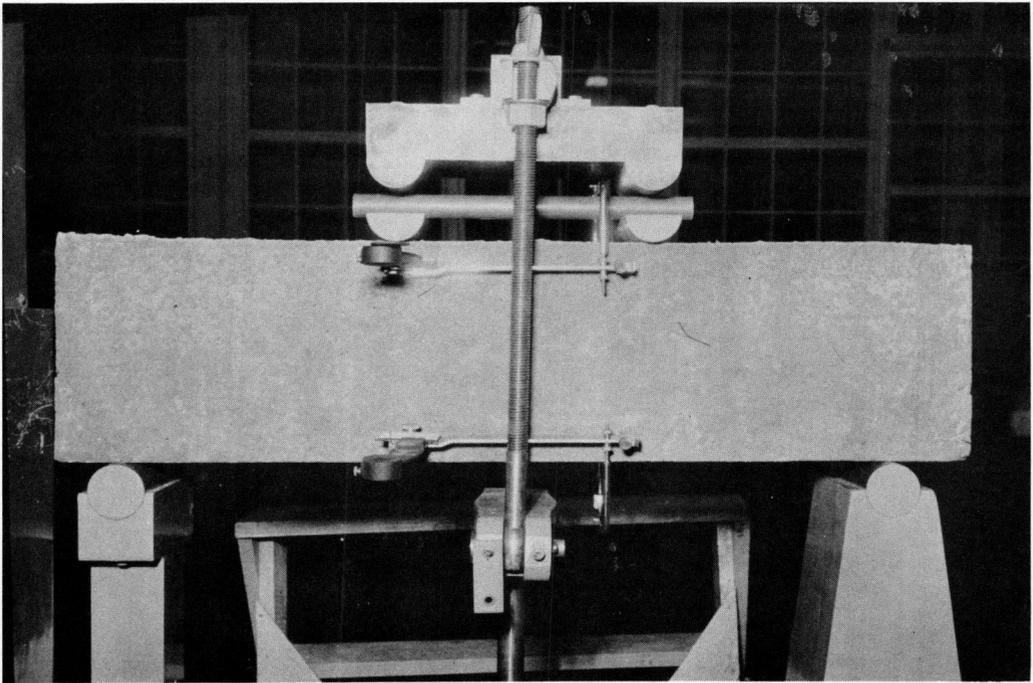
Figure 14. Beam with loading rig and Huggenberger tensometer gages attached in place in beam testing machine. Beams in 70 and 40 F tests had half-round bars at the load points; beams in 100 F tests had round bars.

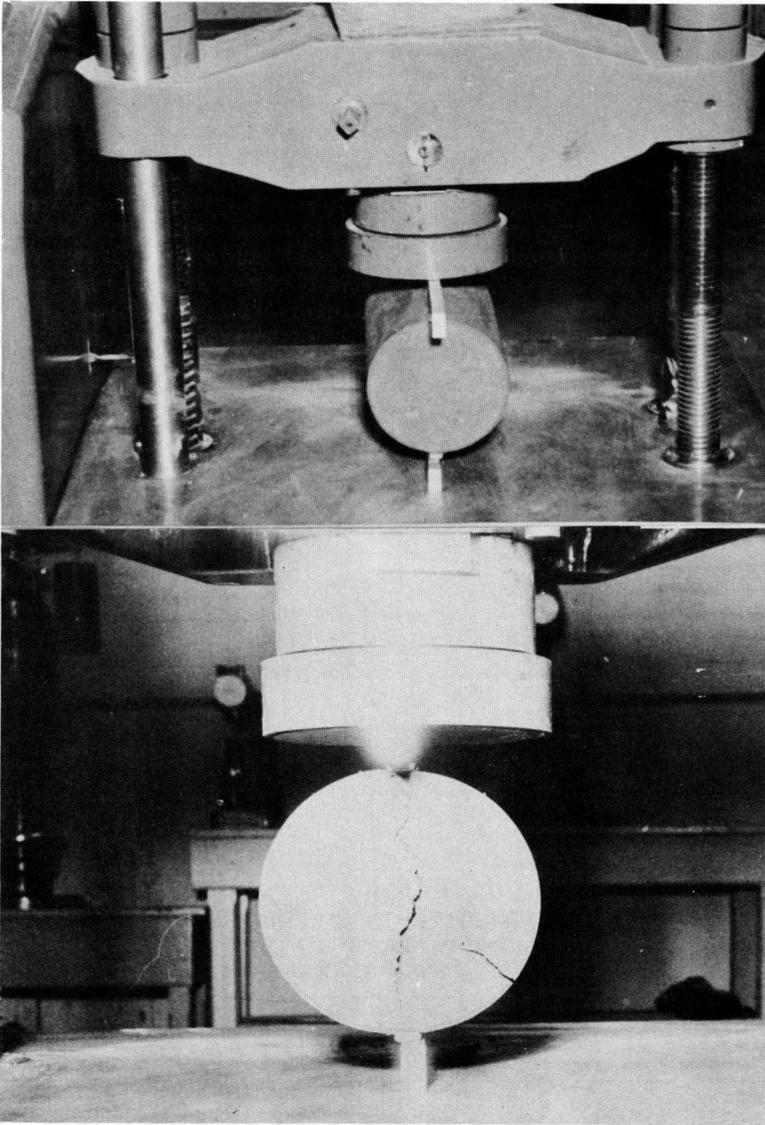
Figure 15. Tensile splitting test—cylinder in place in the testing machine (upper) and immediately after splitting failure (lower).

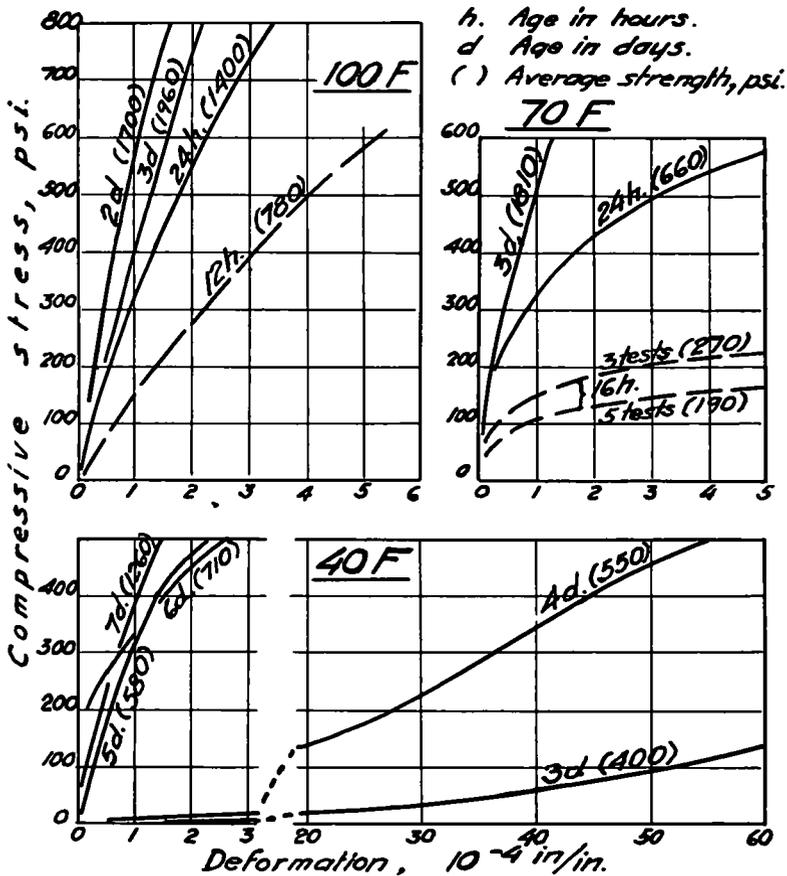
Figure 16. Average deformation-stress diagrams at early age; one cylinder only in 4-, 5-, and 6-day tests at 40 F.

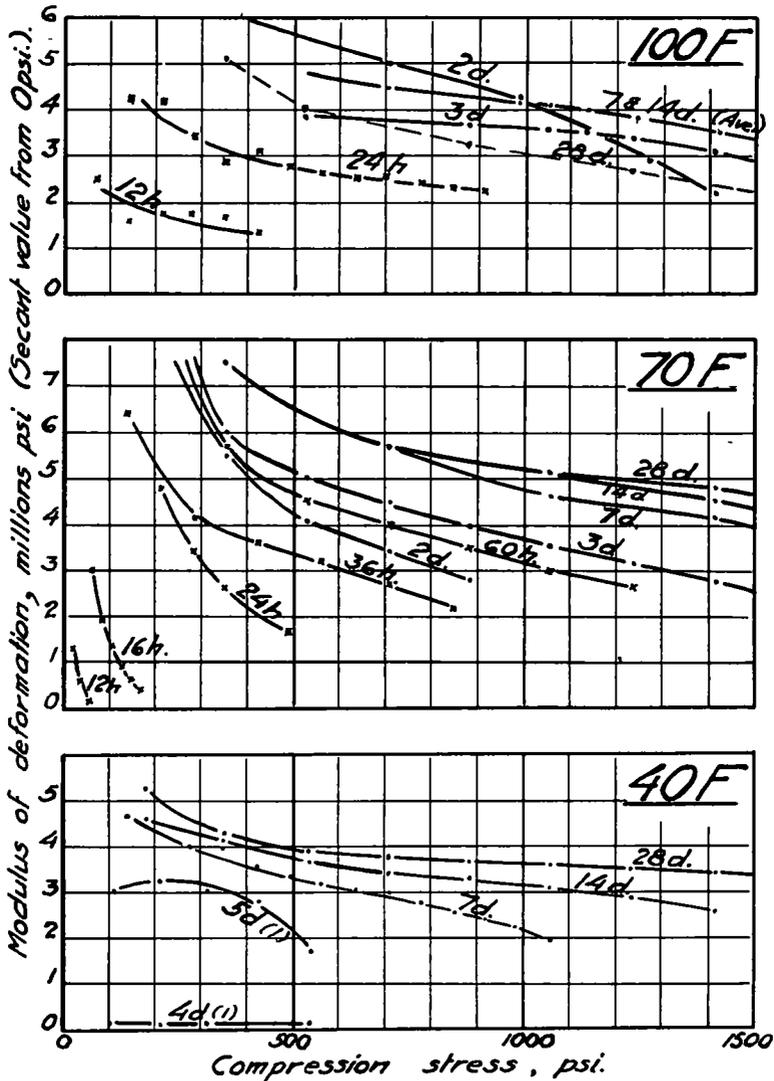
Figure 17. Secant modulus of deformation at different ages, observed on compression cylinders from 0 stress to stress indicated by abscissa.

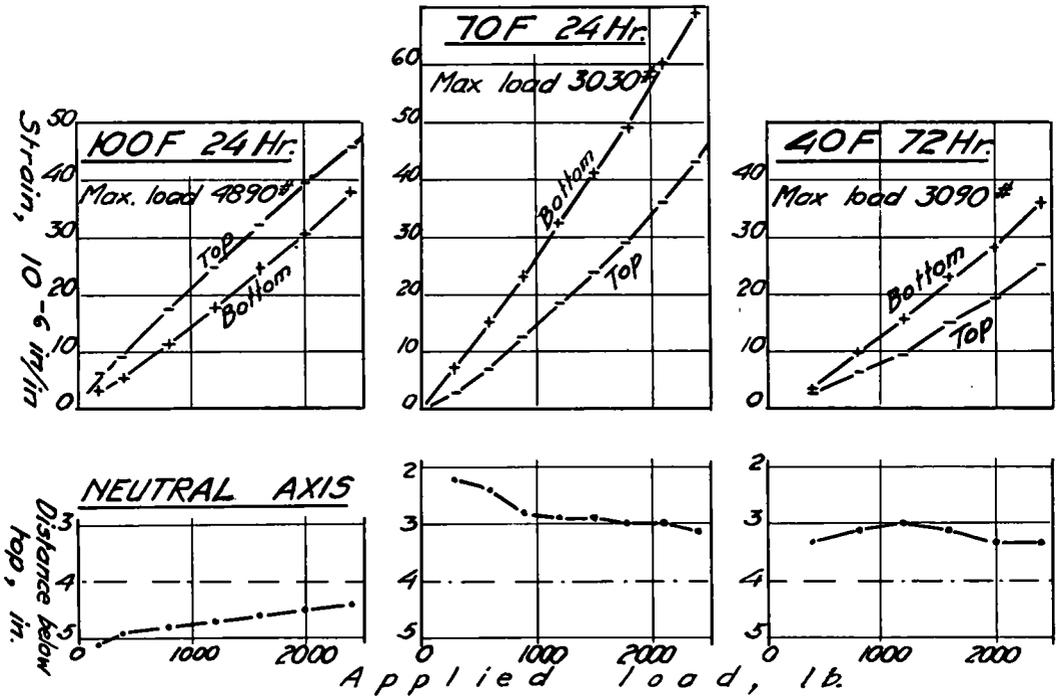
Figure 18. Top and bottom edge strains, and location of neutral axis, in beams for increasing applied load, prorated from observed strains, at early age.

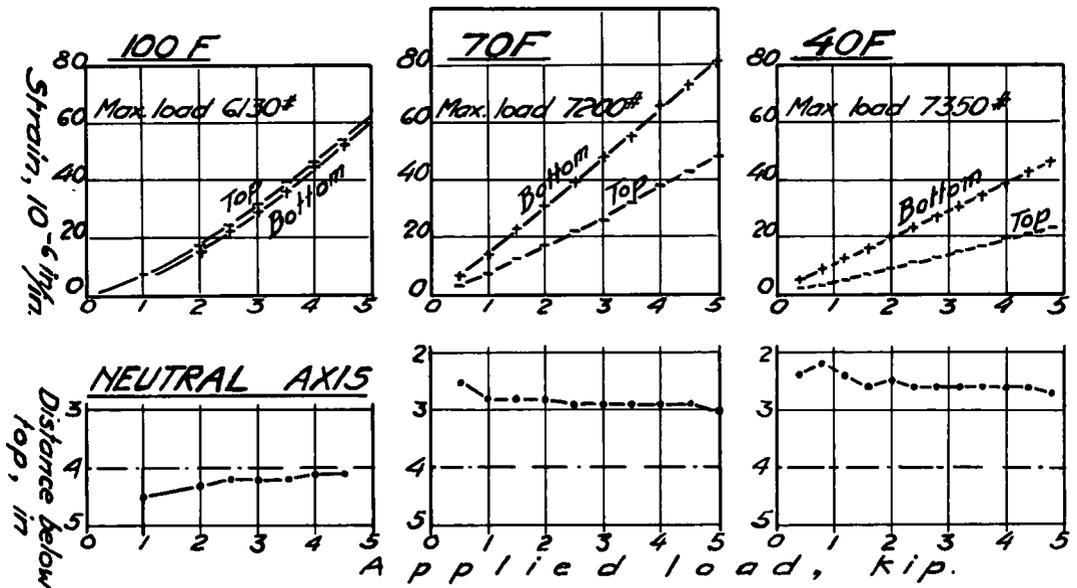
Figure 19. Top and bottom edge strains and location of neutral axis for increasing applied load on 14-day beams.

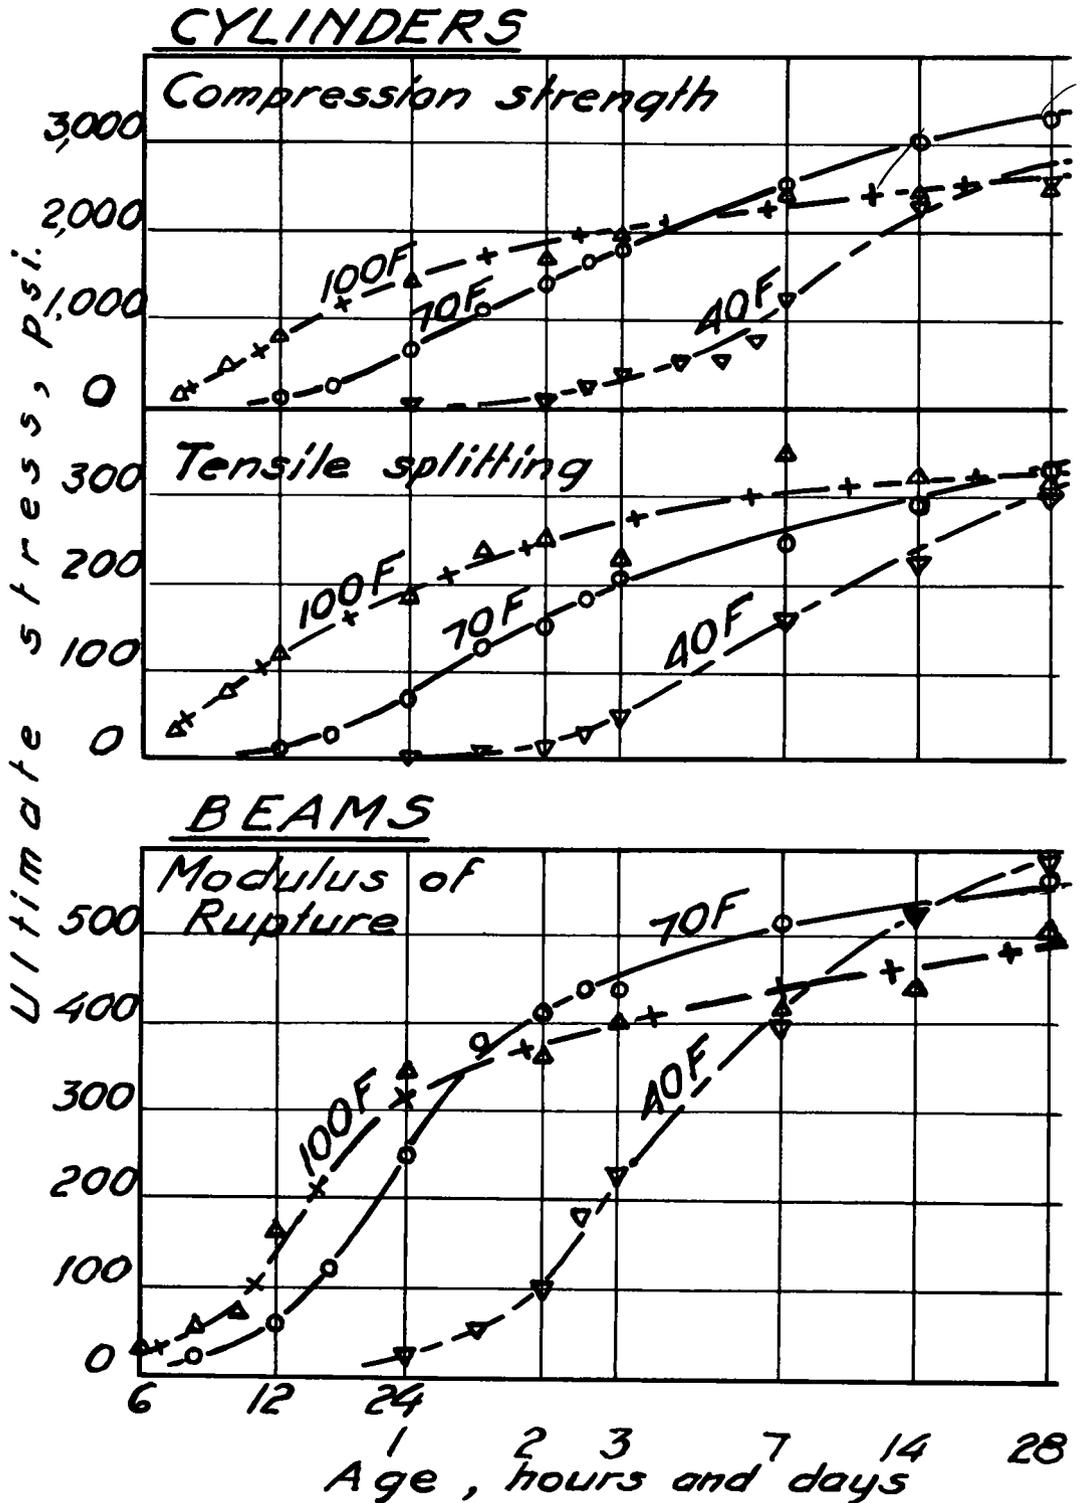
Figure 22. Compression and tensile splitting resistance on cylinders and modulus of rupture of beams at early age to 28 days.

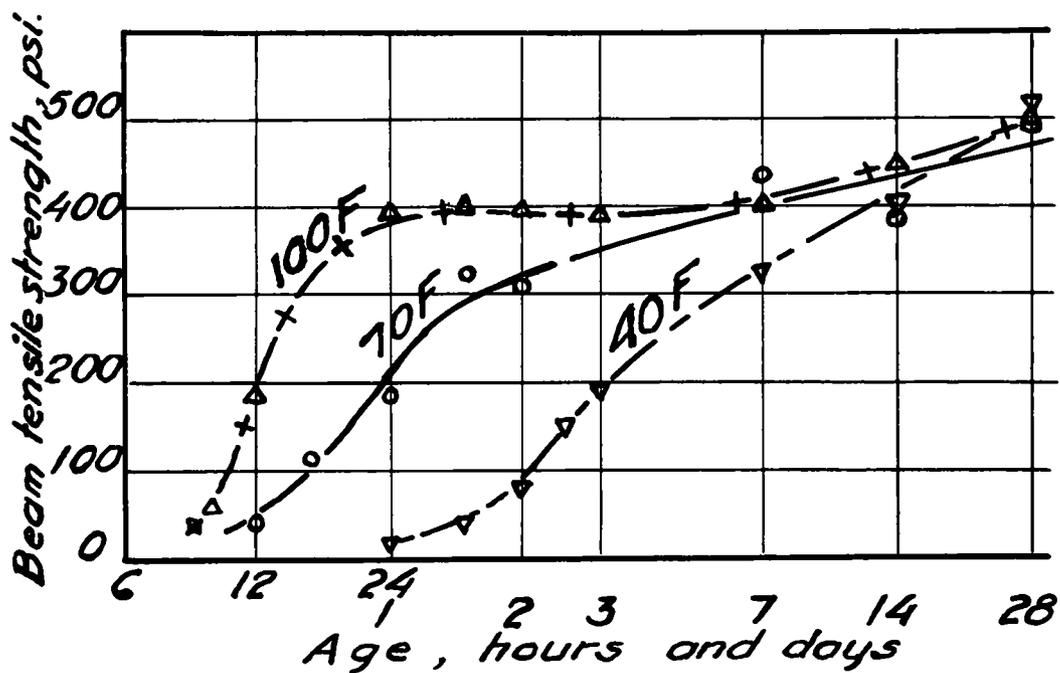
Figure 23. Beam tension strength at early age to 28 days based on stress distribution indicated by beam strains.

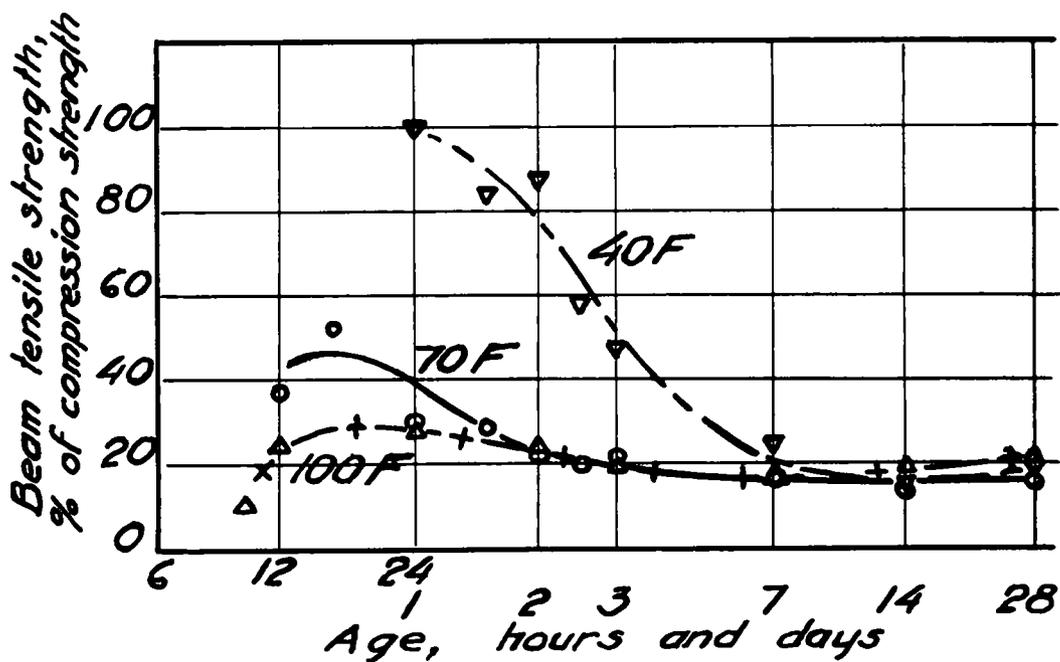
Figure 24. Beam tension strength in percent of compression strength at early age to 28 days.

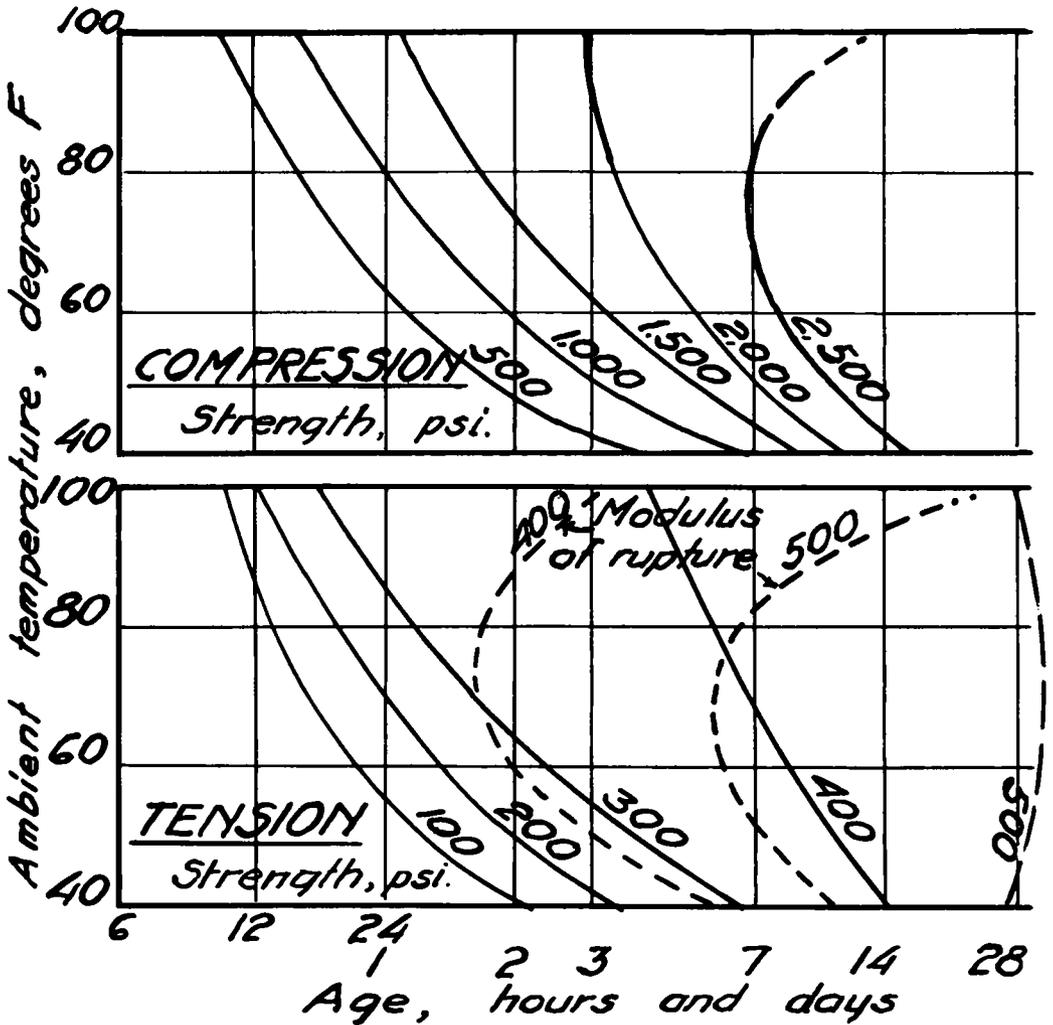
Figure 25. Relation between age and ambient temperature, for concrete to reach indicated strength values in compression and in flexural tension.

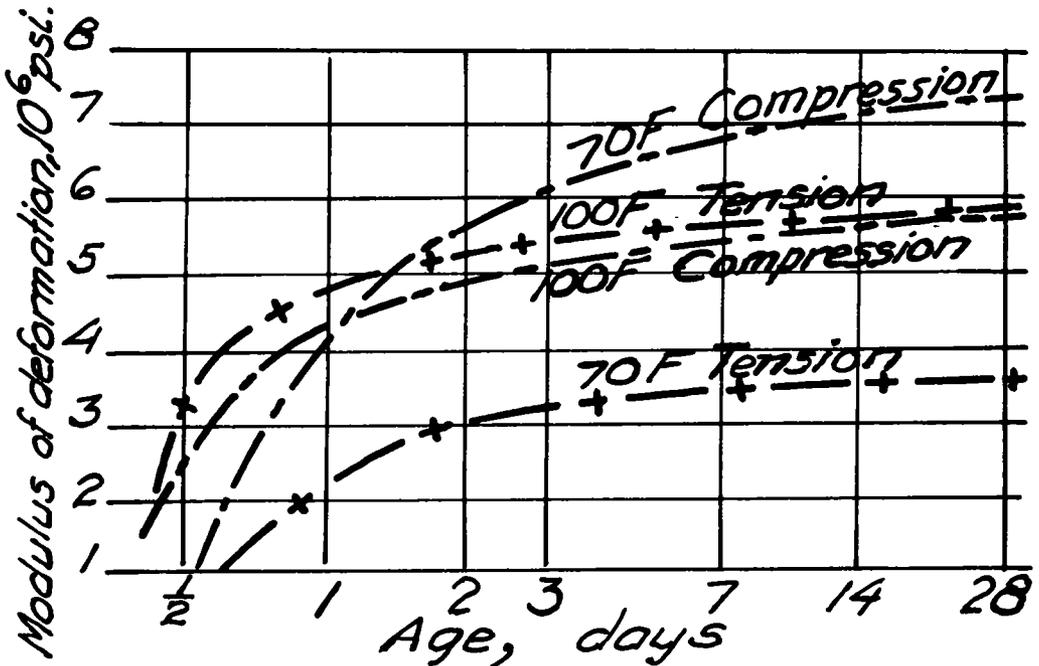
Figure 26. Modulus of deformation (elasticity) at early age to 28 days, in compression and in tension, for stress values within the flexural strengths, at 70 and 100 F ambient temperature.

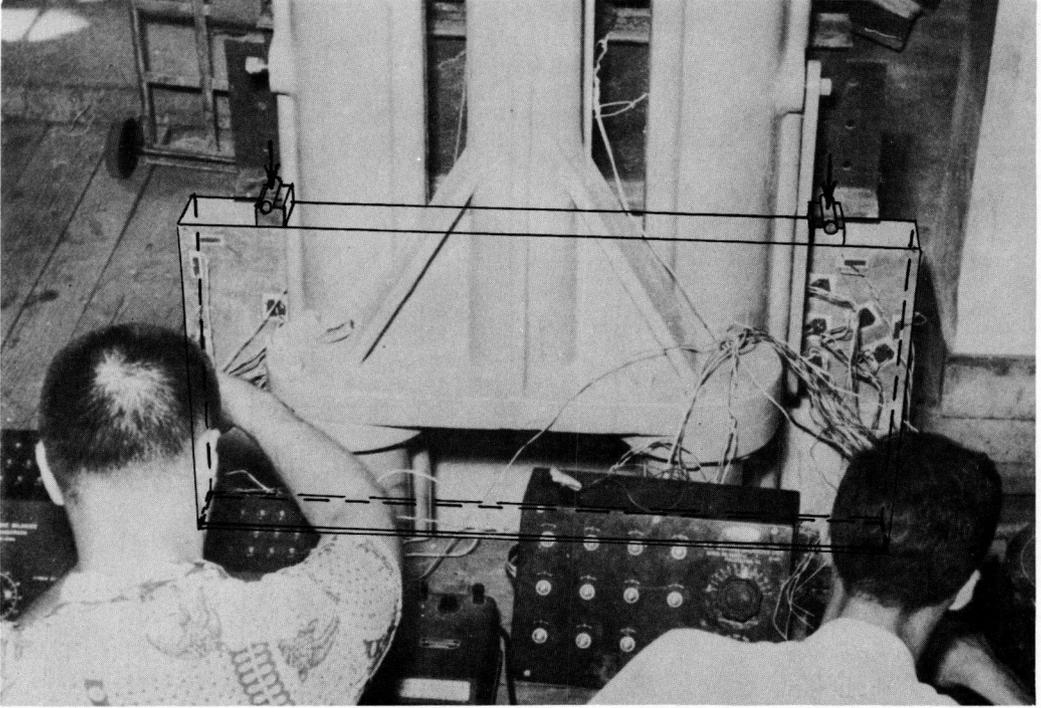
Figure 27. Short-time test specimen in place in testing machine for symmetrical loading with loads 6 in. from each corner.

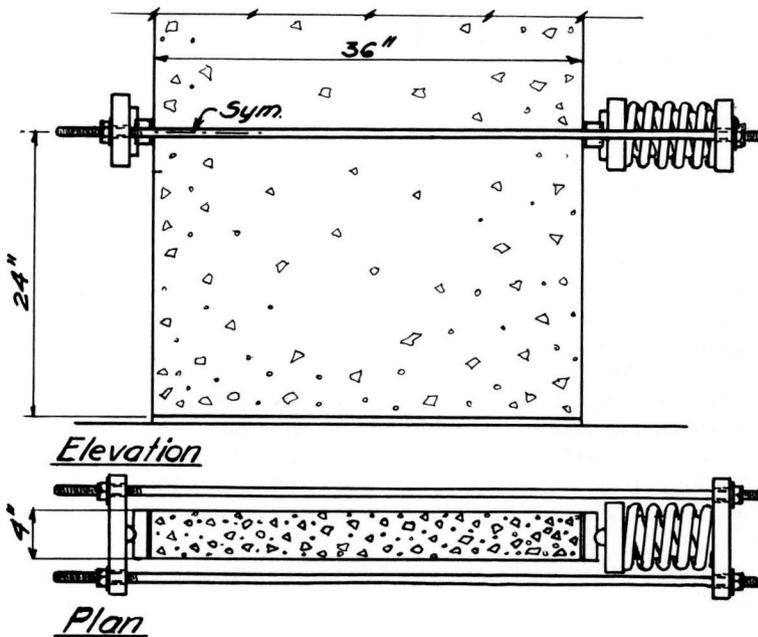
Figure 28. Loading arrangement for long-time tests, center load.
