Bulletin 332

*Rigid Pavement Design Studies*

***Rigid Pavement Design Studies***

# Laboratory Studies of Progressive Bond Failure In Continuously-Reinforced Concrete Slabs

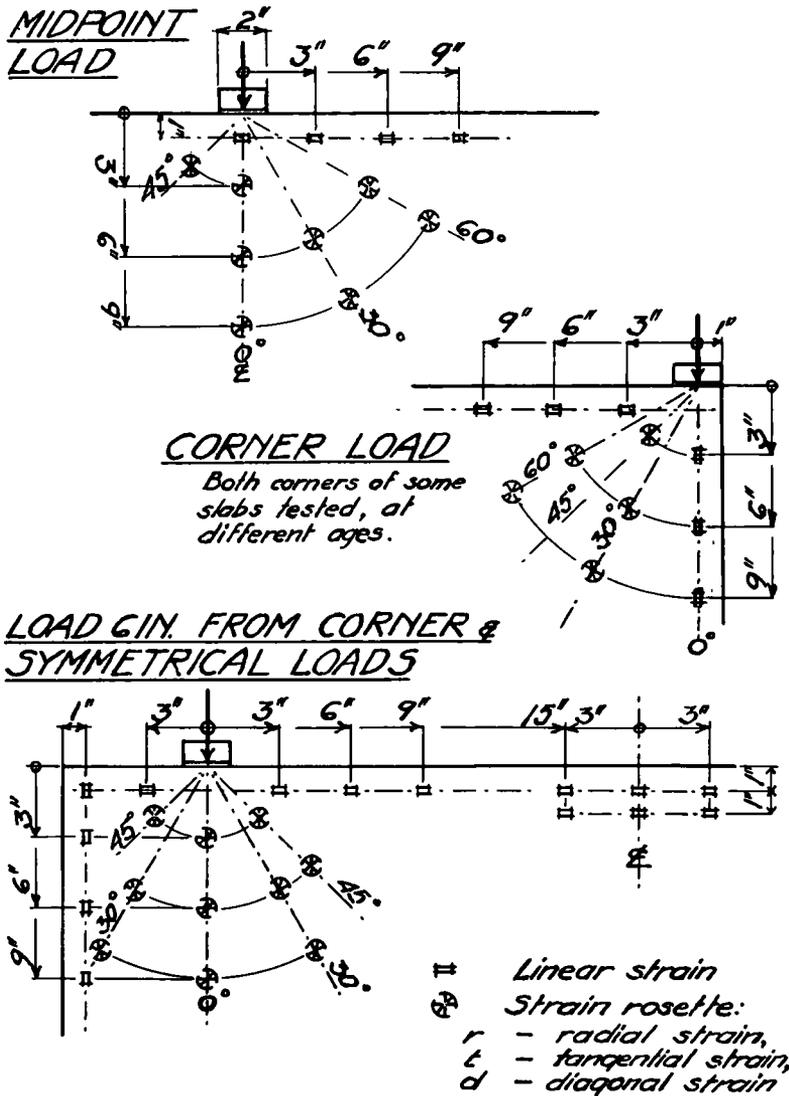
Figure 29. Dimensional orientation and identification of linear and rosette strain gages.

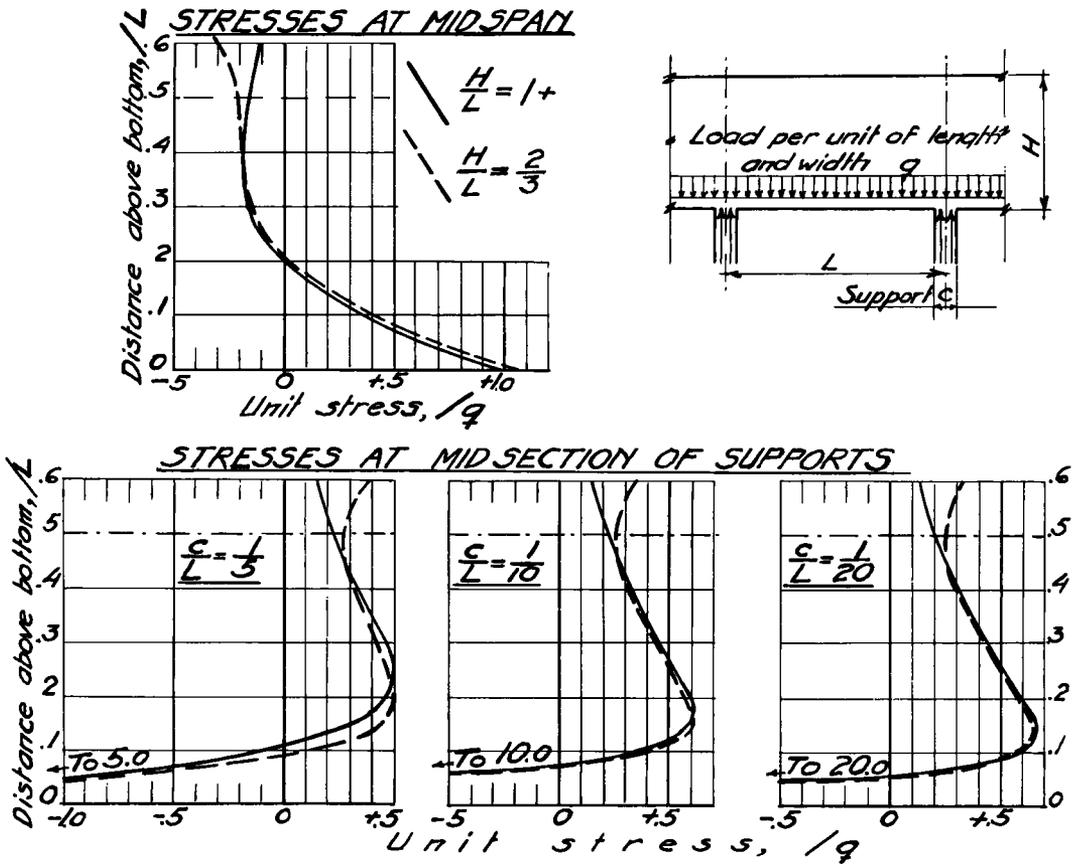
Figure 30. Stress distribution on sections of deep continuous beams with evenly distributed loading, at center span and midsections of the supports, for different support concentrations, Dischinger solutions.

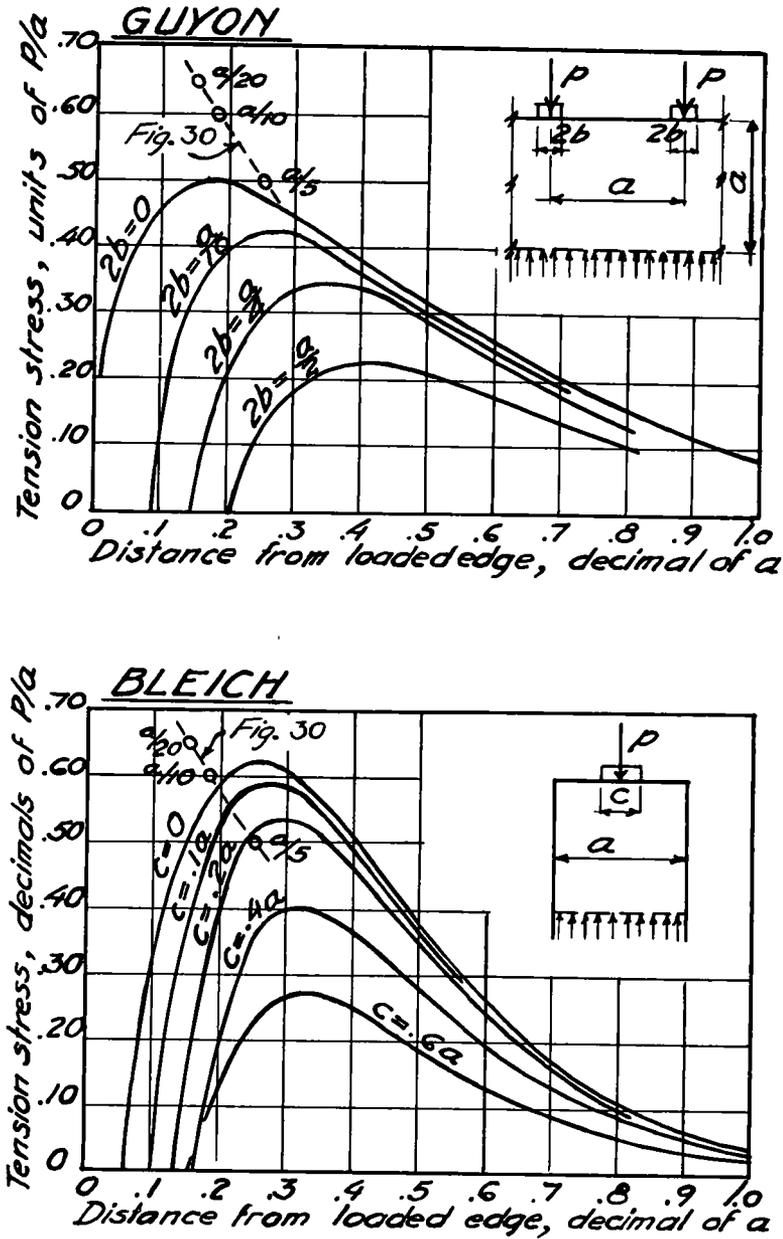
Figure 31. "Bursting" stresses under concentrated loading. End block stresses in prestressed members studied by Guyon; Bleich solutions computed by Ban, Muguruma, and Ogaki.

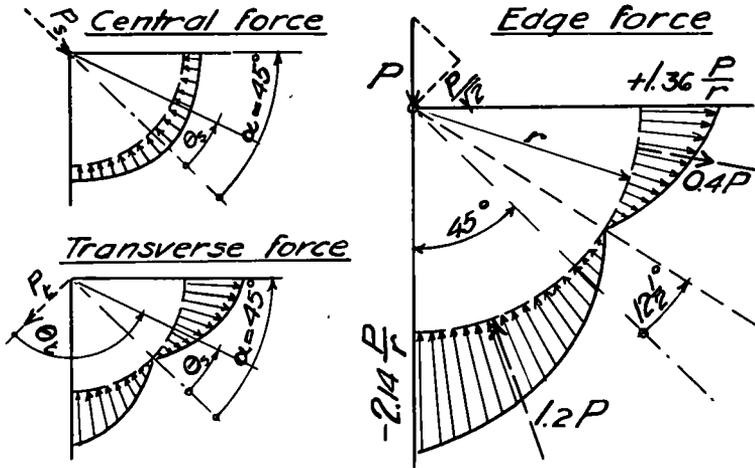
Figure 33. Concentrated forces against 90° corner. Stress distribution for central and transverse force and for force along one edge at the corner.

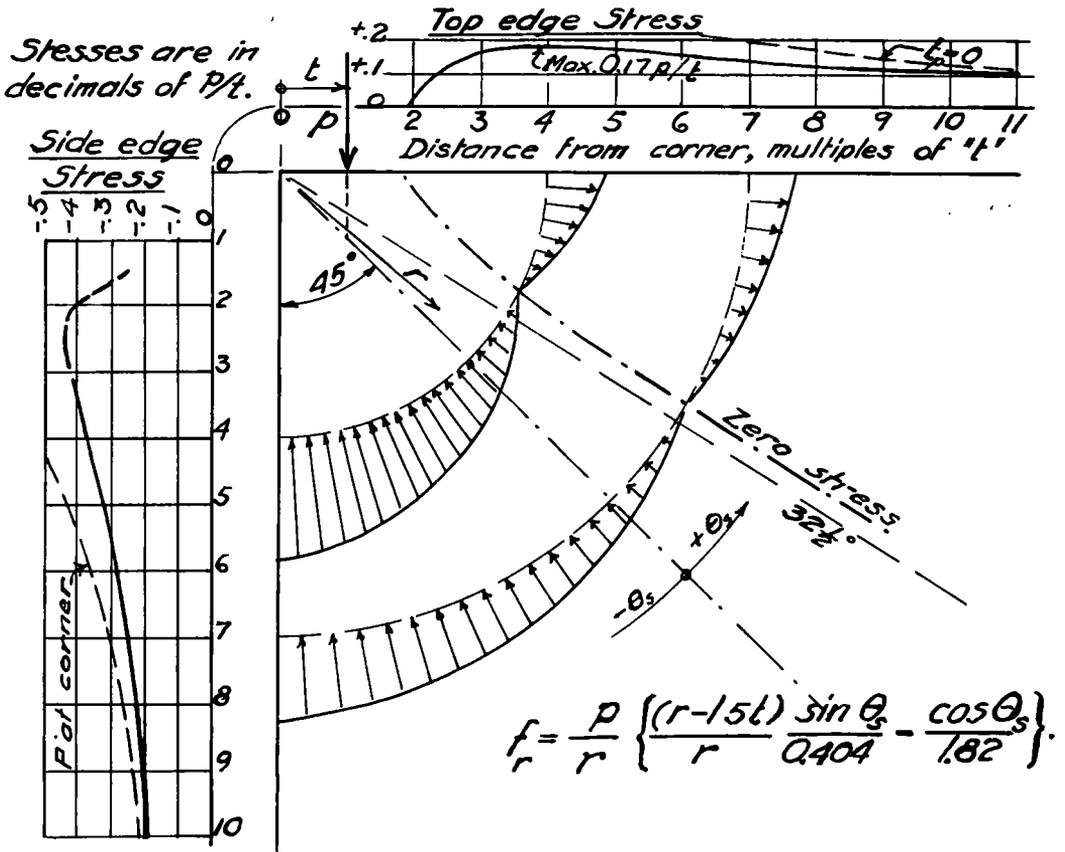
Figure 34. Approximate radial stress distribution on circular slab sections at varying radii from the corner, for load some distance in from and parallel with one edge of a 90° corner.

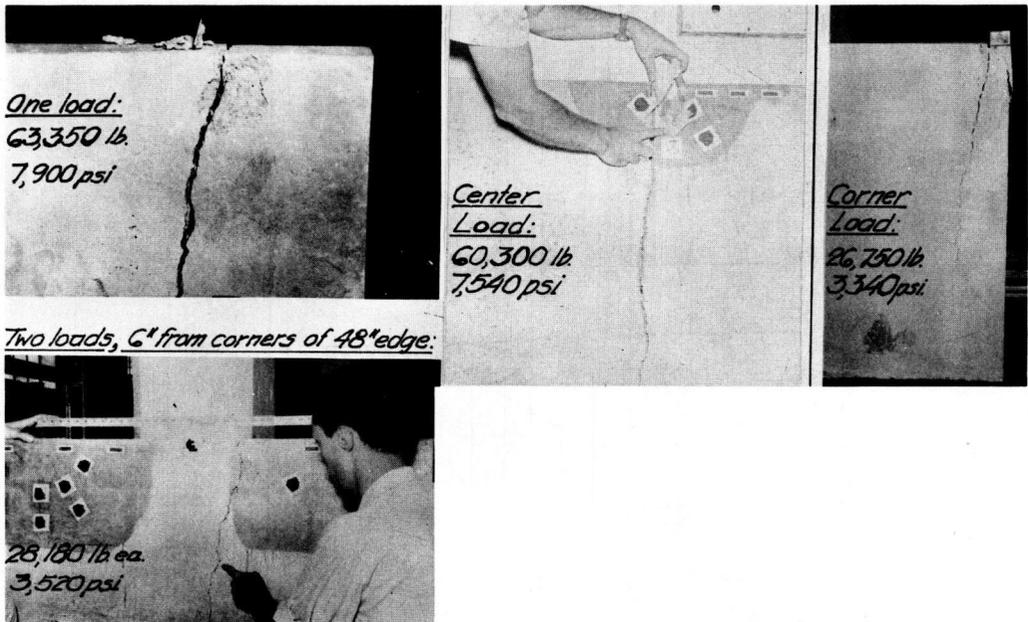
Figure 35. Typical test slab conditions after failure, for single load at center of edge, at one corner, and 6 in. from one corner, Bottom view shows crack near center between two symmetrical loads.

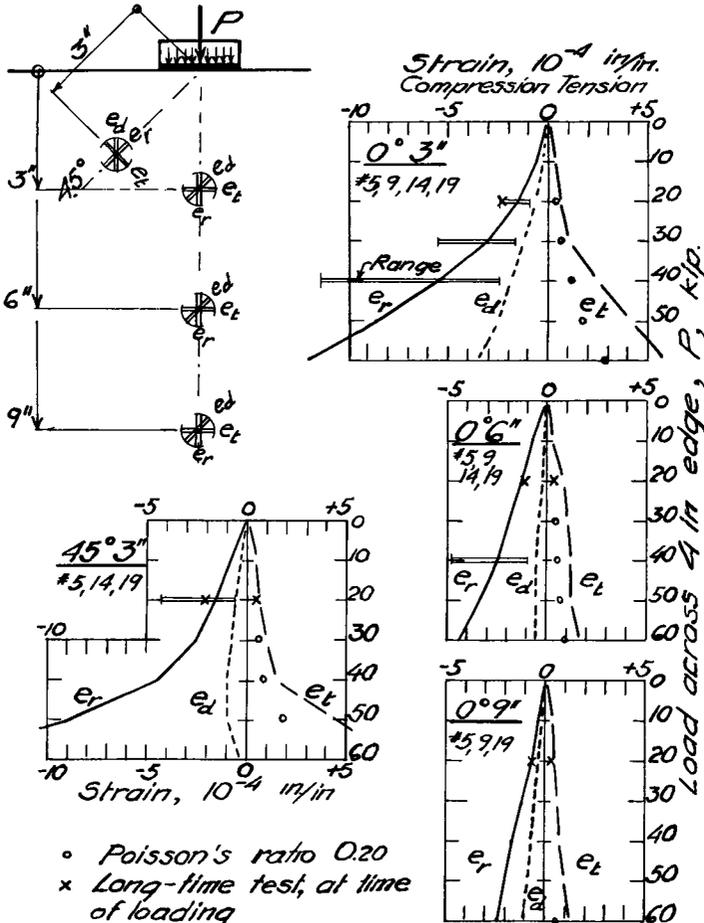
Figure 36. Average rosette strains and range of observed strains for increasing load; for 3, 6, and 9 in. under load; and at  $45^\circ$  angle 3 in. from load at center of edge.

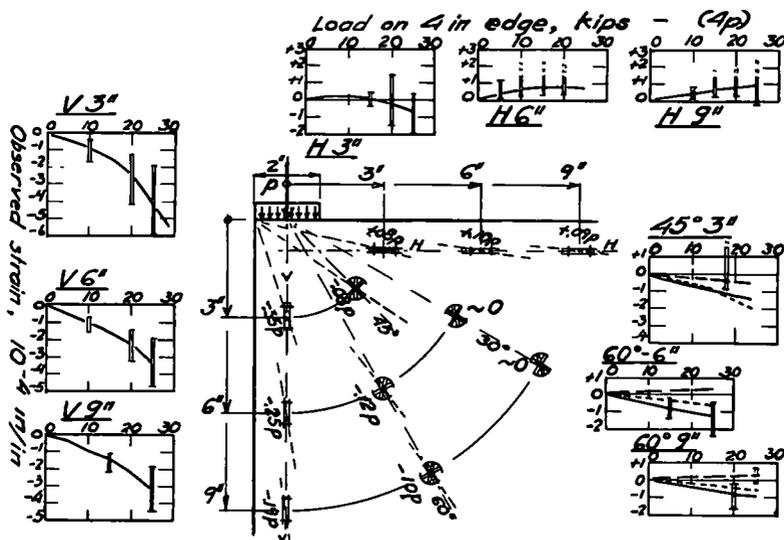
Figure 37. Observed strains in relation to load for linear and rosette strain gages near corner load; radial computed stresses at gage point locations for distributed load indicated.

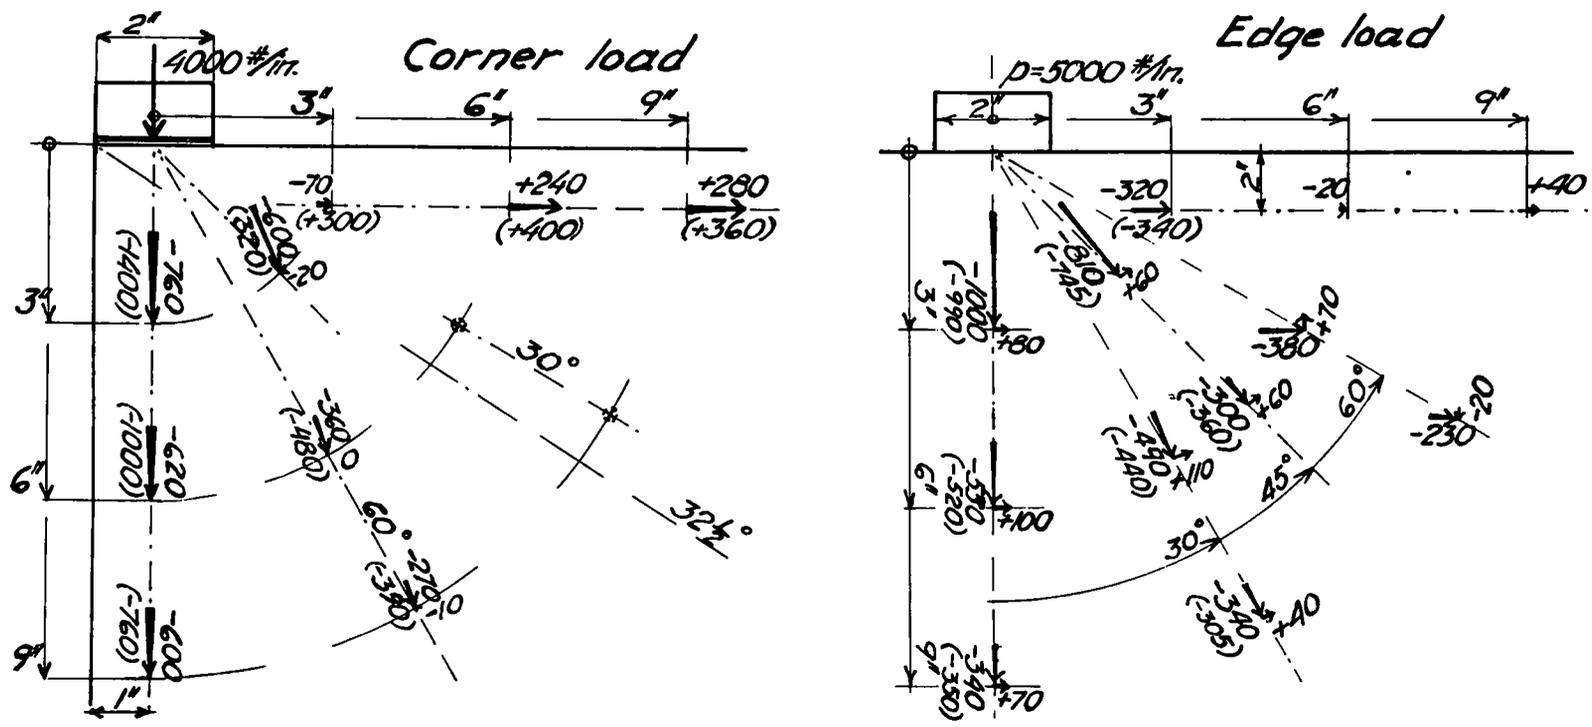
Figure 38. Principal observed stresses near an edge load and a corner load. Theoretical radial stresses shown in parentheses; loads on 4-in. thickness were 20,000 lb for edge load, and 16,000 lb for corner load; assumed modulus of elasticity 4,700,000 psi for edge load, 4,000,000 psi for corner load; Poisson's ratio for edge load, 0.20.

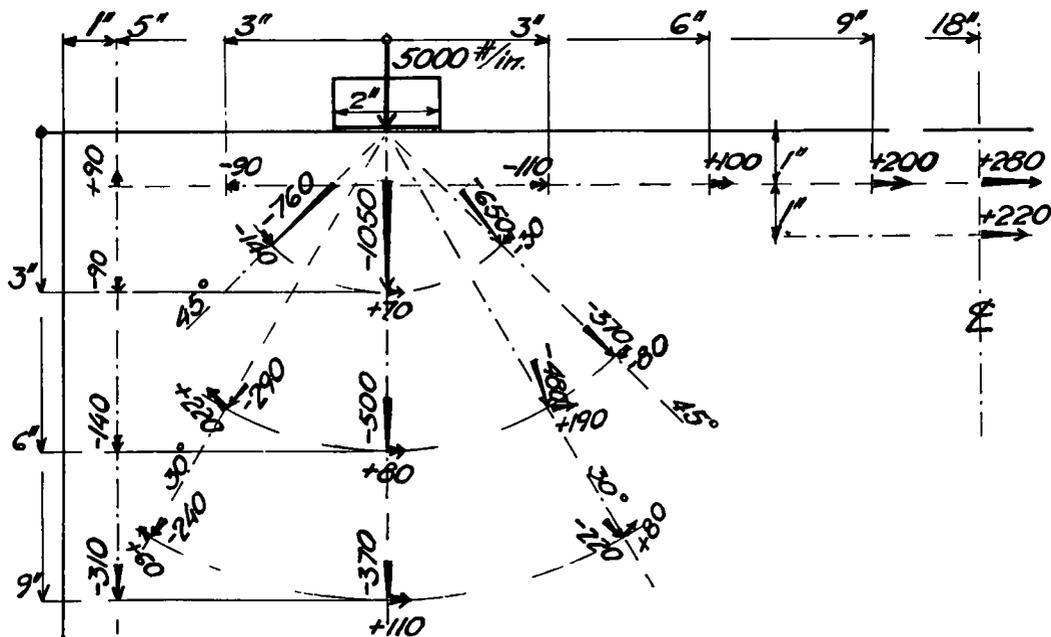
Figure 39. Direction and magnitude of experimental principal stresses for two loads applied 6 in. from each corner, each load 20 kips. Stresses computed from strains, for 4,500,000 psi, modulus of elasticity, and 0.20 Poisson's ratio.

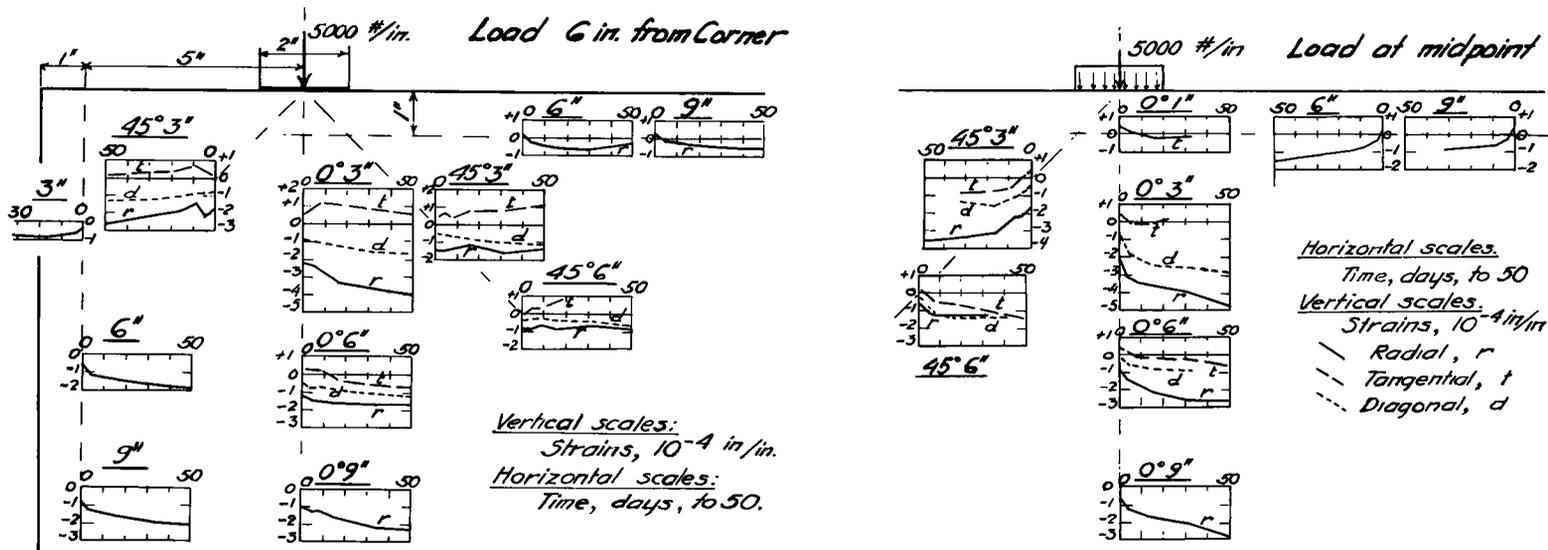
Figure 40. Variation in observed strains near 20-kip loads, for 50 days duration of loading. Loads at center of edge and 6 in. from each corner.
