Thermoplastic Striping Compounds

C. J. KEESE, Research Assistant,
and FRED J. BENSON, Research Engineer,
Texas Engineering Experiment Station

IN 1949, the Texas Engineering Experiment Station inaugurated a research project to develop a compound for striping pavements which would produce stripes with longer service life than those now in general use.

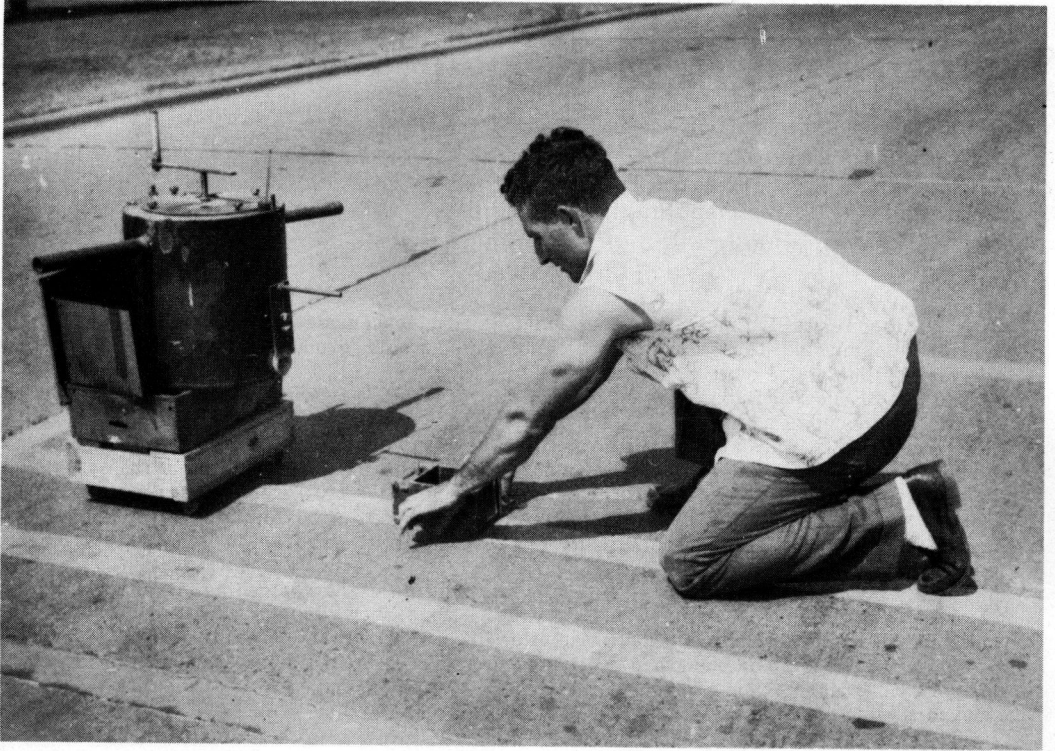
Figure 1. Laying rosin striping compound.

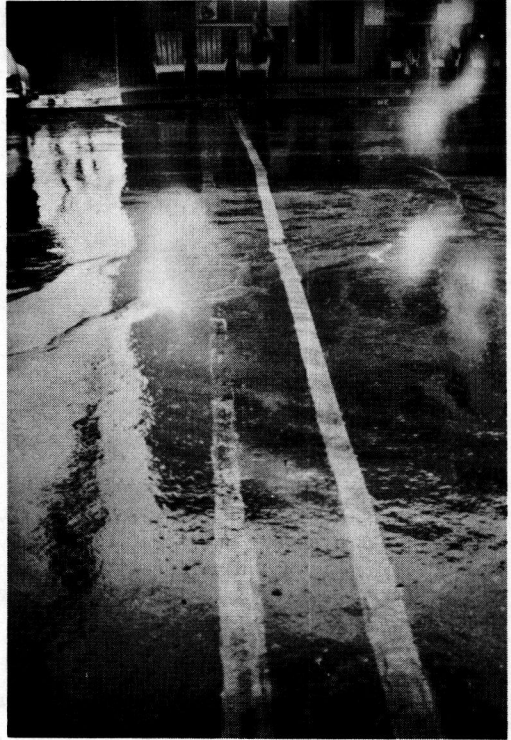
Figure 3. Stripes shown in Figure 2 after 5 months' service. Paint stripe was repainted twice.
