RAPID-DECELERATION TESTS of CHEST-LEVEL SAFETY BELT

J. H. Mathewson and D. M. Severy
Department of Engineering
University of California

This paper presents the engineering and safety aspects in the development, method of mounting, and testing of an automobile safety belt and attachments. Thirteen individual tests were made under controlled conditions in the field. In the series of tests, the automobile and driver were decelerated at rates up to approximately 3.5 G.

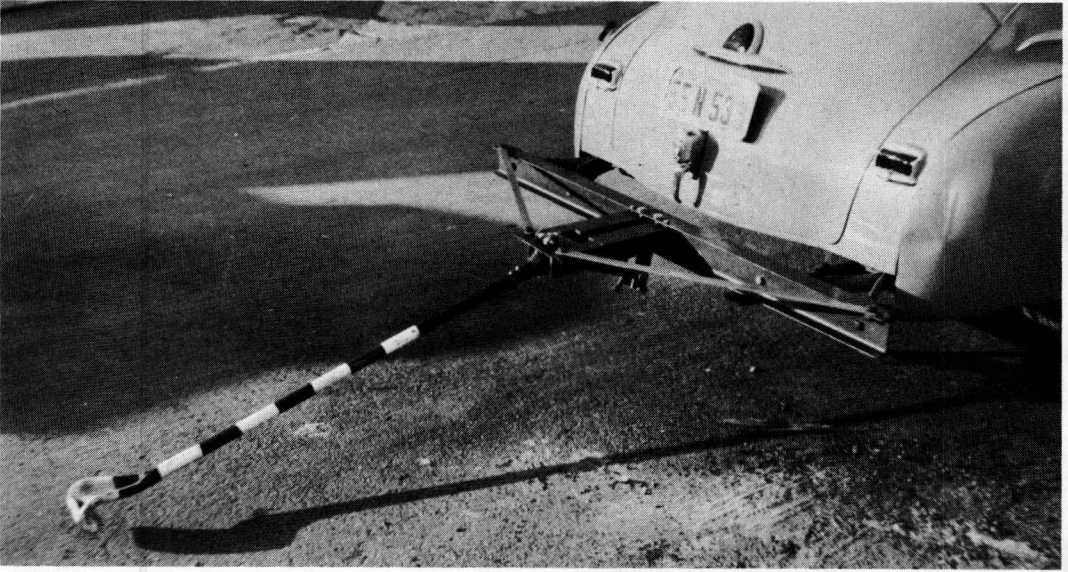
A means was devised which served the purpose equally as well as the desired gear, and with considerably less investment in time and money. A naval aircraft tailhook and supporting mechanism was obtained from a wrecked airplane and was mounted on the rear of the test car. The hook was positioned so that it trailed behind the car with its tip about 1 in. above the ground. This tailhook rig is illustrated in Figure 2.

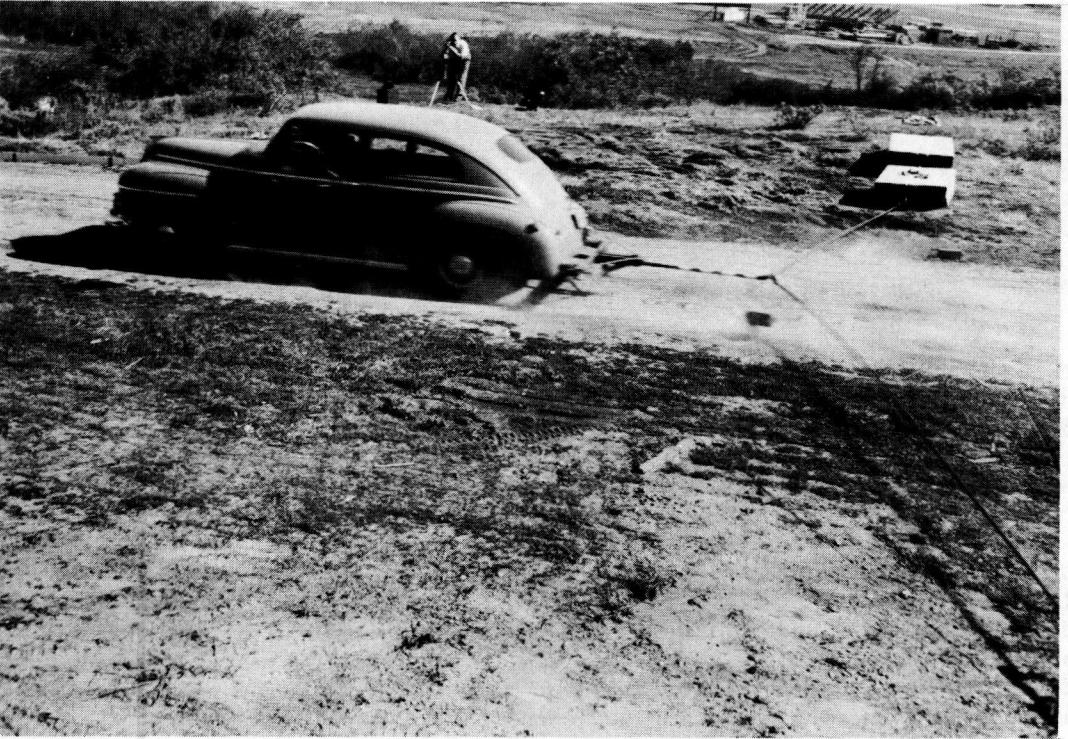
Figure 3.

The arresting gear consisted of four flat concrete blocks joined by 25 ft. of $3/4$ -in. standard hoisting steel cable. Two concrete blocks were placed on each side of the dirt test road with the connecting cable stretched across the road between them. The cable was propped up by wood blocks to about 2 or 3 in. above the road. The test car was driven over this cable at various speeds to get a variation of maximum deceleration caused by the tailhook engaging the arresting cable and pulling the blocks together as well as in the direction of the car's motion (Fig. 3).
