INVESTIGATIONAL CONCRETE PAVEMENT IN CALIFORNIA

By THOMAS E STANTON, *Materials and Research Engineer, California Division of Highways*

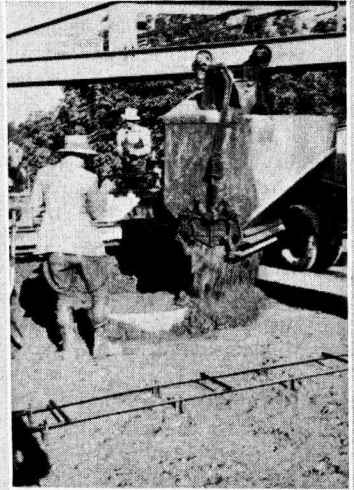
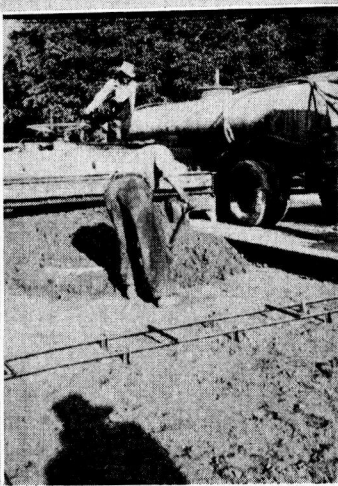
Figure 11. Construction of Concrete Discs for 'k' determinations

Forms placed on subgrade.

Placing concrete around form.

Blaw-Knox Spreader approaching form.

Concrete disc in finished concrete.
