## Report on Experimental Project in Kentucky

D. H. SAWYER, Research Engineer Kentucky Department of Highways

● THE Kentucky Test Road was constructed during the summer of 1940, by the Kentucky Department of Highways in cooperation with the Bureau of Public Roads. The investigational pavement, a part of US 231 (formerly Ky. 71) is 6.27 miles in length and is located approximately six miles southeast of Owensboro, in Daviess County.

This report presents a discussion of pavement performance and observations over a 10-year period, beginning in September, 1940. A complete discussion of the original scope, purpose, and early performance of this cooperative project has been given in previous reports (1, 2, 3).

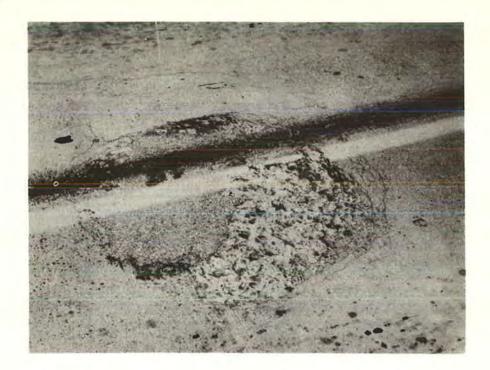
Figure 4. One of the more serious examples of spalling, Section 1 in May 1949.

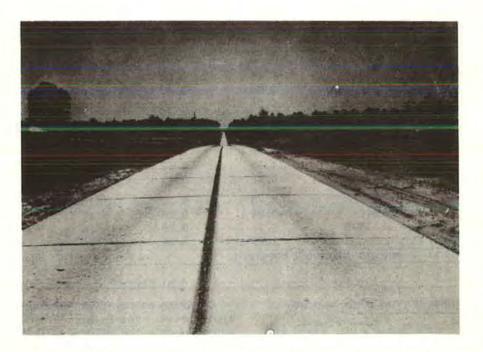
Figure 5. View to north of Section 2-R through Section 1 in May 1949. Pavement in foreground contains expansion joints at 800 foot intervals with dowel bars and contraction joints are at 200 foot intervals without dowel bars. Wire mesh reinforcement was not used in this section.

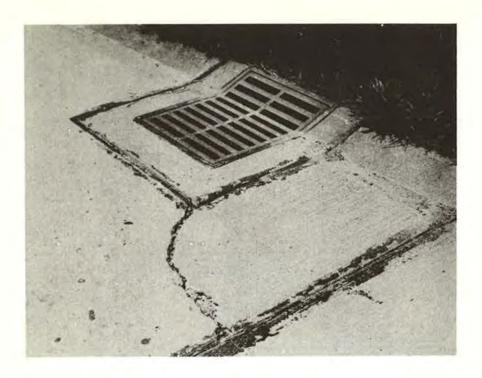
Figure 6. Typical of cracking where drop inlet is constructed near joint installation, Section 4-R in May 1949.

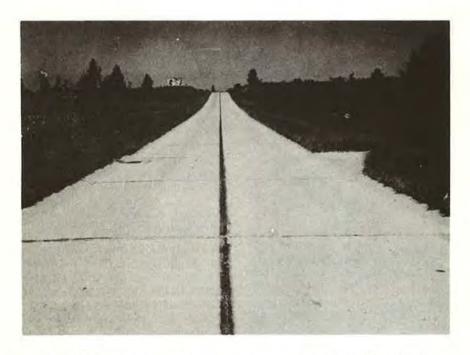
Figure 7. Faulted joint in foreground, Section 4-R. Pavement contained expansion joints at 120 foot spacing with dowel bars and contraction joints at 20 feet without dowel bars. Wire mesh reinforcement was not installed in this section.
