Report on Experimental Project in Michigan

H. C. COONS,* Deputy Commissioner, Chief Engineer
Michigan State Highway Department

● DURING the construction of the Michigan Test Road in 1940 and subsequent to it, many observational and special studies have been made in addition to carrying out the program of seasonal physical measurements which was set up in the original outline. The test road has been in existence now for 10 years and during this period there has been collected and analyzed a considerable amount of data. It is the purpose of this report to present as concisely as possible the significant trends in slab and joint behavior as well as other interesting disclosures which are believed to be of sufficient interest in relation to present design and construction of concrete pavements.

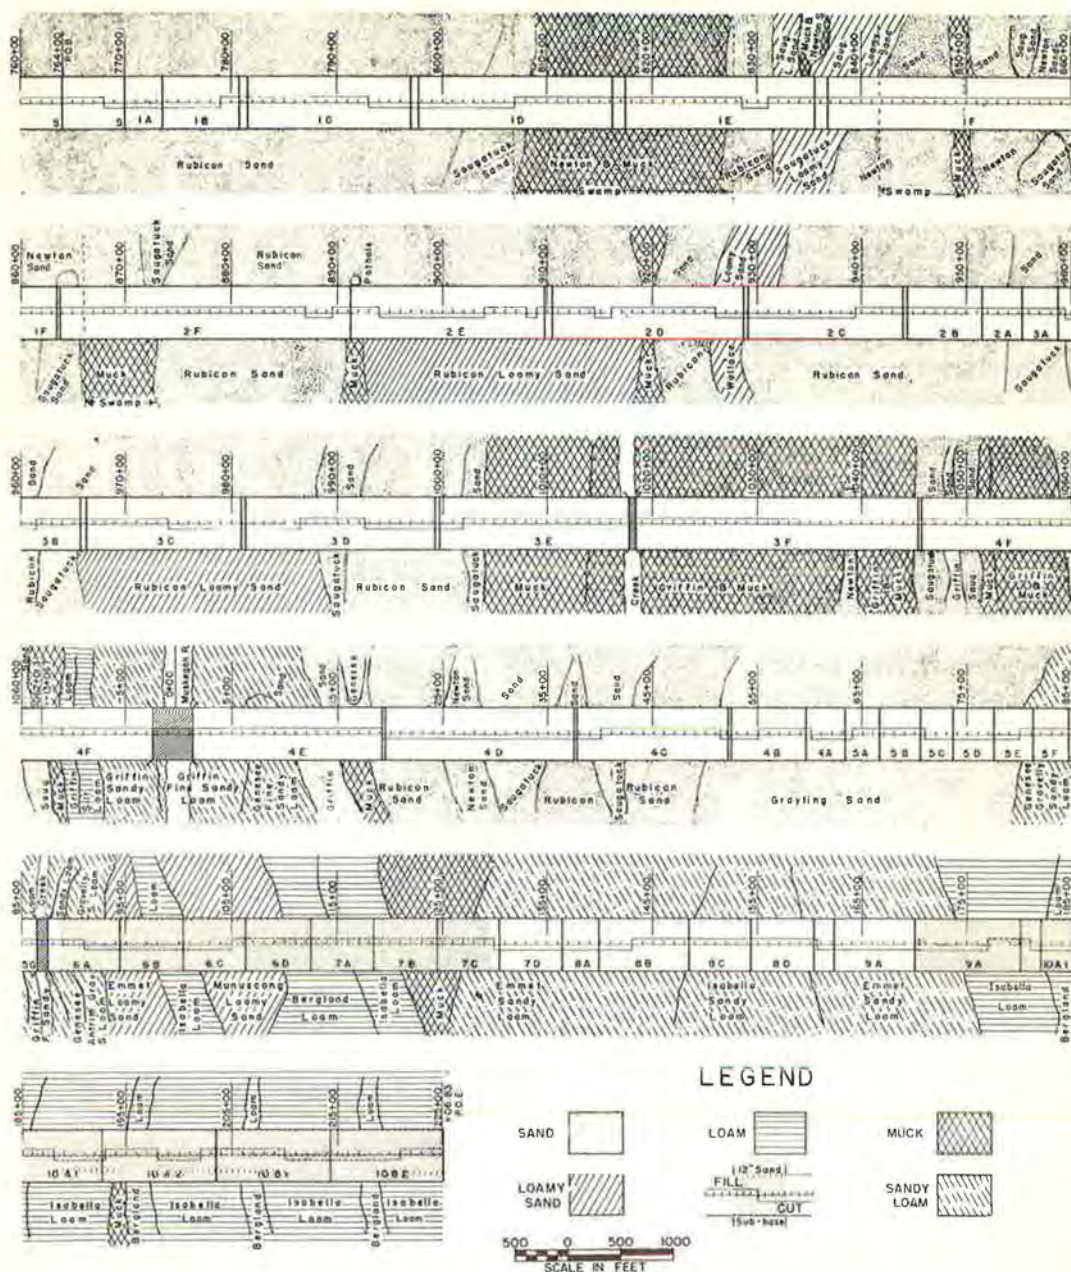
Figure 1. Soil types and earthwork operations.

The extent and relative location of soil types and earthwork operations for the Design Project are illustrated in Figure 1.

A review of Figure 1 will show that Series 8 lies entirely on an excellent granular subgrade soil whereas all of Series 6 and 7, with the exception of Section 7D, were placed on a subbase over a questionable subgrade material. This is no doubt the reason why Series 8 has performed so well over the past years. A complete crack and spall summary will be found in Table 8. For comparative purposes the crack information in Table 8, for Series 6, has been tabulated both for the entire series and also just for those slabs outside of frost heave areas previously described.

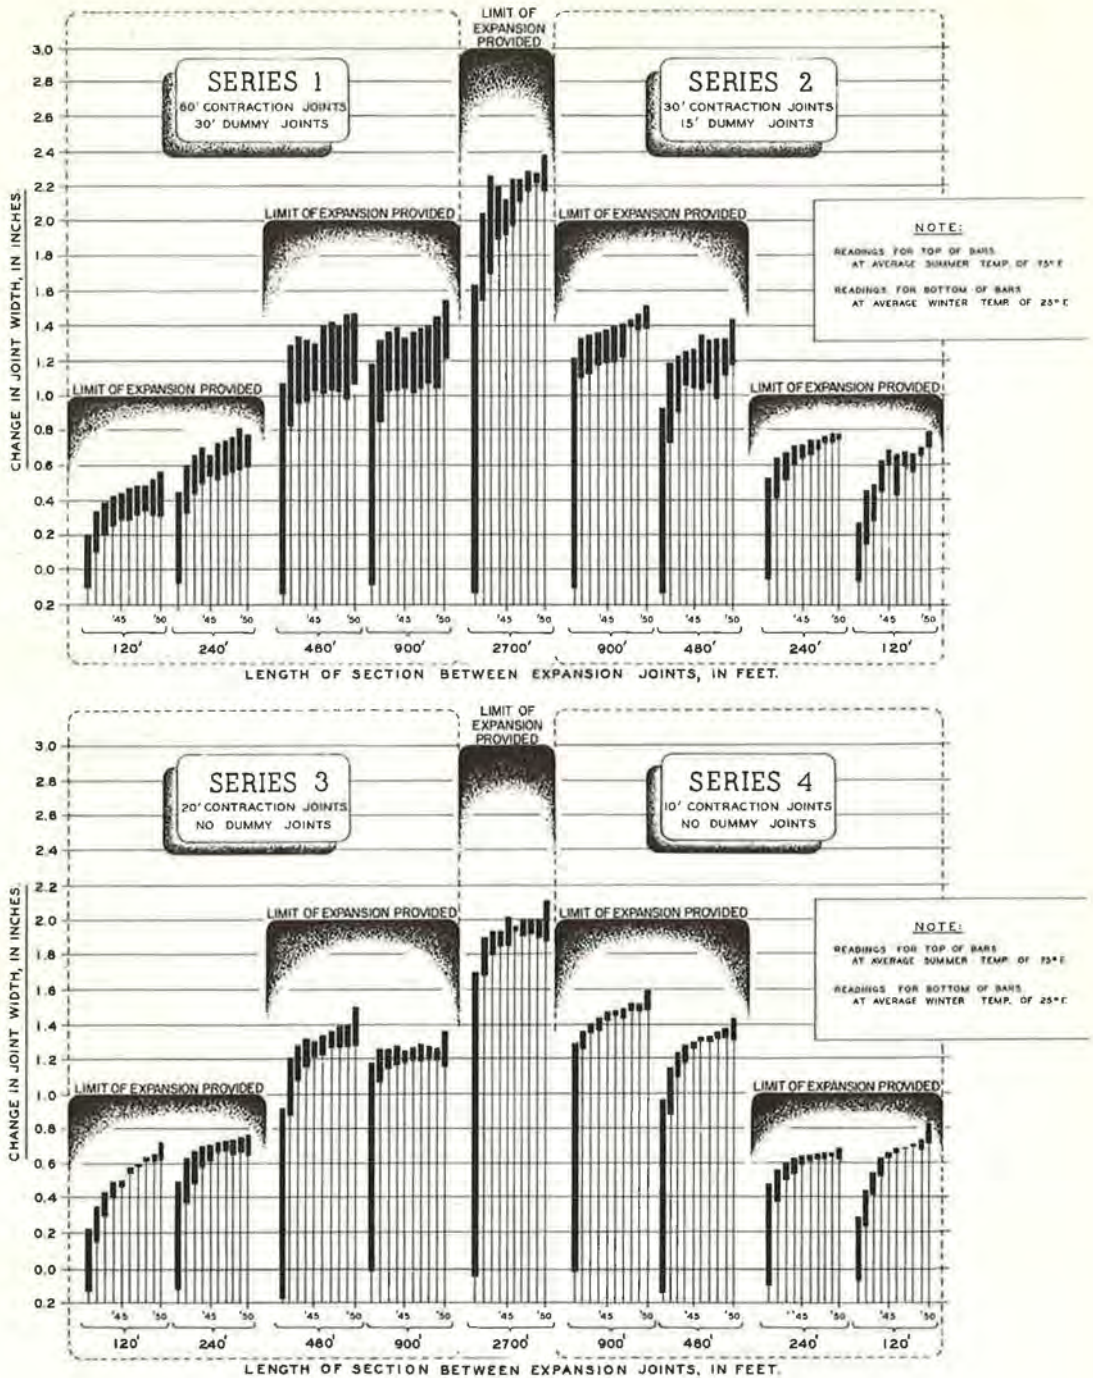
Figure 5. Annual and progressive changes in expansion joint width.

Several significant facts are revealed by the graphs in Figure 5. (1) In most cases the sections contracted sufficiently during the first winter season to cause a slight widening of the expansion joints in excess of the 1-inch width originally provided. (2) Without exception all of the sections experienced their greatest movement during the first year after construction. (3) The annual amplitude of joint width movement diminishes with time. (4) All expansion joints show a progressive, permanent change in joint width resulting in a gradual closing of the joints, to the extent that after 10 years the sections have absorbed approximately 60 to 80 percent of the expansion space provided. There is no doubt that the progress of these residual displacements will diminish rapidly in the future, since the joint filler will eventually reach a stage of compaction sufficient to resist practically all further movement of the slabs adjacent to the joint. (5) As one would expect, the longer sections produced the greatest changes in joint width the first year, although the amplitude of annual joint width movement after the first year is comparable to that of the shorter sections. (6) The amplitude of yearly movement was the least for the sections composed of 10-foot contraction joints and greatest for the sections with 60-foot contraction joints. This phenomenon would indicate that a considerable amount of section movement is absorbed by the greater number of contraction joints existing in a section containing 10-foot contraction joints.

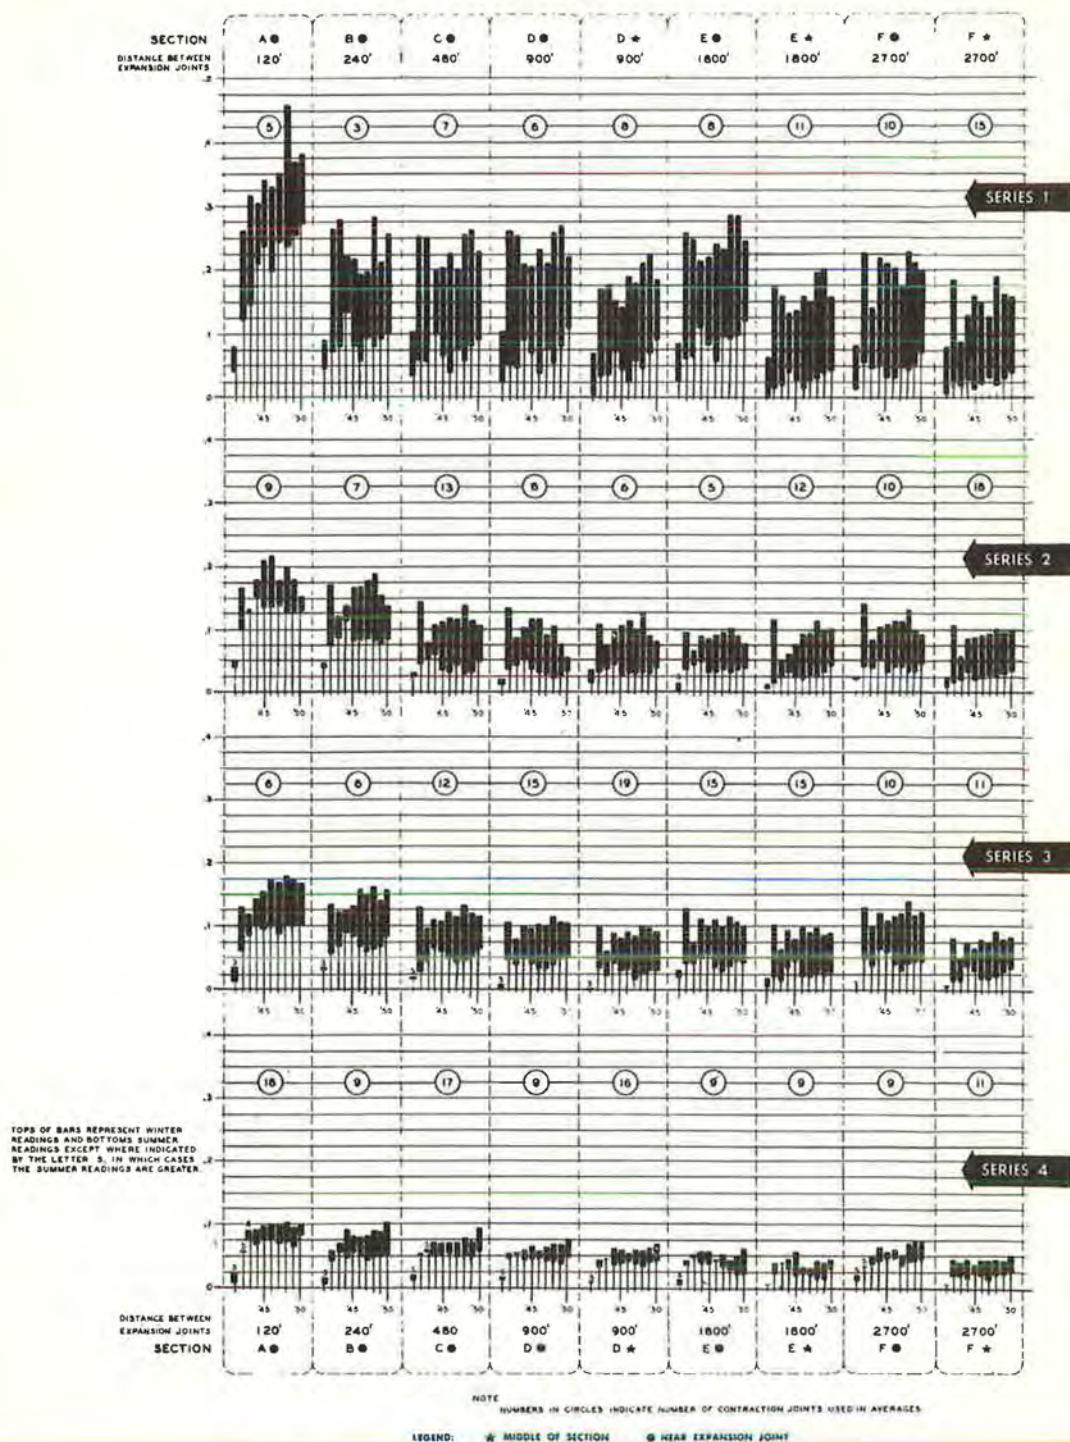
Figure 6. Seasonal changes in contraction joint width.

sons of the year and for the variable expansion and contraction joint spacings included in Series 1-2-3 and 4 are shown graphically in Figure 6. The graphs show the average joint width movements for summer and winter seasons.

the effect of joint spacing upon joint width changes, these graphs show the residual opening of the joints with time and that the joints closest to the expansion joints open more than the joints near the center portion of the section. This same phenomenon

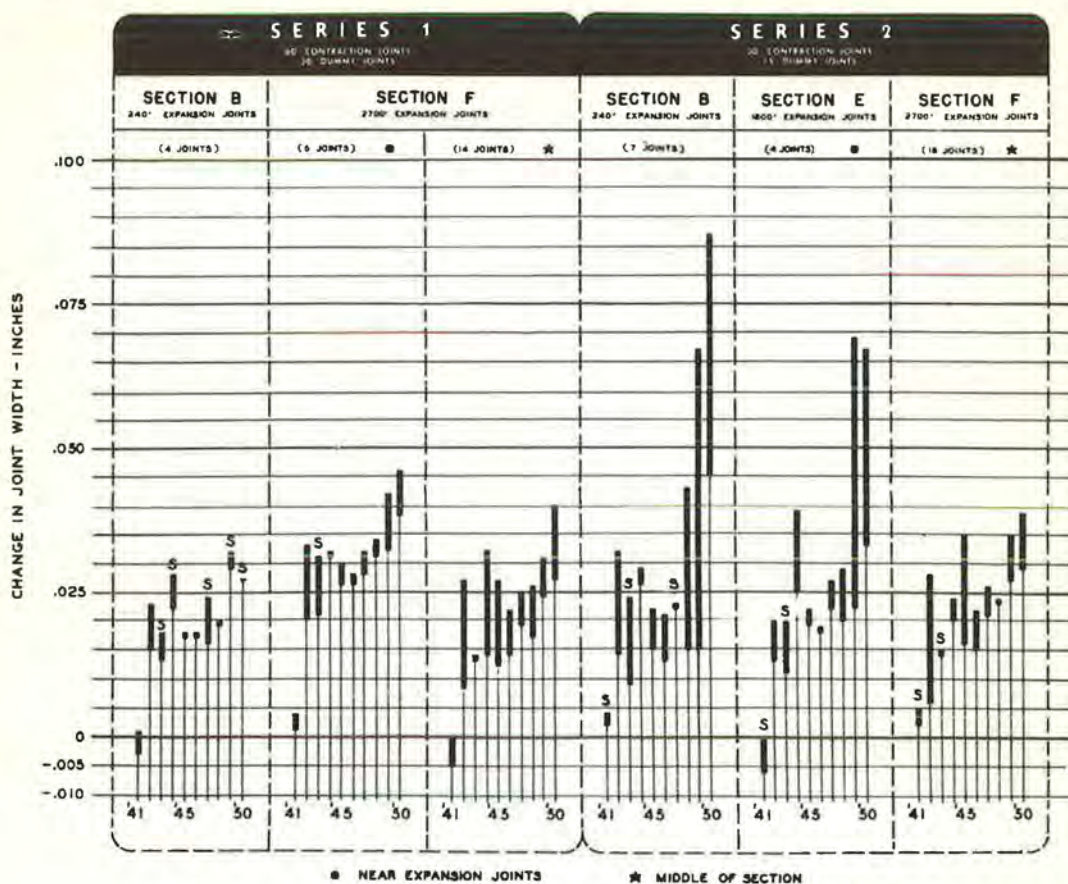
Figure 8. Seasonal changes in dummy joint width.

The graphs show that in practically all cases the maximum opening of joints does not exceed 0.05 inches. As in the case of contraction joints, the movement of the dummy joints near the center of the long sections is less than that of joints near the ends. The graphs also indicate that the dummy joints react in the same manner as contraction joints but to a much smaller degree, in that they fluctuate slightly with seasonal changes and seem

TOPS OF BARS REPRESENT WINTER READINGS AND BOTTOMS SUMMER READINGS EXCEPT WHERE INDICATED BY THE LETTER S, IN WHICH CASES THE SUMMER READINGS ARE GREATER

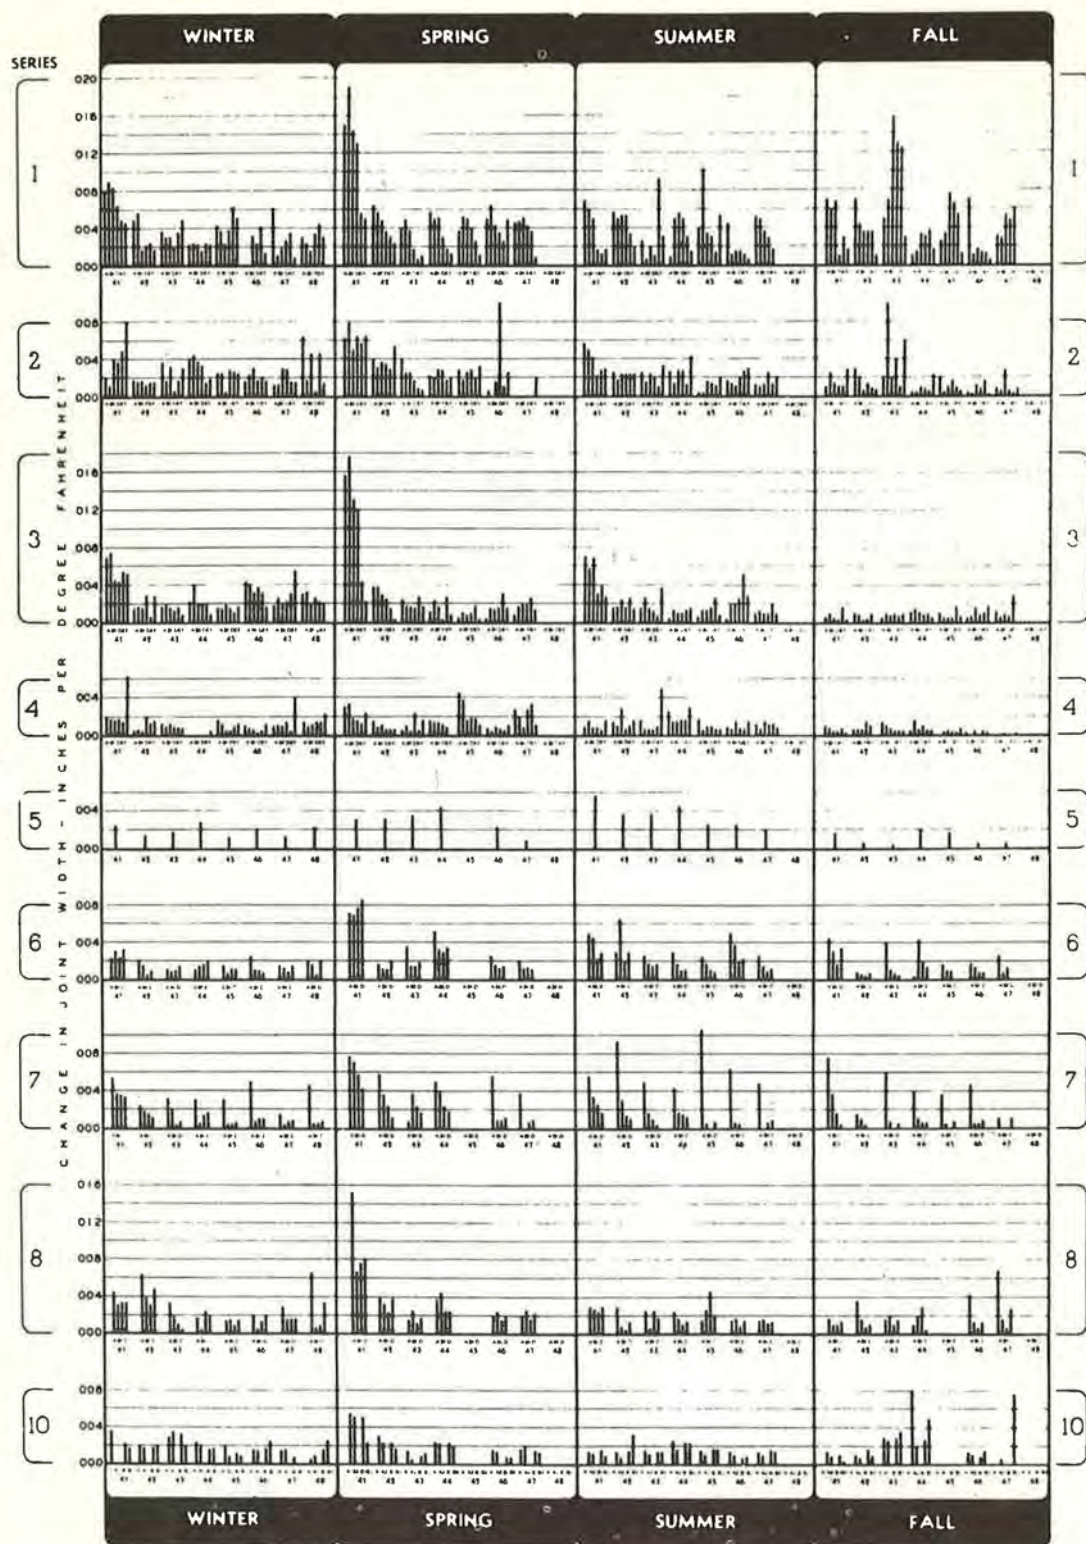
Figure 9. Daily movement of expansion joints based on average of individual joints.

Expansion Joints. The average daily changes in expansion joint widths by years and seasons are represented by bar graphs in Figure 9. Included in the graphs are measurements from selected joints in all ten sections of the Design Project. In general, the data disclose several significant facts. (1) Daily joint width movement is influenced to a certain extent by the degree of pavement restraint which normally increases with age due to depletion of expansion space and residual volume changes in the concrete. (2) Intermediate contraction joint spacing has a decided effect upon daily joint width

movement as may be observed by comparing graphs of Series 1 with those of Series 4. (3) In general, the movement is greatest during the spring and least in the fall seasons, while summer and winter seasonal readings are about comparable. It is believed that this greater movement in the spring than in the fall may be due to the relatively greater freedom of the slab resulting from winter opening of the joints combined with a wider temperature range induced by the radiant heat of the sun, which is maximum at the summer solstice (June 21). (4) No definite relationship is discernible between daily joint width movement and certain construction features such as weight of reinforcement, cross section, thickness, or joint design.

It is believed that the exceptionally high daily movements for all series in section lengths greater than 240 feet are due to the fact that greater expansion space was provided in those cases. Two 1-inch joints were used for the 480 and 900 foot sections, and three 1-inch joints for all sections 1800 feet and 2700 feet in length.

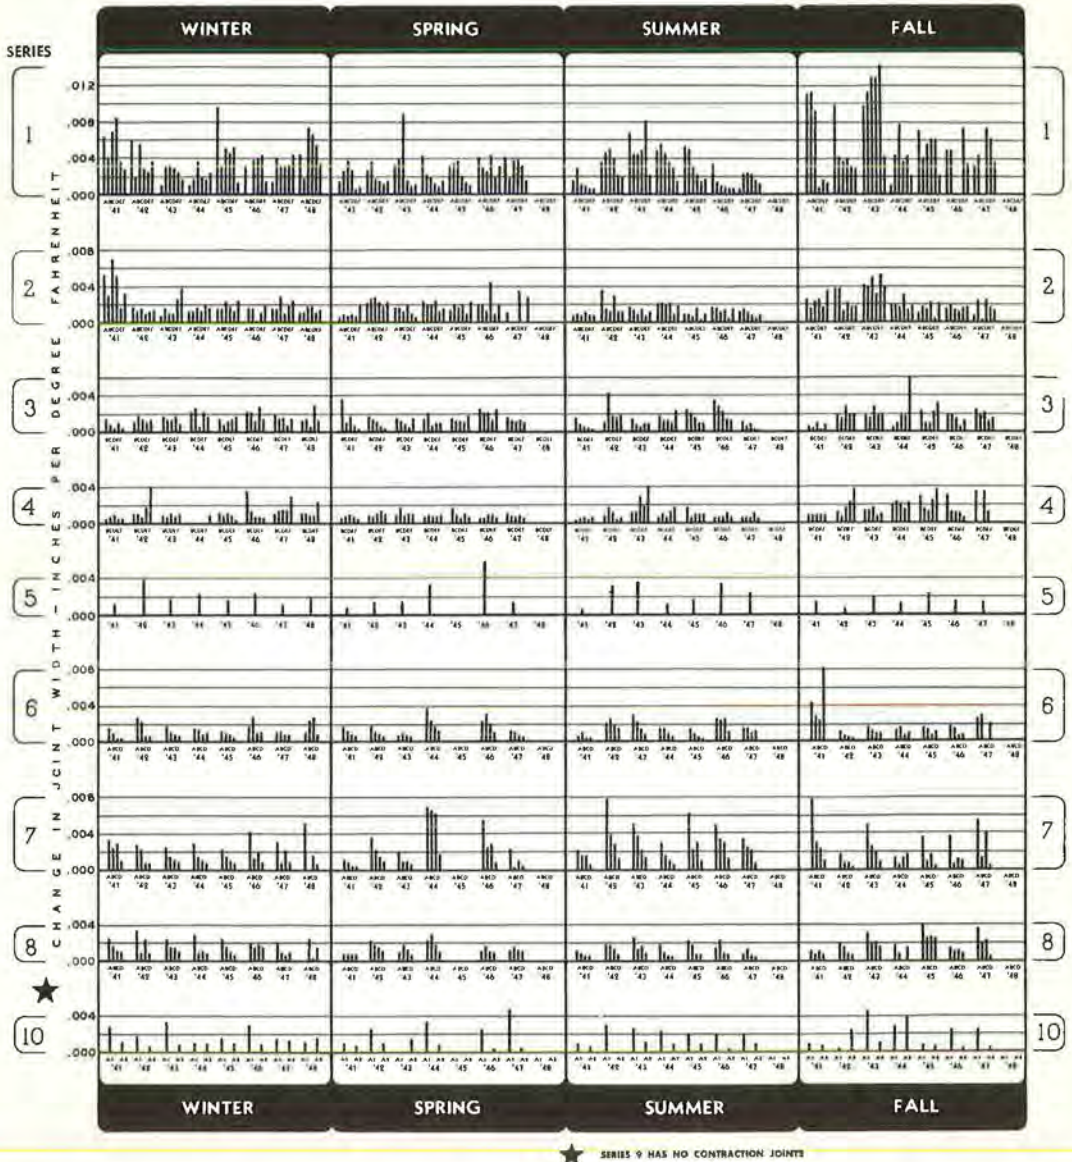
Figure 10. Daily movement of contraction joints.

Contraction Joints. In a similar manner the average daily contraction joint width movements have been presented in Figure 10. The data presented in Figure 10 shows in general that the contraction joints behave in the same manner as the expansion joints. Because of the greater number of joints involved in the case of contraction joints, the relationships between joint width movement and joint spacing are more pronounced.

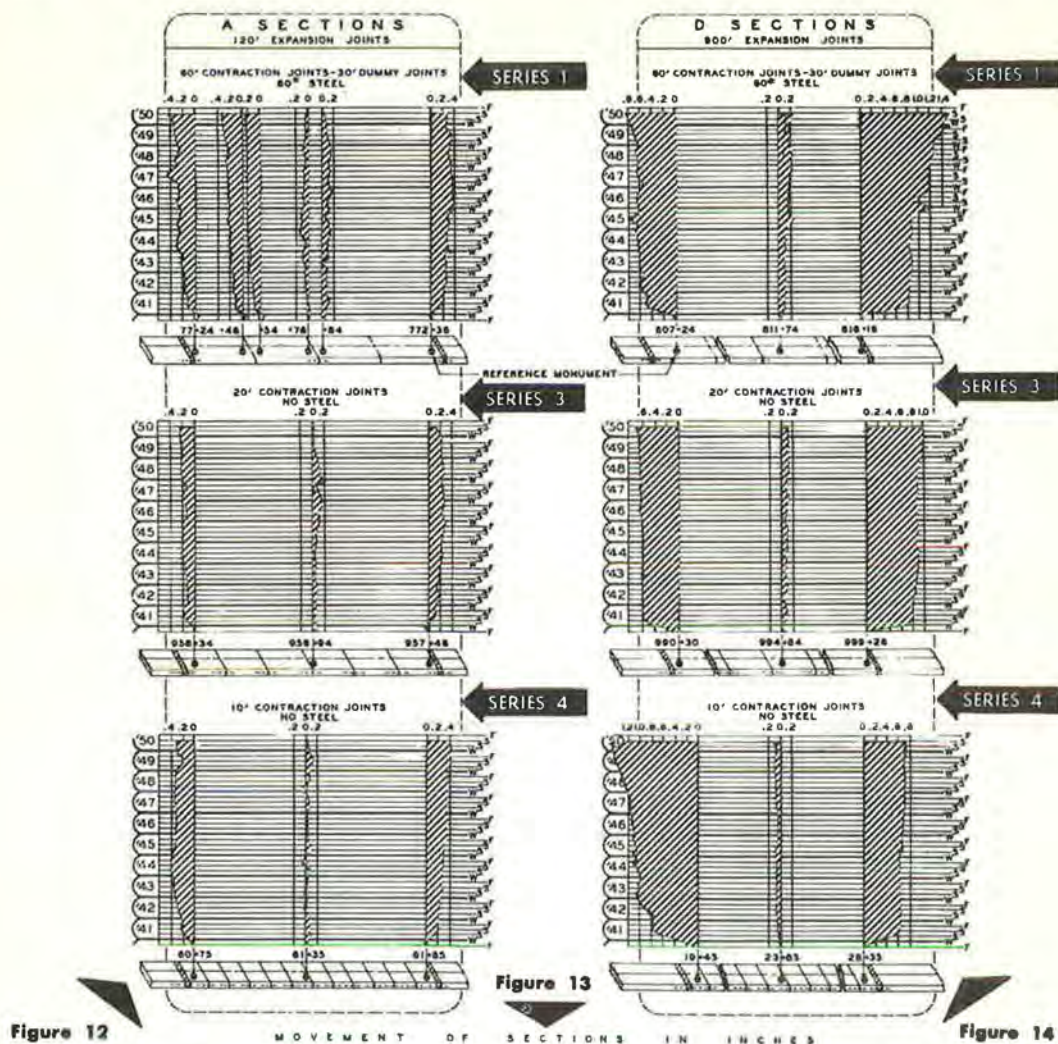
Figures 12, 13 & 14. Seasonal changes in section length.

The data indicate that for long sections of pavement the greatest movement is at the ends and rapidly diminishes until a point is reached at which practically no longitudinal movement takes place. This is clearly shown by graphs presented in Figure 16. For the two 2700-foot sections — Series 1 and Series 4 — the point of zero longitudinal movement was, in 1941, approximately 700 to 800 feet from the ends of the sections but in 1950 the same point had retreated slightly to 1000 and 1100 feet from the ends. It is also noted in Figure 16 that the two sections have acquired a considerable increase in residual displacement during the 10-year interim. The substantially greater movement of the north end of Section 4F is due to the presence of five 1-inch expansion joints at the relief end instead of the usual three expansion joints because of the abut-

ting Muskegon River bridge. Thus, there exists in the central part of the 2700-foot sections in Series 1, 2, 3, and 4, portions of pavement more than 500 feet along which at elevated temperatures are under restraint similar to that of a continuous slab without expansion joints. Therefore, in the case of sections whose lengths are less than

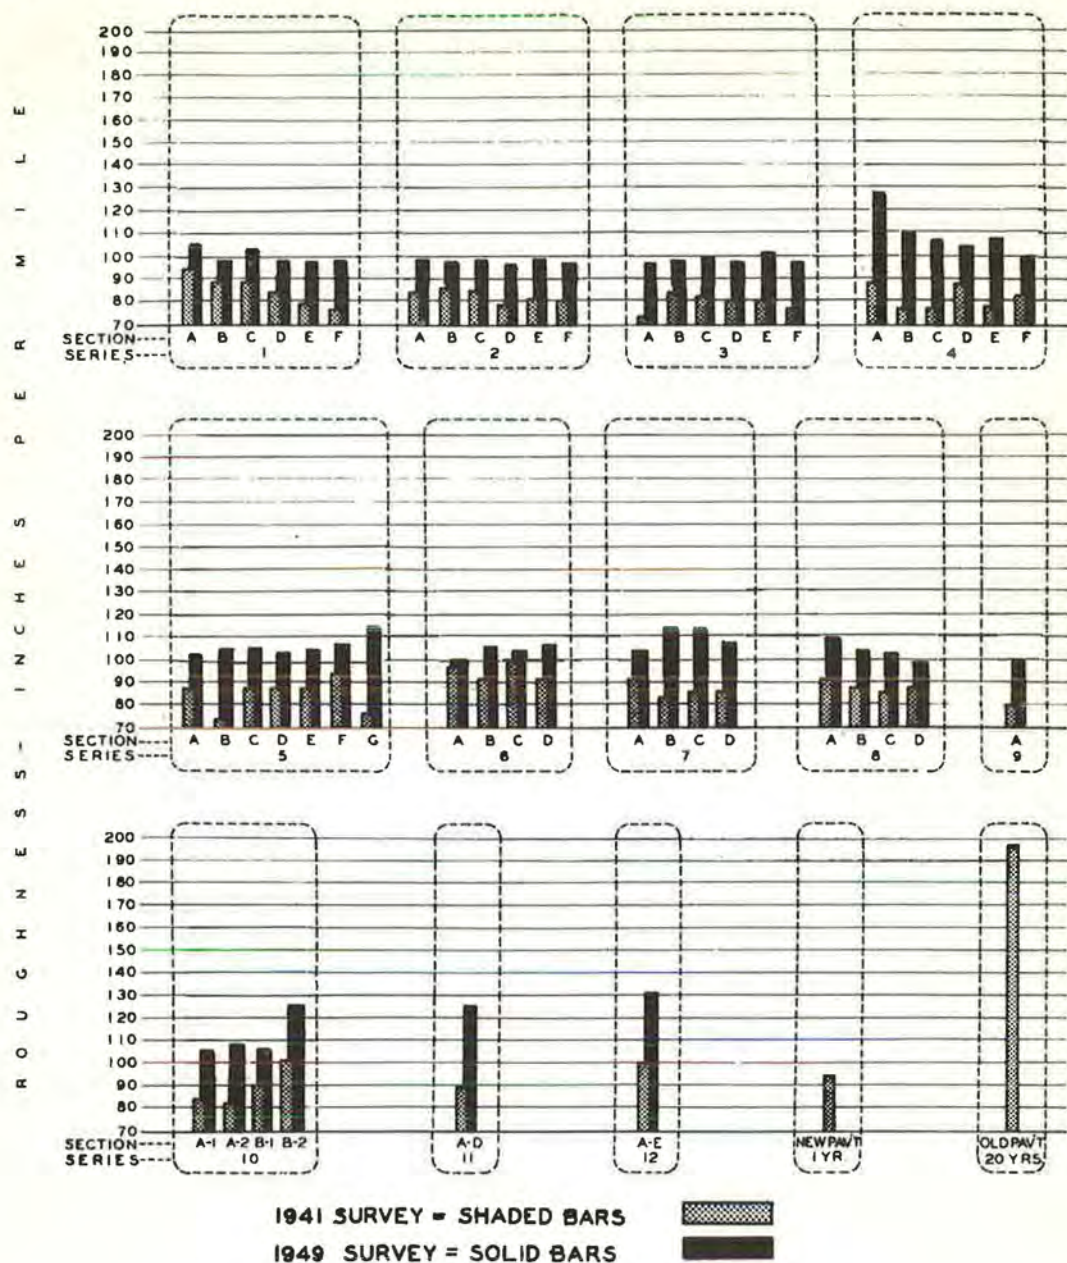
Figure 17. Road roughness data.

In conducting the tests each section of each series was taken as an increment to compare the surface roughness condition for the different joint spacings and concrete mixture variations. In 1941, additional tests were made on nearby projects, one of the same age as the test road and another project 20 years old, to afford a comparison with standard construction and to determine an expectant roughness factor. The roughness data obtained from the two series of tests are presented graphically in Figure 17. The original roughness factor for the entire project ranged from 73 to 101 units per mile, an indication, in general, of good workmanship and excellent riding qualities.

With reference to Figure 17, it will be noted that Series 11 and 12 have riding qualities comparable to the test sections located throughout the Design Project. However, Series 11 with the steel mesh, has a lower roughness factor than Series 12 without steel, which might be significant. Both series have increased materially in roughness over the past ten years.

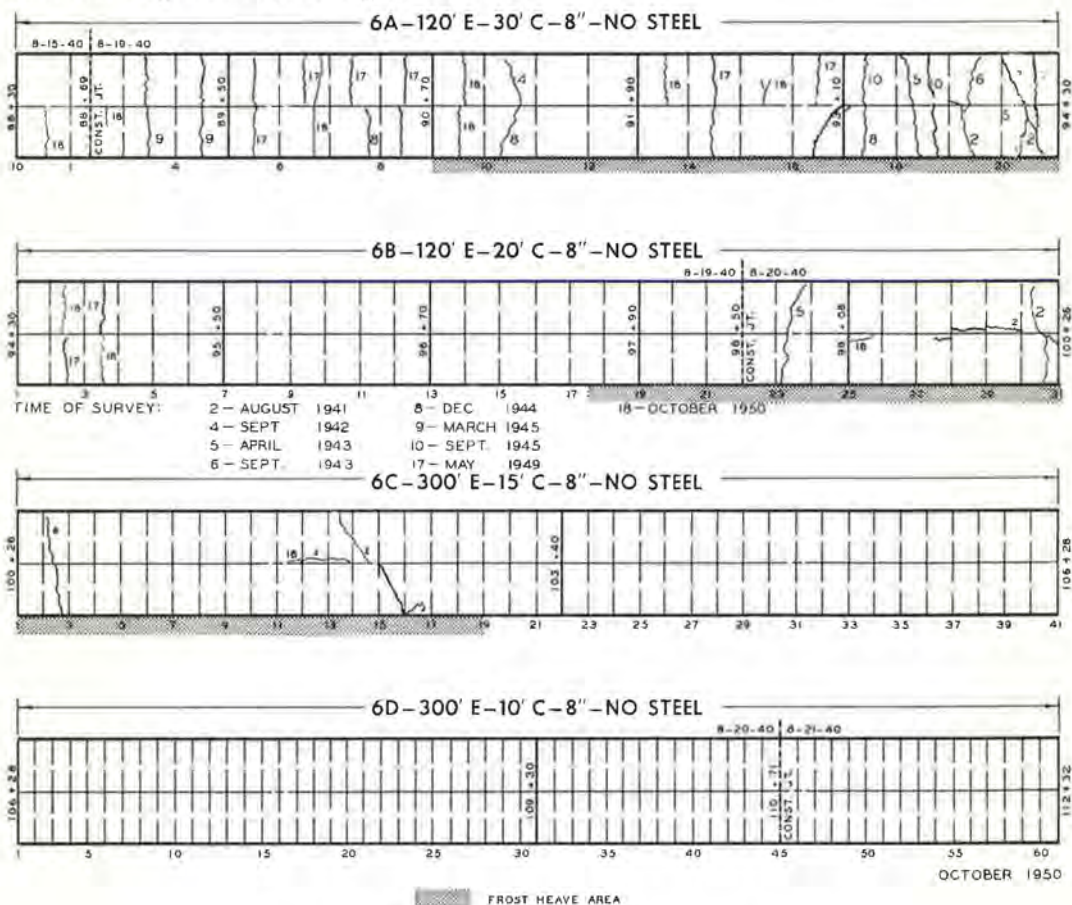
In the winter following the construction of the test road some cracking developed in part of Series 6 from Station 90+70 to 94+30 and 97+60 to 103+00. During the first four years a considerable number of longitudinal and transverse cracks continued to develop in this area as illustrated in Figure 20.

The crack pattern throughout the cracked area is typical of that caused by heaving of a rigid pavement due to volume changes in the subgrade. The pavement in Series 6 was constructed on a 12-inch sand subbase overlying Emmet loamy sand and Isabella loam. A soils survey in the spring of 1944 revealed several factors contributing to the abnormal cracking. In the first place the sandy clay subgrade material was badly rutted, protruding into the subbase material practically the full depth in some places. Such a condition would naturally prevent the normal lateral drainage of the subbase material; consequently, water pockets formed directly beneath the slab, which resulted in the longitudinal cracking of the slab.

Transverse cracks are beginning to appear, however, in other areas of Series 6. In Figure 20 it will be noted that all but two of the 20 slabs in Section 6A have developed transverse cracks.

In addition to the faulty subbase condition it was learned that the subgrade material in the cracked sections contained pockets and laminations of peat, clay and silt, all of which undergo considerable volume change during freezing and thawing of the subgrade. Ice lenses were readily discernible in soil samples from test holes. Such subgrade and subbase soil conditions are no doubt responsible for the preponderance of transverse and diagonal cracks within these areas.

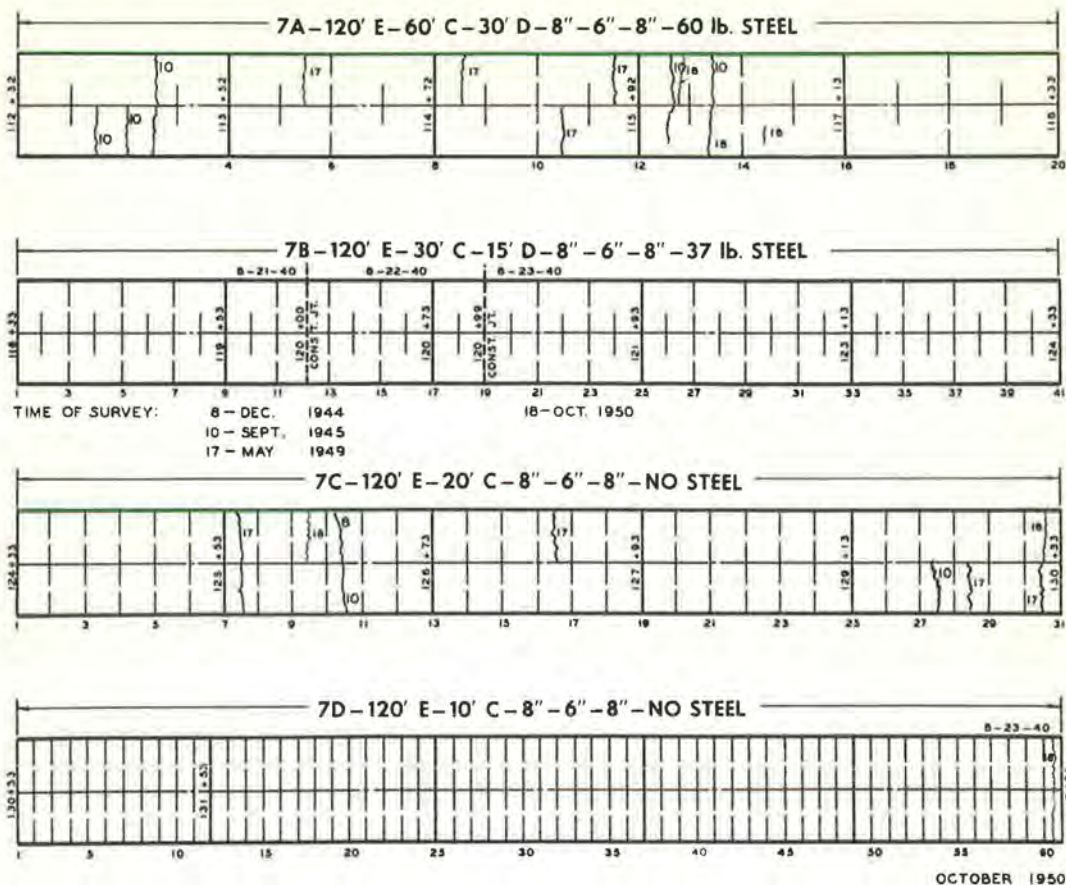
Figure 21. Condition of pavement in Series 7.

In Series 7, with 8-6-8-inch cross section, the first transverse crack was noted in December, 1944 and, since that time, several more have developed as may be seen in Figure 21.

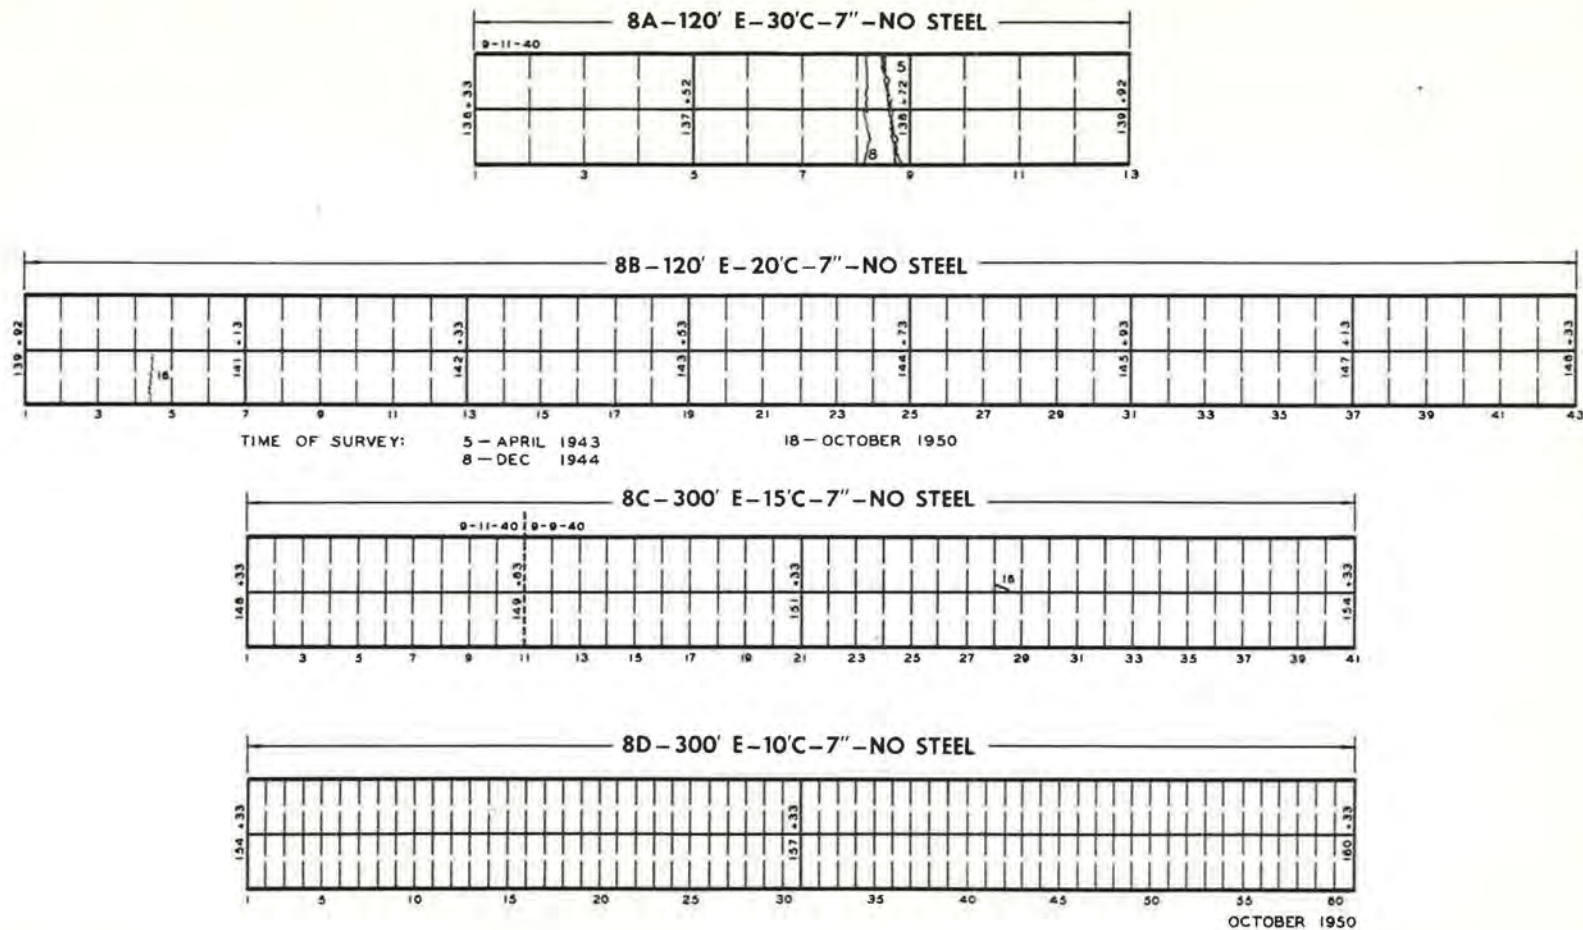
Figure 22. Condition of pavement in Series 8.

Only two transverse cracks have developed in Series 8 with 7-inch slab thickness. The first was observed in April, 1943 and the last in December, 1944 (see Figure 22).

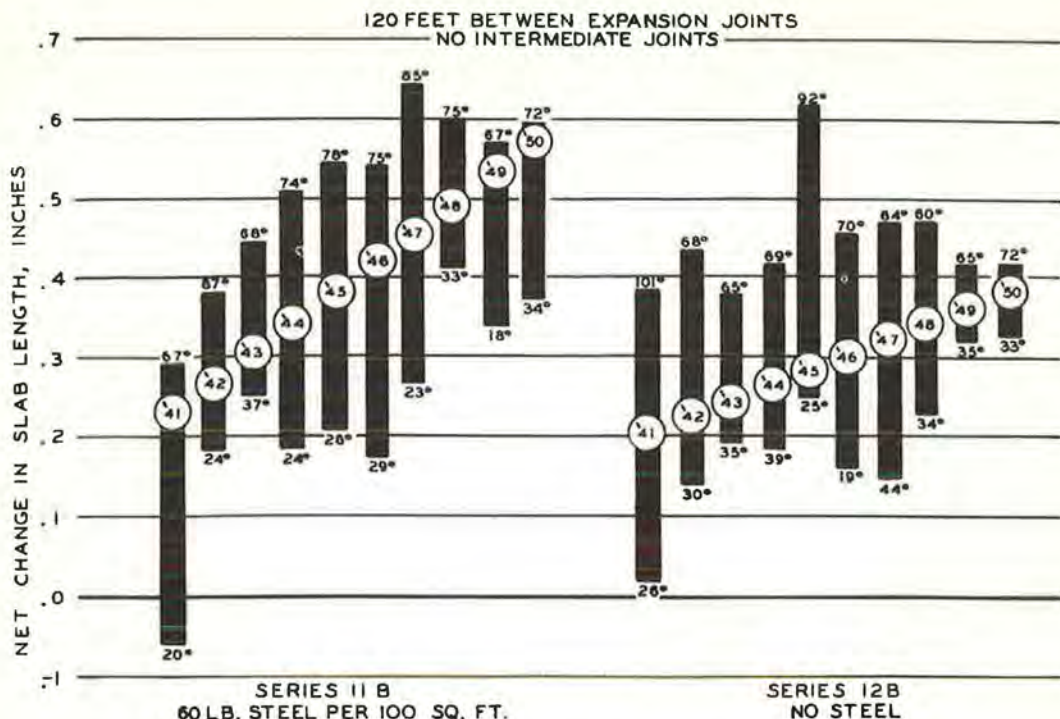
Figure 25. Annual and progressive changes in slab length.

Since the 120-foot slabs of Sections 11B and 12B have not broken, it is possible to observe the net change in their length. The net seasonal and progressive changes for the 10-year period are shown in Figure 25. It may be observed from the plotted data in Figure 25 that both slabs have acquired a residual increase in length of approximately 0.3 to 0.4 of an inch. The greatest net change in slab length apparently took place during the first year, whereas during the succeeding years the increase in length has been gradual and much smaller in amount. The values plotted represent field measurements at the existing slab temperatures indicated for winter and summer seasons.

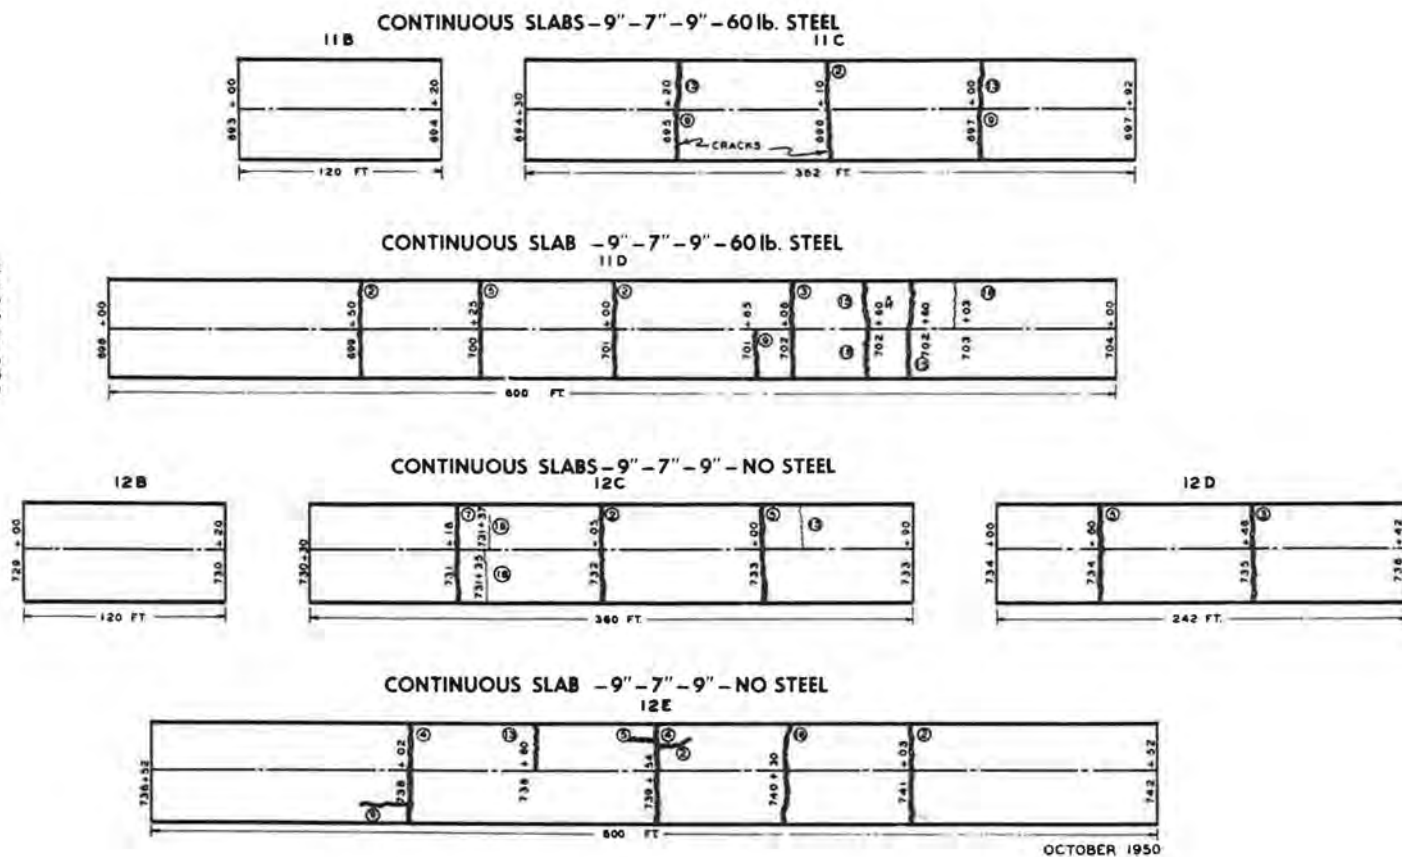
Figure 26. Condition of pavement in Series 11 and 12.

The physical condition of the slabs in both series with respect to cracking is shown in Figure 26. The crack pattern of both series is very similar. For example, the 120-foot sections have not cracked and the 360-foot and 600-foot sections of the two series are cracking in a similar manner. However, the full transverse cracks have formed sooner in the unreinforced section. Fortunately, both Series 11 and 12 have been constructed on the same type of subgrade soil identified as a sand of the Rubicon and Newton series.

The total length of cracking in Series 11C and 11D is 220 feet. In Series 12C and 12E, comparable sections to Series 11C and D, the total length of cracking is 237 feet.

With few exceptions, the cracks formed first at the monument boxes which were set in the slabs to measure slab movement. The maximum width of crack opening in the slabs varied from $\frac{1}{4}$ inch to $\frac{1}{2}$ inch or more. From visual examination and crack width measurements, it is apparent that the steel mesh in Series 11 has broken at the cracks

It is of interest to note that the original test slabs of comparable lengths in both series have broken down into individual slabs of average length, of 91 and 72 feet respectively in Series 11C and 12C and for Sections 11D and 12E, slab length average 86 and 120 feet, respectively. However, individual slab lengths vary in both series from 17 to 152 feet. Summary of slab lengths will be found in Table 9.

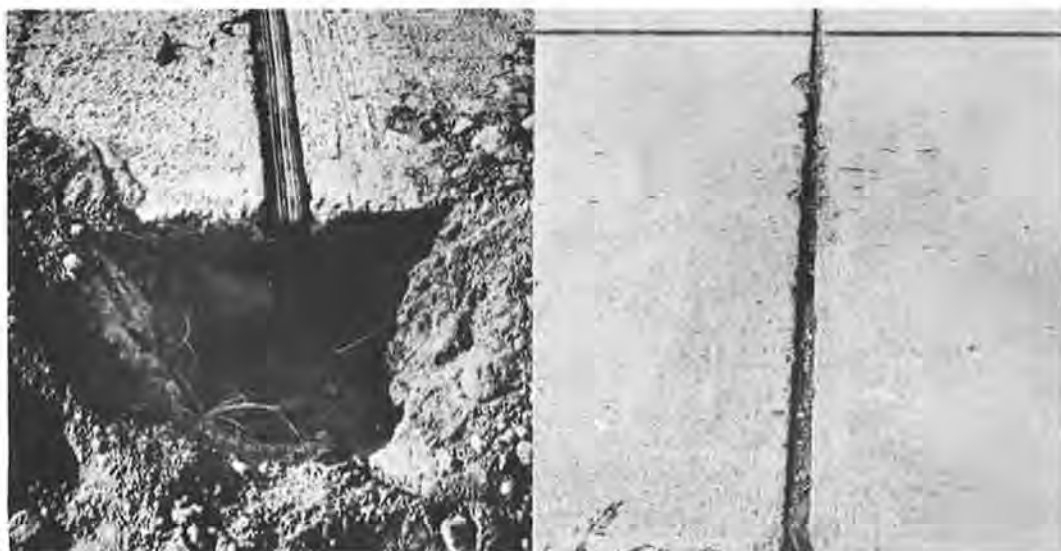
Type TB-(4) Series 9A. The air-chamber expansion joints used in Series 9A, Type TB-(4) have reacted very satisfactorily except for the premolded rubber seal which failed after two years in service. The premolded rubber seal through traffic action was pushed down into the joint about $\frac{3}{4}$ of an inch and rotated 90 degrees in the joints (see Figure 29). Eventually it was necessary to remove the rubber seal, thoroughly clean the joints and reseal. In the resealing process the old premolded rubber material was placed back into the joint opening at a depth of about $\frac{3}{4}$ -inch and new hot-poured bituminous-rubber joint sealing compound was poured on top to effect the seal.

Figure 29. Air chamber expansion joint, Type TB-(4) Series 9A, Station 171+10. (Left) at time of construction, 1940. (Right) same joint 2 years later (1942) when joint had to be repaired.

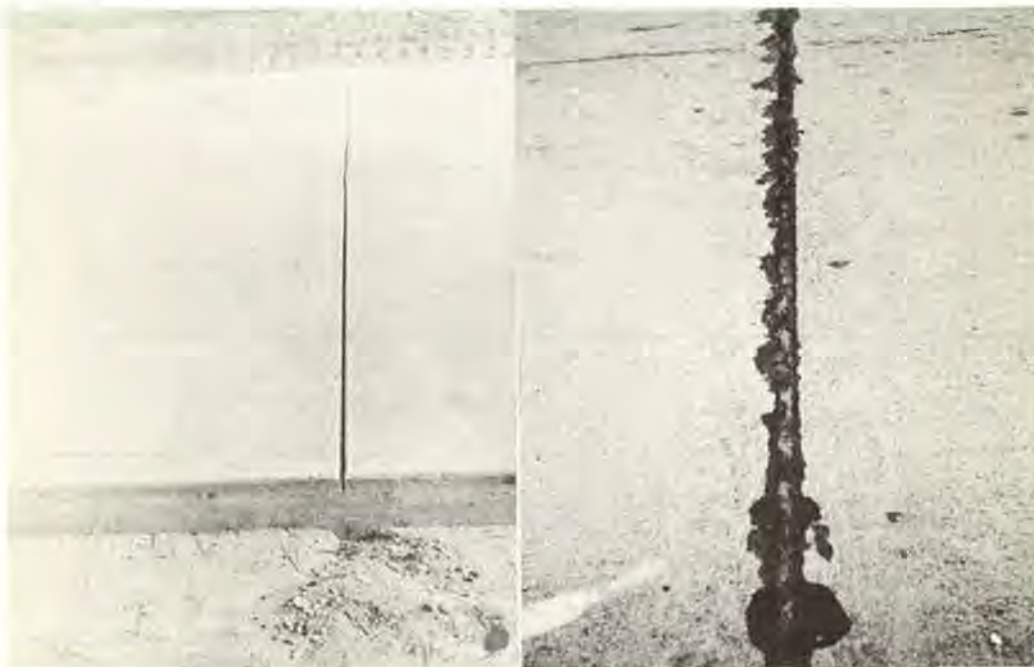
Figure 30. Type 1B contraction joint with groove, Station 64+90.
(Left) joint when installed, 1940. (Right) same, joint, 1950.

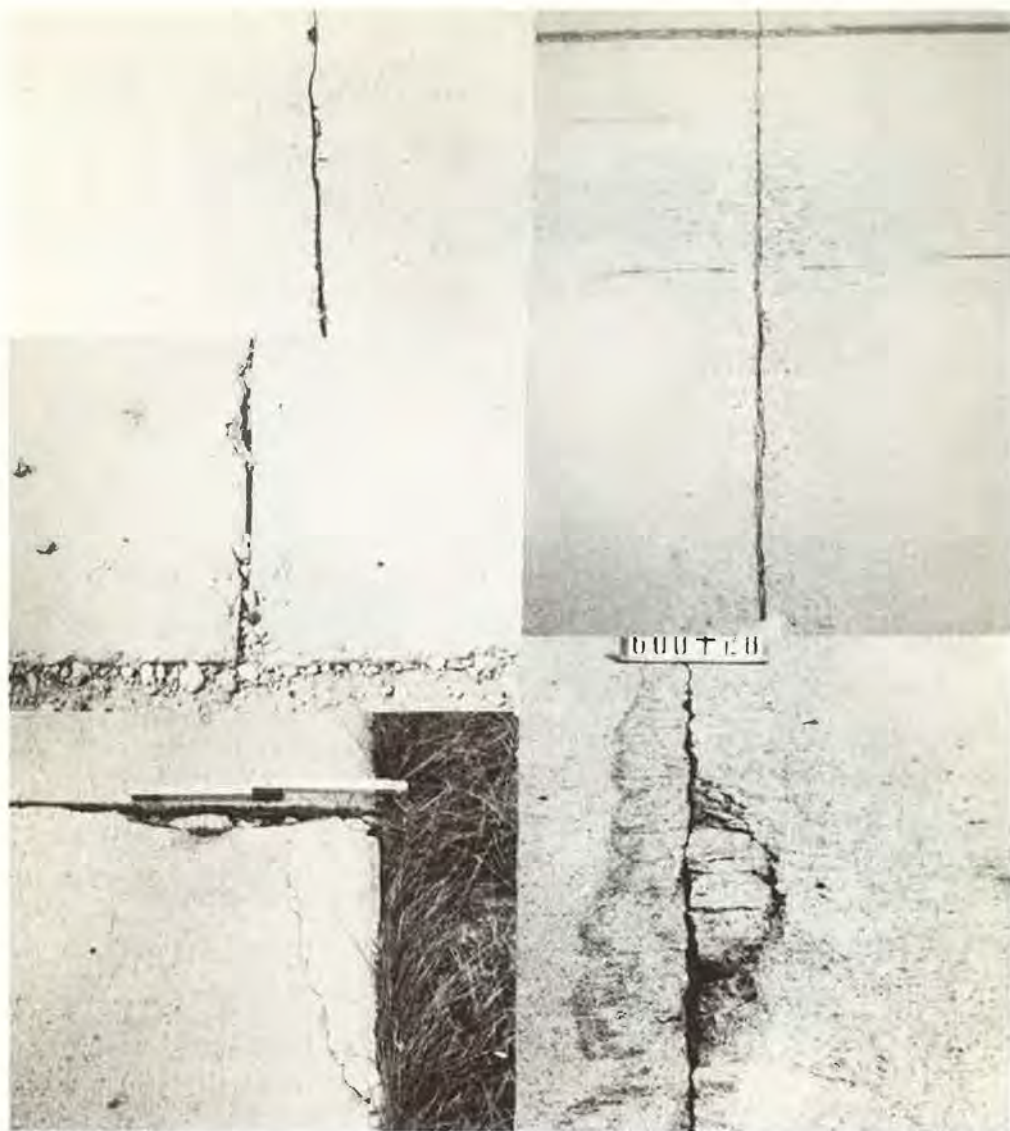
Figure 31. Typical failures common to contraction joints constructed with premolded fiber strips.

Sealing of Joint. Another common fault of the premolded fiber strip is that it does not provide adequate seal, especially during the winter months when the joints are at their maximum opening. In this condition the filler strip is loose in the joint, thus permitting the infiltration of water and inert material. Typical examples of this condition are presented in Figure 33. The seriousness of this condition is naturally affected by joint spacing, being greater in the sections with 60-foot joint spacing than in the sections with 10-foot spacing. In many instances it was noted that at the end of 10
