Report on Experimental Project in Michigan

H. C. COONS,* Deputy Commissioner, Chief Engineer
Michigan State Highway Department

● DURING the construction of the Michigan Test Road in 1940 and subsequent to it, many observational and special studies have been made in addition to carrying out the program of seasonal physical measurements which was set up in the original outline. The test road has been in existence now for 10 years and during this period there has been collected and analyzed a considerable amount of data. It is the purpose of this report to present as concisely as possible the significant trends in slab and joint behavior as well as other interesting disclosures which are believed to be of sufficient interest in relation to present design and construction of concrete pavements.

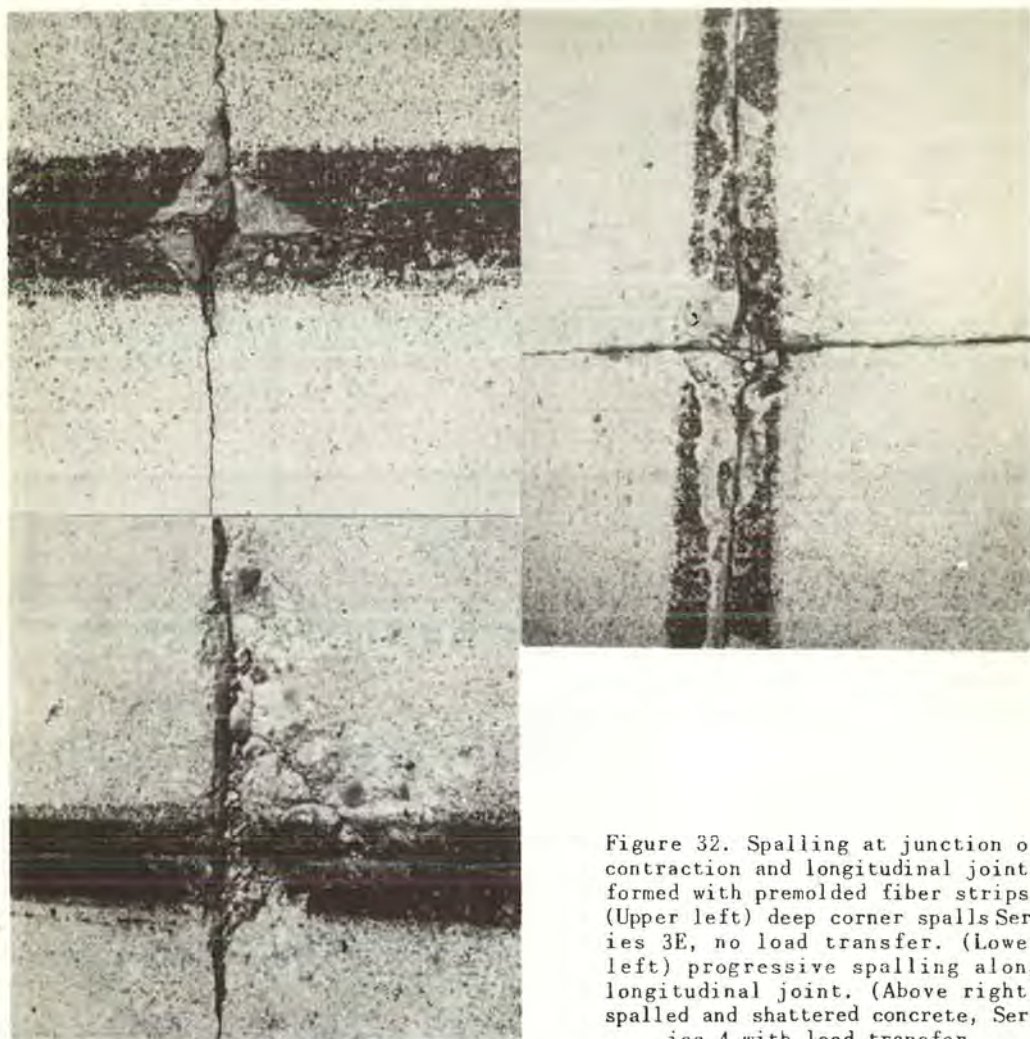
Figure 32. Spalling at junction of contraction and longitudinal joints formed with premolded fiber strips. (Upper left) deep corner spalls Series 3E, no load transfer. (Lower left) progressive spalling along longitudinal joint. (Above right) spalled and shattered concrete, Series 4 with load transfer.

Spalling at Longitudinal Joints. Corner spalling at junction of transverse and longitudinal joints is becoming quite prevalent throughout the Design Project wherever bituminous premolded fiber strip is used in the construction of both type of joints. This

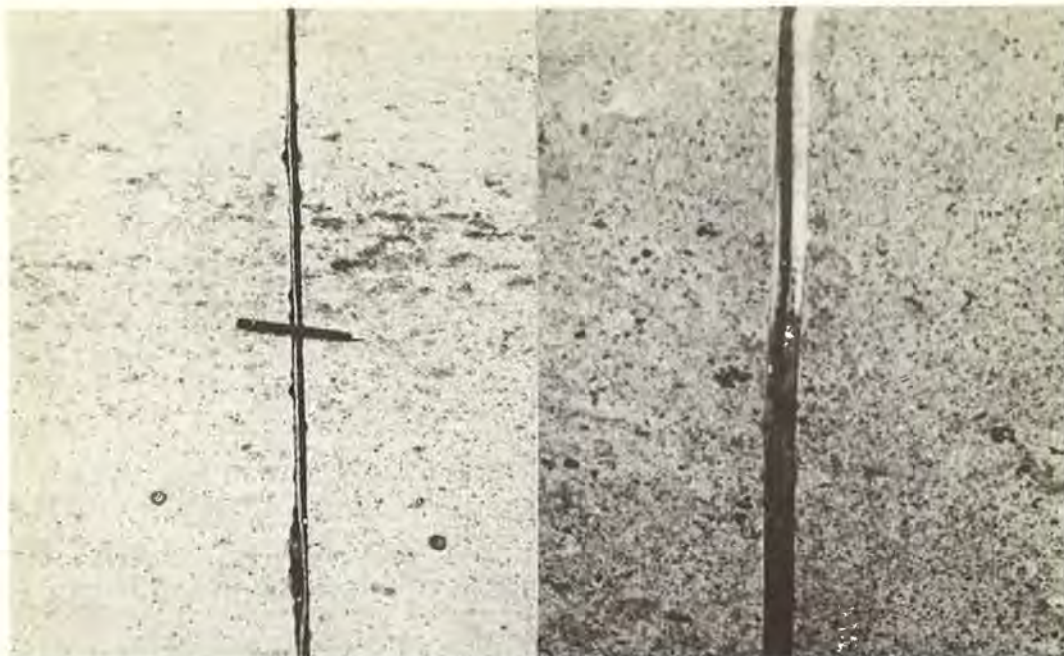
Figure 33. Typical condition of contraction joints in winter with bituminous premolded fiber strip, Series 1A, 60-ft. contraction joint spacing. Winter 1944-45. (Left) open to permit intrusion of inert material. (Right) snow and ice forms in joint.

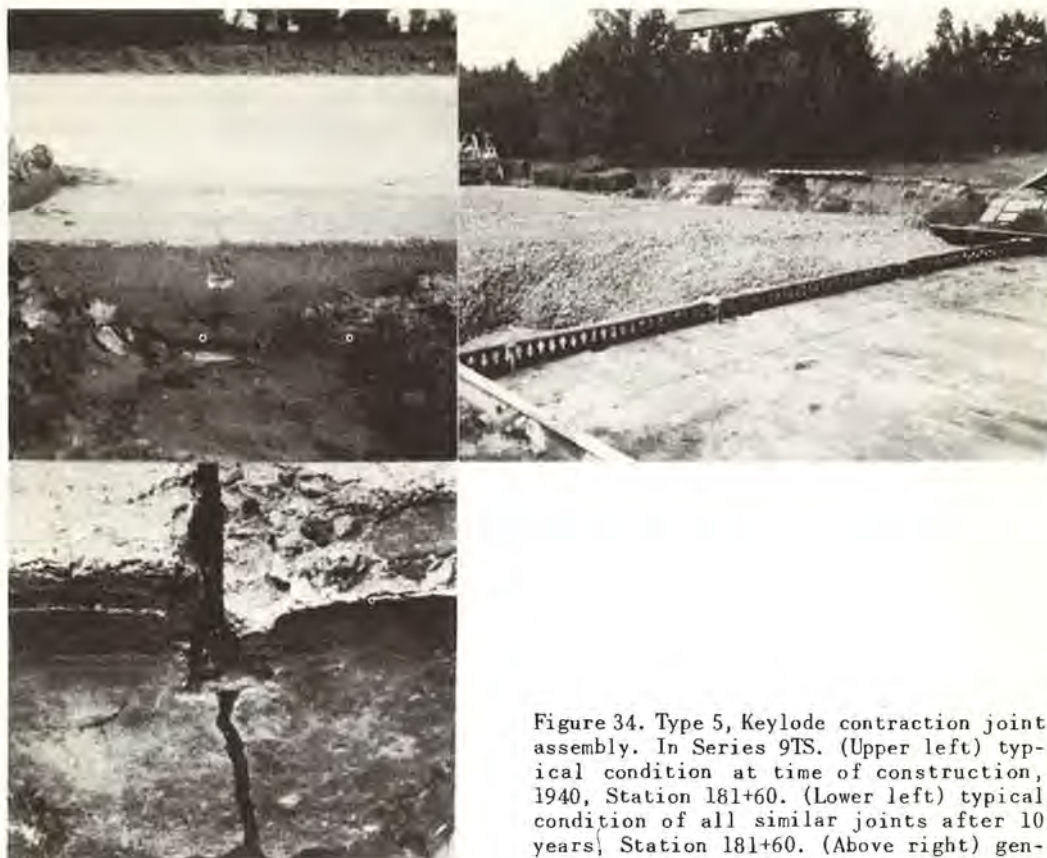
Figure 34. Type 5, Keyhole contraction joint assembly. In Series 9TS. (Upper left) typical condition at time of construction, 1940, Station 181+60. (Lower left) typical condition of all similar joints after 10 years, Station 181+60. (Above right) general view of joint assembly.

Views illustrating typical conditions of Type 5 joint at construction and 10 years later are presented in Figure 34. In Figure 34, two physical weaknesses are in evidence.

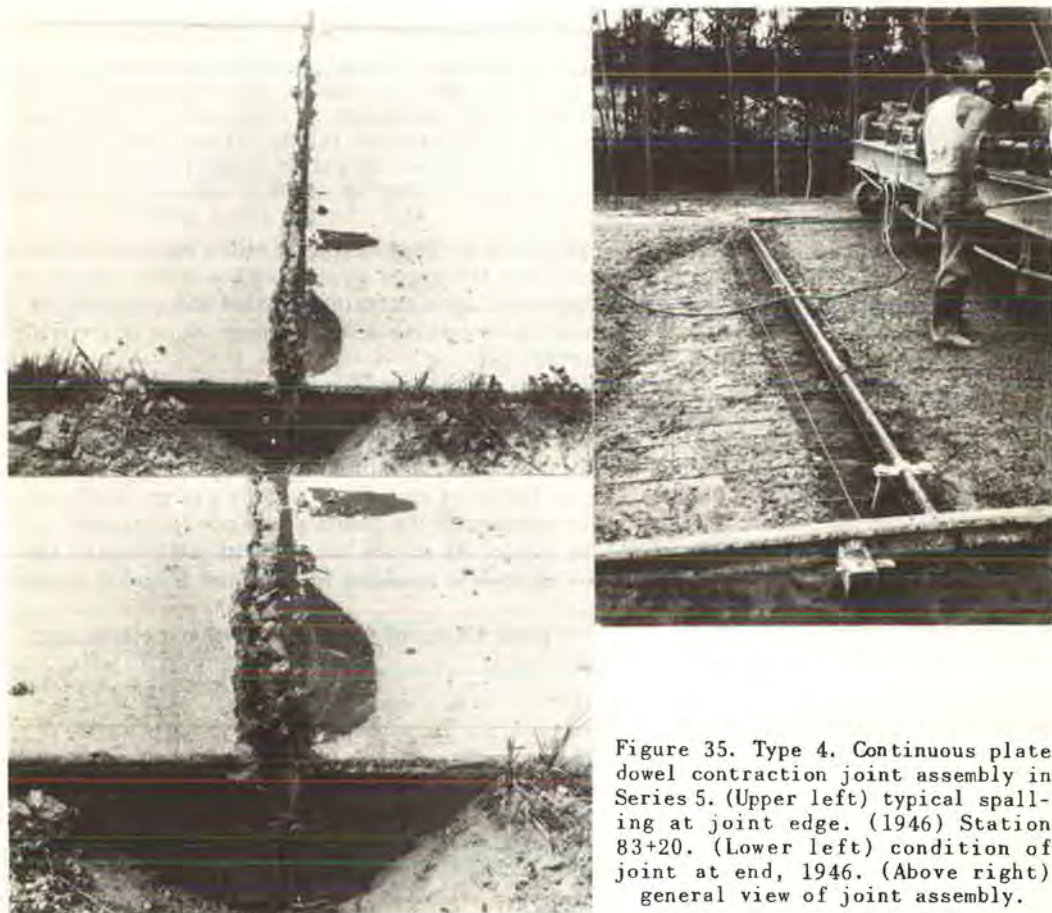
Figure 35. Type 4. Continuous plate dowel contraction joint assembly in Series 5. (Upper left) typical spalling at joint edge. (1946) Station 83+20. (Lower left) condition of joint at end, 1946. (Above right) general view of joint assembly.

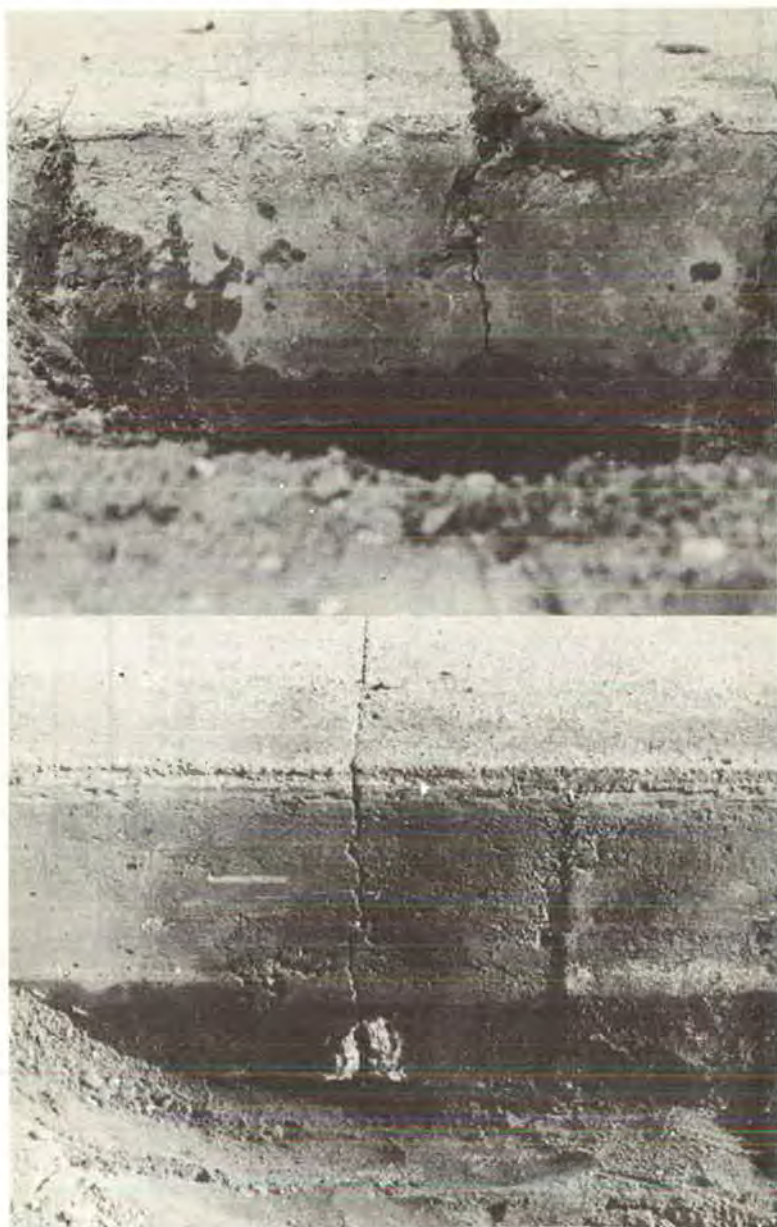
Figure 37. Effect of bottom parting strip on joint cracking. (Top) typical cracking at plane of weakness joint without parting strip at bottom. (Bottom) typical cracking when parting strip is properly installed.

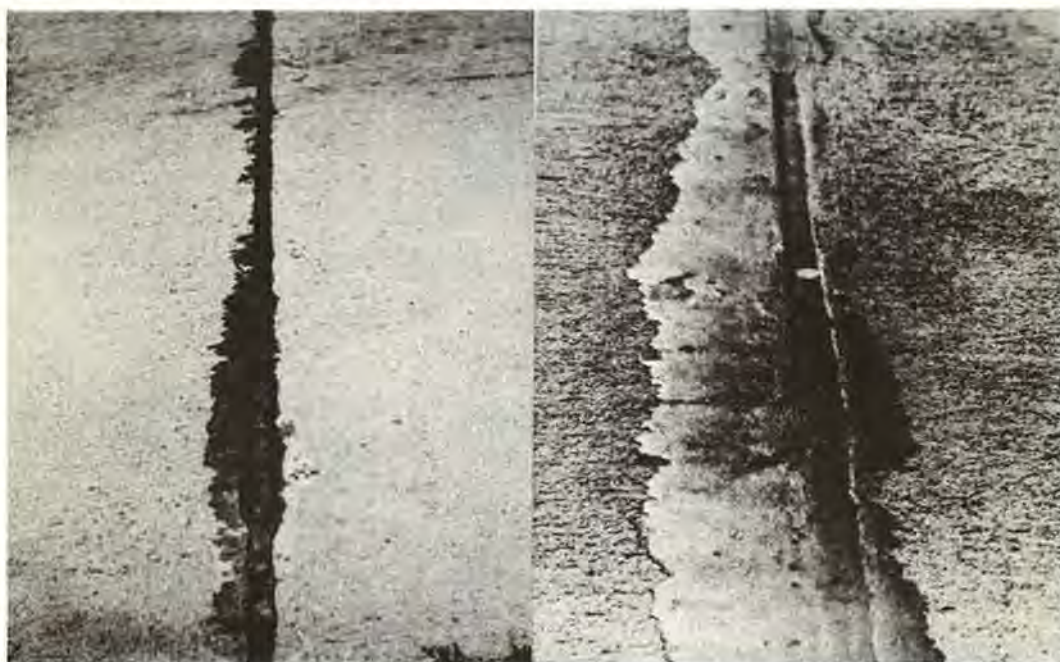
Figure 38. Present condition of bituminous-rubber material after 10 years. (Left) asphalt-latex sealing compound. (Right) thermoplastic sealing compound.

The Thermoplastic hot-pour rubber-type compound is still in excellent condition after 10 years of service (see Figure 38).

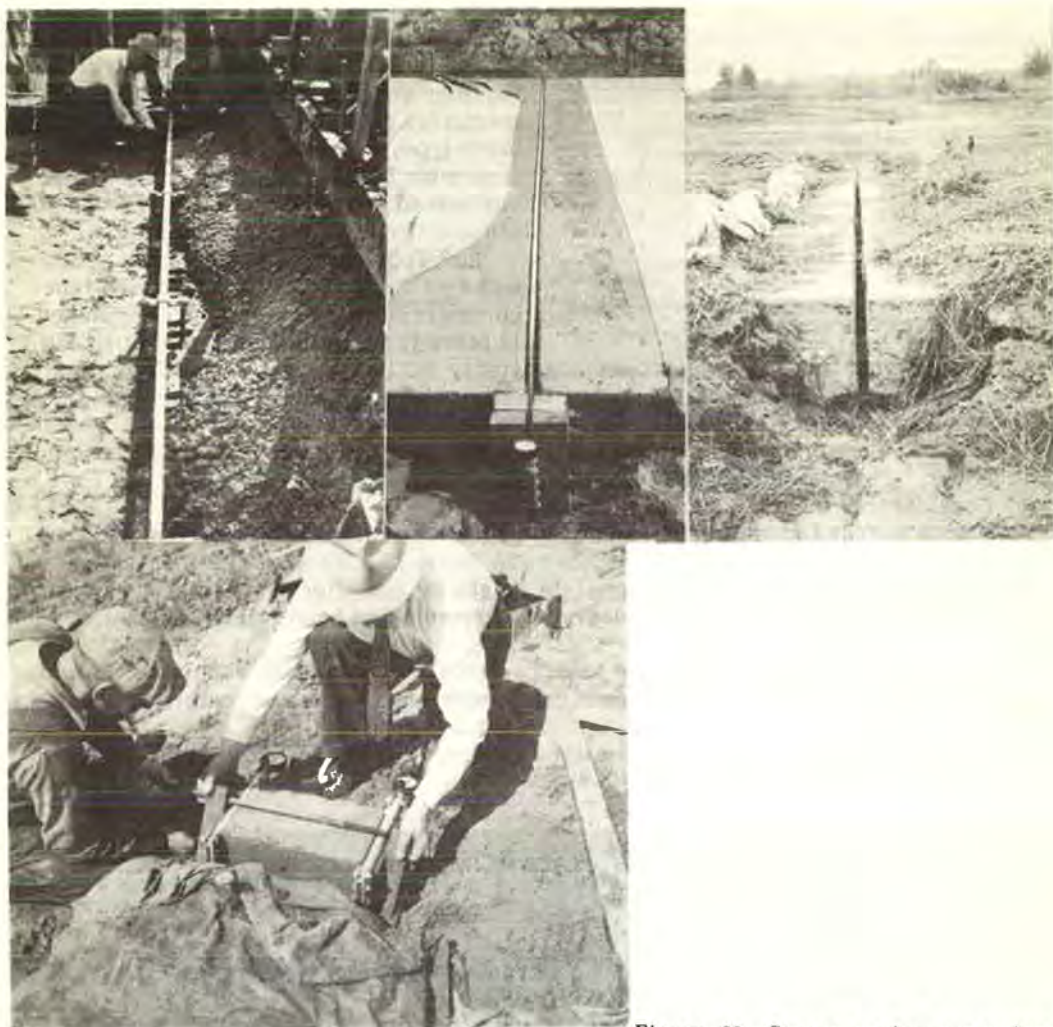
Figure 39. Stress curing operations.

the beams for modulus of rupture tests reached the 7-day specification strength of 550 psi. The application of pressure was accomplished by using canvas covered rubber hose pressure cells inserted in the expansion joint openings. The pressures were increased at a rate controlled by determinations of strength increase in test specimens up to a maximum of 200 psi. (see Figure 39).

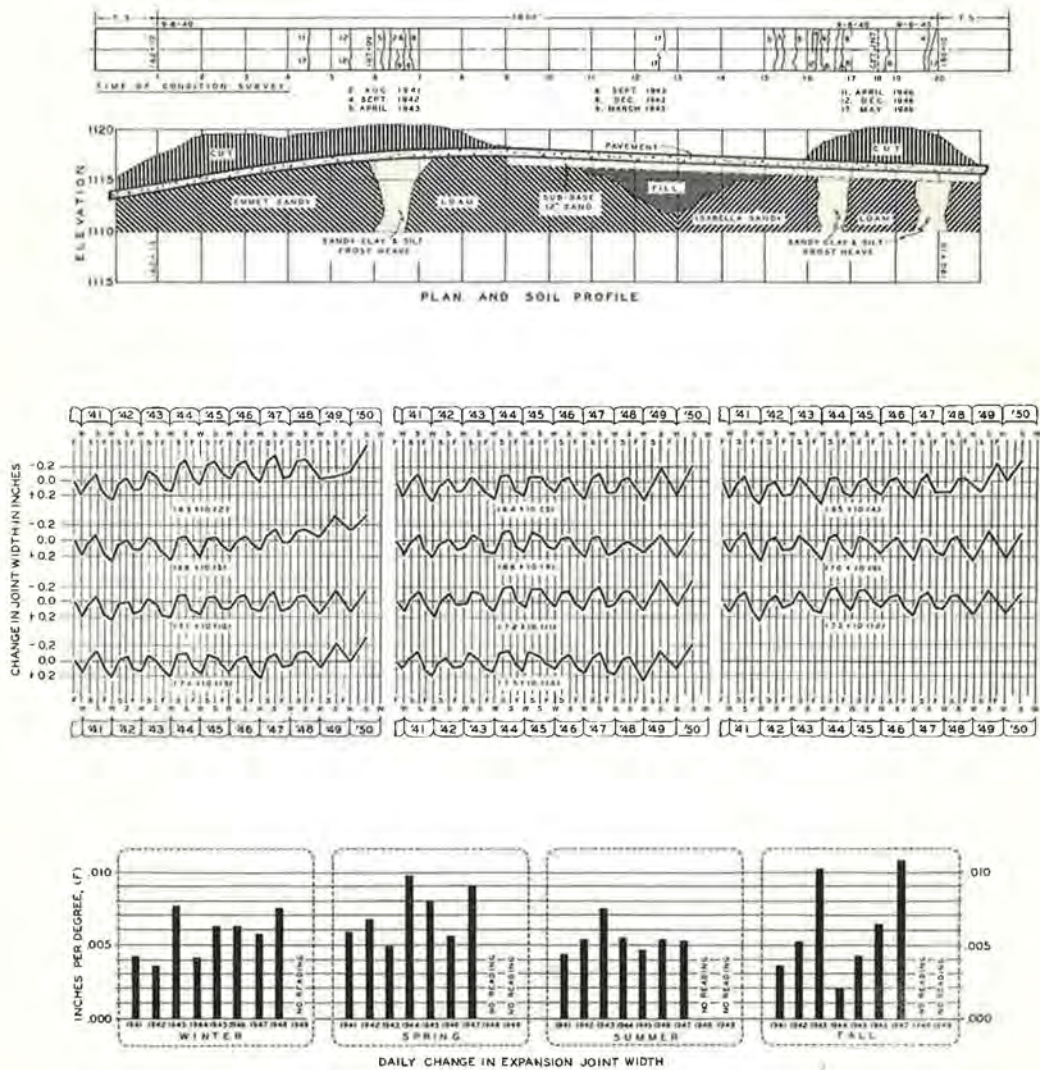
Figure 40. Stress cured concrete.

At the end of 10 years, 10 of the 18 slabs are in apparently perfect condition. The remaining 8 slabs have cracked as shown in Figure 40. The first crack in the entire test section occurred in the slab between Joints 6 and 7 prior to the survey conducted in August, 1941. The progressive development of cracks is also illustrated in Figure 40 by the numbers appearing at each crack.

In Series 9A, 1,800 feet of concrete pavement was placed by the stress curing method, which eliminates reinforcement and transverse joints other than those provided for expansion. The slabs were laid in 100-foot lengths. The concrete was subjected to controlled compressive forces during the 7-day curing period, or until such time as
