HIGHWAY RESEARCH BOARD

Research Report 17-B

Joint Spacing in Concrete Pavements:

10-Year Reports on Six Experimental Projects

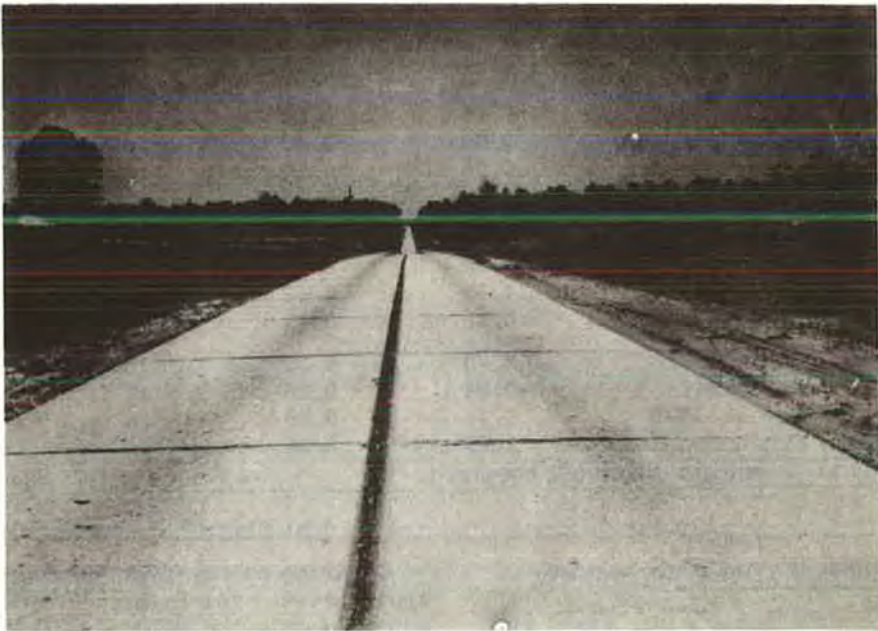
Figure 5. View to north of Section 2-R through Section 1 in May 1949. Pavement in foreground contains expansion joints at 800 foot intervals with dowel bars and contraction joints at 200 foot intervals without dowel bars. Wire mesh reinforcement was not used in this section.

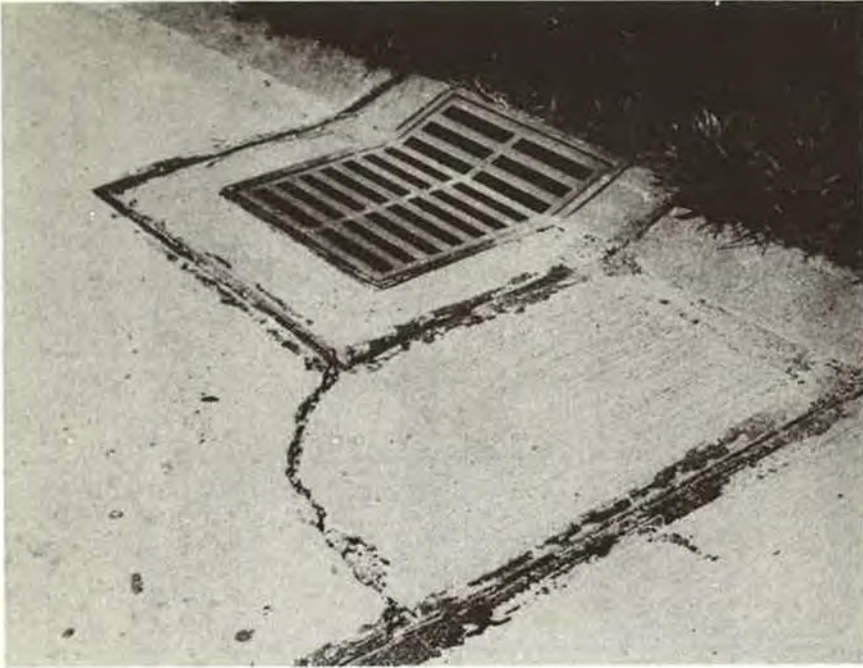
Figure 6. Typical of cracking where drop inlet is constructed near joint installation, Section 4-R in May 1949.

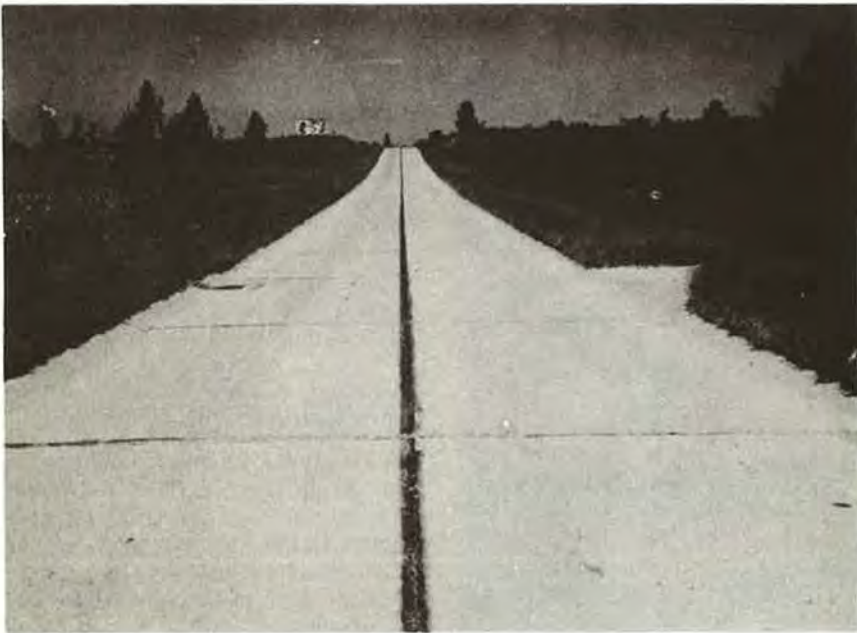
Figure 7. Faulted joint in foreground, Section 4-R. Pavement contained expansion joints at 120 foot spacing with dowel bars and contraction joints at 20 feet without dowel bars. Wire mesh reinforcement was not installed in this section.

Faulting, though not infrequent, exists in such magnitude as to defer any particular emphasis on relative merits of design or imply definite association with particular construction features. Additionally, neither the presence of expansion joints nor their spacing as compared with contraction joints, had any measurable effect on faulting or differentials in pavement elevations in adjacent slabs. Little or no significant evidence of pumping was observed to have occurred in any of the sections during the 10-year period.

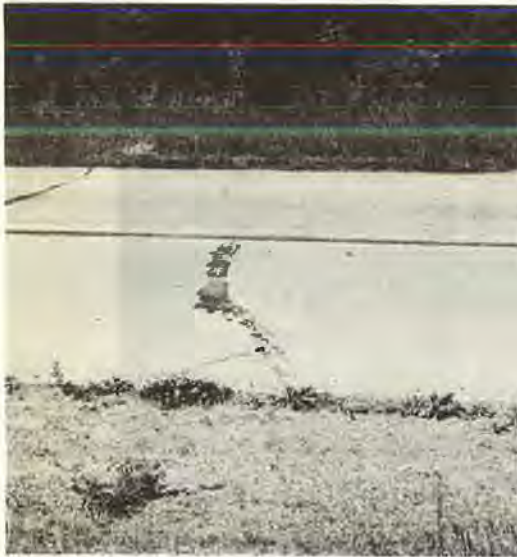
Figure 8. Irregular transverse cracking in east lane of Section 5-R in May 1949. Section does not contain wire mesh reinforcement.

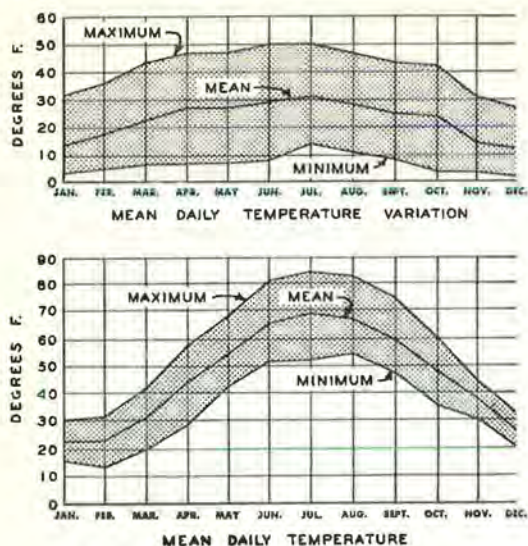
Figure 4. Temperature record.

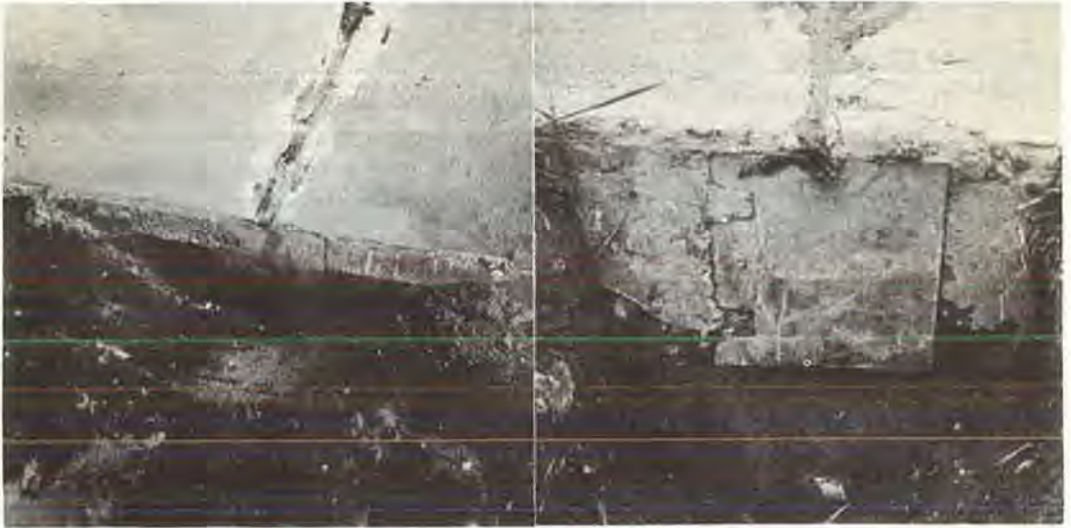
Figure 28. Air chamber expansion joint, Type DB-1 (3) Series 5, Station 79+60. (Left) at time of construction, 1940. (Right) 10 years later, 1950.

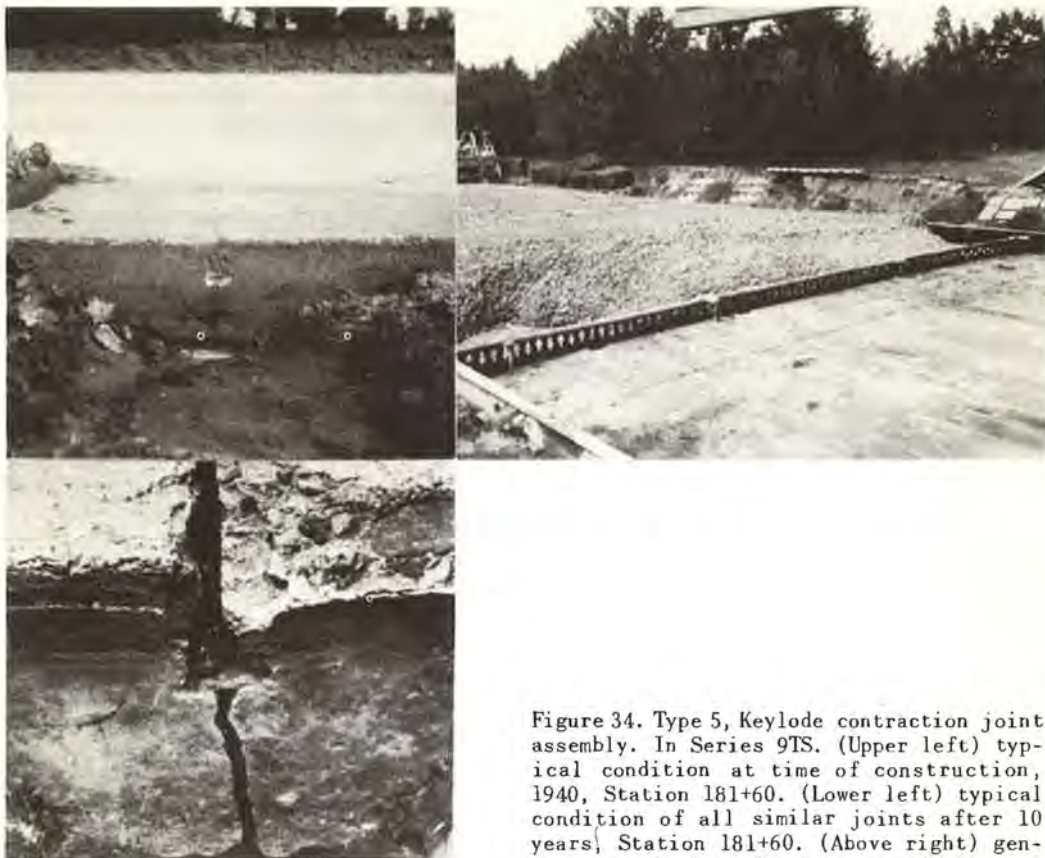
Figure 34. Type 5, Keylode contraction joint assembly. In Series 9TS. (Upper left) typical condition at time of construction, 1940, Station 181+60. (Lower left) typical condition of all similar joints after 10 years, Station 181+60. (Above right) general view of joint assembly.

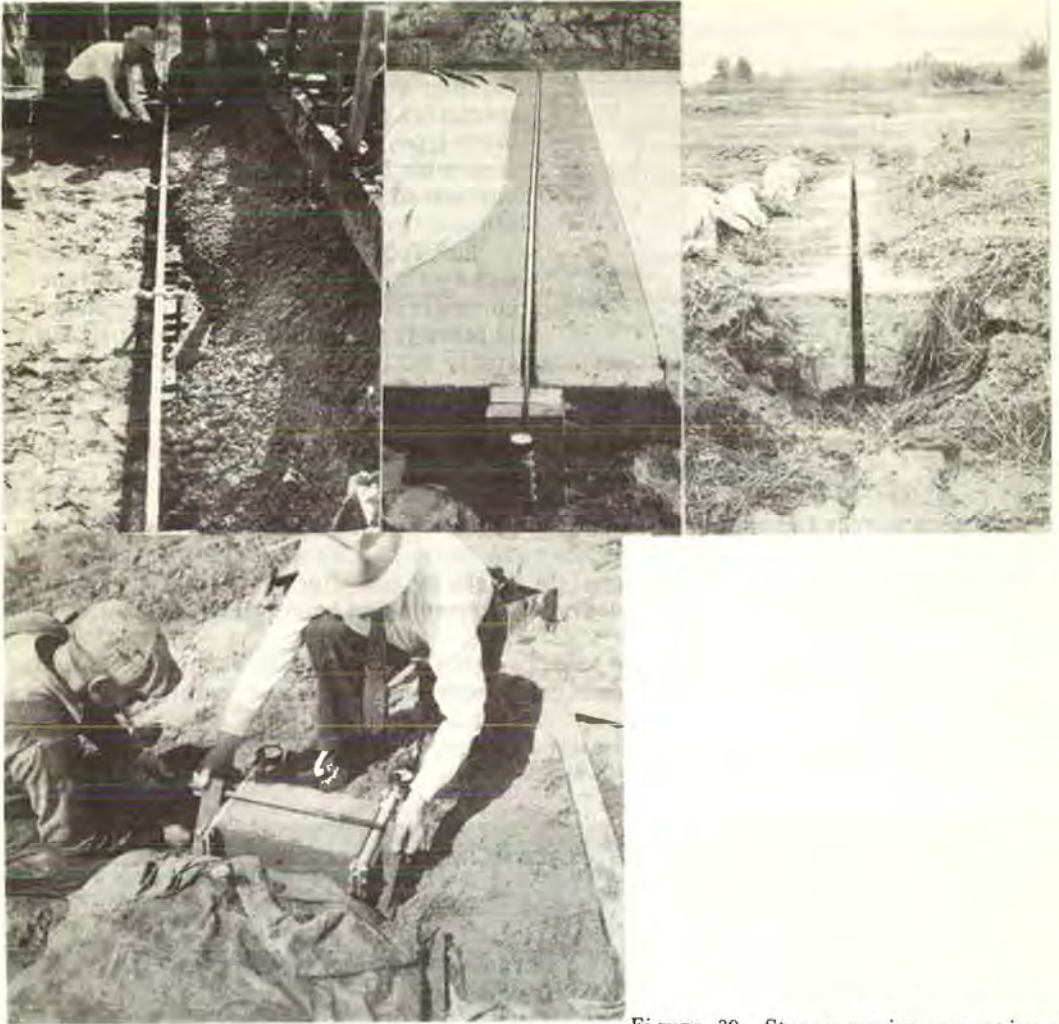
Figure 39. Stress curing operations.

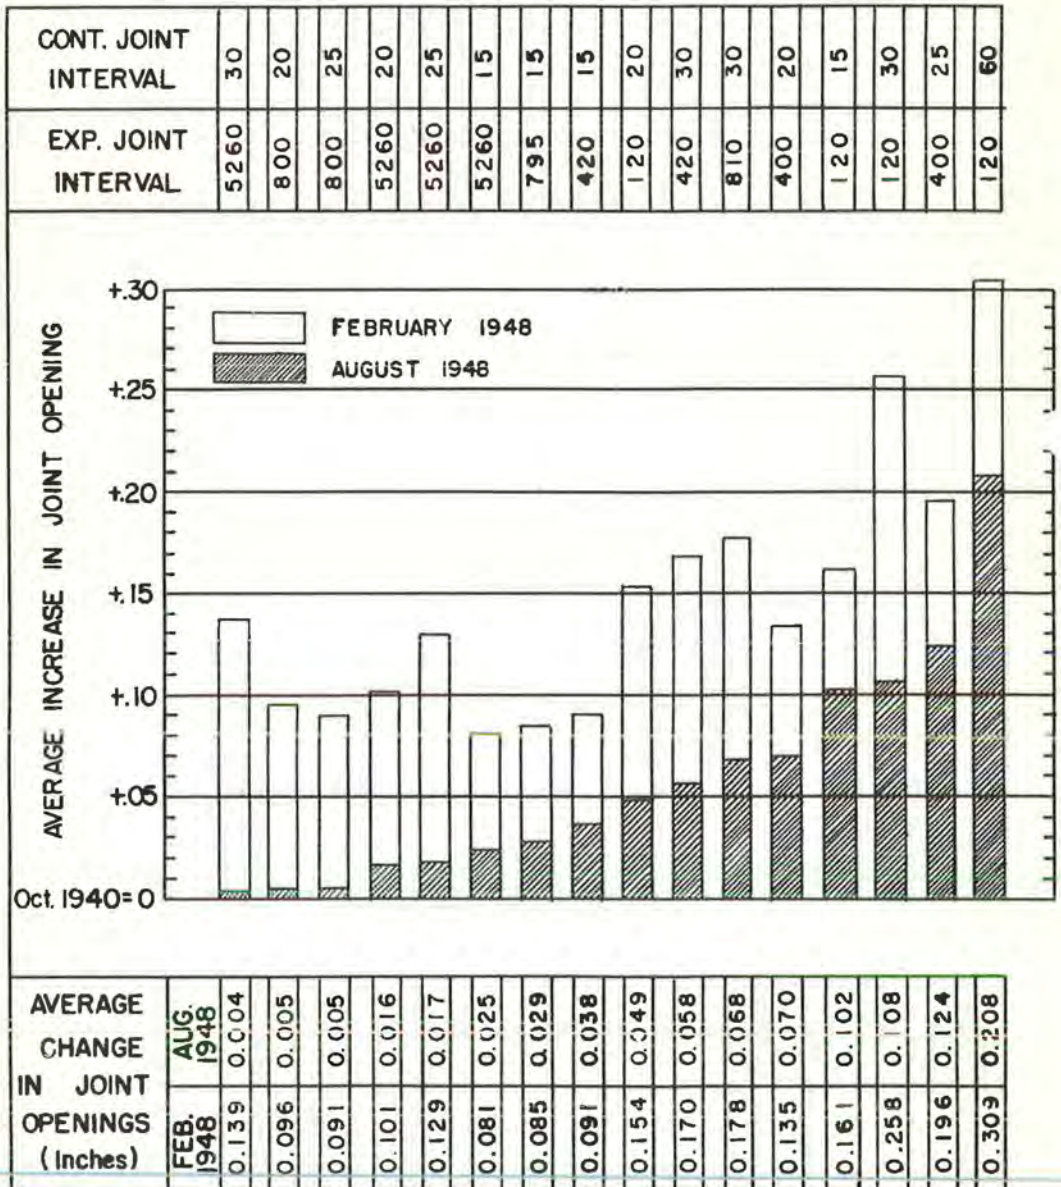
Figure 38. Average increase in contraction joint openings.

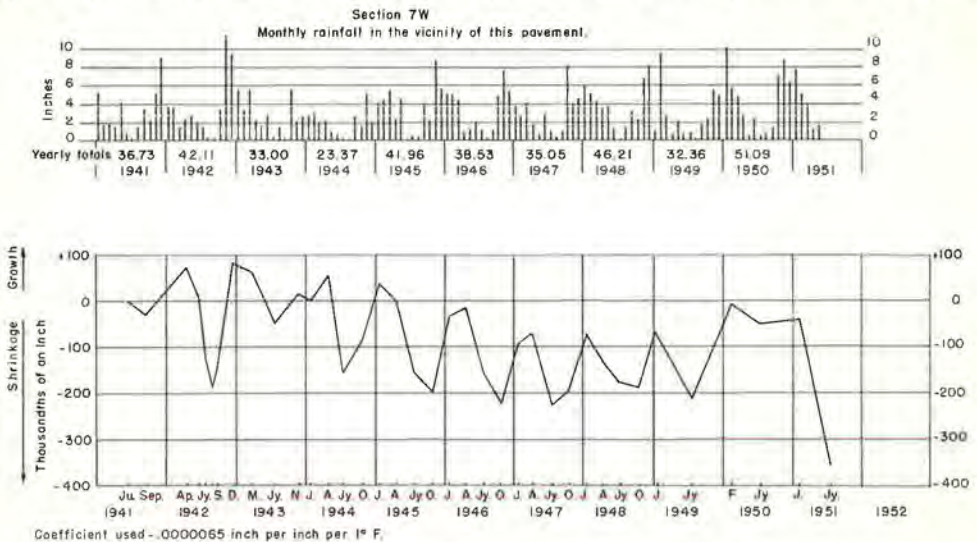
Figure 5. Lombard-Killingsworth pavement. Length changes in 120 feet corrected for a concrete temp. of 40° F.
