# Slab Breaking and Seating on Wet Subgrades With Pneumatic Roller

JAMES W. LYON, JR., Testing Engineer, Louisiana Department of Highways

This paper reports on a long-range field study to determine the practicability of using a pneumatic tire 50-ton roller to break and seat old concrete pavements before overlaying with hot-mix asphaltic concrete. The method of study is a comparative analysis of the behavior, under traffic, of various roadway sections employing different breaking and seating techniques of the 50-ton pneumatic roller and an impact hammer on a construction project generally having a wet subgrade condition.

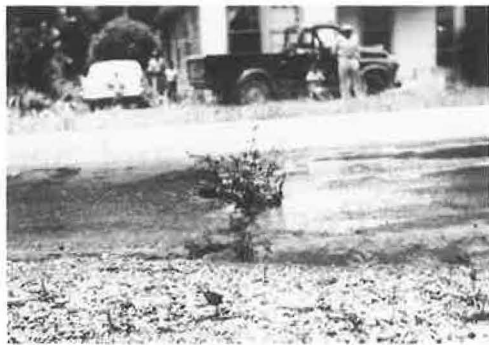
Figure 1. Typical slab pumping under truck traffic on old roadway before construction.

The project site being used for this study is  $15\frac{3}{4}$  mi of old, badly pumping, 18-ft wide concrete pavement, comprising State Route 1 between Donaldsonville and Napoleonville, in the bayou country of south Louisiana (Fig. 1). The existing concrete slab is 6 in. thick at the center, thickened to 8 in. at the edges, and widened 3 ft on each side with concrete. It was overlaid in the winter months of 1959 with hot mix, after various slab breaking and seating techniques with the 50-ton roller and the presently used impact hammer. The hot-mix overlay was  $3\frac{1}{2}$  in. of binder and wearing course, with a quantity of binder course for leveling, equivalent to 1 in. of thickness (Fig. 2).

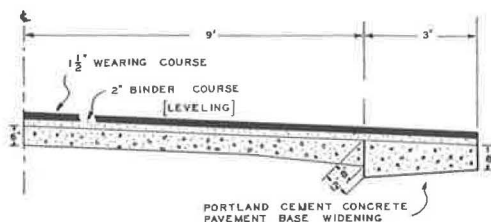
Figure 2. Typical section, as constructed.

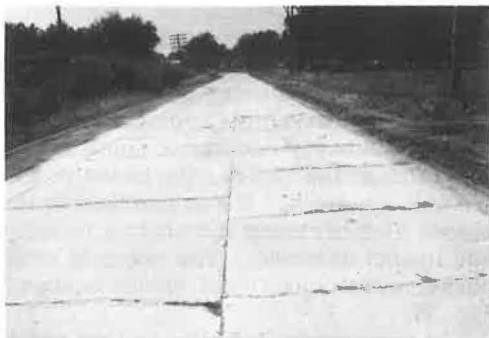
Figure 3. Old roadway showing pumping under normal traffic; 3-ft base widening in place, before any breaking and seating operation.

The concrete pavement was generally unreinforced (Fig. 3). Transverse,  $\frac{1}{2}$ -in. round by 4-ft long, deformed bars, spaced 5 ft on centers, were employed along the longitudinal center joint. Transverse expansion joints consisted of a premolded joint filler and eight  $\frac{3}{4}$ -in. smooth, round dowel bars, 4-ft in length for load transfer. The

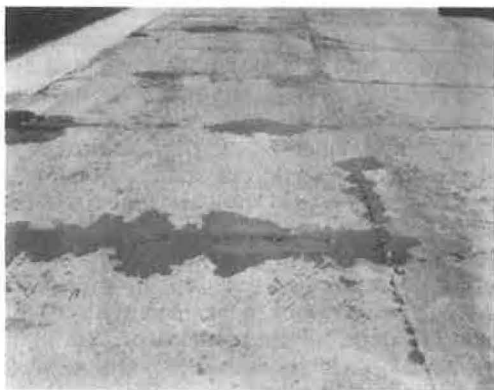
Figure 4. Wet material displaced by rolling at typical pumping slabs.

The 3-ft base widening definitely interferes with the lateral movement of any underlying wet soil slurry. The roller forces this material through the joints or breaks in the slab and along the edge of the slab when the existing shoulder or the 3-ft base widening was in place. The majority of this project was studied with the base widening in place (Figs. 4, 5, and 6).

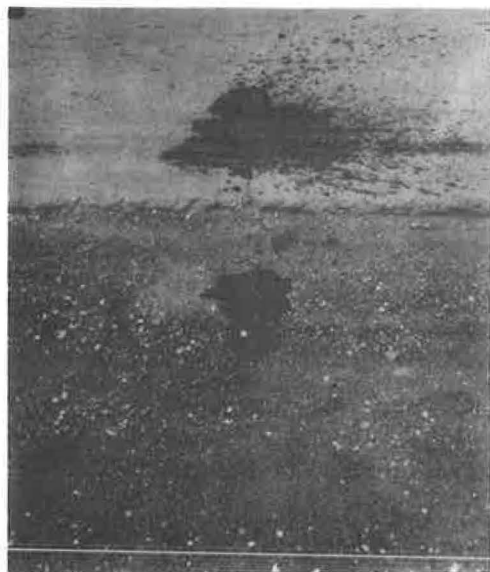
Figure 6. Wet subgrade material forced through shoulder by roller.

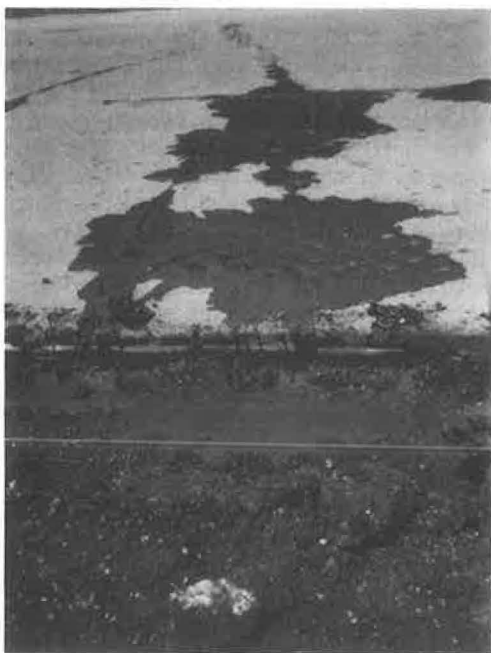
Figure 5. Wet material removed by roller from subgrade under slabs broken by traffic; removed mud in trench.

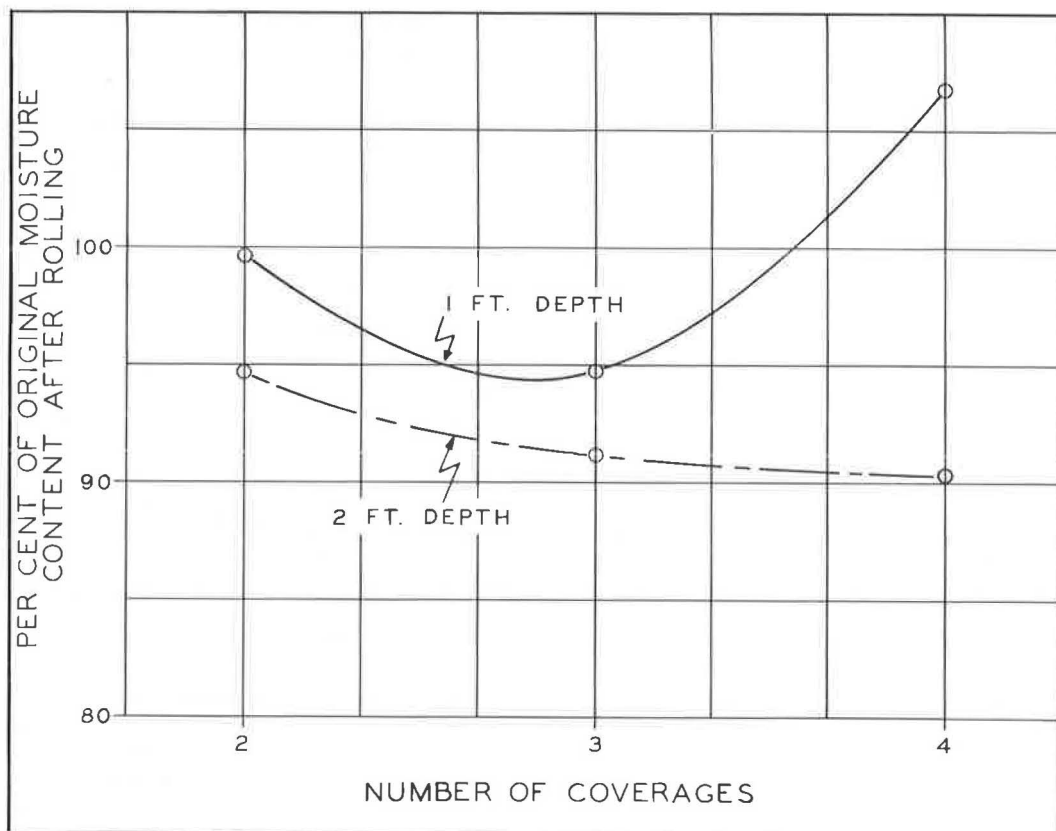
Figure 7 shows the effects of roller coverages on the subgrade moisture contents at 1- and 2-ft depths below the concrete pavement expressed as a percentage of the moisture content immediately after rolling, as compared to that just prior to rolling. Two roller coverages appear to draw moisture from the 2-ft depth into the 1-ft depth in an amount that would offset the moisture removed from the 1-ft depth. Three roller coverages appear to be more effective in subgrade drying, removing relatively more water from either the 1- or 2-ft depths than that pumped up into these layers. Four roller coverages apparently pump water into the 1-ft depth faster than it is removed. Also, four coverages probably begin to draw water from the deeper subgrade into the upper 2 ft of the subgrade. Six roller coverages were observed during breaking and seating operations, and field observations indicated that slab pumping was intensified under this number of coverages. Although the 50-ton roller undoubtedly created a

Figure 7. Effects of roller coverages on subgrade moisture contents during rolling.

migrating moisture condition, three coverages appear to be optimum for maximum water removal.

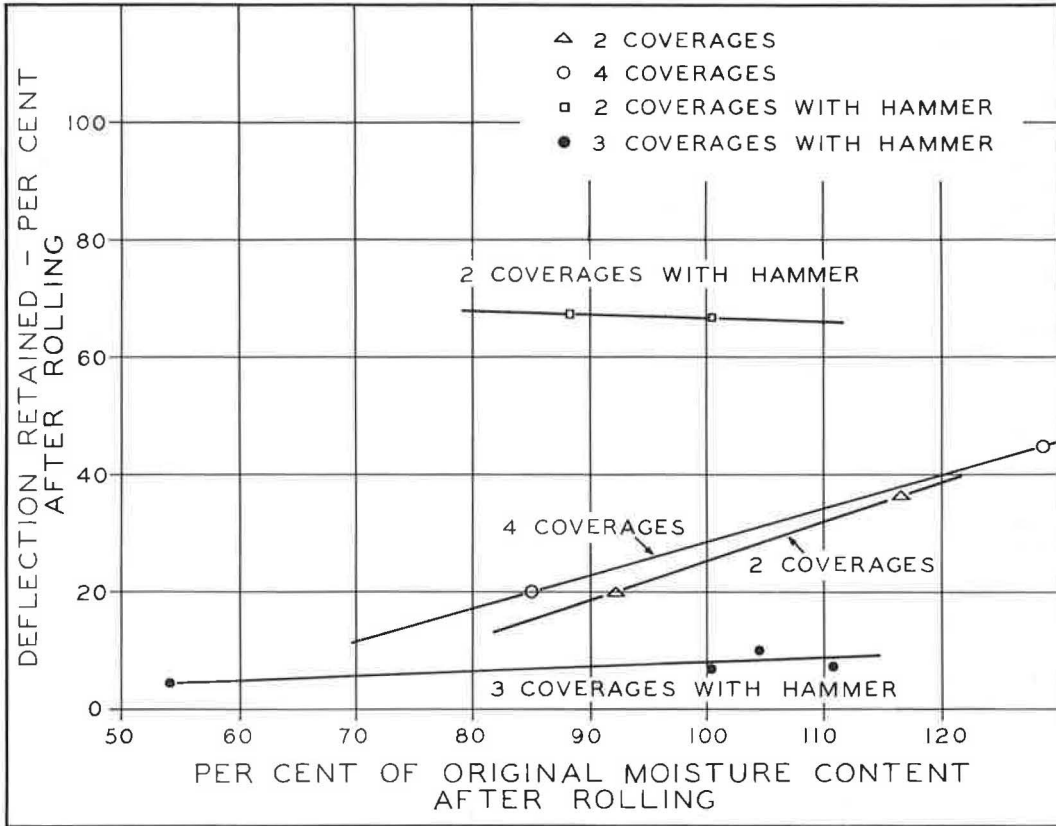
Figure 8 shows the effects of moisture content variation and roller operations on deflection. The moisture content scale is a comparison of the moisture content after rolling to that determined immediately before rolling. The percent deflections are comparisons of the deflections one year after overlaying to those determined before breaking and seating. The operation of the roller in conjunction with the impact hammer gives a relatively consistent change in deflection regardless of any changes in moisture content. This is shown by the horizontal plots of two roller coverages with hammering, and three roller coverages with hammering. Where the roller only was used, changes in moisture content have a definite effect on changes in deflection. However, the most significant indication of this is the effect of three roller coverages and the impact hammer on deflection, regardless of moisture content variation, reducing one-year deflections to less than 10 percent of that before breaking and seating.

Figure 8. Effects of various roller treatments and moisture content changes during rolling on deflections after 1 yr of traffic vs that immediately before rolling operations.

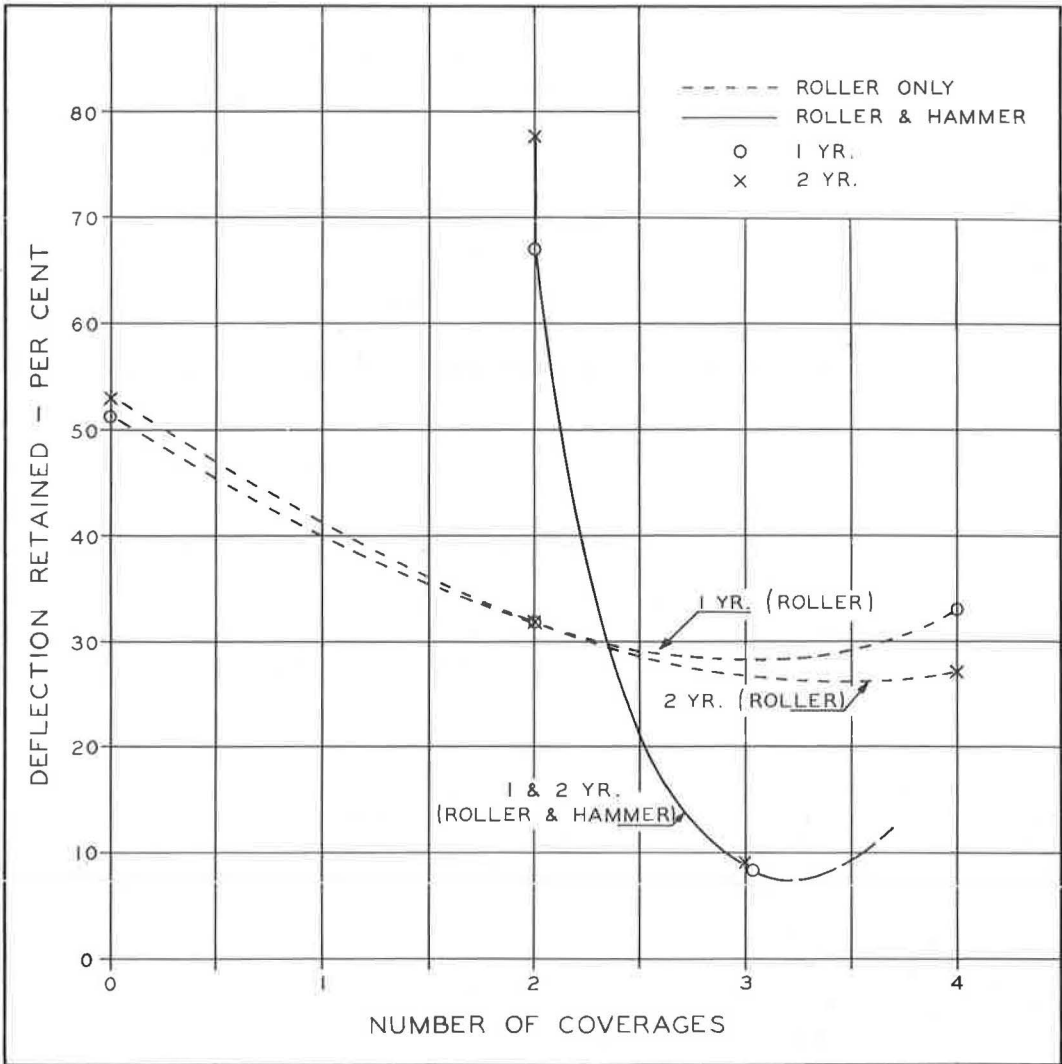
Figure 9 shows the effects of the number of roller coverages on the deflection at one and two years, expressed as a percentage of the deflection before breaking and seating operations. Of interest is a comparison of the changes in deflection between the use of the roller alone and the use of the roller in conjunction with the hammer. The number of coverages of the roller alone apparently would not require as close a field control as that of the roller and hammer; however, the reduction in deflection would not be of the

magnitude as when using the roller and hammer together. Although the number of coverages of the roller, when used with the hammer, appears to be critical, this treatment reduced the deflection, when three coverages were used, more than any other treatment or combination of treatments used in this study. In addition, there is no change in roadway conditions from the one and two years' results where the roller and hammer were used together.

Figure 9. Effects of various roller treatments on Benkelman beam deflections after 1 and 2 yr of traffic vs deflections immediately before breaking and seating operations.

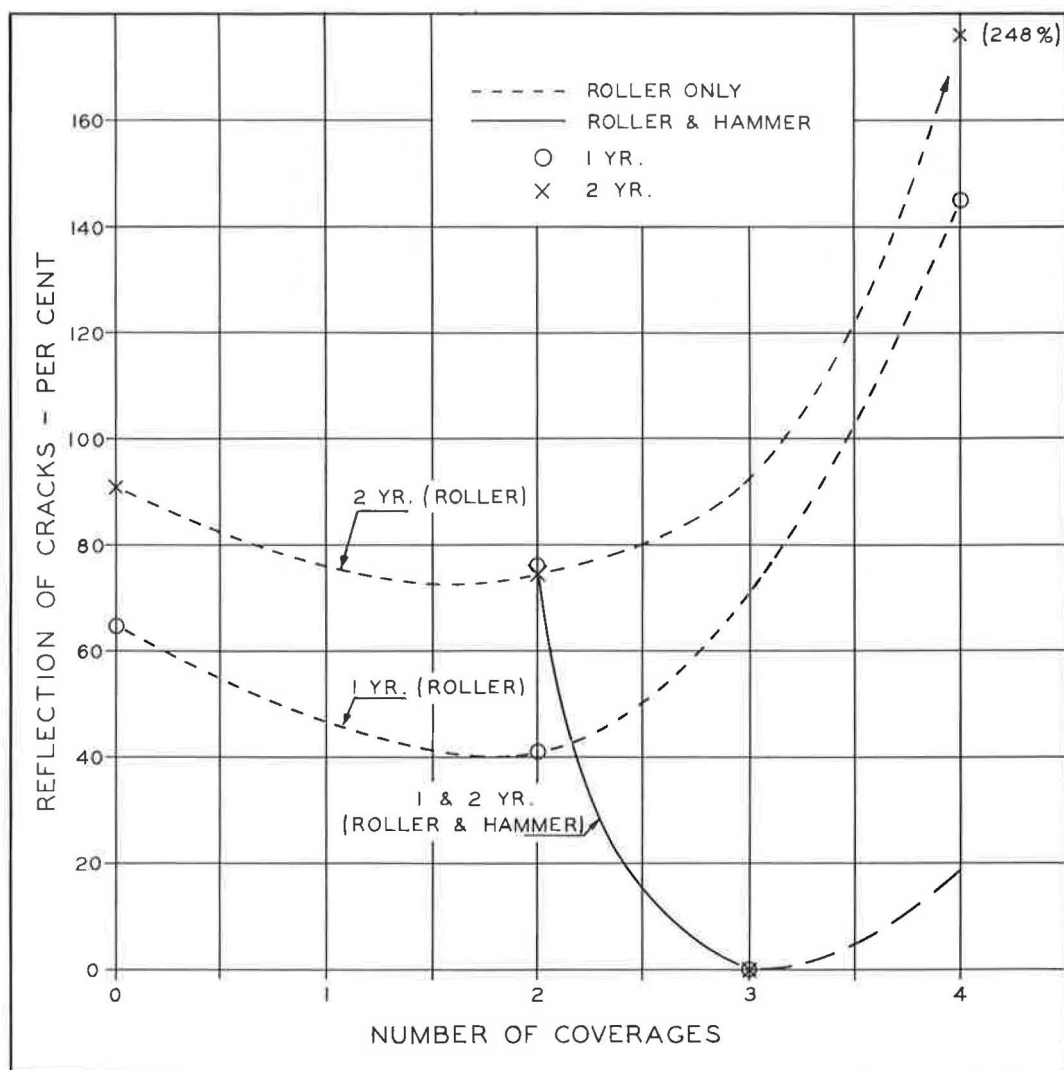
Figure 10 shows the effects roller coverages have on the reflection cracking at one year and at two years after overlaying, as compared to the joints and cracks observed before breaking, seating, and overlaying. Three coverages of the roller with impact hammering eliminated reflection cracking at the applicable test stations. Where the roller only was used, reflection cracking was increased when four roller coverages were applied, indicating overrolling. There is a large amount of change in reflection cracking between the one-year and two-year results where the roller only was used. There is no change in reflection cracking where the hammer and roller were jointly used.

Figure 10. Effects of various roller treatments on reflection cracking after 1 and 2 yr of traffic vs joints and transverse cracks before any treatment.

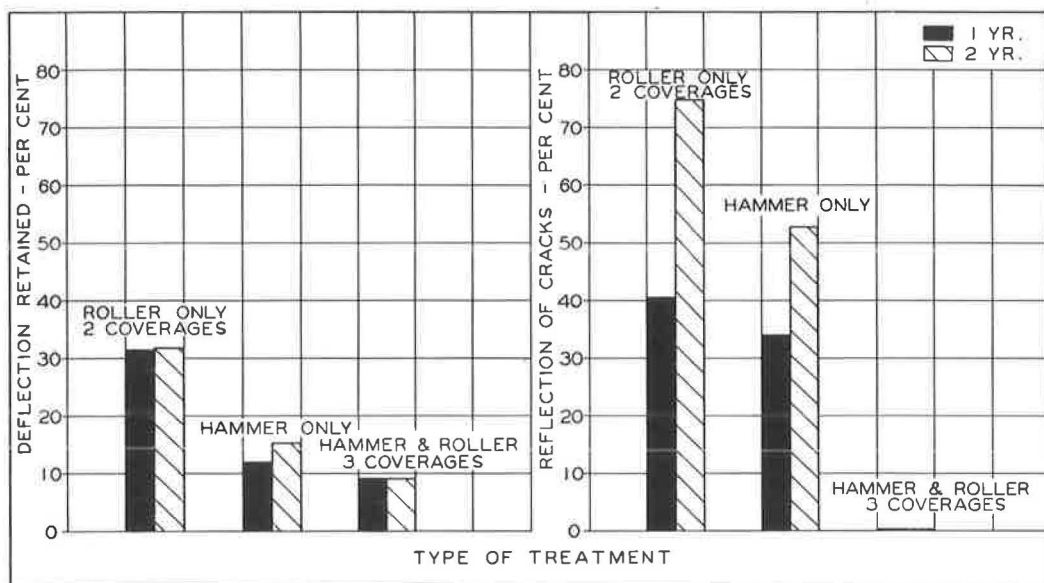
This study, after two years of service, points out the superiority of a breaking and seating procedure for old pavements on wet subgrades, consisting of a combination of three roller coverages and impact hammering, as shown in Figure 11. The recommended field procedure would be to locate moving slabs with one coverage of the 50-

Figure 11. Changes in reflection cracking and deflections for 1 and 2 yr of traffic vs original conditions, for various optimum treatments.
