HIGHWAY RESEARCH RECORD

Number 11

Maintenance Practices

Presented at the
42nd ANNUAL MEETING
January 7-11, 1963

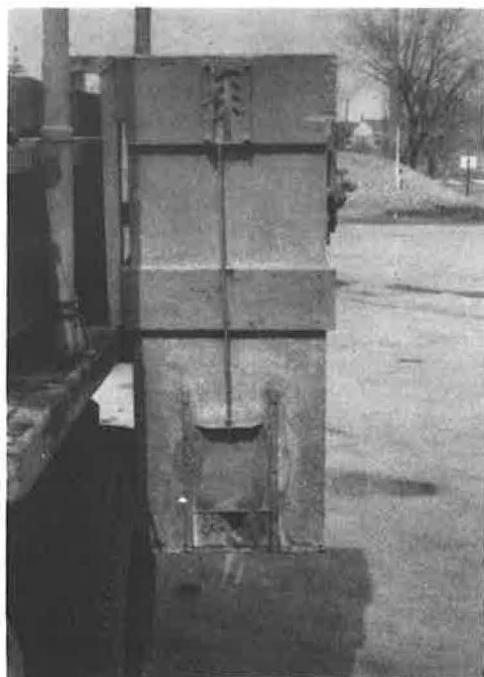
Figure 5. Chemical dribbler.

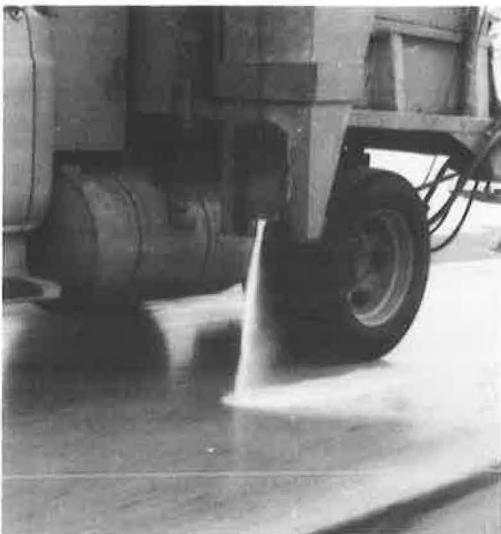
Figure 6. Dribbler applying evaporated salt.

In Figure 6, the application of evaporated salt is shown to produce a very narrow band of chemical on the roadway, whereas in Figure 7 the mixture of calcium chloride and sodium chloride is shown to scatter considerably. Similar scattering was noted with straight calcium chloride pellets as well as with rock salt. The calcium chloride flakes, however,

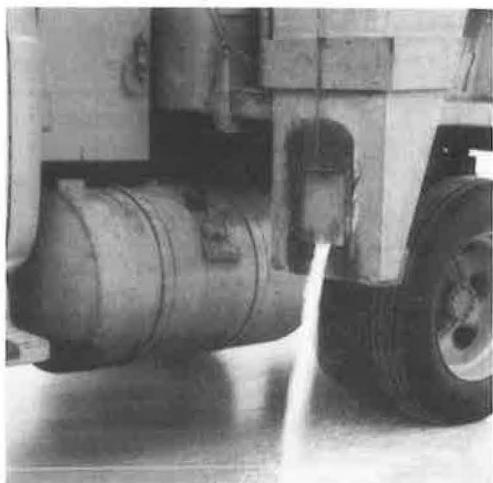
Figure 7. Dribbler applying calcium chloride and sodium chloride mixture.

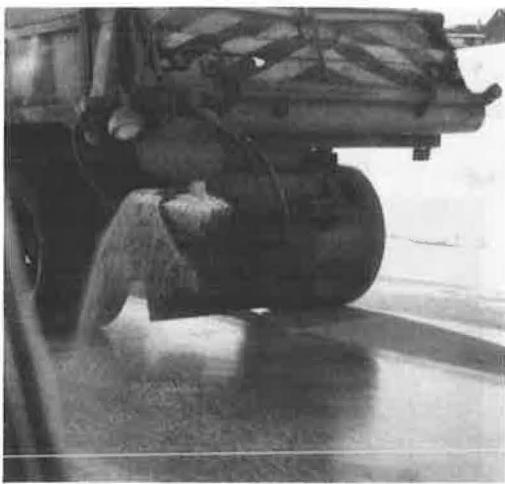
Figure 8. Disc spinner applying abrasive mixture.

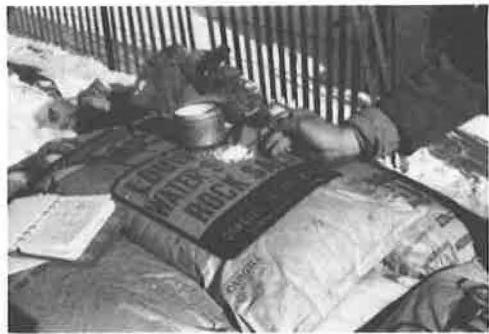
Figure 26. Method of taking moisture sample from packaged NaCl.

Single moisture samples were taken of the bagged material by cutting a small opening near the center of the bag, as shown in Figure 26, removing about 300 g of salt and then taping the opening closed.

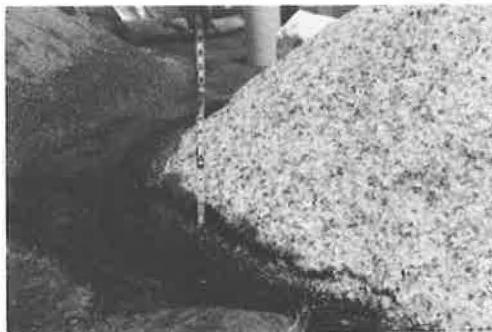
Figure 27. Base crust formation in rock salt.

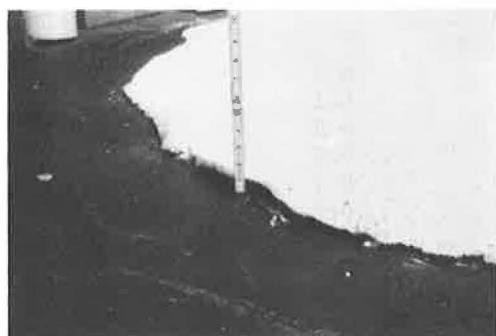
Figure 28. Base crust formation in calcium chloride.

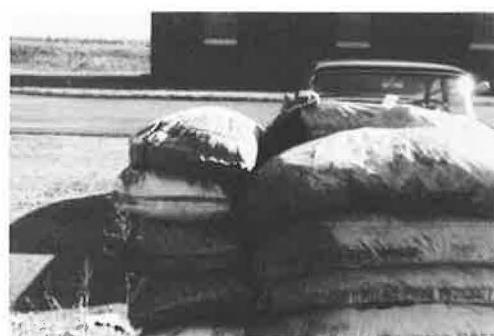
Figure 29. Collection of moisture on bags.

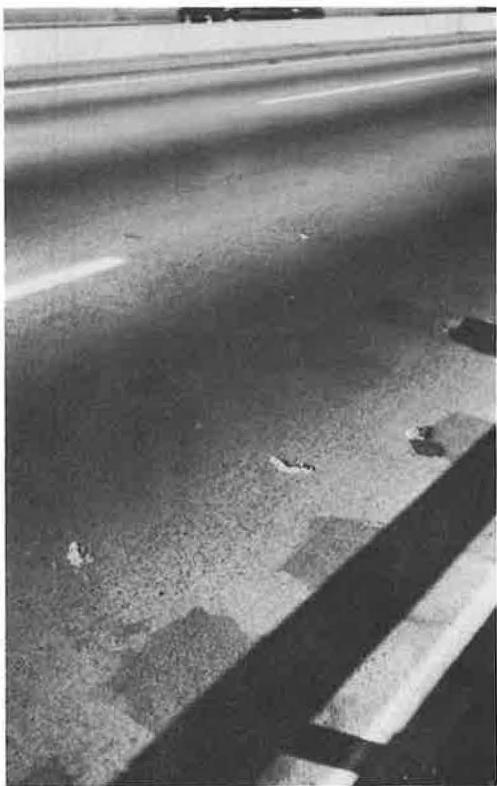
Figure 1. First stage spalling.

Spalling first appears as a small pock mark, generally not much larger than one's fist (Fig. 1). Usually, the appearance of a spall corresponds with the appearance of rust on the surface directly over a reinforcing bar. By tapping the area around these spalls with a small chipping hammer, a dull, hollow sound is often noted indicating that there is a much larger ring of unsound concrete surrounding the spall. Over a period of several weeks, and particularly during the winter, these spalls will grow rapidly in area and somewhat in depth until relatively large areas of reinforcement steel are exposed (Fig. 2). It is not uncommon for a spall to grow into a pothole 2 ft in diameter and 2 in. deep in one month's time. Normally, about 200 sq ft of new spalled areas are discovered each month, although twice, during wintertime, new spalls were created at the rate of over 1,200 sq ft per month.

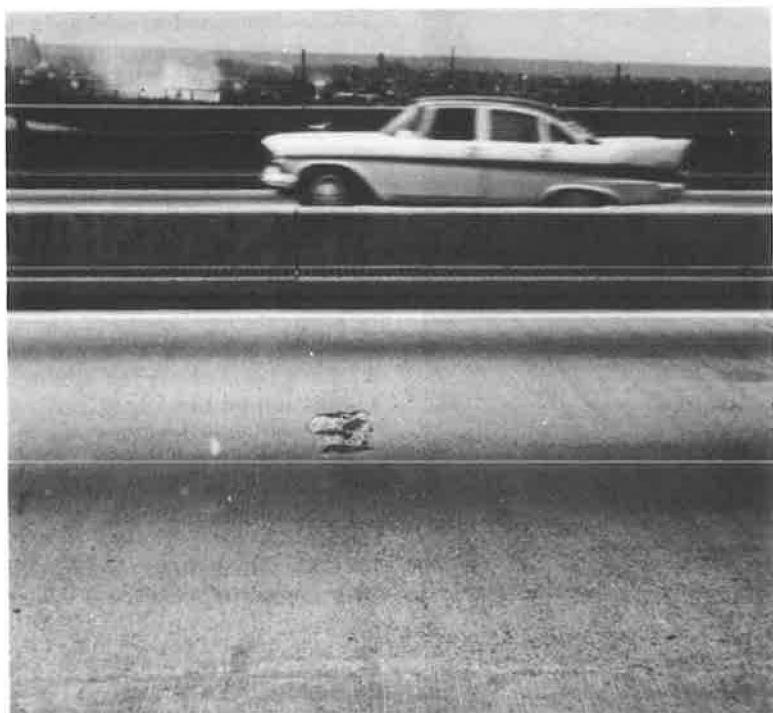
Figure 2. Second stage spalling.

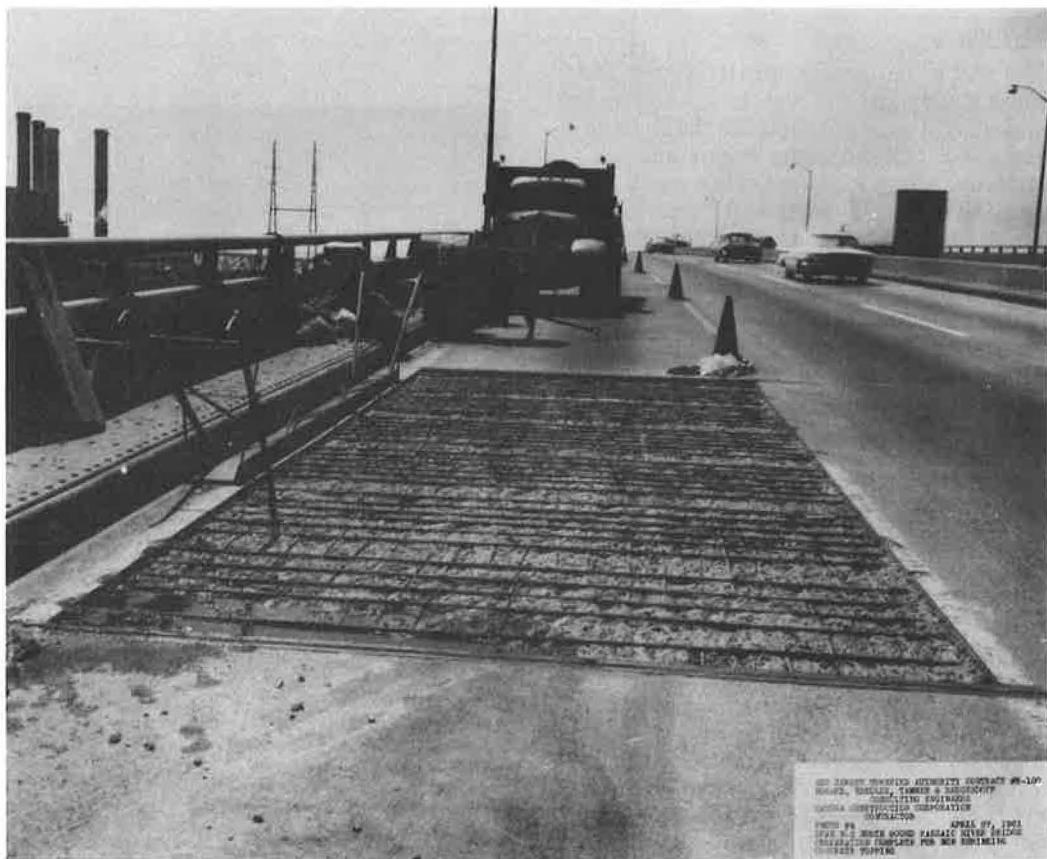
Figure 6. Excavated surface ready for nonshrink concrete topping.

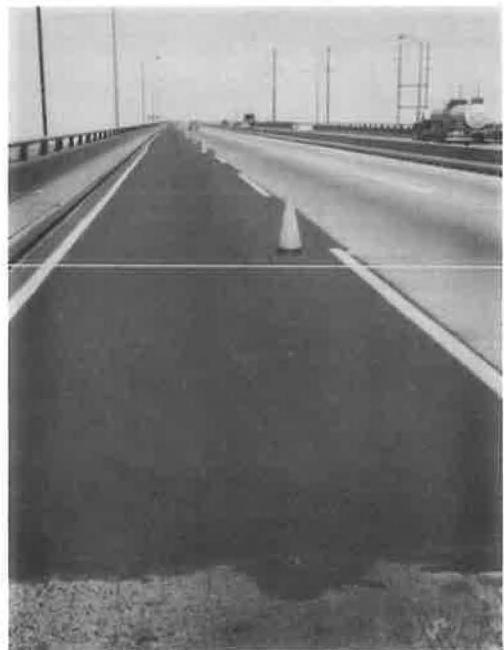
Figure 10. Coal-tar epoxy resin roadway surfacing.

This latter type of treatment has markedly reduced the rate of spalling in the old concrete. To date, an 80 percent reduction has been realized in the rate of new spalled areas created. As a further note, at least one-half the spalls that did occur under the resinous paving cement were

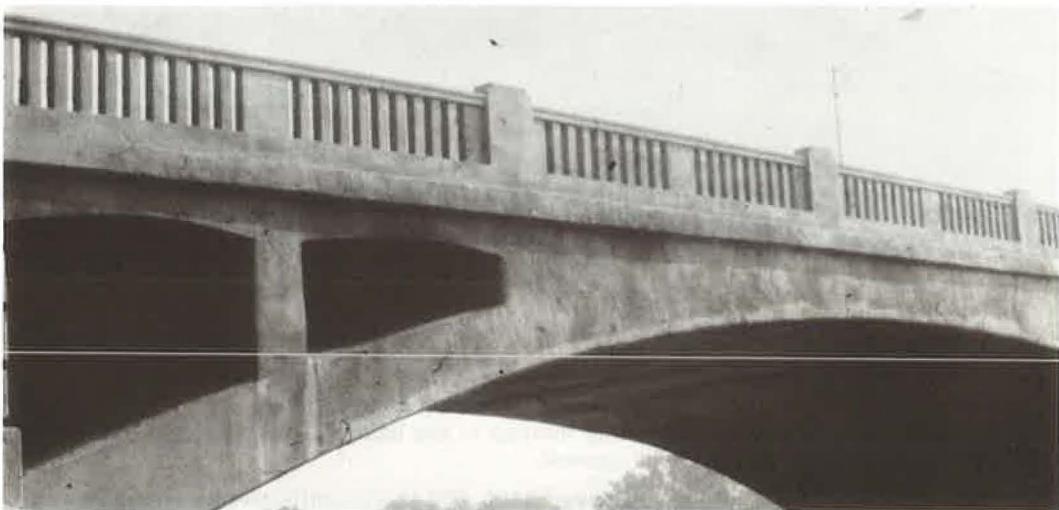
Figure 4. Railing after repair with gunite and waterproofing paint, 112th St. Bridge, Troy.

bad concrete removed, then were coated with an epoxy bonding compound before applying gunite (Fig. 4). The proper outlines were restored by use of shooting strips, rubber trowels, and other means known to guniting operators. Finally, all concrete surfaces were sprayed with two coats of a waterproofing bakelite paint (Penetron). The second coat had a color to it which made all concrete surfaces have the same color and which greatly dressed up the concrete in appearance (Fig. 5).

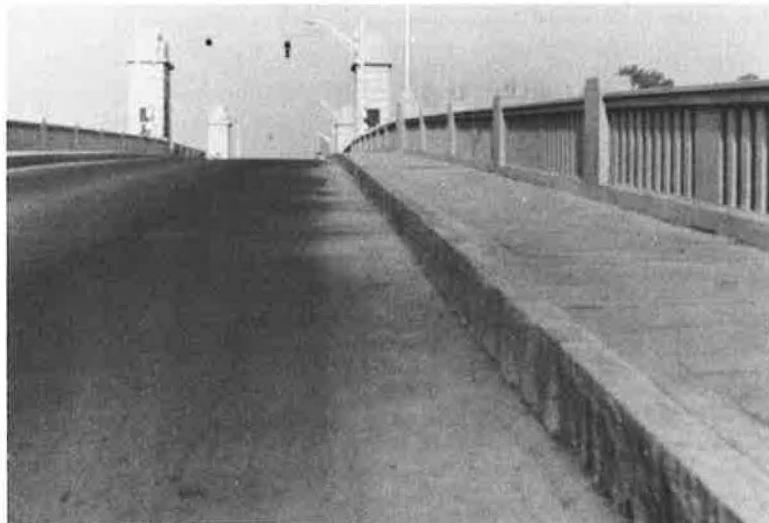
Figure 6. 112th St. Bridge, Troy, after repair; new roadway slab and steel grating on bascule span, new granite curbs, sidewalks repaired and protected by epoxy bonding compound covered with silica sand for traction, all concrete repaired and waterproofed.

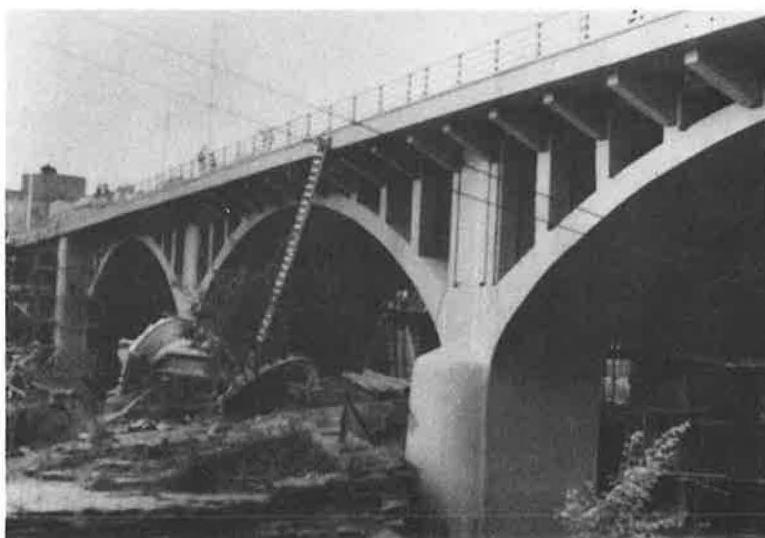
Figure 11. West side of Glens Falls Bridge after being repaired and waterproofed.

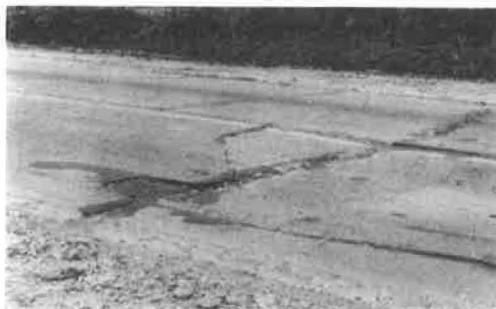
Figure 1. Old, broken, and rough rigid pavement.

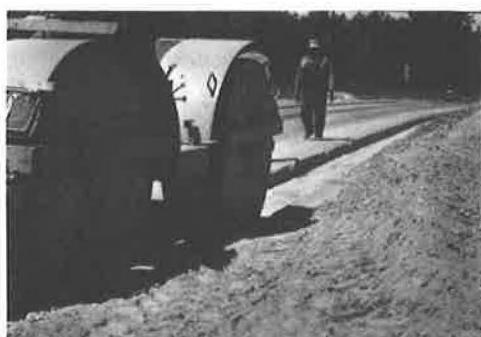
Figure 2. Compacting trench subgrade.

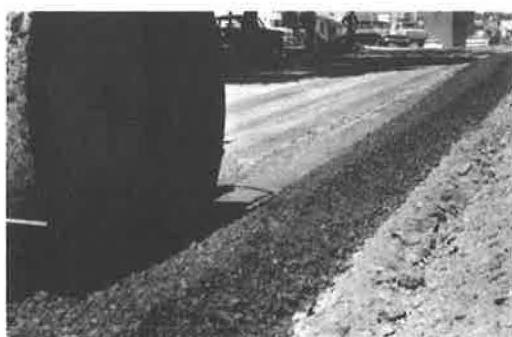
Figure 5. Rerolling surface to finished grade.

The cement-stabilized stone mixture is prepared in a portable mixing plant set up at a suitable location on the project; all ingredients consisting of coarse aggregate, binder, cement, and water are mixed, transported to the project, and spread by specially constructed spreaders (Fig. 3) for the widening and the ordinary type of spreader for the full section after which the mixture is compacted by rolling (Fig. 4) to 100 percent maximum density (AASHO Method T 99). After compaction, the surface is finely graded and rerolled to the finished grade (Fig. 5). These operations are followed

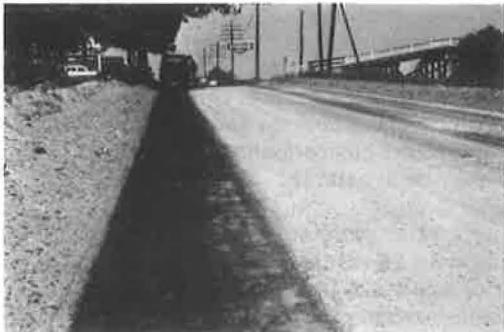
Figure 6. Bituminous prime coat.

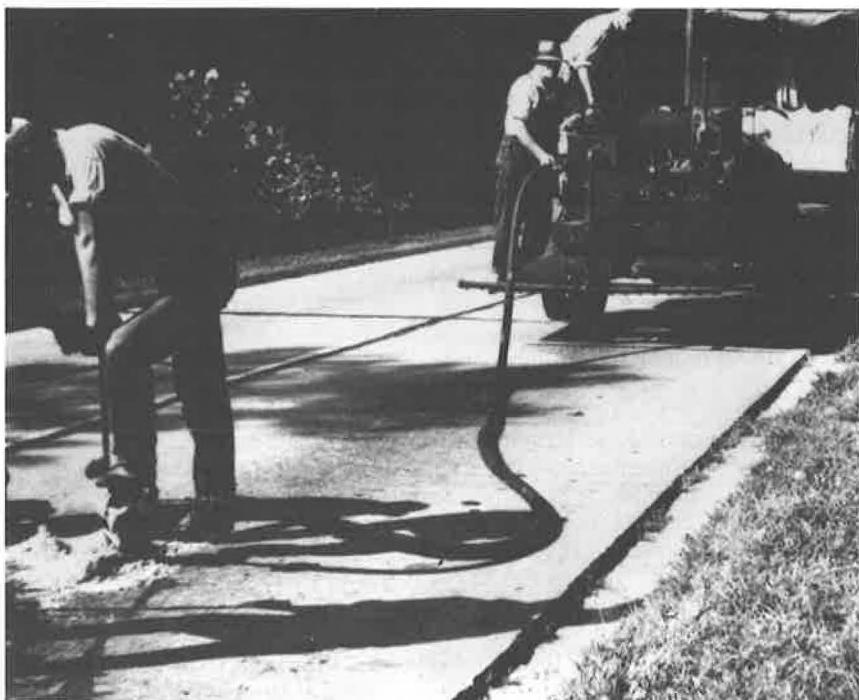
Figure 2. Pumping of subsealer.

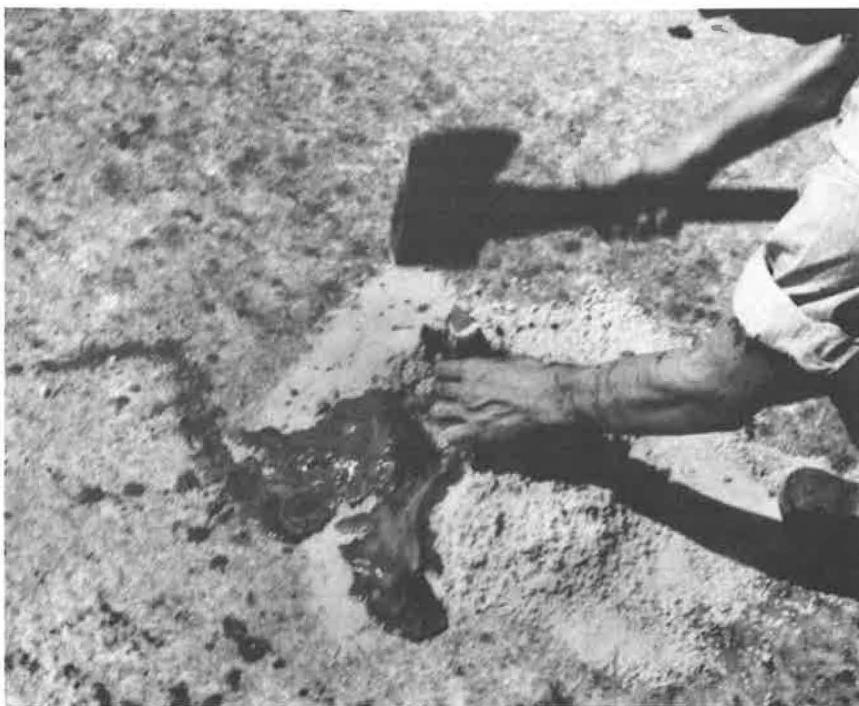
Figure 3. Wooden plug being driven into slab.

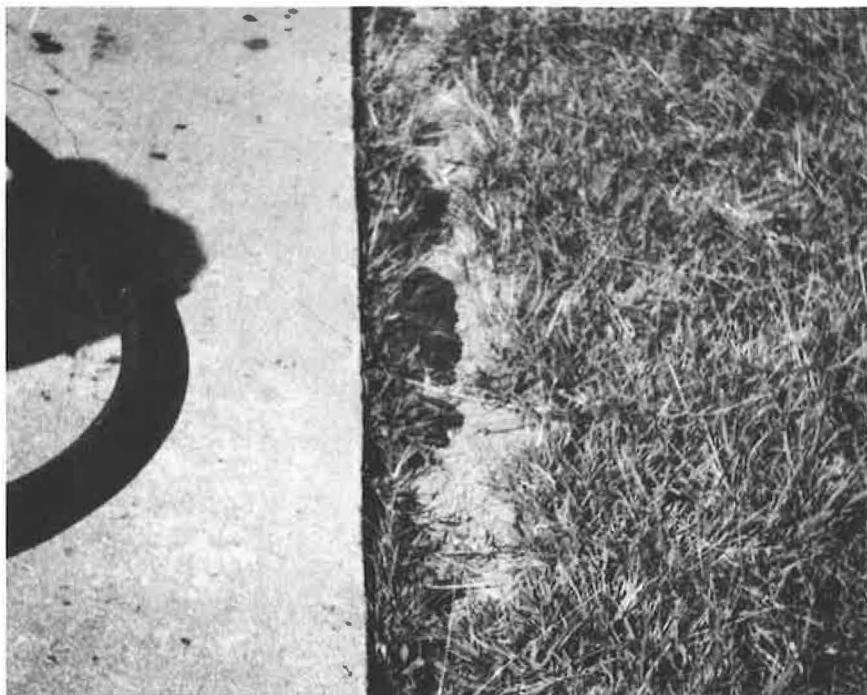
Figure 4. Undiluted Subsealer II being exuded from edge of pavement.

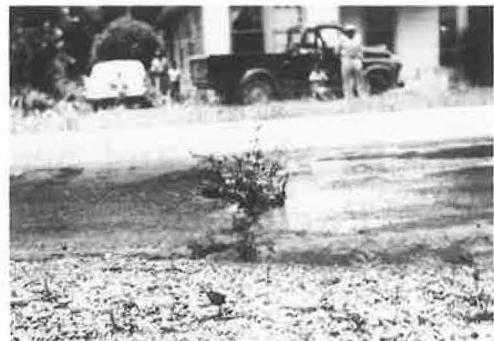
Figure 1. Typical slab pumping under truck traffic on old roadway before construction.

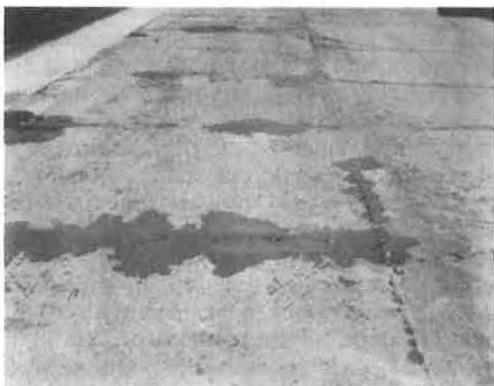
Figure 4. Wet material displaced by rolling at typical pumping slabs.

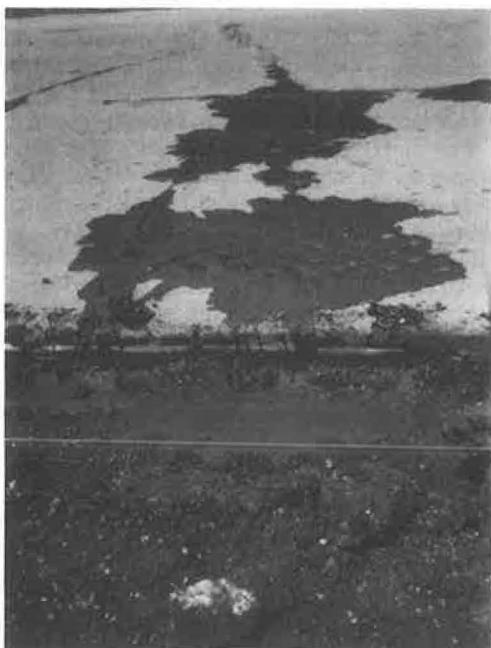
Figure 5. Wet material removed by roller from subgrade under slabs broken by traffic; removed mud in trench.

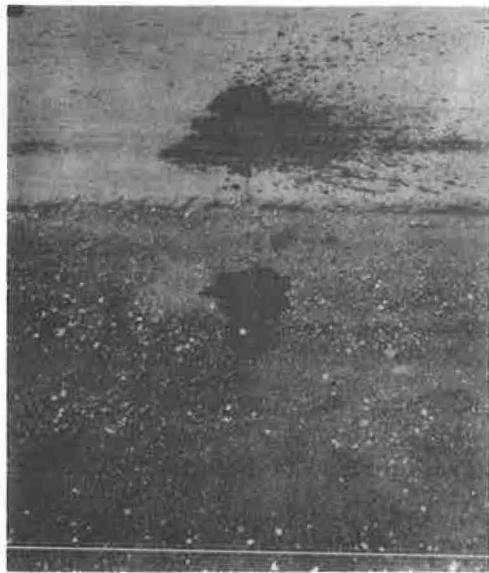
Figure 6. Wet subgrade material forced through shoulder by roller.
