# HIGHWAY RESEARCH RECORD

Number 14

*Concrete Bridge Decks and  
Pavement Surfaces*  
*8 Reports*

Presented at the  
42nd ANNUAL MEETING  
January 7-11, 1963

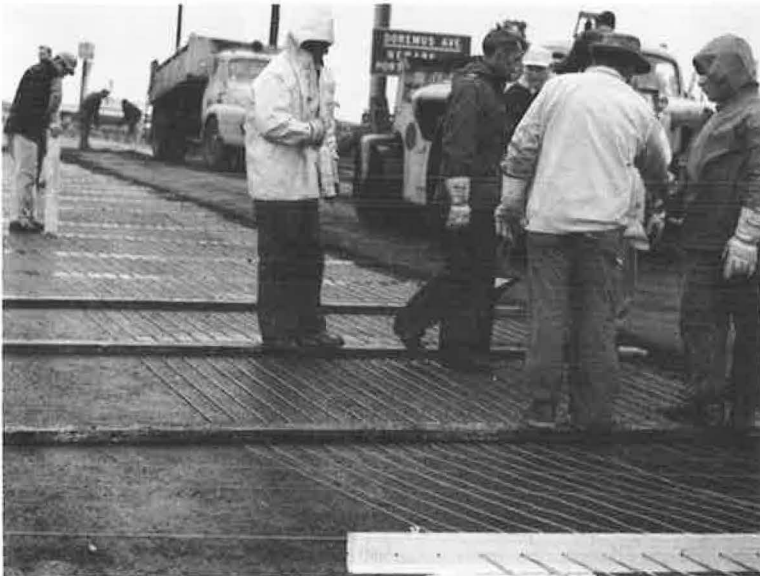
Figure 4. Laying cable, land fill area.

lugs of the size and spacing required to maintain the  $3\frac{3}{4}$ -in. spacing of the cable (Fig. 4). Each unit was secured to the pavement with asphalt joint sealer before the templates were removed.

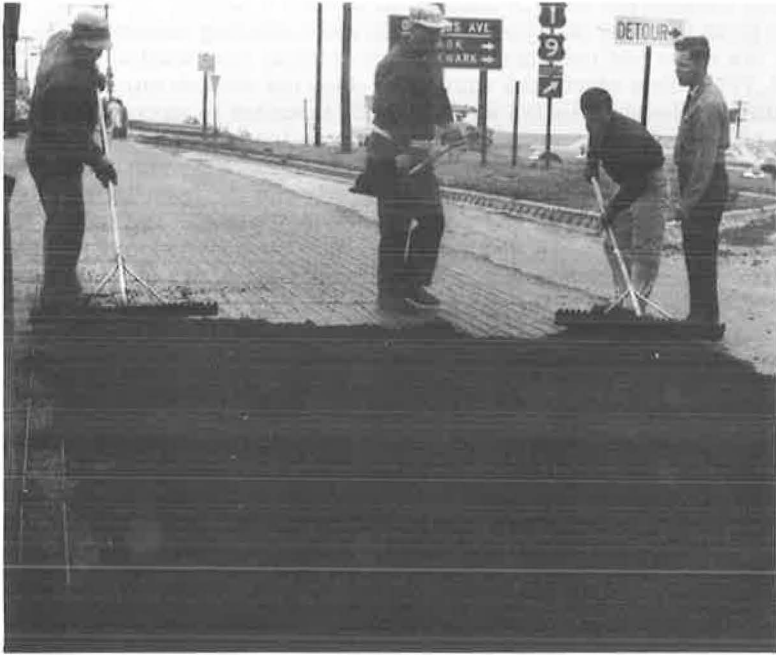
Figure 6. Spreading sand-mix asphalt.

The rig was started and moved down the road at the rate of 5 to 10 ft a minute. The work of securing the cables to the binder course followed about 30 ft behind the laying rig at the point where the cables lay naturally on the roadway surface. At 4-ft intervals, a piece of 2- by 6-in. timber was laid across the cables, holding them firmly against the surface of the road while the asphalt joint sealer was poured (Figs. 6 and 7).

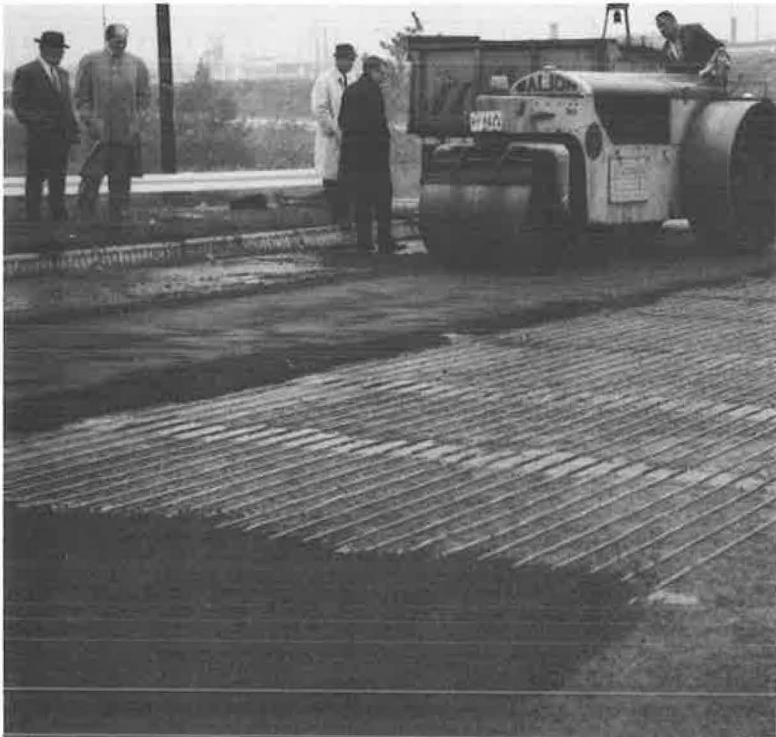
Figure 7. Rolling sand-mix.

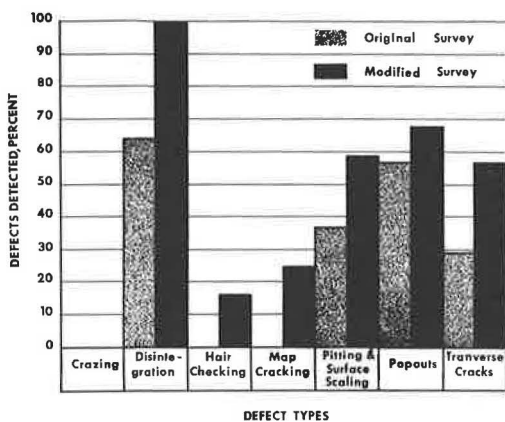
Figure 2. Percent defects detected in surveys.

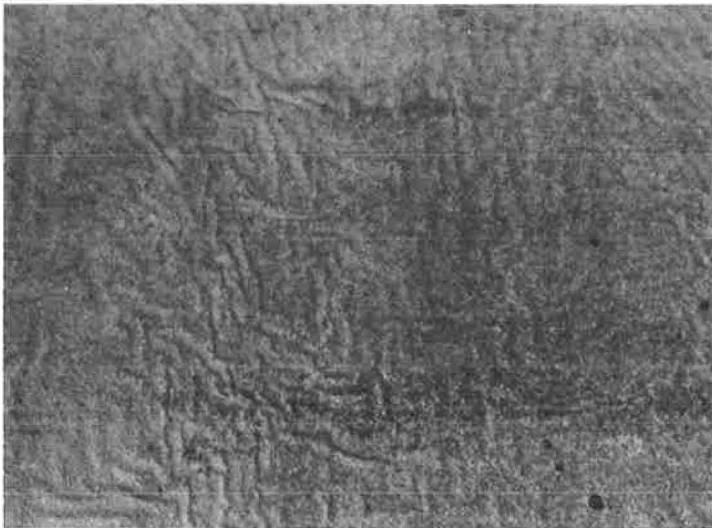
Figure 2. Polyester mortar overlay on PCC surface.

passed between the compacting roller and mortar is responsible for the rippled appearance in the mortar's surface. Placing techniques are discussed in more detail later in the paper. The core holes in Figure 3 are the result of in-place tensile tests which are also discussed later. Additional field trials are being conducted on publicly traveled bridges.

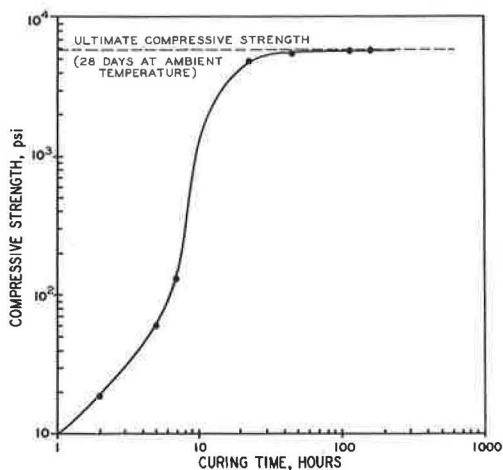
Figure 6. Increase of compressive strength of mortar with curing time.

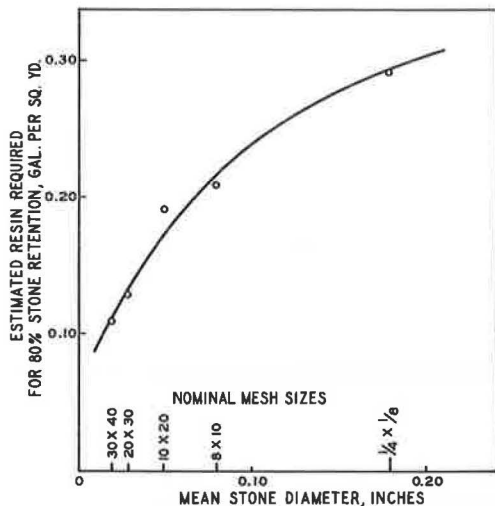
Figure 10. Relation between resin requirements and stone size for 80 percent stone retention after 3 yr of service on PCC surface.

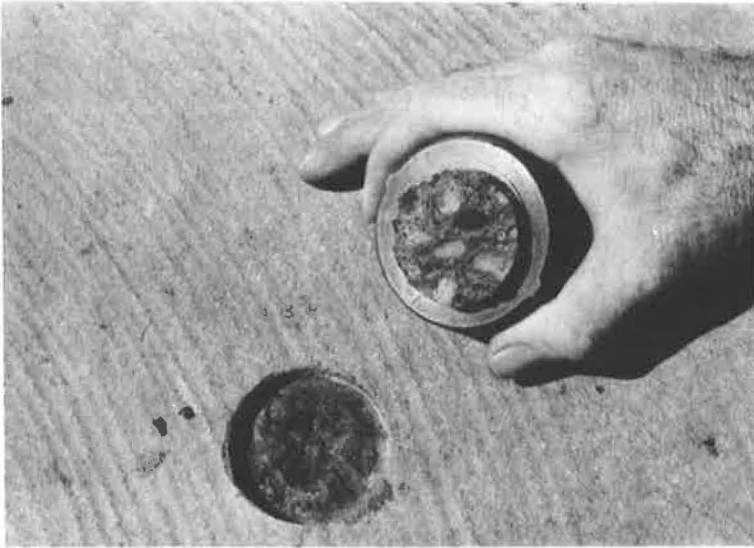
Figure 11. Typical cohesive bond failure in concrete.

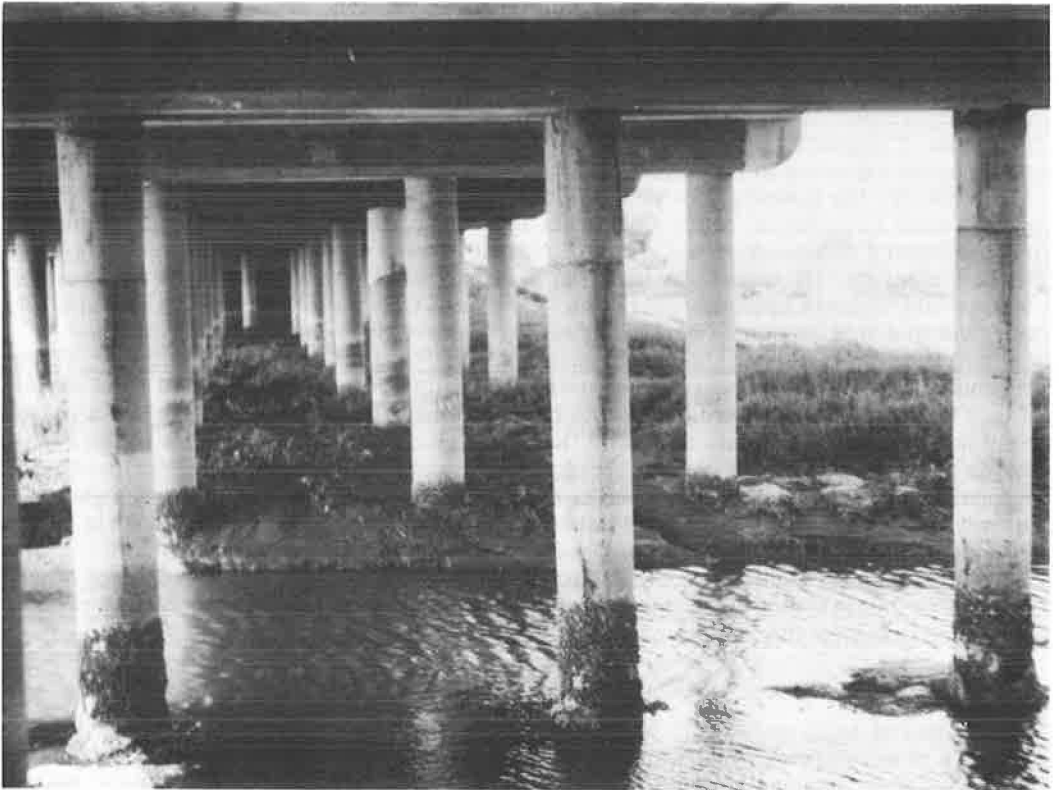
Figure 1. Vertical concrete cracking of 10-yr-old reinforced concrete bridge piles in tidal water near San Diego, Calif., 1962.

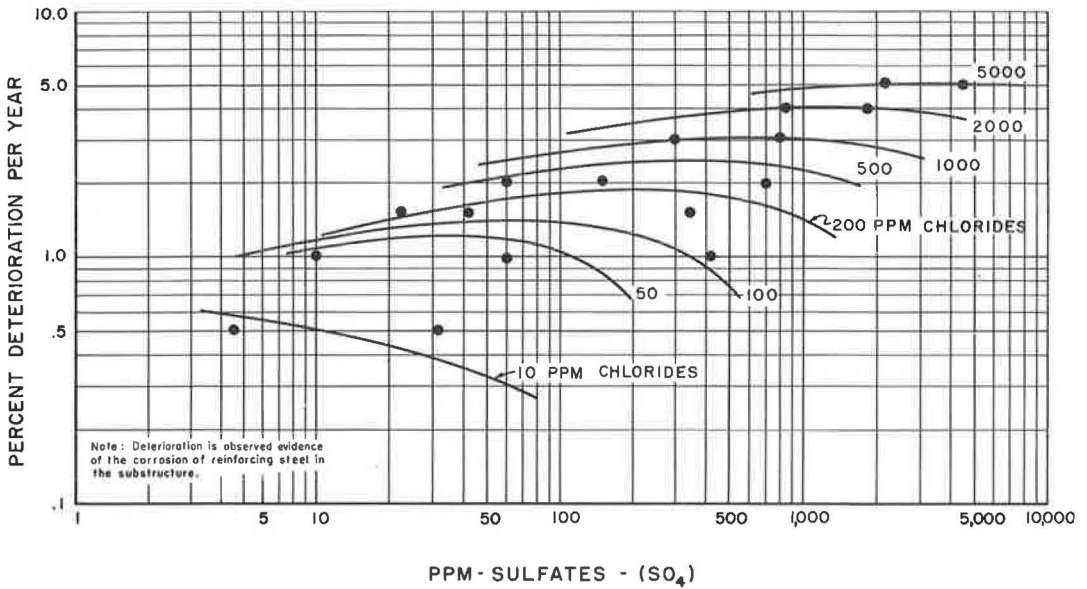
Figure 5. Influence of sulfate and chloride concentration on bridge deterioration.

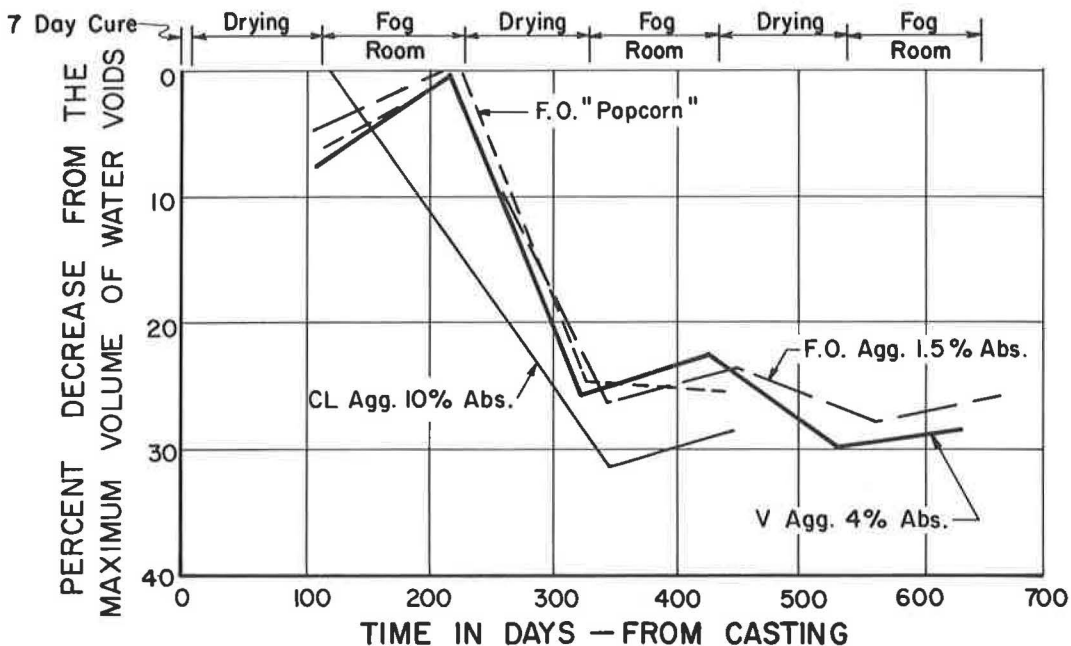
Figure 8. Influence of aggregate on volume change of water voids—cement content constant. Water voids computed from measured volume of moisture gained and lost during indicated exposure; concrete not oven dried; drying and fog room at 73.4 F, and 50 and 100 percent relative humidity, respectively.

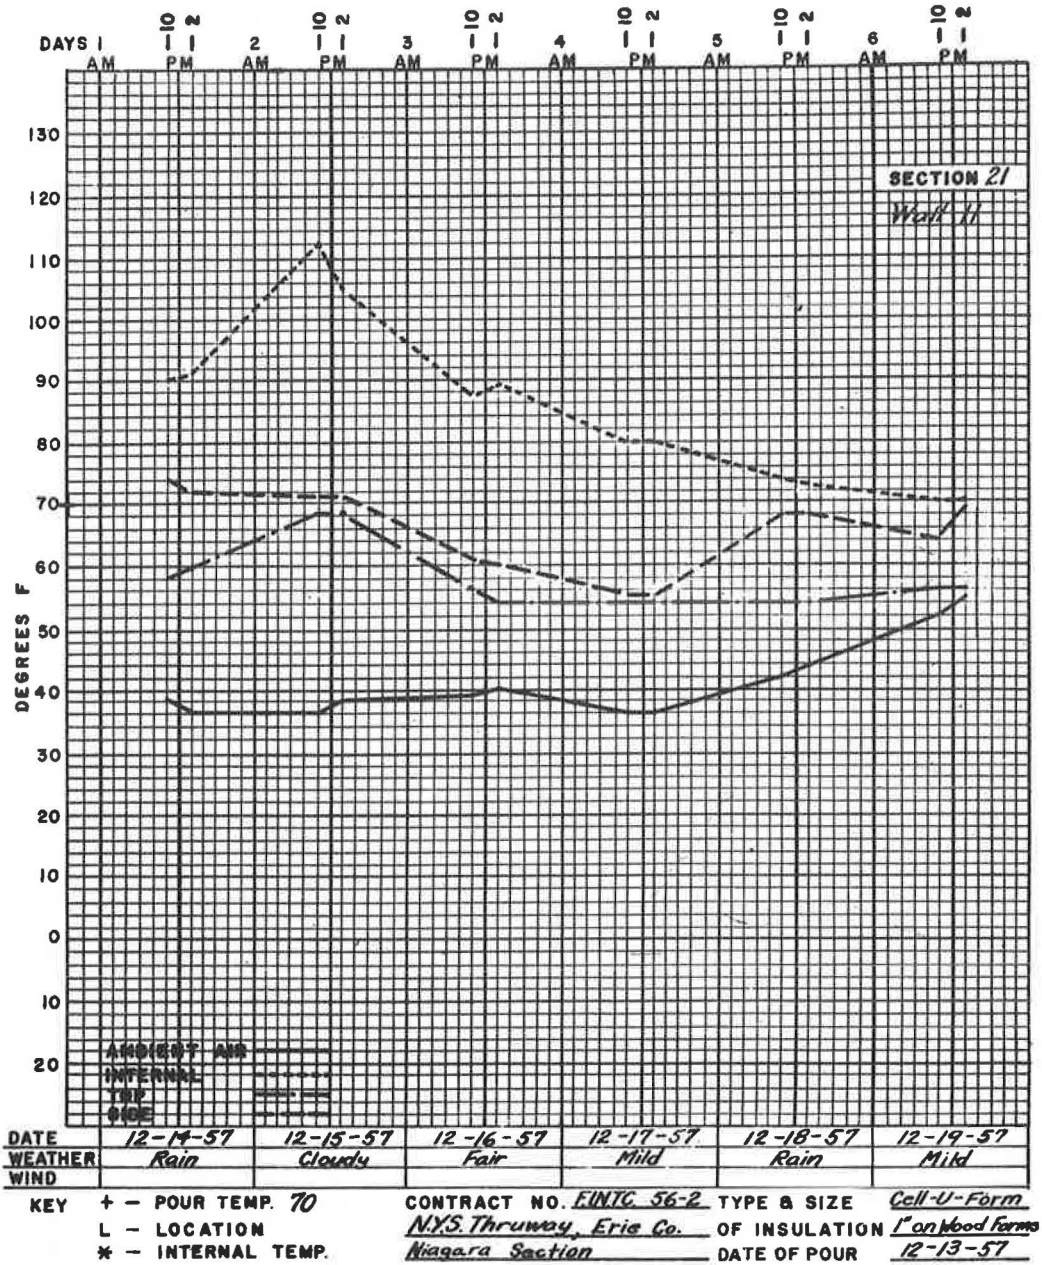
Figure 6. Wall stem temperatures.
