Riprap Requirements for Overflow Embankments

THOMAS E. MURPHY and JOHN L. GRACE, JR., U. S. Army Engineer Waterways Experiment Station

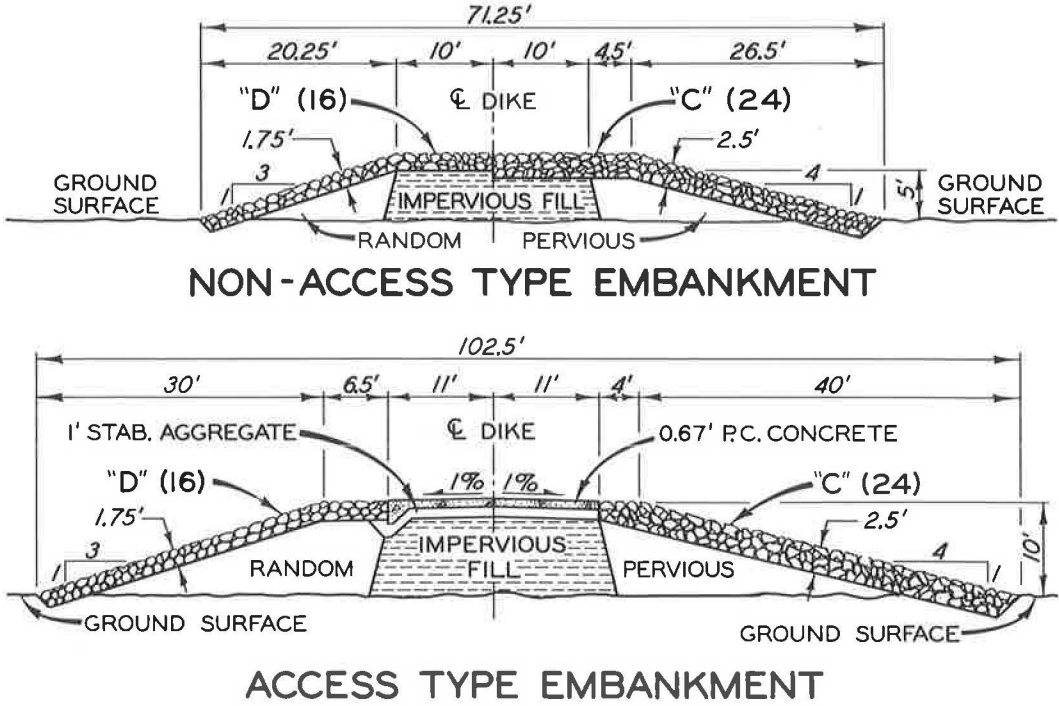
Figure 1. Embankment sections.

Thus, it became the purpose of the series of model tests to determine riprap requirements for typical overflow embankments (in Fig. 1). The embankment without a roadway was 6.75 ft high, had a 1 on 3 upstream face, a 24.5-ft wide crown, and a 1 on 4 downstream face. The particular gradation of riprap used on each face was continued to the center line of the crown. The access type embankment studied in the model was 10 ft high, had a 1 on 3 upstream face, a 32.5-ft crown width of which 22 ft was paved roadway, and a 1 on 4 downstream face. The particular gradation of riprap used on each face was continued to the edge of the roadway.

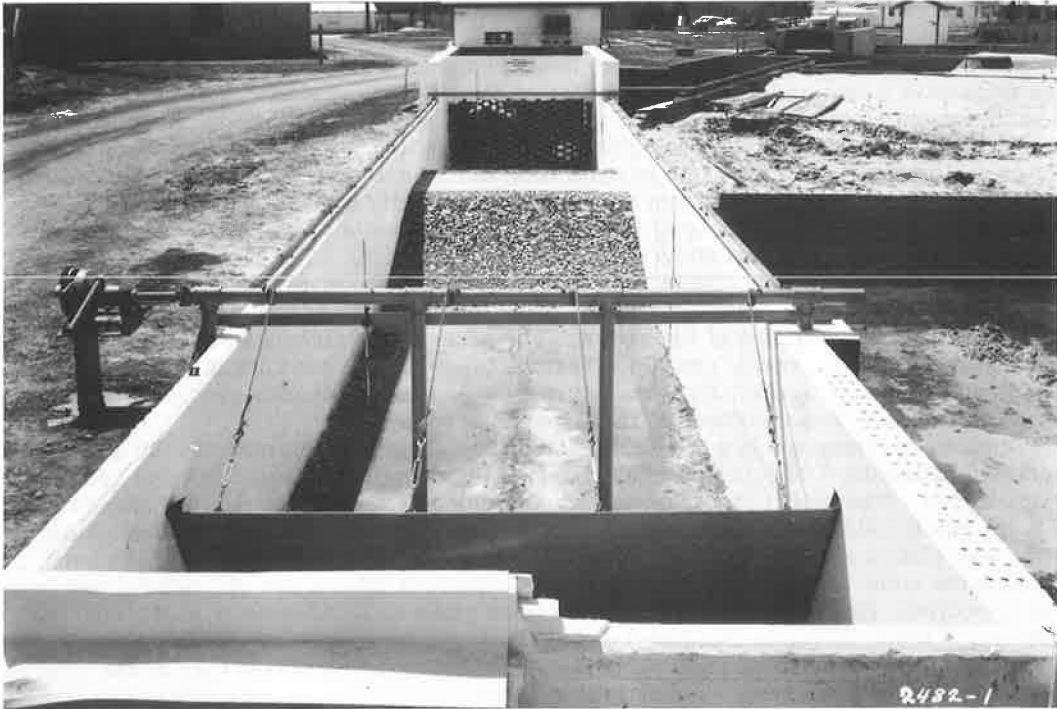
Figure 2. General view of model.

Tests were conducted in a 1:4 scale model (Fig. 2) which reproduced a 40-ft wide section and included 90 ft of approach channel, the overflow embankment and 140 ft of exit channel. The model embankments were molded in sand to the desired shape over a brick cutoff wall which prevented seepage through the embankment. A fiber glass cloth was placed over the sand to serve as a filter and prevent migration of the sand through the voids of the stone. Gravel or crushed rock filters are planned for use in the prototype. However, it is felt that the fiber glass cloth adequately performed the function of these filters in the model and at the same time made re-sorting of the riprap and restoration of damaged portions of the embankment much easier than would have been possible with a coarse sand or gravel filter.

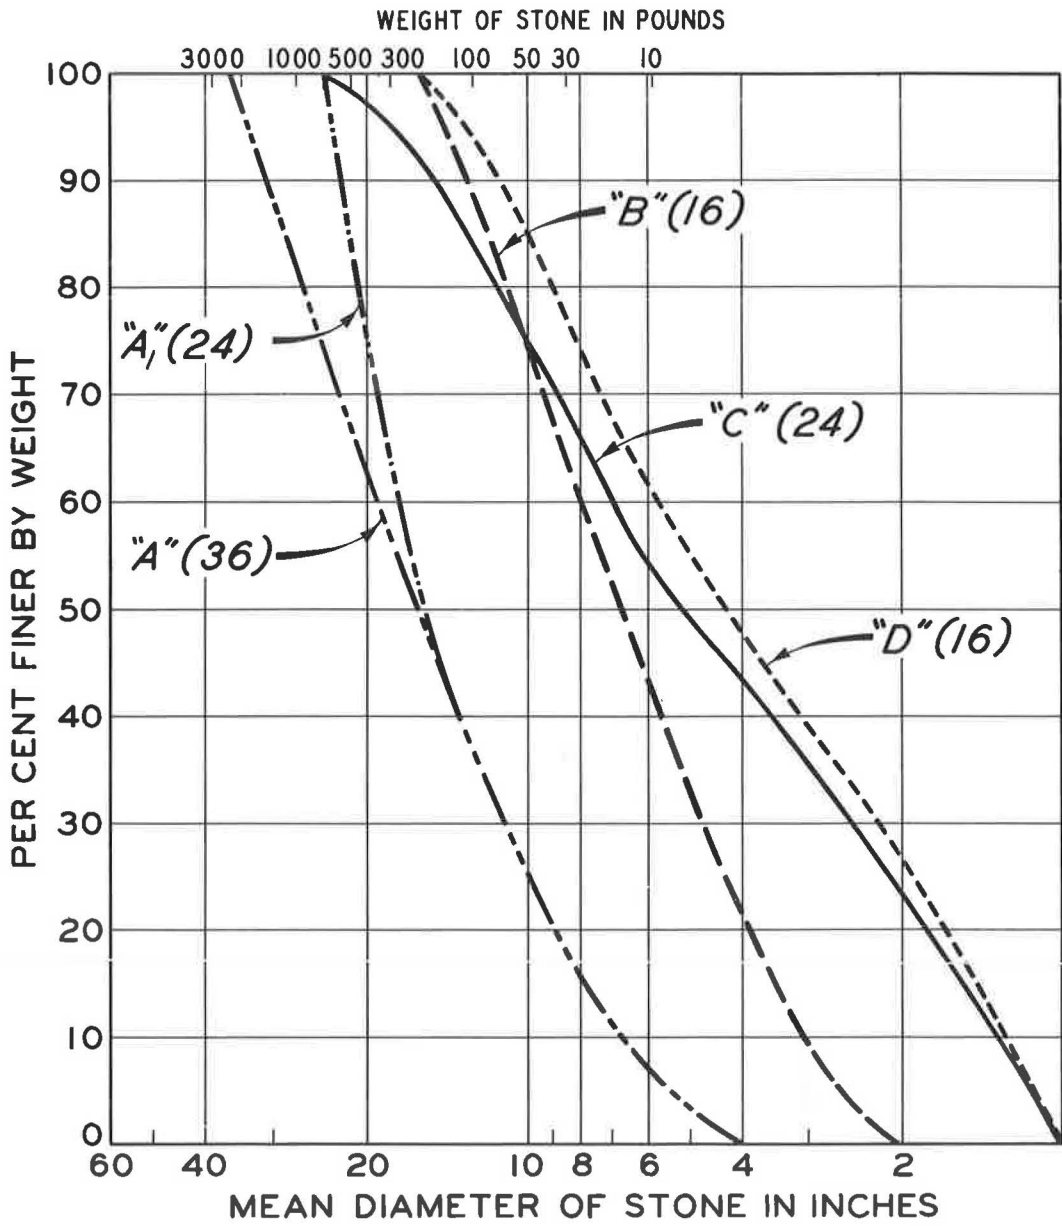
Figure 3. Protective stone gradation curves.

Figure 9 shows the headwater-tailwater conditions under which failure of the access type embankment occurred. Gradations A and A₁, and gradations B and C failed under the same conditions. This also was true in the non-access type embankment (Fig. 10). The gradation curves (Fig. 3) show that although gradation A had maximum pieces 36 in. in diameter (2,300 lb) as opposed to 24 in. (700 lb) for gradation A₁, stones 16 in. in diameter (200 lb) constituted 50 percent of each of these gradations. Also gradation C had maximum pieces 24 in. in diameter as opposed to 16 in. in gradation B, but 75 percent of each of these gradations consisted of stone 10 in. in diameter (50 lb) or smaller. In the model tests, the large pieces in gradations A and C were dislodged by undercutting resulting from removal of the smaller pieces. Thus it appears that the critical size stone in each gradation is that stone which represents a certain percentage of the total. For the case at hand it seems that the critical size stone is that which represents 60 to 65 percent of the total. In other words, the pieces of stone which are larger than those which represent 60 to 65 percent of the total do not increase the effectiveness of the particular gradation.

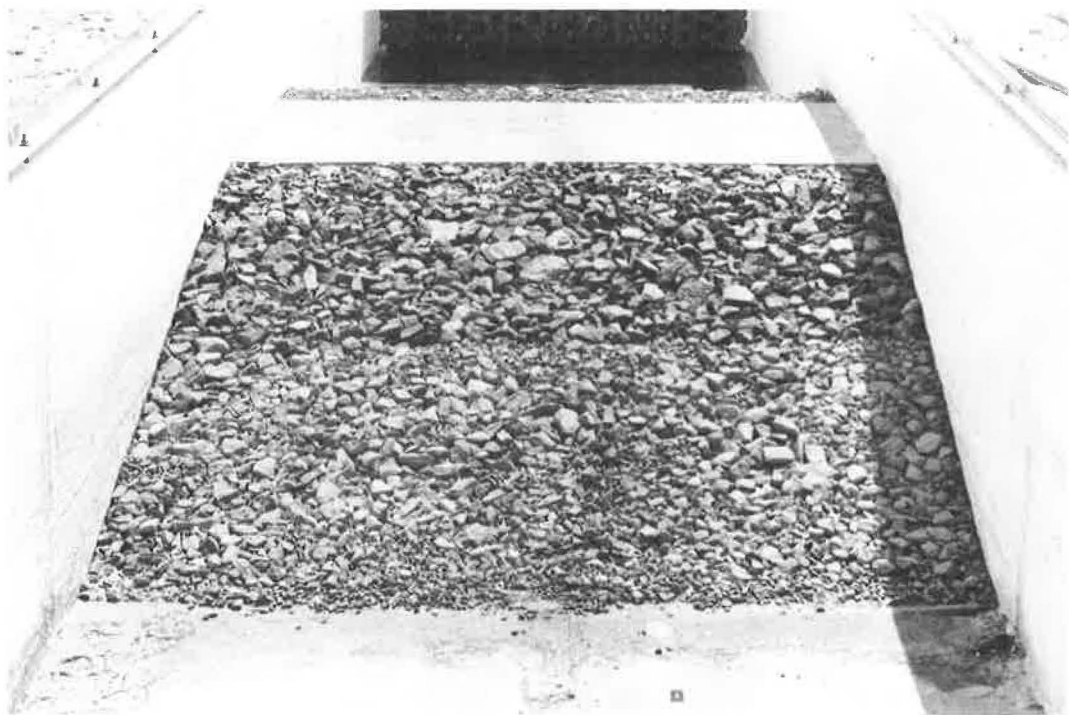
Figure 4. Test section prior to test.

The test section was constructed in the dry (Fig. 4) and then the model was flooded by introduction of water on each side of the test section. With a high tailwater, the desired discharge through the model was established. Tailwater depth was decreased slowly until movement of the stone was observed. This flow condition was allowed for 30 minutes and then a water-surface profile was obtained, the flow was stopped, the model drained slowly and a profile of the disturbed portion of the riprap was made. Flow conditions which resulted in failure at discharges of 20 and 60 cfs are shown in Figures 5 and 6. In the tests, failure of the stone was defined as that condition where all sizes of stone were moved over a considerable area. This did not require that the depth of scour be equal to or greater than the depth of the riprap blanket. The test section following movement of the riprap by a discharge of 60 cfs is shown in Figure 7.

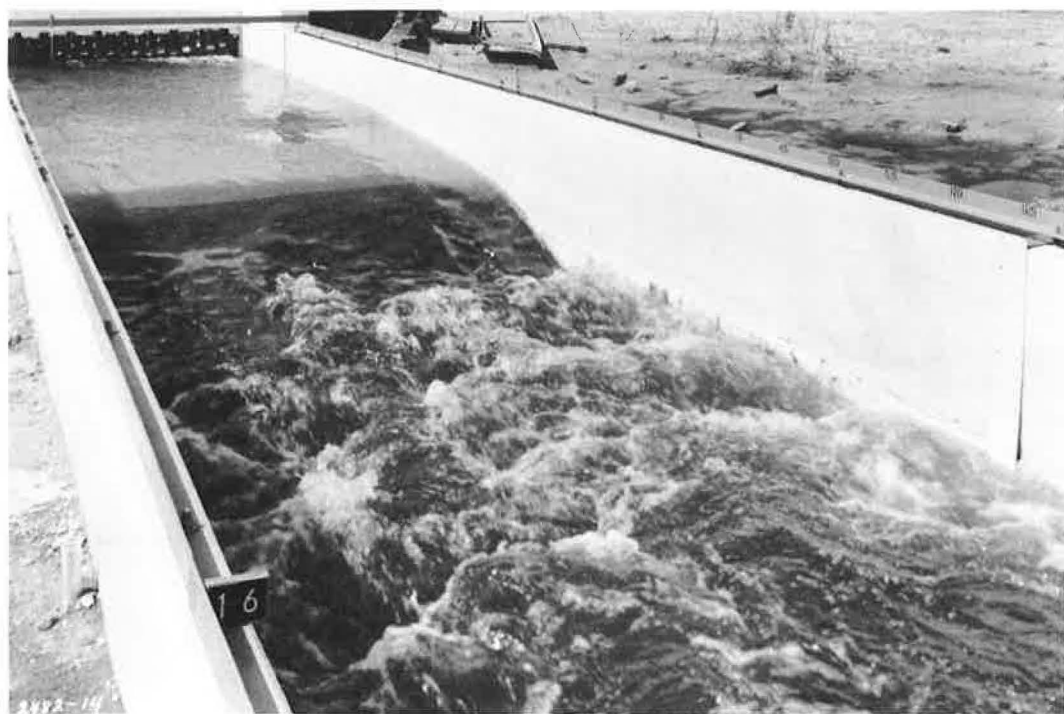
Figure 5. Flow through model, 20 cfs.

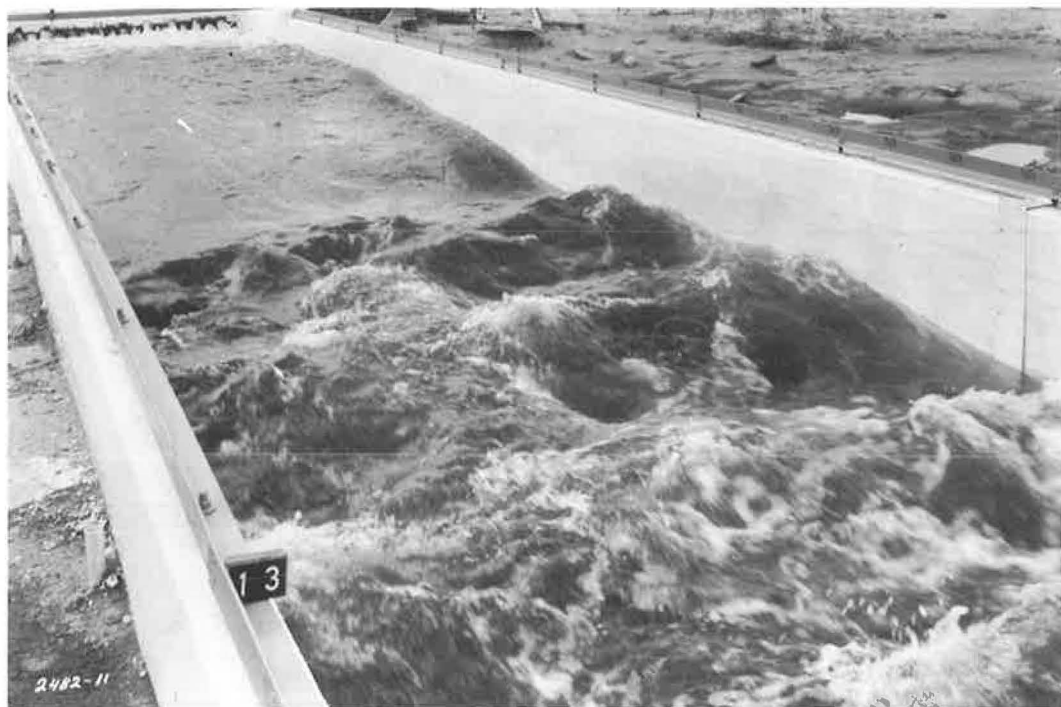
Figure 6. Flow through model, 60 cfs.

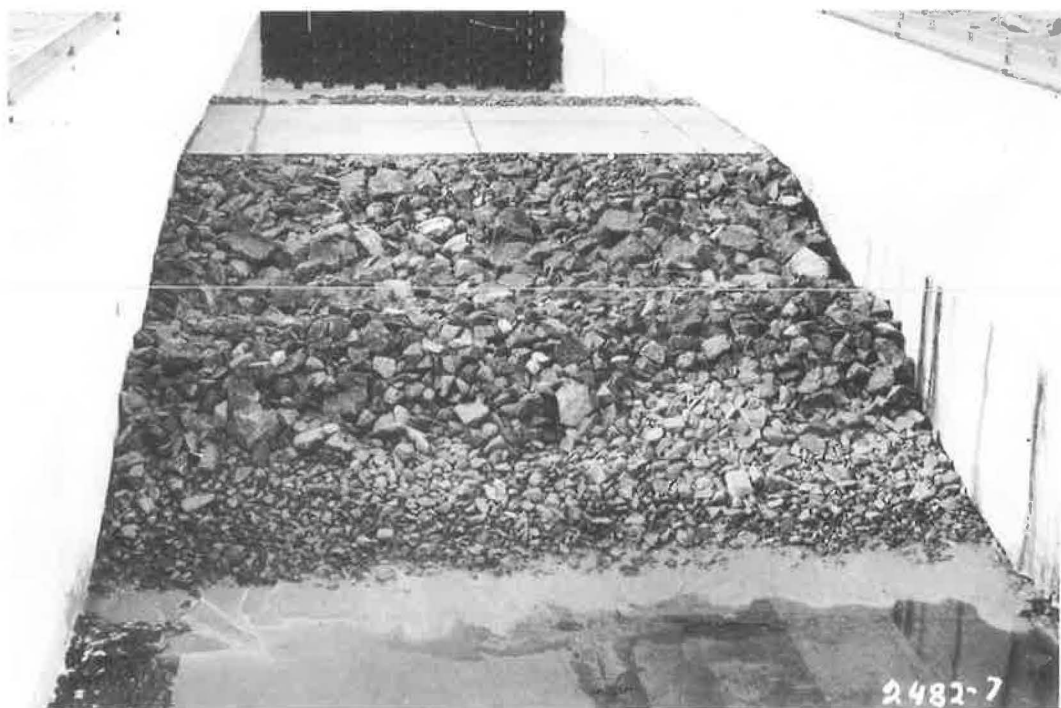
Figure 7. Disturbed test section.

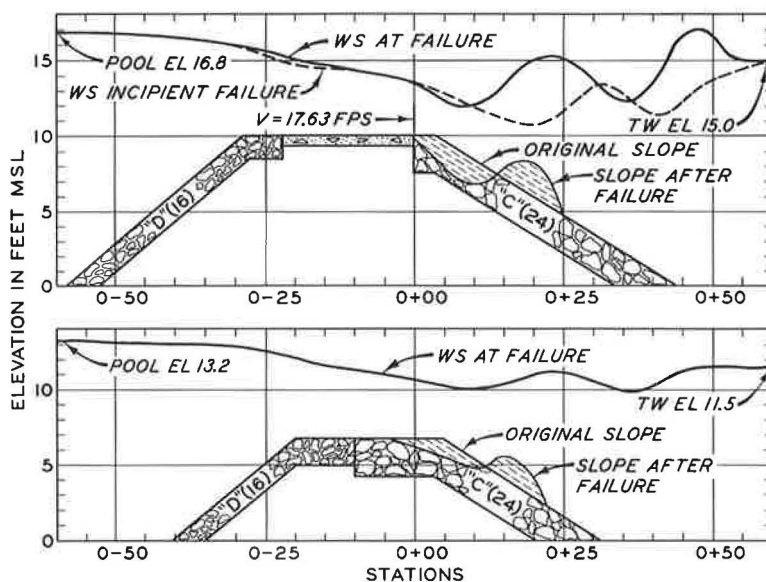
WATER-SURFACE AND SCOUR PROFILES

Figure 8. Typical profile plots.

Riprap and water-surface profiles before and after failure for each of the two types of embankments are shown in Figure 8. All failures occurred at the top of the downstream slope. Indications are that failure was caused by a combination of velocity and uplift pressure. The uplift pressure resulted from percolation of flow up the downstream face of the embankment to the vicinity of the crown. Also in all cases the disturbed stone formed a "lip" (Fig. 8) and deflected flow along the surface of the tailwater. Under no conditions was there movement of the type D stone (maximum 200 lb) on the upstream faces of the embankments.

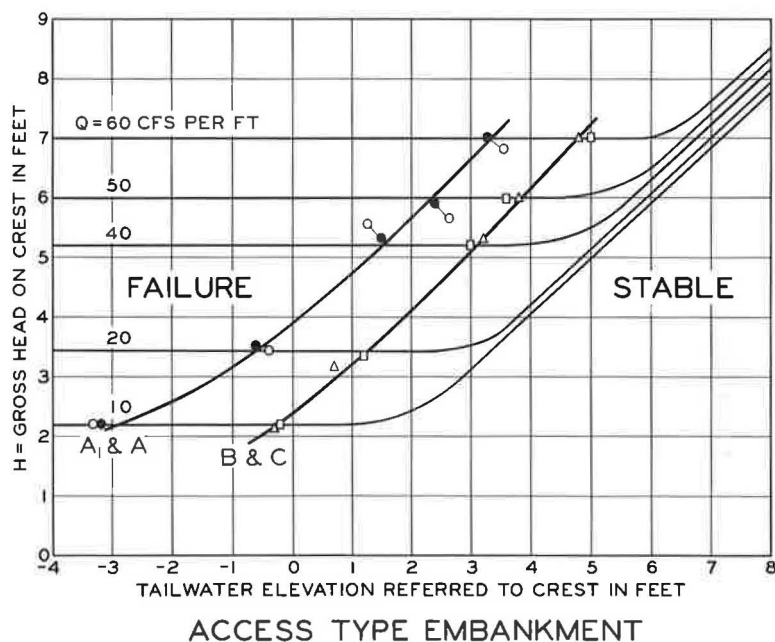
Figure 9. Headwater-tailwater for failure of access embankment.

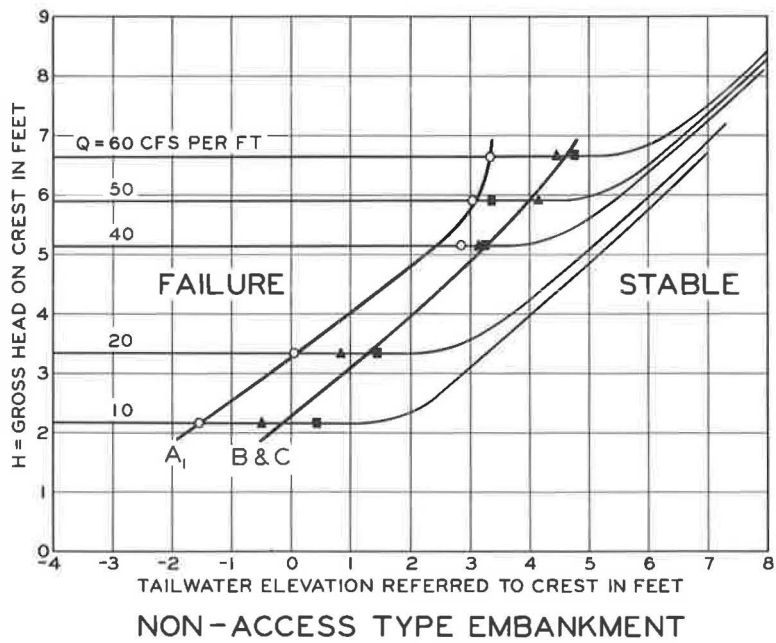
Figure 10. Headwater-tailwater for failure of non-access embankment.

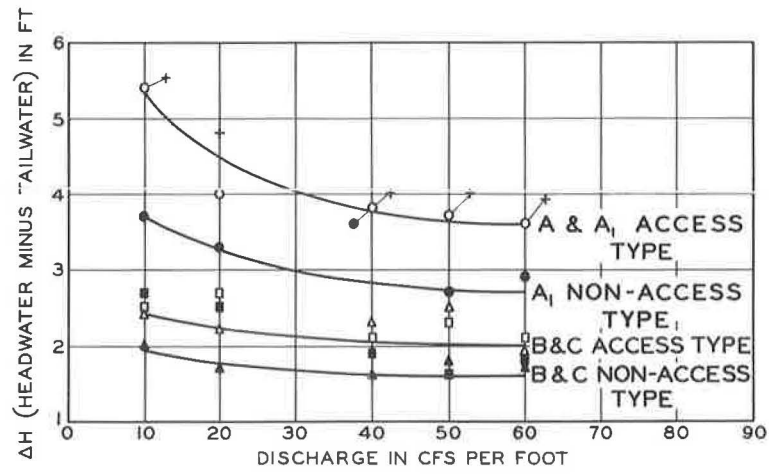
Figure 11. Conditions of failure.

Figure 11 plots the head differentials at which failure occurred. At the high discharges, 40, 50, and 60 cfs per ft, this differential was found to be essentially constant for a particular set of embankment conditions. However, failure of a particular gradation of riprap occurred at a lower differential on the non-access type embankment than it did on the access type. The reason for this must be due either to the difference in crown widths, 32.5 ft for access type and 24.5 ft for non-access type, or to flow percolating from the headwater through the upper layers of rock in the non-access type embankment and exerting added uplift pressures on the rock in the failure zone.
