Approach-End Treatment of Channelization—Signing And Delineation

NEILON J. ROWAN, Assistant Research Engineer, Texas Transportation Institute

The general objectives of the research project were to evaluate the effects of design, signing, delineation, and illumination of channelization on the factors of safety, efficiency of operation, and capacity. The specific phases of research covered in this report dealt with the signing and delineation of channelization, and with the effect of channelization and approach-end treatment on certain characteristics of driver behavior.

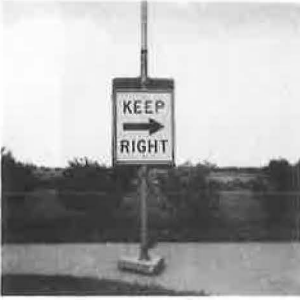
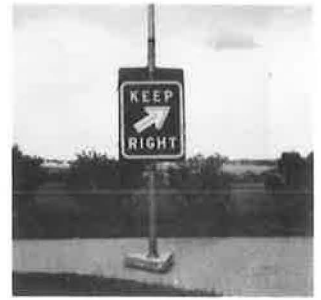
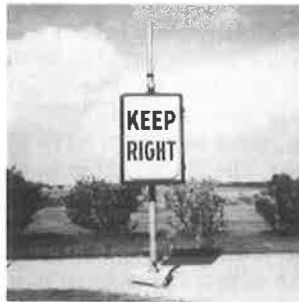
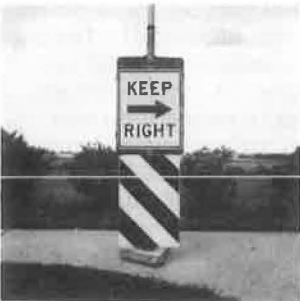
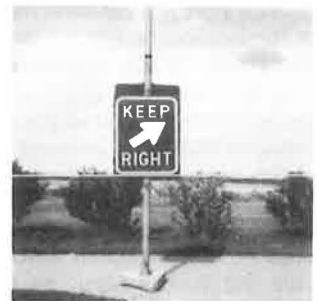
Figure 5. Test signs.

Sign No.	Type of Sign	Sign Size (in.)	Letter size (in.)
1	Beads-on-paint; black letters on white background (Texas Highway Department Standard)	24 by 30	5
2	Reflective sheeting; black letters on white background	24 by 30	5
3	White letters and arrow inset with prismatic reflectors on black background	24 by 30	4
4	Internally illuminated; black letters on white opaque background (no arrow)	24 by 36	7
5	Same as No. 1 except black and white hash mark panel mounted below sign	24 by 30	5
	Panel	24 by 36	-
6	Same as No. 1 except externally illuminated	24 by 30	5
7	Same as No. 2 except externally illuminated	24 by 30	5
8	White reflective sheeting letters and arrow on black background	24 by 30	5

The KEEP RIGHT sign is of generally standard form (Fig. 5). However, there are several different innovations, depending primarily on the different types of materials and construction techniques.

Sign No. 3, on which the message is composed of letters and the arrow formed of prismatic reflectors, has been used favorably on high-type facilities. Also it has seen some application as a KEEP RIGHT sign. Sign No. 8 was selected to provide a materials comparison with No. 3.

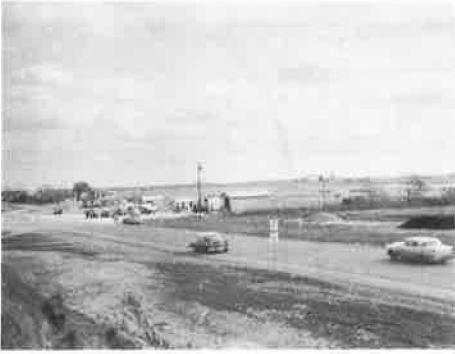
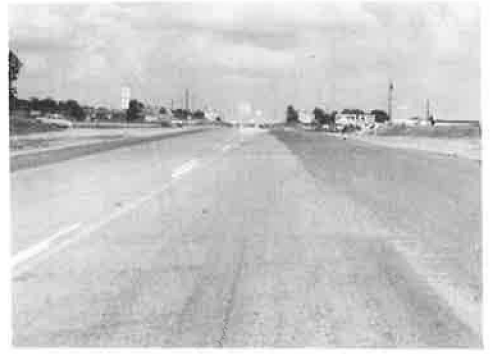
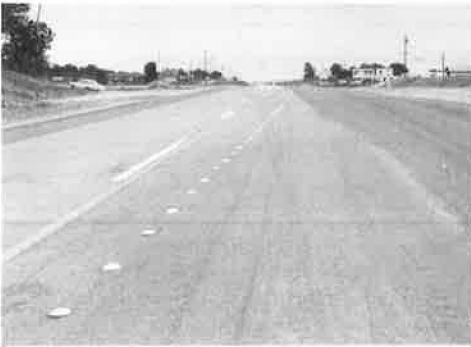
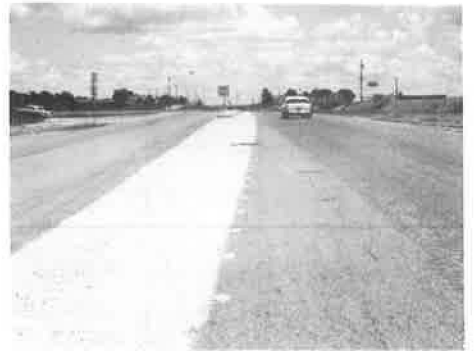
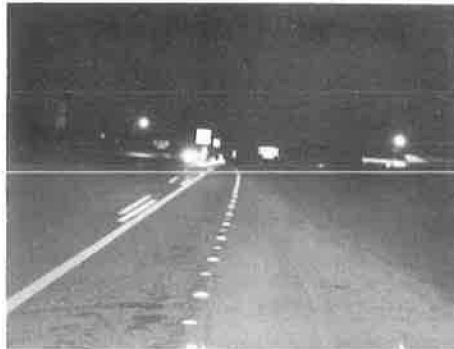
Figure 14. Views of Elgin Study.

CONDITION 1 - NO CHANNELIZATION

CONDITION 2 - CHANNELIZATION

CONDITION 3 - DELINEATION LINE

CONDITION 3 - RUMBLE STRIP

CONDITION 3
NIGHT VIEW OF
DELINEATION LINE
