# HIGHWAY RESEARCH RECORD

Number 31

## Traffic Control 3 Reports

# Shoulder Use on an Urban Freeway

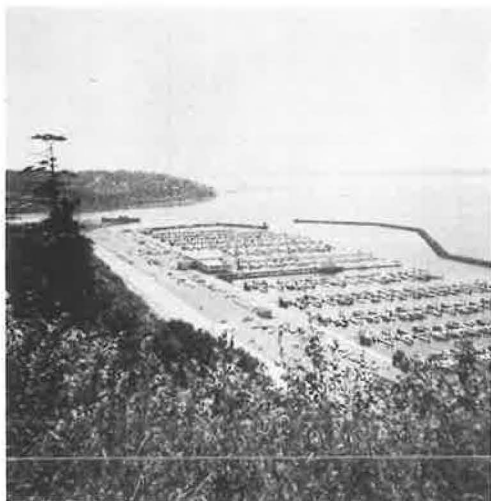
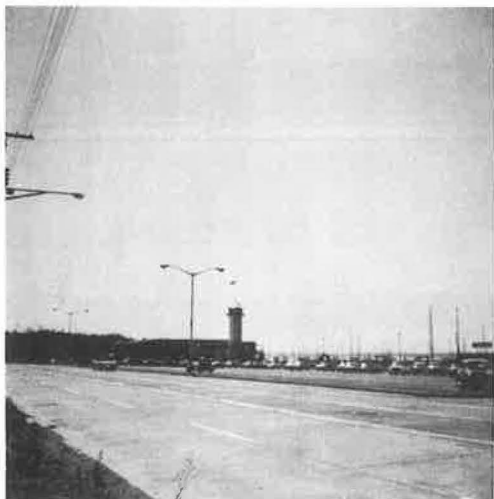
Figure 3. 2WLTTL installation serving a boating marina and beach area.

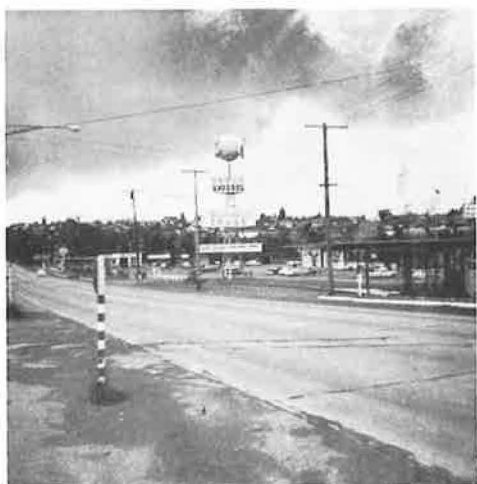
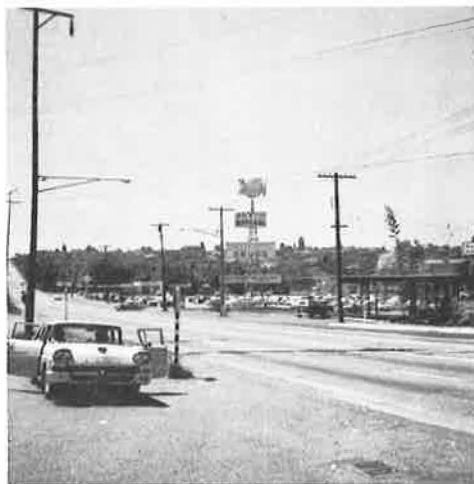
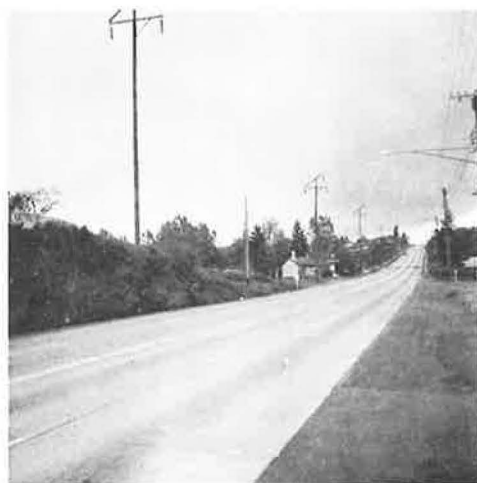
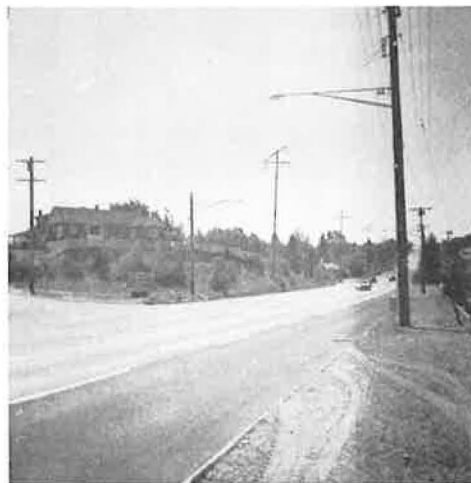
Figure 4. 2WLTL installations serving an outlying shopping center.

Figure 4 shows before-and-after views of a 2WLTL installation on an arterial serving an outlying shopping center. At the bottom, the existing inside lane to the right of the center line has been marked off as the 2WLTL and the shoulder has been paved over to become the new outside lane. However, many of the 2WLTL's have been added without constructing new lanes. Ordinarily, installation of a 2WLTL costs less than construction of a series of unidirectional left-turn lanes.

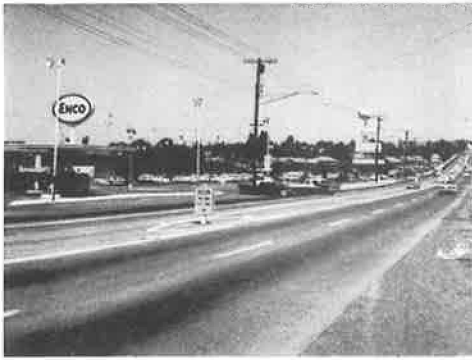
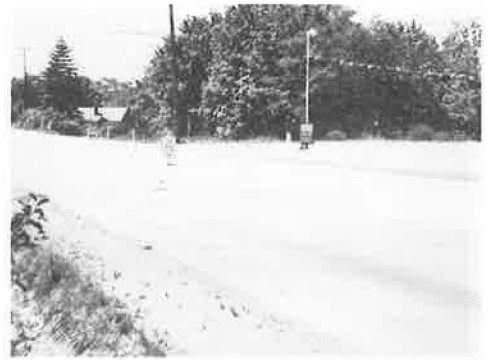
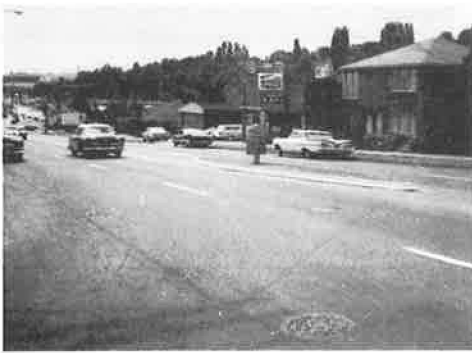
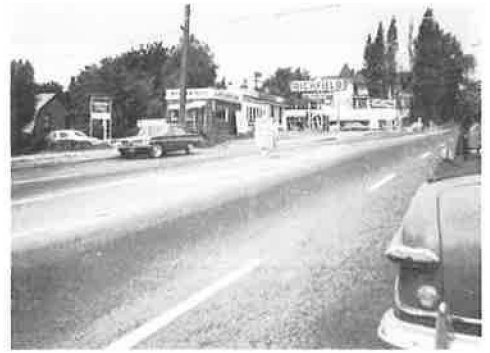
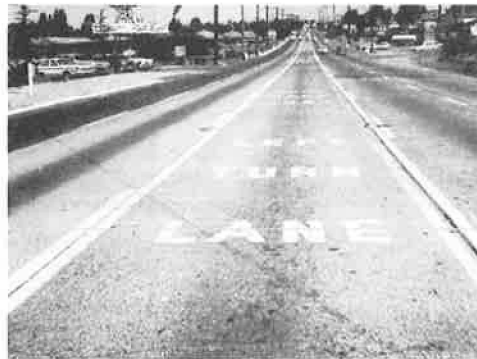
Figure 5. Signing and marking for 2WLTL installations.

Figure 5 shows examples of signing and marking for the 2WLTL. Figure 5A shows the signs placed at the beginning and end. These signs have also been used when the

2WLTL is interrupted by a unidirectional left-turn lane. The signs are set in small medial islands demarcated by traffic buttons. They are less likely to sustain damage, however, when placed on raised islands as in Figure 5B. Paint marking and button placement for the lane are shown in 5C. Note the use of the legend, "LEFT TURN LANE." This legend is always placed in a back-to-back manner so that it can be read from both directions of travel.

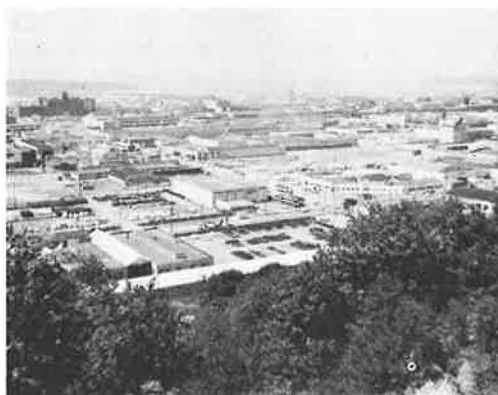
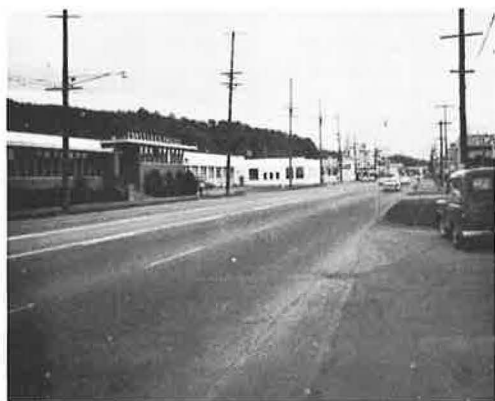
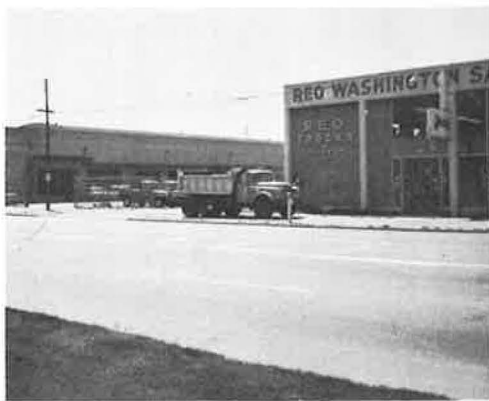
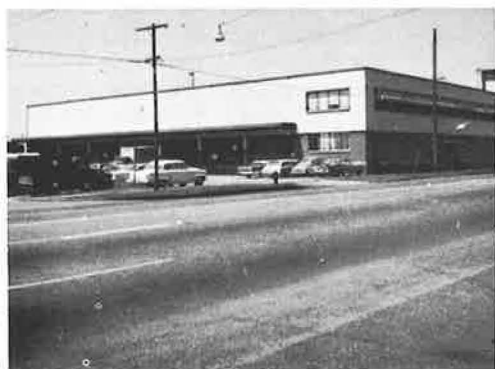
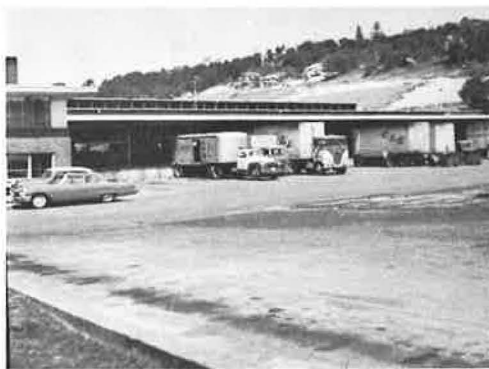
**A. Area served by Airport Way and 4<sup>th</sup> Ave. S. 2WLTL'S.**

**B. Typical generators along Airport Way.**

Figure 6. 2WLTL sites used in accident study.

These 2WLTTL sites are located in the industrial area of Seattle where various light and heavy industrial plants, warehouses, and trucking terminals are located. A part of the area served by these streets and close-ups of the streets and typical establishments located along them are shown in Figures 6 and 7. Characteristics of these installations are given in Table 1.

All cross streets along Airport Way and 4th Ave. S. are dead-ended by railroad tracks, except for two cross streets. Airport Way also lies beside a steel hill (Fig. 6B). Thus around-the-block movements cannot be used to effect left turns, making the use of a 2WLTTL highly desirable. Fourth Ave. S. originally had a raised median varying from  $2\frac{1}{2}$  to 5 ft in width (slightly wider where unidirectional left-turn lanes were located) before the 2WLTTL was installed. There were median openings at intersections and also a few midblock openings. Sketches of sections of Airport Way and 4th Ave. S. both before and after installation of the 2WLTTL are shown in Figure 8. A unidirectional left-turn lane was added at each of the two major intersections on Airport

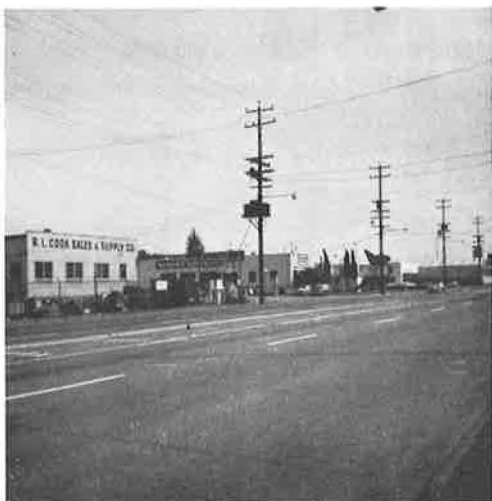
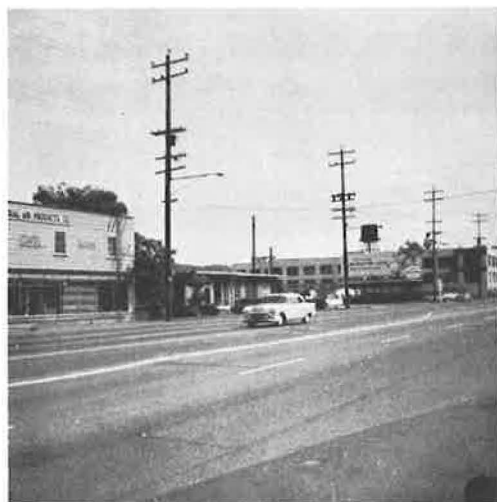
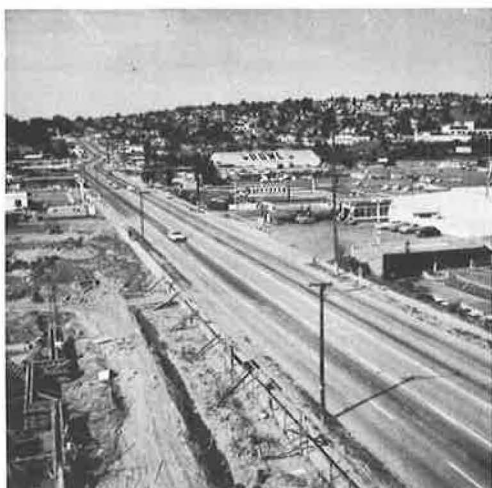
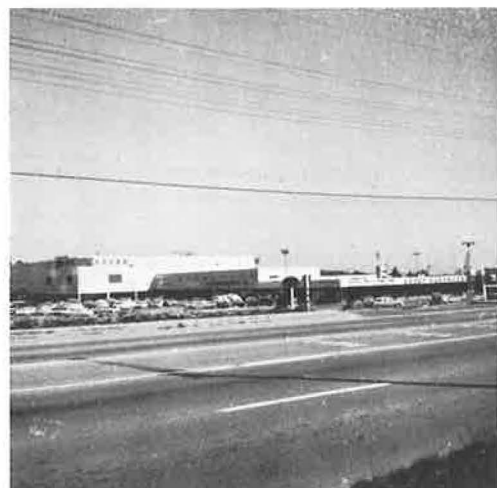
A. 4th Ave. S.

B. 25th Ave. N.E.

Figure 7. 2WLTL sites used in accident study.

A 2WLTL installation on 25th Ave. N. E. (Fig. 7B) was selected for studying only those accidents directly involving the 2WLTL. Because this street was widened from 2 to 5 lanes after installation of the 2WLTL, and because many new generators have been built since the installation, this street could not be used for a detailed before and after accident study. However, the various generators along the 2WLTL section (community shopping center, motels, apartments, filling stations) produce a high usage of the 2WLTL and an attendant greater number of 2WLTL accidents than on Airport Way and 4th Ave. S. This installation was also used in a study of certain operational charac-

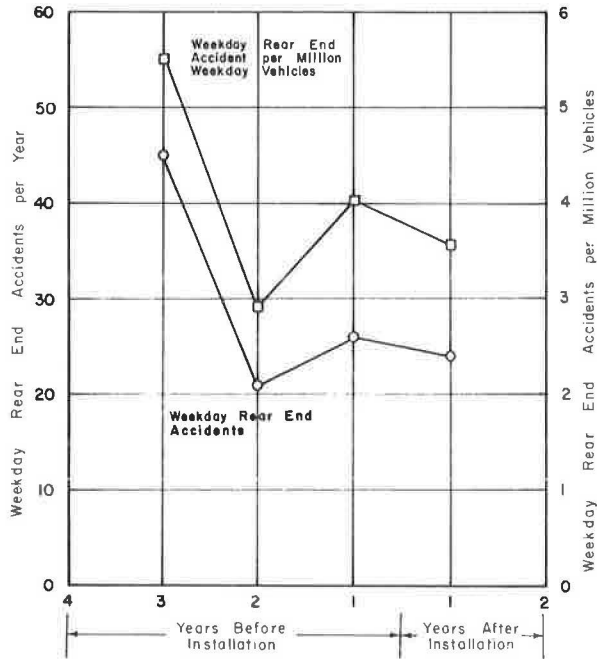
Figure 26. Weekday accidents and weekday accidents per million weekday vehicles on 4th Ave. S.

Figure 27. Weekday rear-end accidents and weekday rear-end accidents per million weekday vehicles on 4th Ave. S.

Volume-based accident rates for total weekday accidents and weekday rear-end accidents (Figs. 26 and 27) correspond rather closely to the related curves in Figure 23. Although Figures 28 and 29 show that total and rear-end accidents have been decreasing as compared to increases in Seattle accidents as a whole, the first year after shows a correspondence between Seattle and 4th Ave. S. data in terms of total and rear-end accidents.

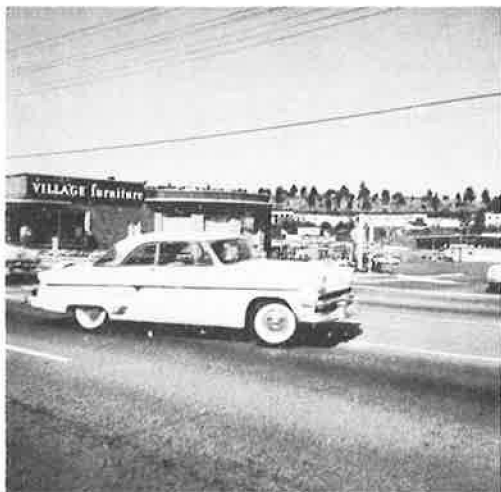
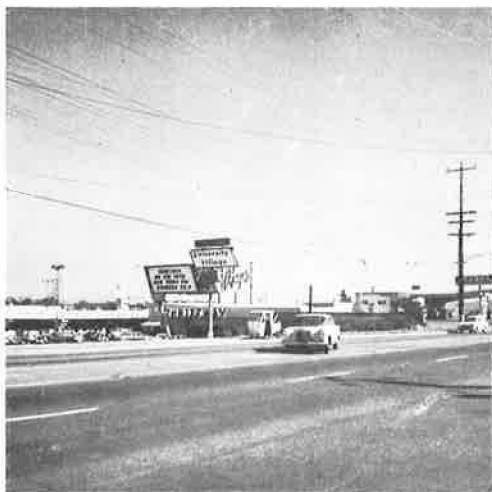
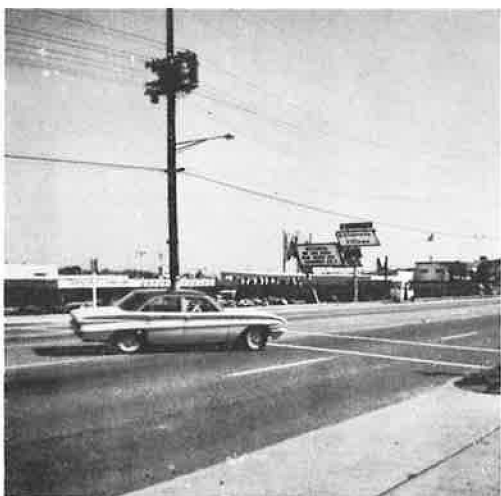
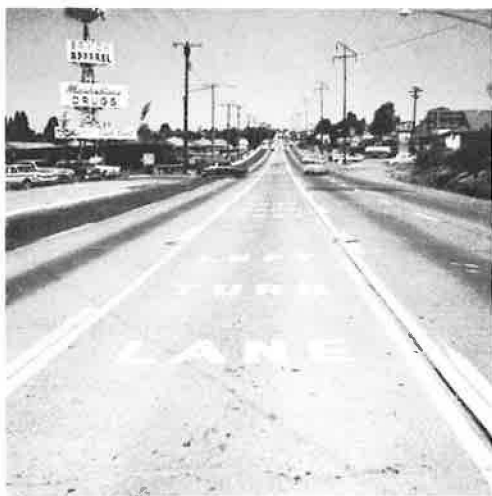
Figure 36. Motorists fail to make full use of 2WLTL.

**A. Motorists fail to use 2WLTL in turning left to generators and turn directly from the through lane.**

**B. Motorists turning left from generators cut directly across 2WLTL. Photo on right shows a vehicle crossing 2WLTL and entering the outside through lane.**

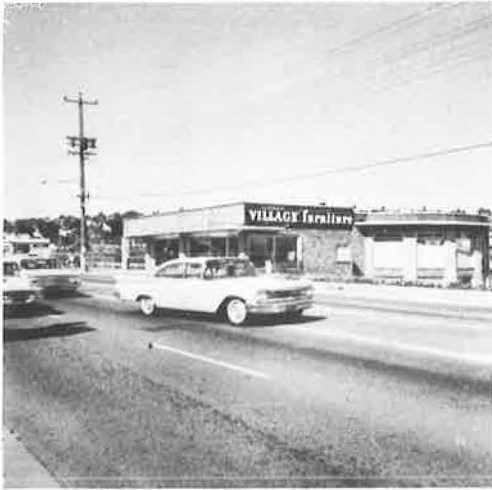
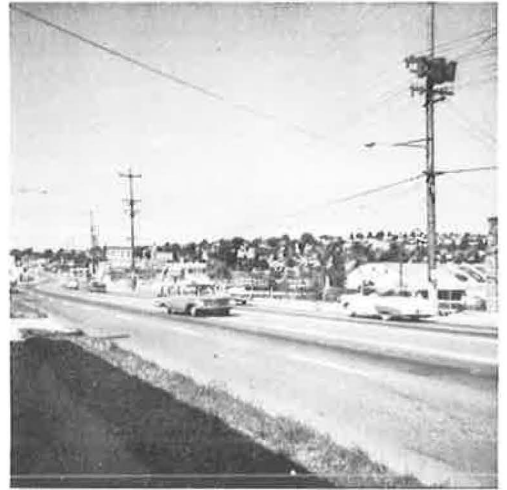
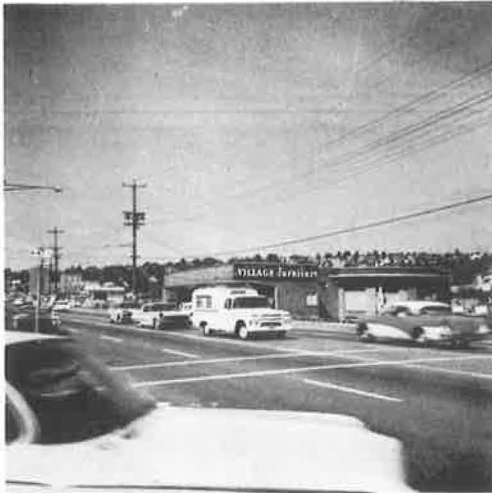
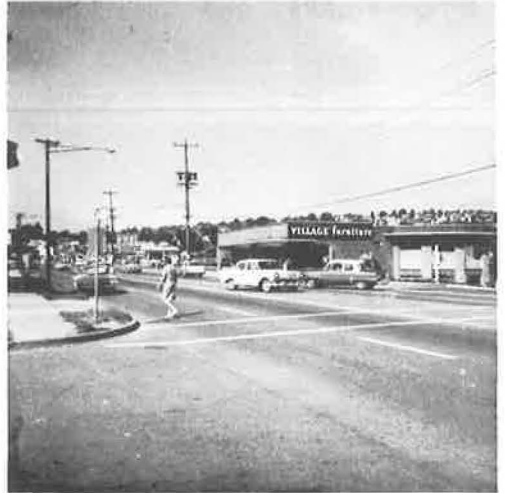
Figure 37. 2WLTL usage by automobiles on 25th Ave. N. E.

Most automobile drivers enter the 2WLTL on a reverse-curve path and entry is completed within 40 to 50 ft. Typical entry maneuvers by automobiles are shown in Figure 37A. A sample distribution of the distance traveled in the 2WLTL by automobiles at the 25th Ave. N. E. installation is shown in Figure 38. A fairly symmetrical distribu-

Figure 37B shows several automobiles waiting in line for the opposing traffic to clear before making their left turn. The 2WLTL offers an advantage over the unidirectional left turn with regard to limitations of storage and stopping in the through lane because the left-turn lane is full. There is fairly even placement of the vehicles in the 2WLTL. Figure 37C, however, shows a left-turning vehicle crowding the 2WLTL lane

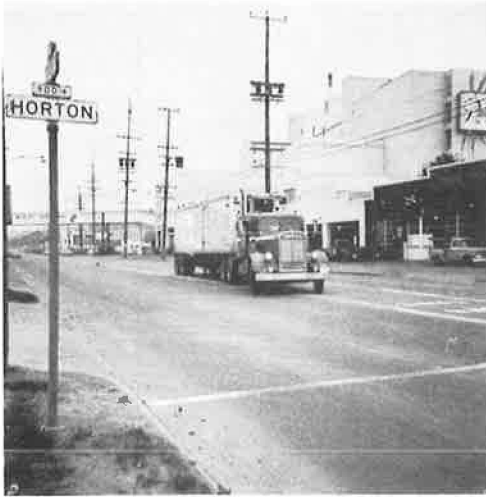
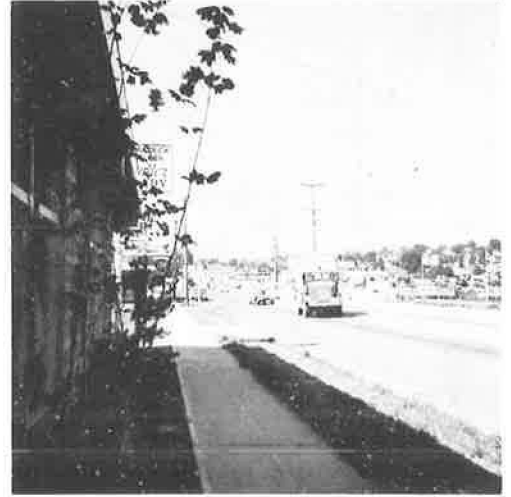
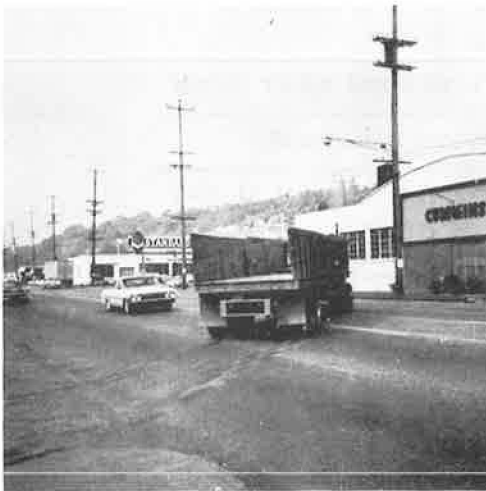
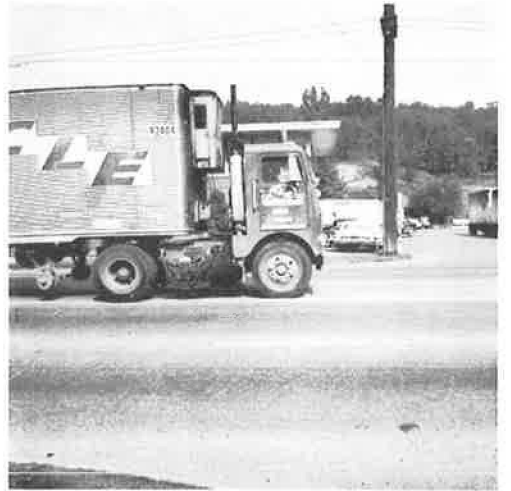
Figure 39. 2WLTL usage by trucks.

General observations of the use of the 2WLTL by trucks on Airport Way show that these drivers tend to use the 2WLTL in a fairly satisfactory manner. Figures 39A and B show trucks gradually easing into the through lane as they use the 2WLTL to accelerate to through traffic speed. Truckers make use of the 2WLTL for left turns from the generators to the through lanes (Fig. 39C). The large trucks occupying the 2WLTL in A and D demonstrate the desirability for providing a lane width equal to and perhaps greater than that of the through lane, which should be at least 10 ft wide.

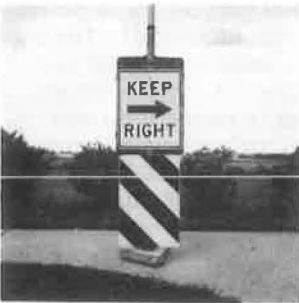
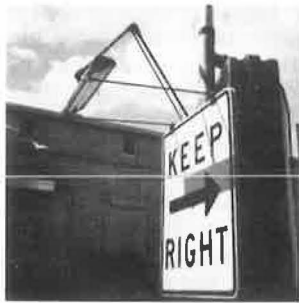
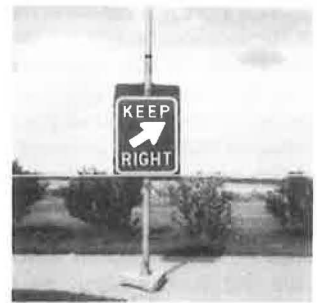
Figure 5. Test signs.

The KEEP RIGHT sign is of generally standard form (Fig. 5). However, there are several different innovations, depending primarily on the different types of materials and construction techniques.

Studies were conducted to compare the visibility and legibility characteristics of several types of signs and sign arrangements currently being used. The signs selected for study are shown in Figure 5 and described in Table 3. Most of these signs were selected because of their particular appeal in certain areas. The standard Texas Highway Department sign (No. 1) is used extensively throughout the State; however, some districts have recently gone to other types of signs or modifications of the standard type. In some districts, a hash mark panel has been placed immediately below the KEEP RIGHT sign. Also, some districts have installed external illumination on the standard type signs.

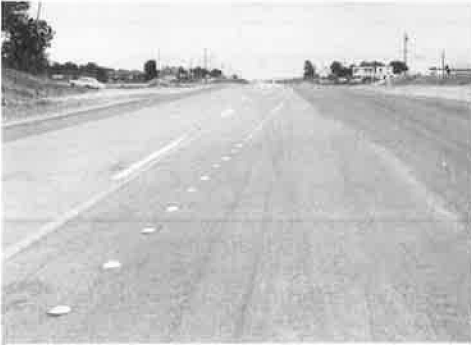
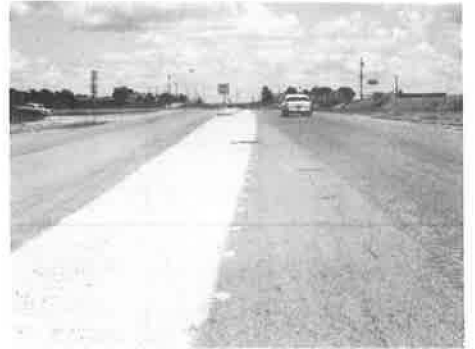
Figure 14. Views of Elgin Study.

CONDITION 1 - NO CHANNELIZATION

CONDITION 2 - CHANNELIZATION

CONDITION 3 - DELINEATION LINE

CONDITION 3 - RUMBLE STRIP

CONDITION 3  
NIGHT VIEW OF  
DELINEATION LINE
