# Correlates of 30-MPH Intersection Collisions

DERWYN M. SEVERY, Research Engineer, Institute of Transportation and Traffic Engineering, University of California, Los Angeles

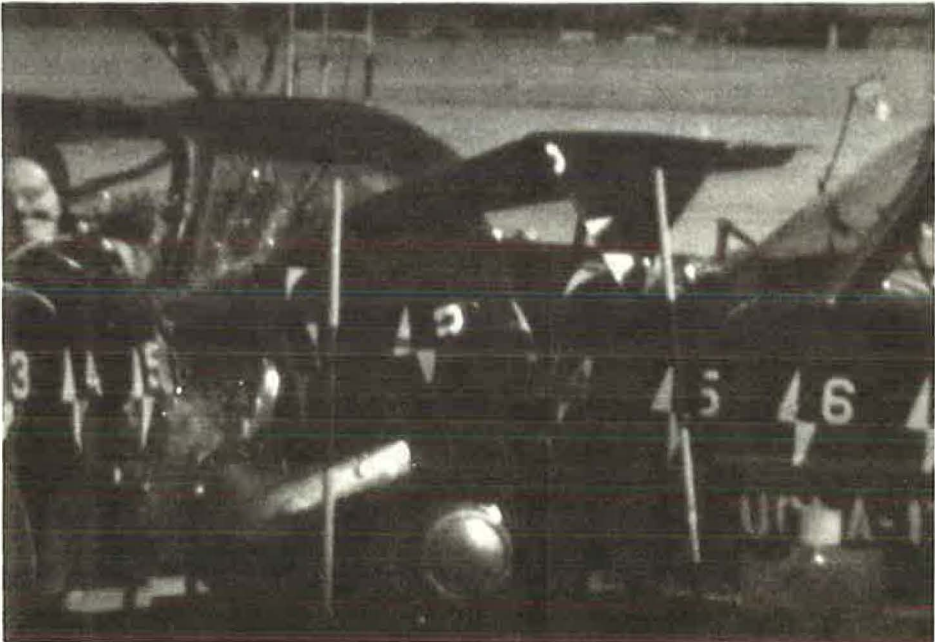
Figure 7. Experiment 62.

The driver of the struck car for both X-57 and X-62 wore a lap belt only. This condition of restraint was held constant in order to evaluate two different types of side-window glass adjacent to his head. In X-57 the left front side-window of the struck car was of tempered glass, whereas in X-62 it was of laminated glass. The impact of the driver's head shattered out the left front window of the struck car during X-57 (Fig. 6): the laminated glass was fractured during X-62 but remained in place (Fig. 7). The tempered glass accounted for a 53G peak acceleration, whereas the laminated glass accounted for an 82G peak acceleration (Figs. 4 and 5). Analysis of high-speed motion picture film showed that in both instances the head struck the side-window glass and that this glass was not additionally backed up by direct contact of opposing striking car structure.

The explanation for these anomalous data, wherein the resistance to blunt impact by tempered glass was less than the resistance by laminated glass of the same thickness, may be found by referring to the three causes of side-window breakage mentioned earlier. Inasmuch as both heads were seen by high-speed photography impacting the side glass, this action was quite understandably assumed to be the cause of the glass fracture. However, the other two factors, the motorist's shoulder stressing the base of the window and the striking car encroachment below the window were also operating and with considerable force. It appears that these stress concentrations increased sufficiently during the onset of the head impact with the glass to crack the glass with results different for tempered than for laminated. All head impact resistance by the tempered glass abruptly terminated when the edge stress reached a value sufficient to crack the glass and the glass ruptured completely from its mounts. A similar crack or series of cracks developing in the laminated glass will not appreciably diminish its

16. The impact of the driver's head shattered out the left front tempered window of the struck car during X-57; the corresponding laminated glass was fractured during X-62 but remained in place.

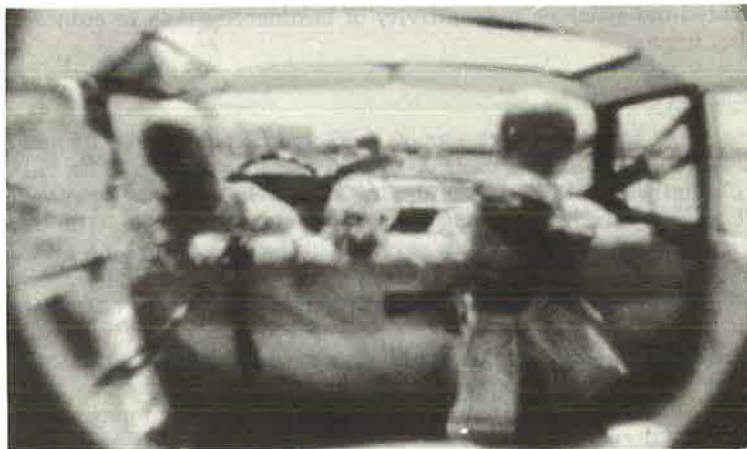
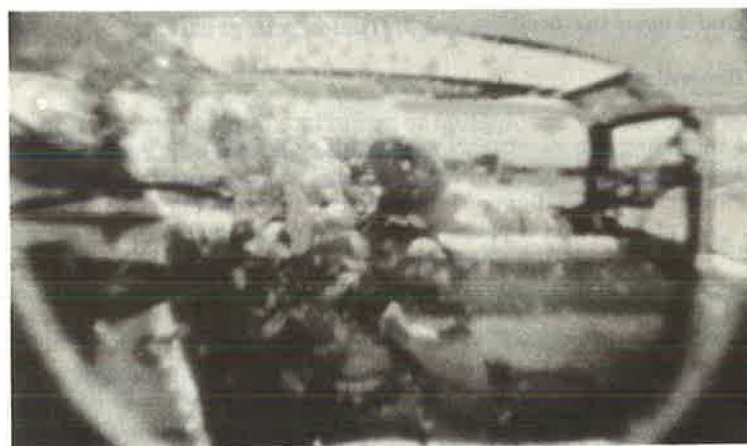
Figure 8. Inside struck car, X-57.

This discussion has concerned the movement of the right front seat passenger of the struck car illustrated in the sequence Figure 8 (X-57) and the companion Figure 9 (X-62). The shoulder cross-strap shown in Figure 8 for the front seat passenger passes from upper right shoulder to lower left hip and, therefore, does not offer as positive an upper torso restraint for impacts directed to the left side of the car, as for impacts directed at the right side. To the extent that the struck car is moving forward when impacted at its side, the contact at the side by the striking car decelerates the struck car; the inertial forces of the right front seat passenger develop forward movement of the dummy's hips (relative to the car interior) that function to tighten, through the slip-link, the diagonal chest strap. As a consequence of this slip-link feature, in the majority of the UCLA intersection collisions directed toward the belt side affording reduced protection, the dummy appeared to be rather well restrained by the cross-strap during the collision. The right front seat occupant's sideward movement for the two 30-mph correlate experiments shown in Figures 8 and 9 (struck car) was approximately the same for the dummy with a diagonal strap and lap belt as for the dummy with only the lap belt. Some allowance should be made, however, for the reduced degree of spinal articulation common to anthropometric dummies, as compared with their human counterpart.

In the same Experiment 62, referring this time to the striking car, a similar three-year-old child dummy was equally as effectively protected by the adult-type lap belt; although the rear seat back tore loose and contributed to the forces the dummy sustained (Fig. 11). When the three-year-old is standing on the right side, behind the front seat in the striking car, the exposure is substantially less than the comparable position for the struck car, because the striking car is abruptly jerked to its left, tending to pin the child against the right side of the car in a not-too-abusive manner. This description assumes that the right rear door remains closed under the high-collision tension-failure forces that are augmented by human body inertia forces collectively acting to open the door. Had the struck car been traveling in the opposite direction, the child would have been thrown violently across the front seat back to her left much in the manner experienced by the child shown in the Figure 8 sequence.

For Experiment 57 the struck car side-window glass was tempered and both left rear and left front windows were shattered with greater than 50 percent of the glass dispersal forced inside the car (Fig. 8). For Experiment 62 under the same collision exposure conditions, laminated side-window glass was installed. Both front and rear side-window glass fractured extensively but remained in place, except for about 10 percent of the glass for the upper forward corner of the left rear window that dislodged and was found inside the rear seat compartment.

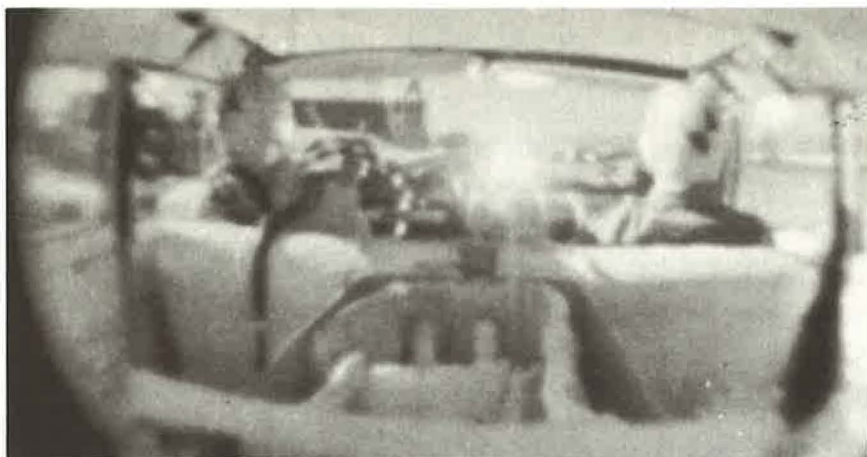
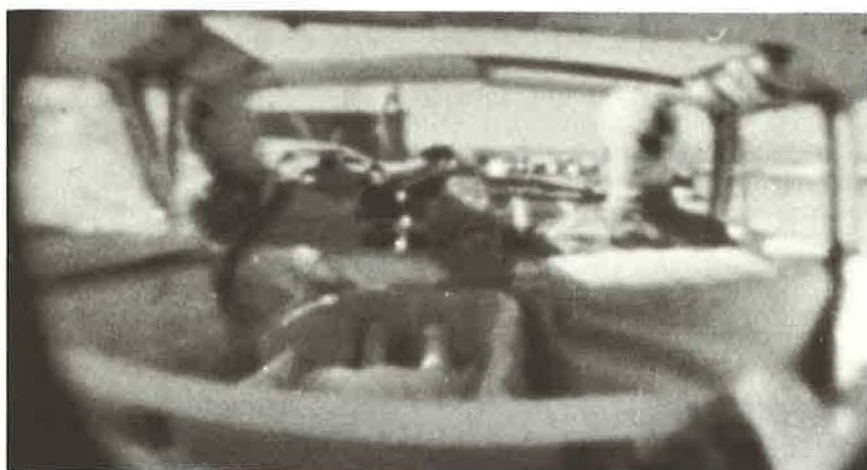
Figure 9. Inside struck car, X-62.

The infant standing in the center of the front seat of this struck car was provided with harness-type restraint and may be seen in Figure 9 riding out the crash in a rather uneventful manner, except for the abusive force applied subsequently by the adult sitting to her right (Fig. 12). An identical simulated six-month-old with the same harness restraint was seated between the two front seat motorists of the striking car and was observed equally as effectively restrained and was not so severely contacted by these front seat motorists.

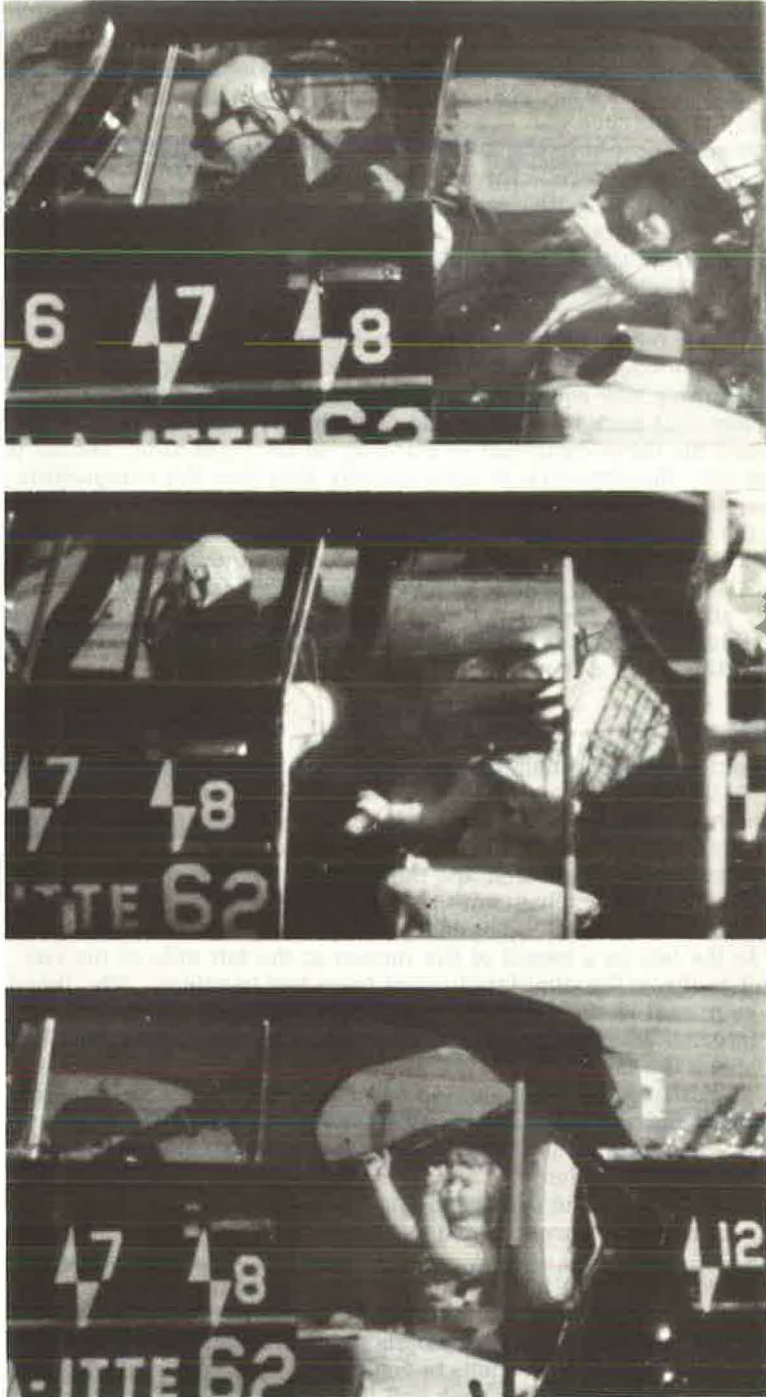
Figure 11. Lap belt protecting 3-yr-old.

Simulated children were included in this correlate experiment to provide additional information on the relative exposure hazards of children in various seated positions and postures with various means of restraints. In Experiment 62 the instrumented three-year-olds registered a 10G chest deceleration when riding in the striking car and a 10.7G chest deceleration when riding in the struck car (Fig. 5). However, the three-year-old in the struck car is secured by a lap belt that registered 200-lb loading, whereas the three-year-old in the striking car was unrestrained. The exposure positions are generally more severe for occupants in the struck car. The unrestrained child that was subjected to a 10G peak chest deceleration will frequently receive serious head injuries, for this exposure. The Figure 8 sequence, X-57, shows the probable extreme abuse a child experiences during impact when standing behind the front seat in the struck car. Under identical collision exposure conditions for X-62, except with this child dummy sitting on a cushion and restrained by an adult-type lap belt, the child was observed riding out the impact in an uneventful manner.
